SUMMARY

1212 Eagle View Dr NE, Pilot, VA
24138
Jay Garland
March 9, 2026

Randall Jenkins
Affordable Home Inspections
5409150107
rajones601@gmail.com

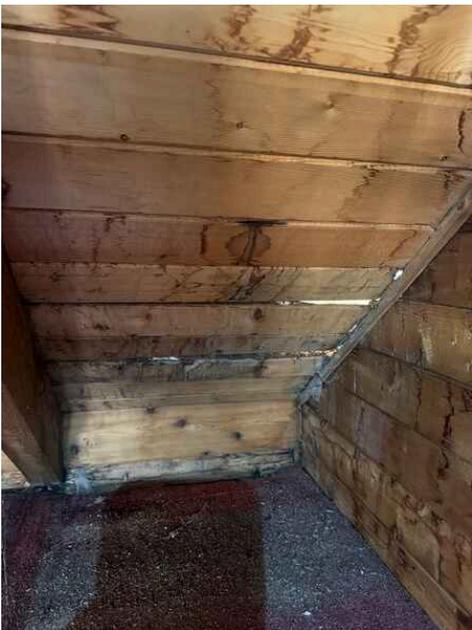
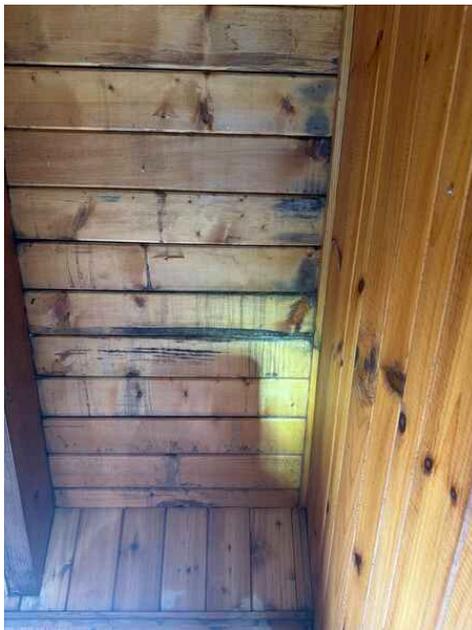
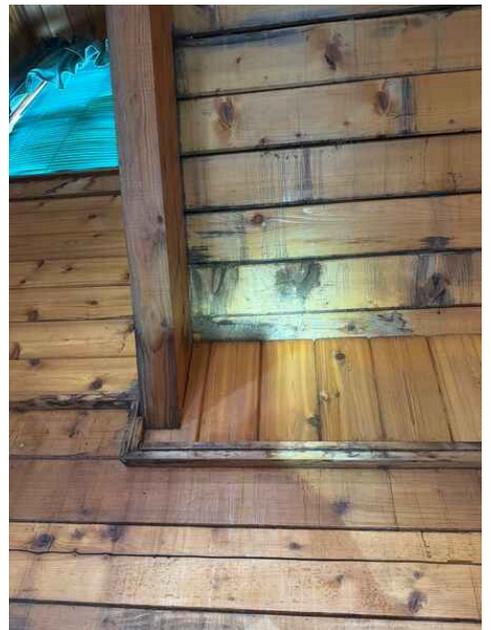
11.5.2 Ceilings

RECENT ROOF LEAK DAMAGE

Stains on the ceiling appear to be the result of roof leaks. The source of leakage should be identified and corrected, and the ceiling re-painted.

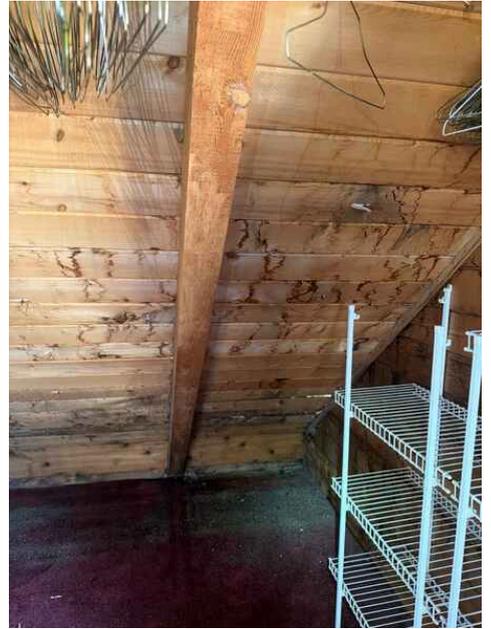
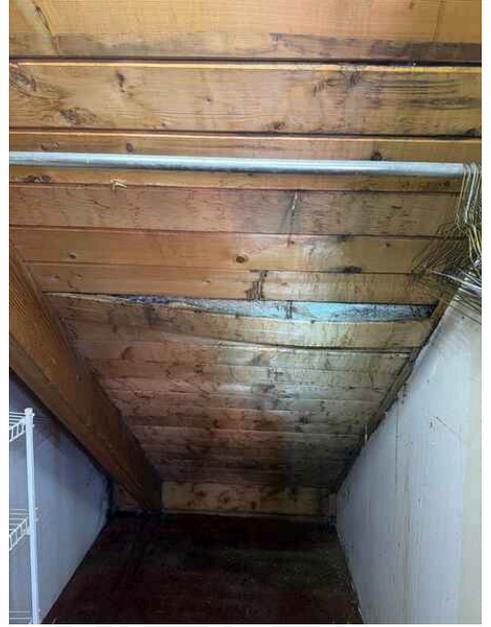
11.5.3 Ceilings

SEVERE DAMAGE

Severe ceiling damage observed. Recommend a qualified drywall or structural engineer evaluate and advise.

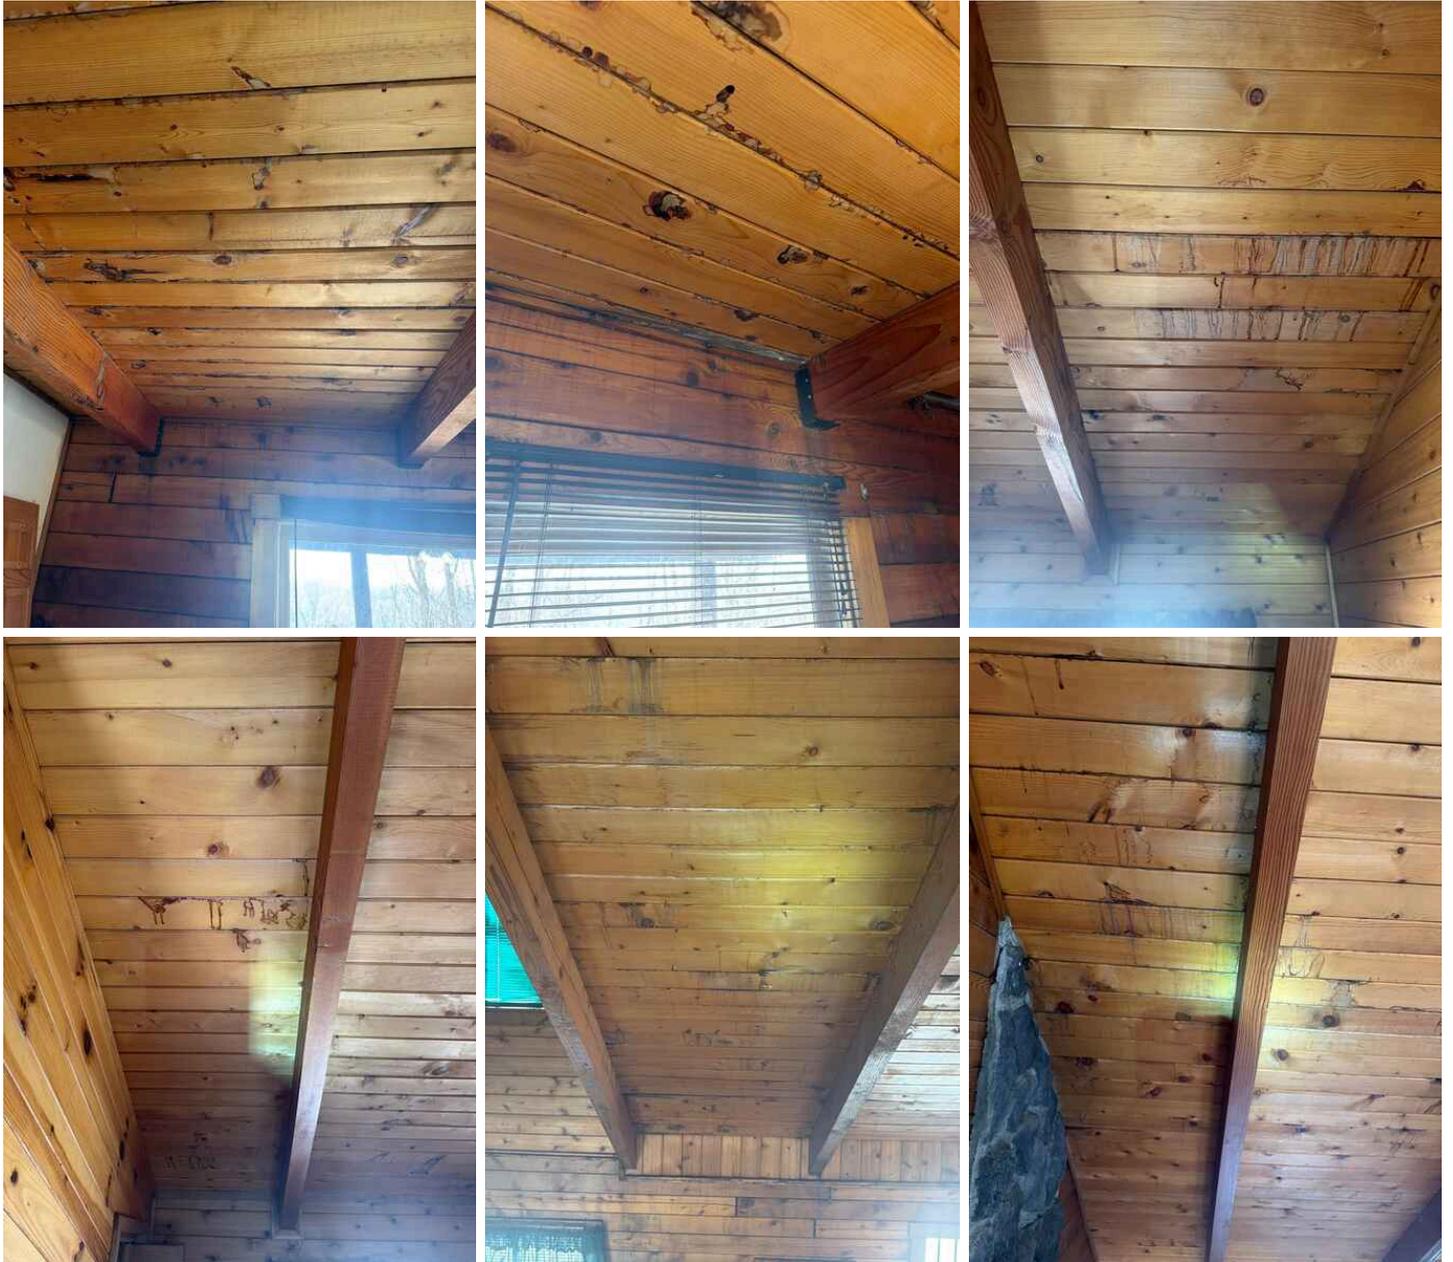
STAIN(S) ON CEILING

There is a stain on ceiling/wall that requires repair and paint. Source of staining should be determined.

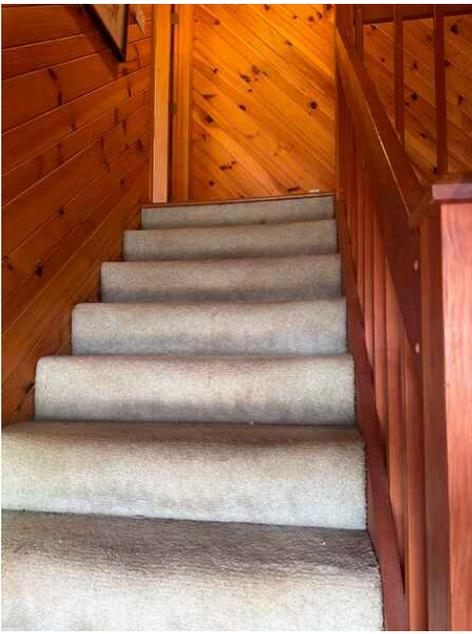
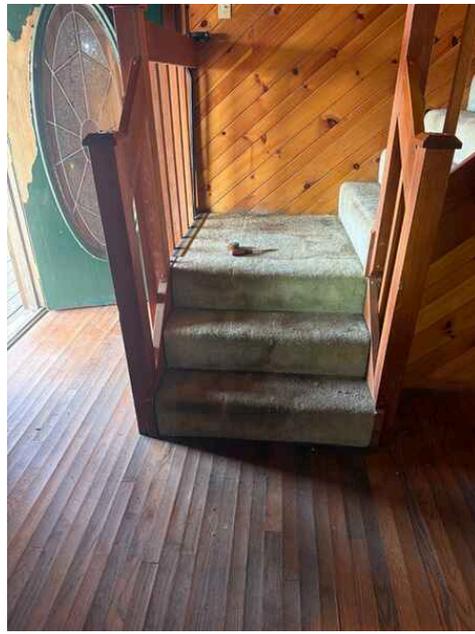
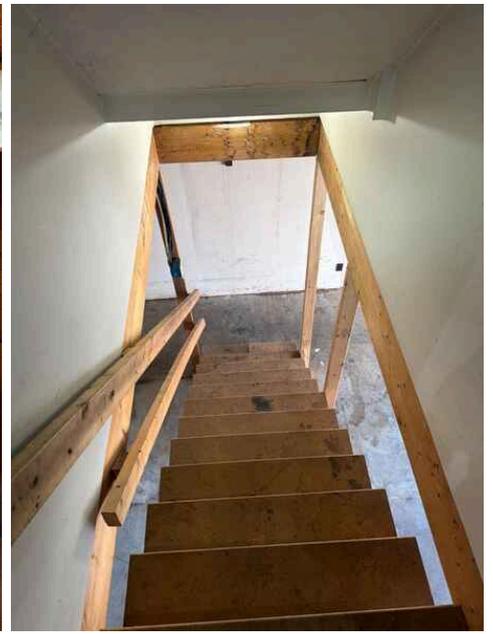
NO HANDRAIL

Staircase had no handrails. This is a safety hazard. Recommend a qualified handyman install a handrail.

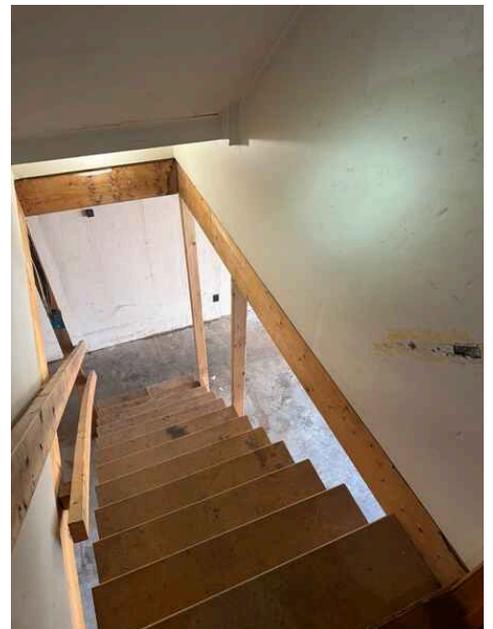
11.6.2 Steps, Stairways & Railings

NO GUARD RAILING

BASEMENT STAIRS

Contact a qualified professional.

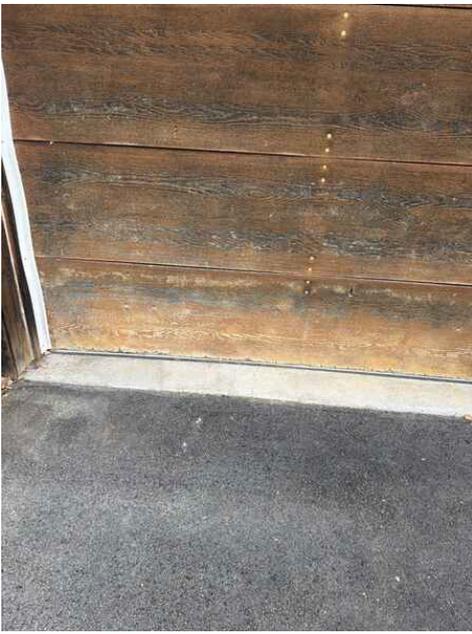
PANEL DAMAGE

Garage door panel is damaged and may need repair/replacement. Recommend a qualified garage door contractor evaluate.

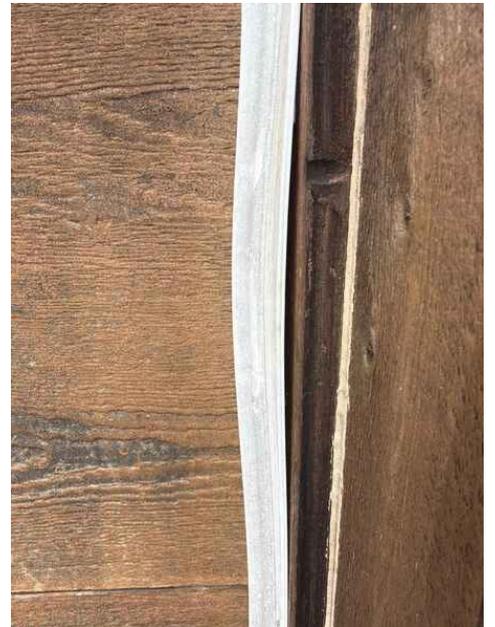
13.4.3 Garage Door
GARAGE DOOR SEAL

Door seal is loose or missing.

Recommendation
Contact a qualified professional.
