# ADM Home Inspections LLC

## SUMMARY REPORT

**Client:** Scott & Brooke Gordon  
**Inspection Address:** 1932 Aspen Ln, Overgaard, AZ 85933  
**Inspection Date:** 9/18/2026 Start: 9:00 am  
**Inspected by:** Ayrton Mapes

## CONFIDENTIAL INSPECTION REPORT

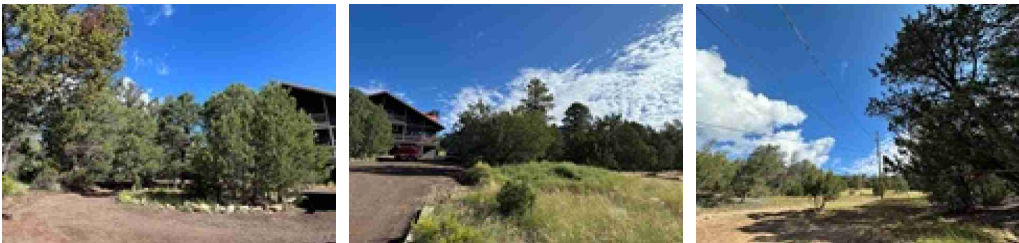
The property's shrubs and trees, in general, appear healthy. As we are not specialists in shrubs and trees, I recommend that you consult a landscape/nursery contractor or arborist for a specialist's opinion.

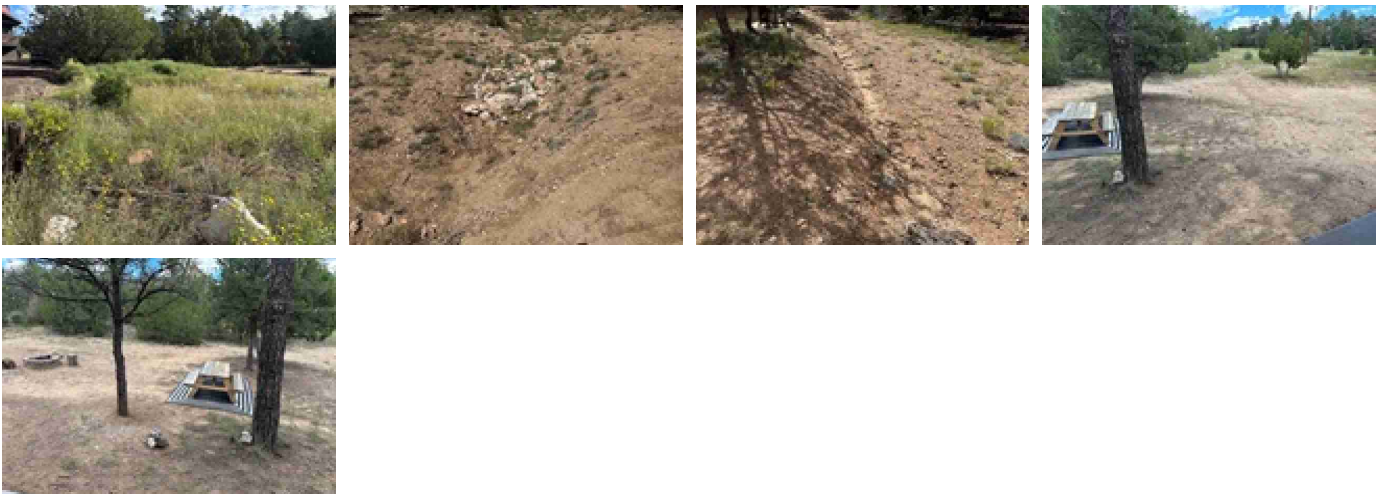
Landscaping remains incomplete and or natural, but should include hard surfaces, area drains, and proper drainage away from the foundation walls etc.

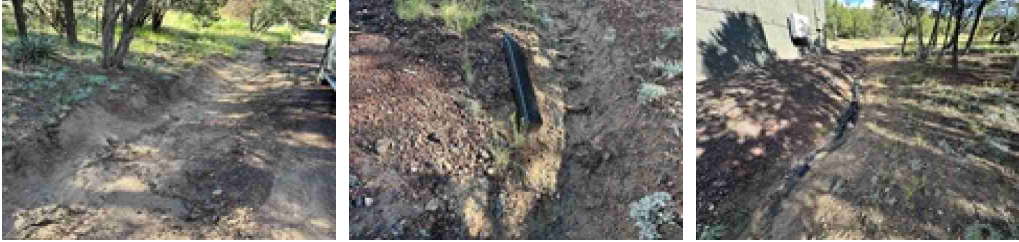
There are missing or broken area drain covers which is indicative of poor maintenance service - *Continued*

There are missing or broken area drain covers. This is indicative of poor maintenance service, and could have allowed leaves and other debris to enter the drain lines and contribute to blockages. Therefore, it would be prudent to have the lines flushed through to the street or to their termination point before the broken covers are replaced.

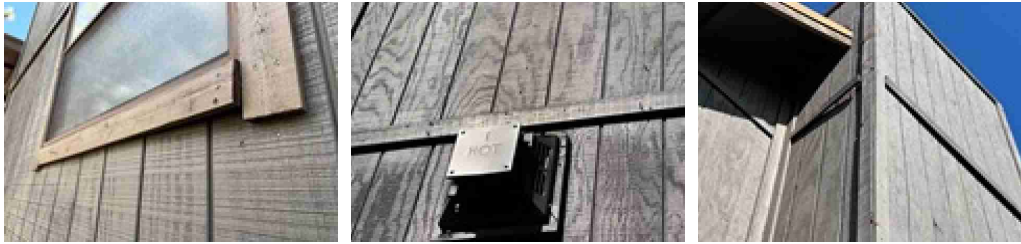
A portion of the trim pieces are loose and or damaged - *Continued*

Sections of the fascia and trim are weathered and need typical maintenance type service such as sanding, painting or staining in order to protect the wood underneath. This is particularly true on the south facing side where they are exposed to direct sunlight.

A portion of the trim pieces are loose, missing and or damaged.

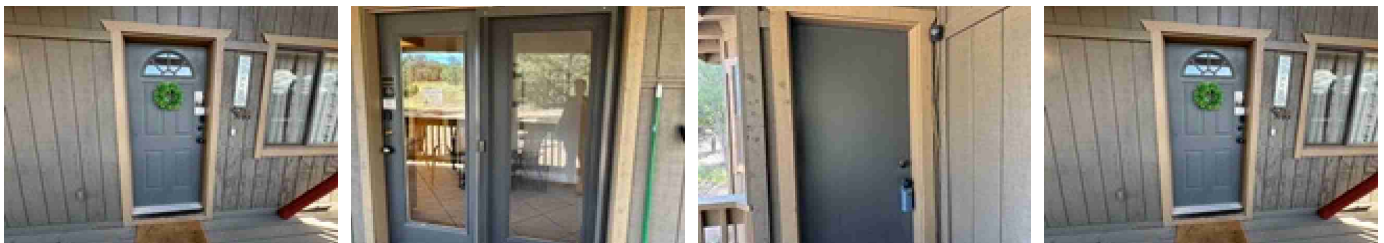
All exterior doors are in acceptable condition. They open and close smoothly as intended.

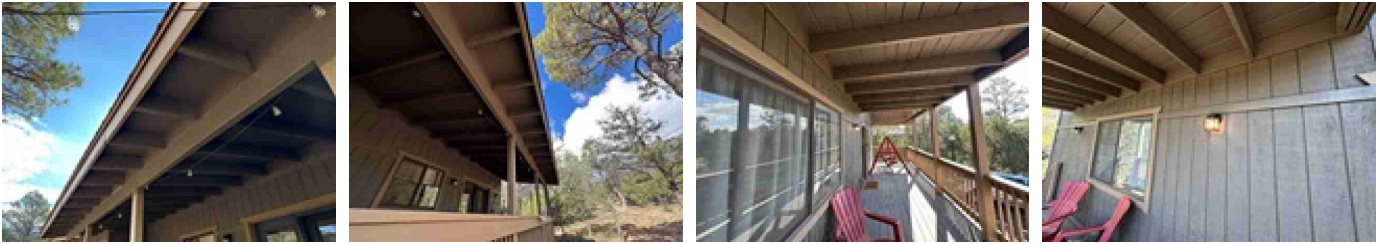
The patio cover is in acceptable condition - *Continued*

The patio cover, in general, is sturdy and in acceptable condition.

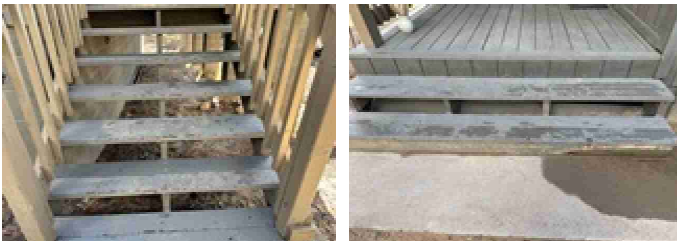
The steps are in acceptable condition.

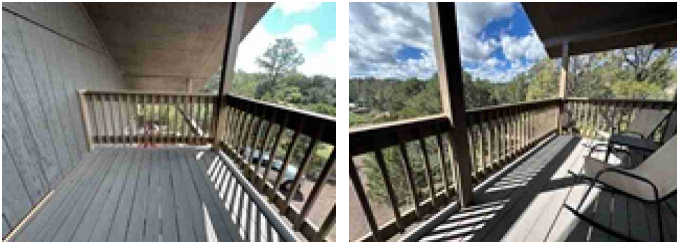
Balcony decking needs typical maintenance - *Continued*

Balcony decking needs typical maintenance, such as securing loose planks, setting nails, sanding, or sealing, all of which will prolong the life of the balcony.

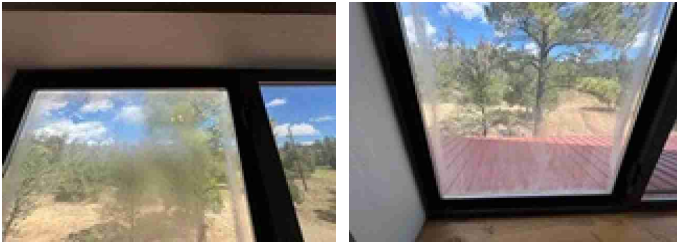
There are window panes with broken hermetic seals that should be replaced - *Continued*

There are multiple window panes with broken hermetic seals which you should have all windows evaluated by a glass company and repaired as needed. Upstairs small bedroom.

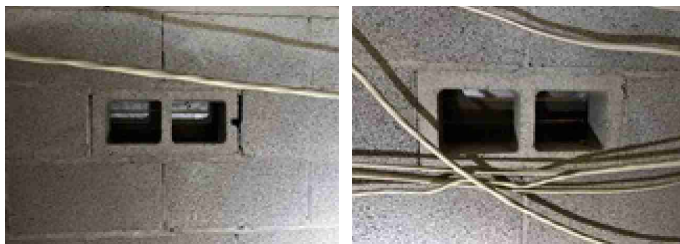
The crawl space vents have been closed. You should consider re-opening the vents to provide adequate and positive air flow in order to prevent moisture related issues.

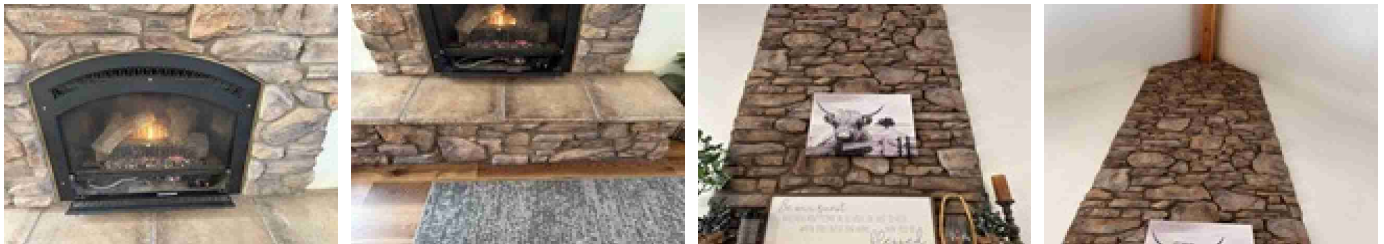
The gas fireplace is in good condition which is located in the main living area. The hearth appears to be in good condition. There is a 3 walled metal flue extending through the chimney chase with a metal cap.

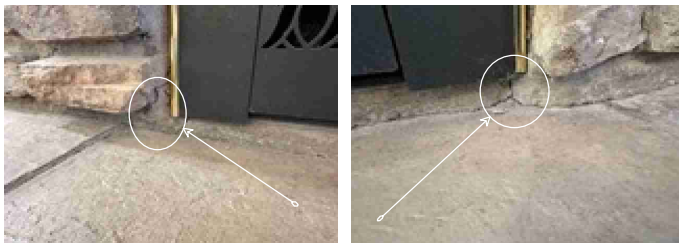
There are insignificant cracks, or missing mortar, in the fireplace that would not necessarily need to be serviced, but you may wish to have a specialist confirm this.

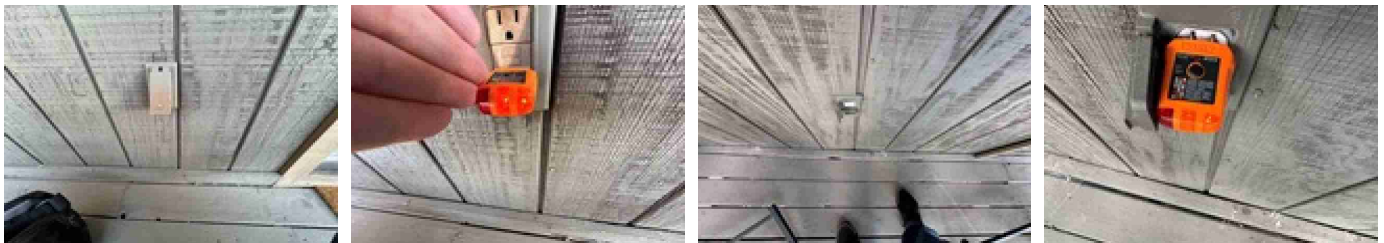
A ground-fault protected outlet does not trip when tested and should be serviced. Next front door.

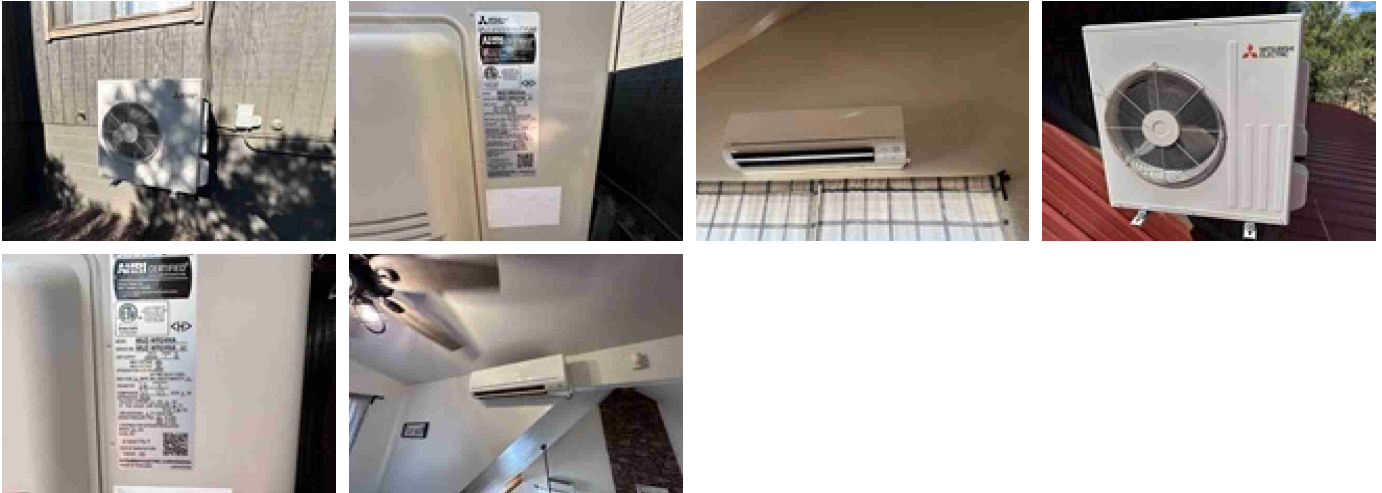
Central heat and air-conditioning are provided by a heat pump, with an air handler located on the side of the house.

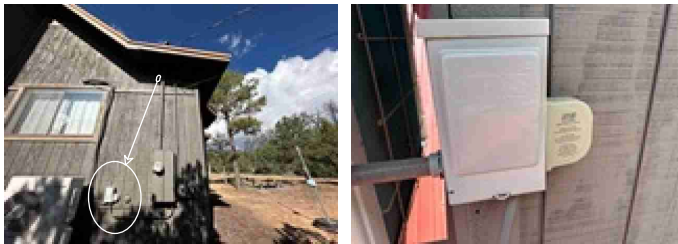
The electrical disconnect at the condensing coil is functional.

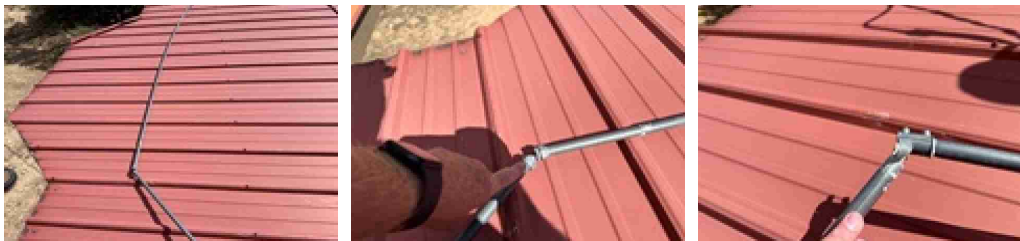
The electrical connection to the heat pump has been made without a wire clamp to protect the wires from chaffing.

Electrical conduit not well secured to the wall.

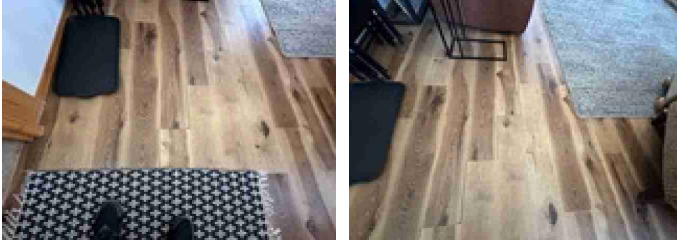
The floor coverings have typical lived in cosmetic damage, which is typical for the it's age.

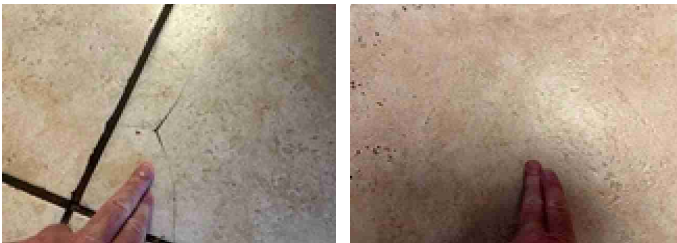
There are cracks in the tiles, which you should view for yourself. They are likely to have been caused by foundation movement, cracking or an insubstantial mortar base, but you may wish to seek the opinion of a specialist.

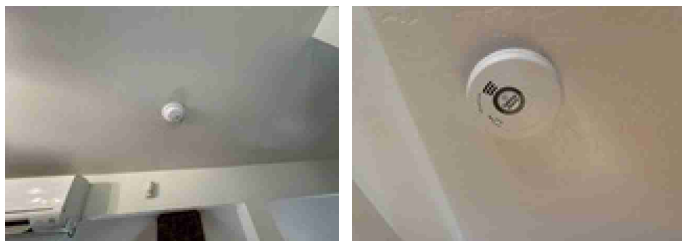
All installed smoke detectors within reach are functional, each should be checked periodically for battery life. It's recommended to install detectors in every bedroom and main living space throughout the house. I also recommend installing new batteries and testing the units when you move in to ensure your safety and every six months thereafter. If the detectors are suspected to be older, I recommend replacing.

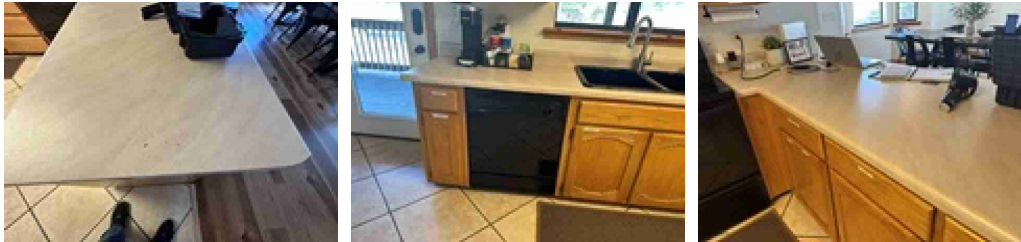
The counter top has typical cosmetic damage, which would not necessarily need to be serviced.

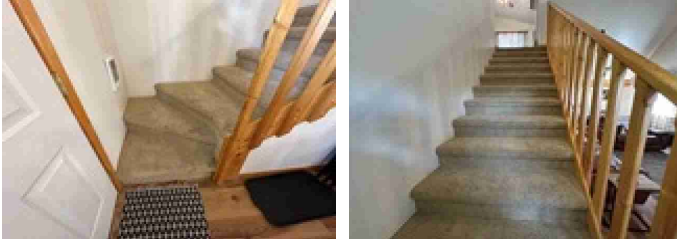
The floor has no significant defects. Each tread and riser are equally spaced.

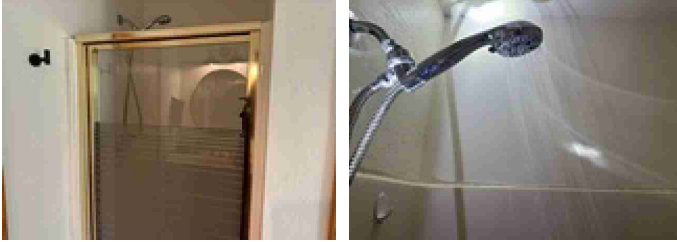
The stall shower is functional - *Continued*

The stall shower is functional. The surround will need to be re-caulked annually as preventative maintenance, in order to maintain a water tight seal.
