# **Inspection Report**

Property Address: 252 Ryland Road Tyner NC 27980

Home Spec of NC, Inc.

**Style of Home:** Single Family Home, Manufactured Age of the Structure: 1998 +/- Client Is Present: No

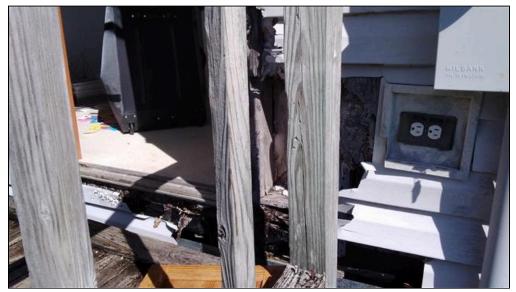
2.0 Item 12(Picture)

**2.0** Numerous siding panels are showing broken and open areas. Examples: 1-12 These are all around the house.

Refer to a siding contractor for an evaluation and an estimate to repair or replace.

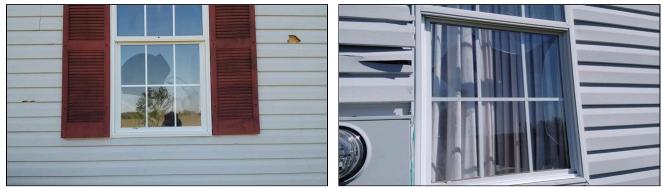
2.2 Item 1(Picture)

**2.2** Right elevation, front window. Item 1(Picture)

Window next to rear entrance. Item 2(Picture)

Refer to a window specialty contractor for repair of this broken glass.

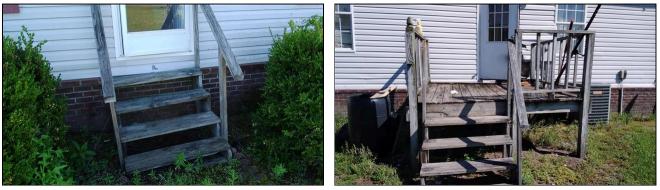
2.3 Item 1(Picture)

**2.3** Front and rear steps show amateur workmanship and aged materials. Item 1(Picture) Item 2(Picture)

Plan on replacing these steps.

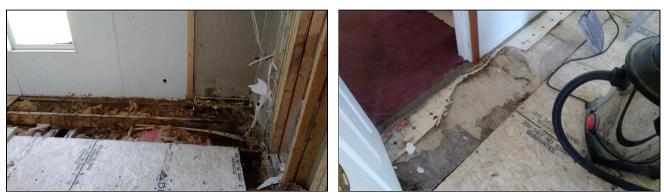
3.2 Item 3(Picture)

**3.2** Essentially all floor coverings will need to be replaced. Some have already been removed for floor structural repairs.

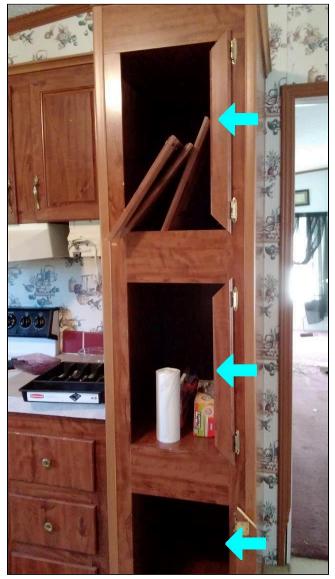
3.3 Item 3(Picture)

(2) Multiple damaged cabinet doors were found. Item 3(Picture)

Refer to a technician who can replace these doors.

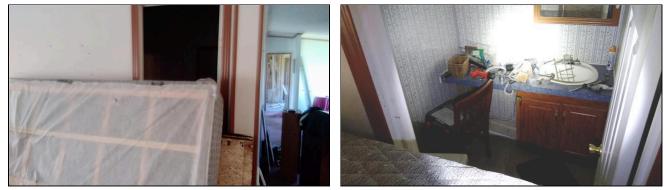
3.7 Item 1(Picture)

**3.7** Half bathroom was not observed. Construction materials are blocking the entrance. Item 1(Picture) Item 2(Picture)

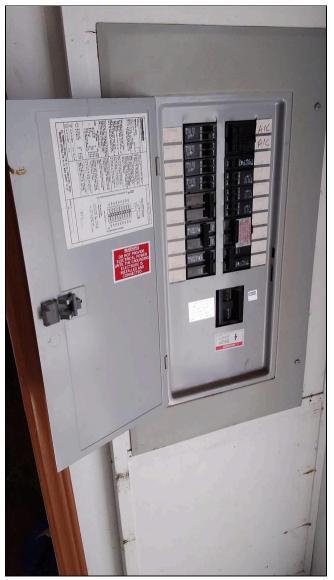
6.1 Item 1(Picture)

**6.1** The main panel box is located in the utility room. There were no sub-panels found. The panel was opened for observation. Item 1(Picture) Item 2(Picture)

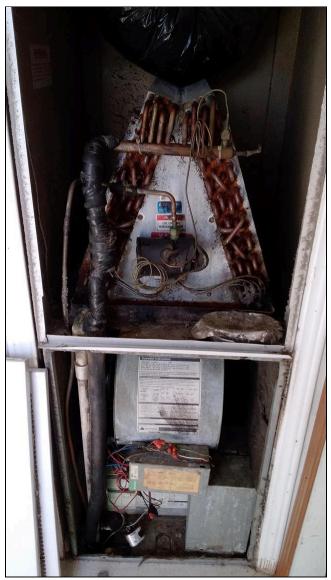
7.0 Item 2(Picture)

**7.0** Intertherm/Nordyne original unit. This is a 3 1/2 ton split system heat pump. Item 1(Picture) Item 2(Picture) Item 3(Picture)

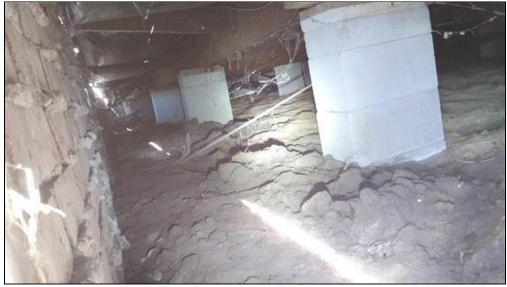
10.5 Item 1(Picture)

- **10.4** Ventilation is present around the foundation.
- 10.5 Foundation materials are masonry materials. Item 1(Picture)

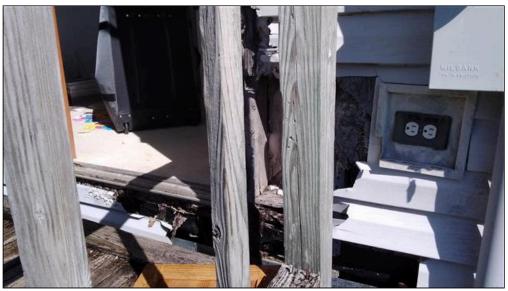
2.0 Item 12(Picture)

Numerous siding panels are showing broken and open areas. Examples: 1-12 These are all around the house.

Refer to a siding contractor for an evaluation and an estimate to repair or replace.

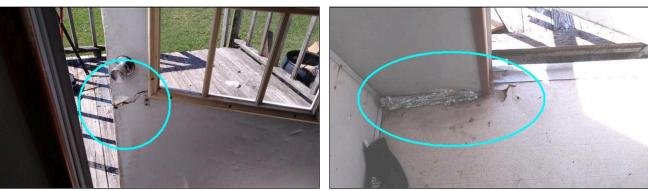
2.1 Item 1(Picture)

Rear door is broken and there is evidence of water leakage at the bottom corner of the opening. Item 1(Picture) Item 2(Picture)

Refer to a contractor for evaluation and repair or replacement.

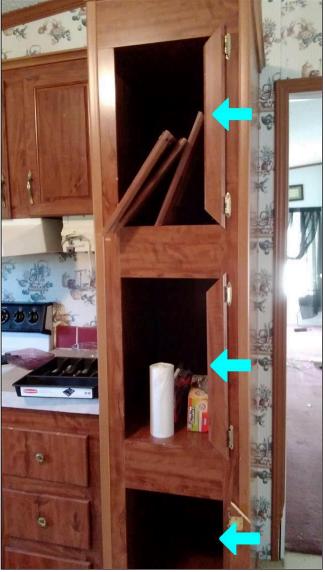
3.3 Item 3(Picture)

3.3 COUNTERS AND A REPRESENTATIVE NUMBER OF CABINETS Inspected, Repair or Replace
(2) Multiple damaged cabinet doors were found. Item 3(Picture)

Refer to a technician who can replace these doors.
