Home Inspection Report

7506 W Montecito Ave
Phoenix, Arizona 85033

Prepared for: [Joseph Markowicz](#)

Prepared by: [I.C. Home Inspections](#)
[1061 E Washington Ave](#)
[Gilbert, Arizona 85234](#)

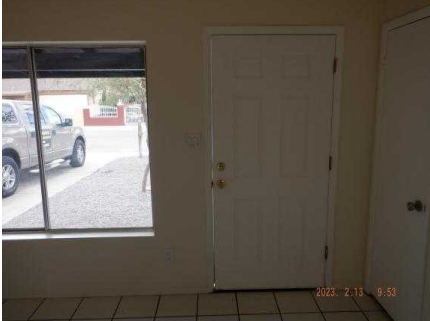
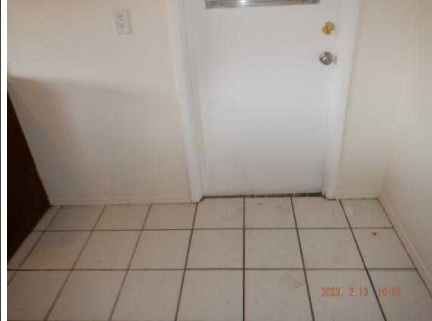
1. Exterior Perimeter Exterior Surface Entryway Doors (#15): [operation of all] All exterior doors:
 - The kitchen door is missing the threshold (bottom seal).
 - The front door weather-stripping is missing or needs adjustment so that daylight is not seen from the inside when the door are closed.
 - The door to the carport is damaged. A qualified licensed contractor is recommended to inspect this system, evaluate all findings, make recommendations and estimate repairs or maintenance.

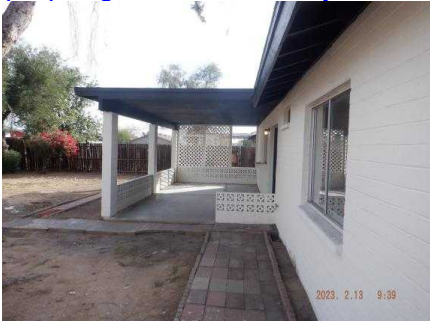
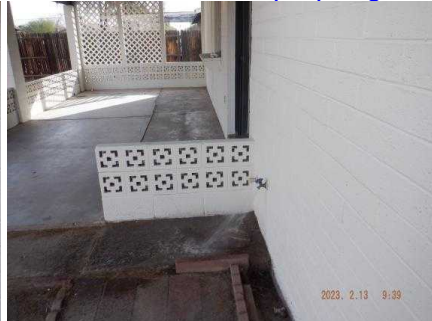
2. Exterior Perimeter Exterior Surface Grading, Drainage (#22): Flat grading with minor slope for Drainage: (Improper Slope) Water will pool next to the foundation at many areas around the home. Water should always pool away from the foundation. A small slope away from the foundation is the recommended slope. This will minimize the risk of settling, water penetration, wood rot and emulsification (damage to the cement due to excessive moisture by washing away of the cohesive minerals). A qualified licensed contractor is recommended to inspect this system, evaluate all findings, make recommendations and estimate repairs or maintenance.

(Proper Grade) As a general rule a proper grade makes water run to the sides of the home, away from the foundation and runs out toward the front of the home and onto the street. It is not always possible to determine proper grade and the buyers is advised to monitor for proper grade when it rains.

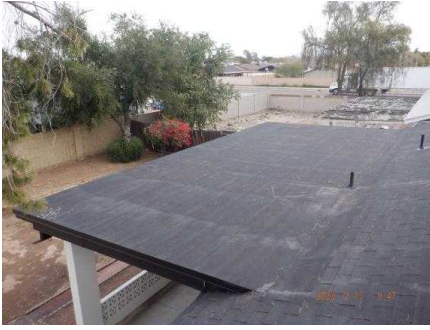
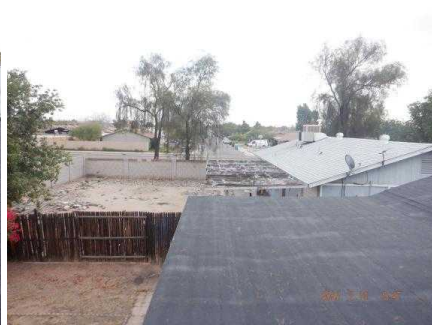
3. Patio Roof Roof Surface Roof Covering Material (#25): Rolled Roof:
 - The patio rolled roof needs was painted in black paint (should be coated with an Elastomeric coat - unknow what effects regular paint will have - unprofessional work to say the least). A qualified licensed contractor is recommended to inspect this system, evaluate all findings, make recommendations and estimate repairs or maintenance.

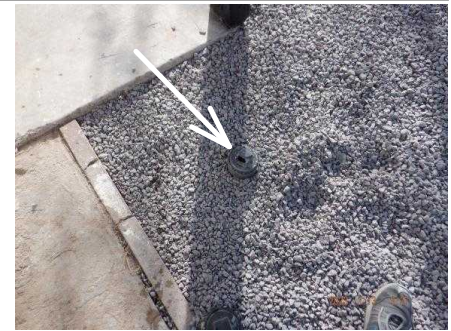
4. Waste & vent piping system (36): ABS Pipe:

- One of the access covers is damaged. A qualified licensed contractor is recommended to inspect this system, evaluate all findings, make recommendations and estimate repairs or maintenance.

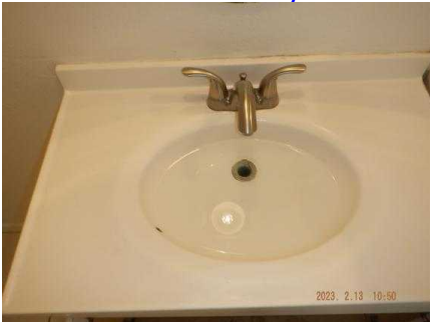
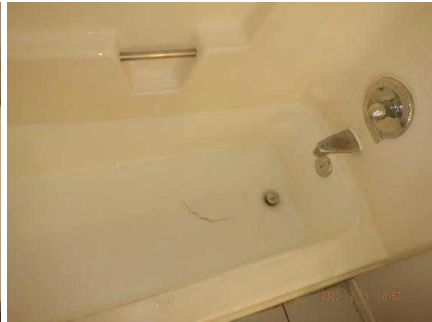
5. Functional Drainage (#38): A minor obstructions were found:

- The bathroom sink and tub have what is considered a slow drain (hair in the traps?). A qualified licensed contractor is recommended to inspect this system, evaluate all findings, make recommendations and estimate repairs and or maintenance.

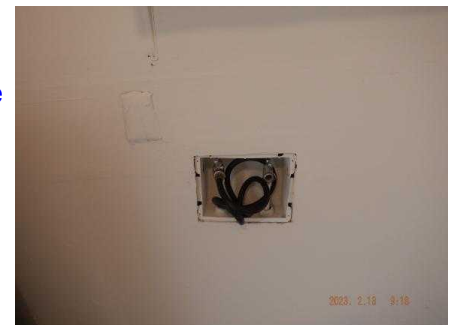
6. Laundry Washer Hose Bibs (#32): Rotary Hose Bibs:

- The moisture cover is missing. A qualified licensed contractor is recommended to inspect this system, evaluate all findings, make recommendations and estimate repairs or maintenance.

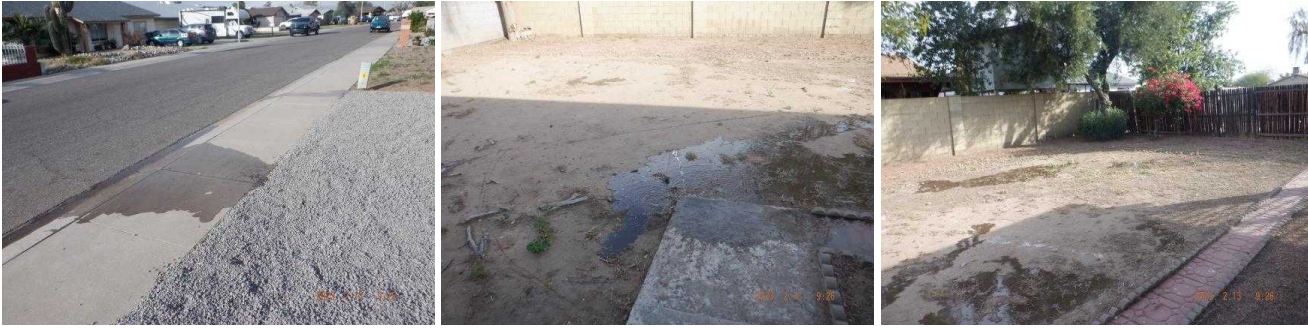
7. Sprinklers/Drip System: Front and back yard:

- The sprinkler system appears to have a broken under ground pipe (water coming up from the dirt). A qualified licensed contractor is recommended to inspect this system, evaluate all findings, make recommendations and estimate repairs or maintenance.

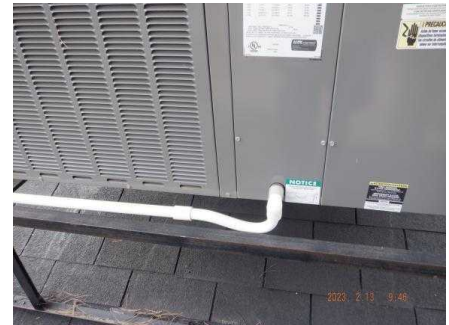
- The pipe is missing an air gap. A qualified licensed contractor is recommended to inspect this system, evaluate all findings, make recommendations and estimate repairs or maintenance.

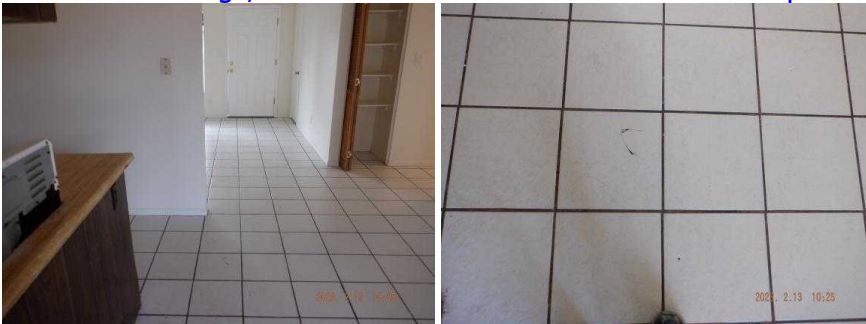
**11. SYSTEM: INTERIORS****10. All living areas and garage Living Space Interior Floors (#70): Tile Floors:**

- Minor defects were found as shown. A qualified licensed contractor is recommended to inspect this system, evaluate all findings, make recommendations and estimate repairs or maintenance.

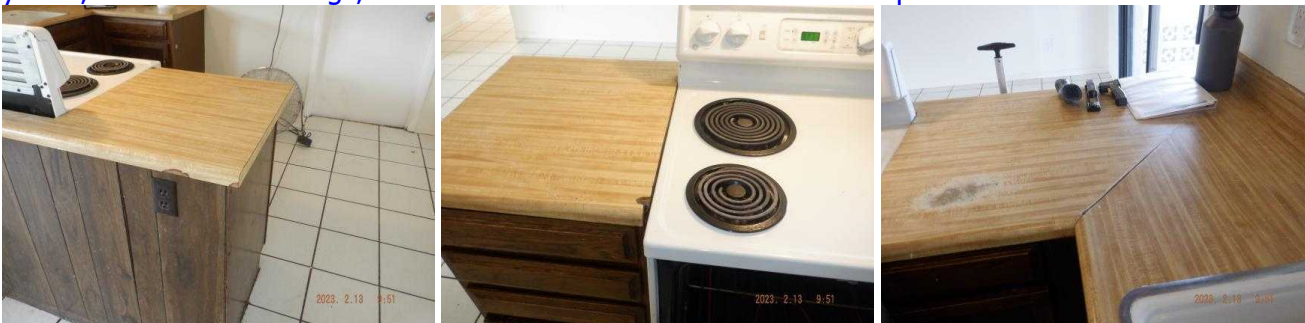
**11. All living areas and garage Living Space Counters (#73): Laminate:**

- Multiple flaws were found on the surface as shown. A qualified licensed contractor is recommended to inspect this system, evaluate all findings, make recommendations and estimate repairs and or maintenance.

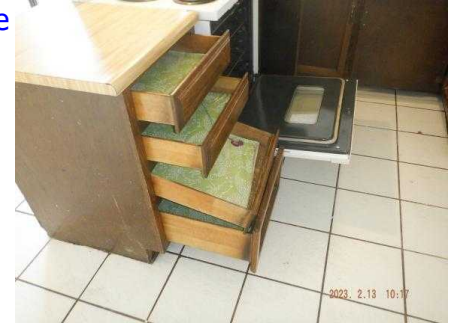
- One of the kitchen drawers falls when opened. A qualified licensed contractor is recommended to inspect, evaluate all findings, make recommendations and estimate repairs or maintenance.

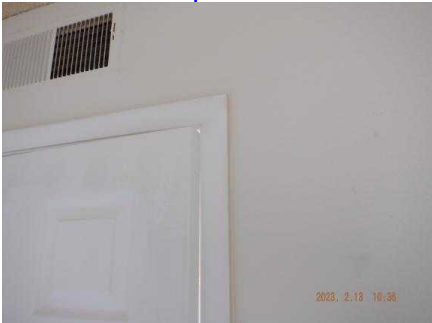
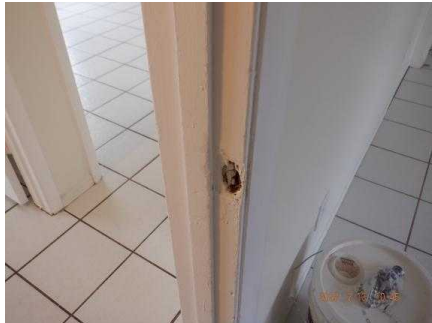
13. All living areas and garage Living Space Doors (operation RN) (#74): Hollow core doors:

- Some of the closet doors are missing or need adjustment.
- The master bedroom door does not close properly (sagging and hits the frame and is missing the strike plate). A qualified licensed contractor is recommended to inspect this system, evaluate all findings, make recommendations and estimate repairs and or maintenance.

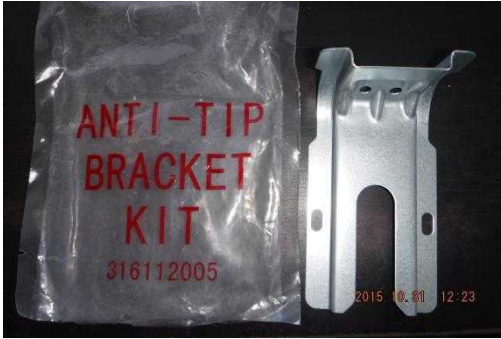
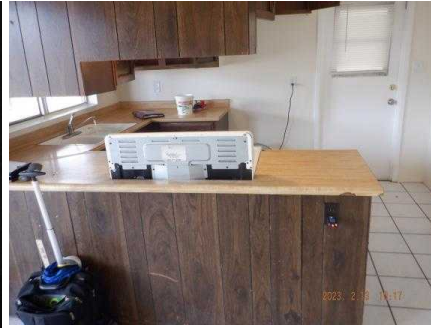
14. Main living area Kitchen Cooking Appliances: General Electric:

- The wrong type of stove was installed for the opening (no back).

(Recommended Update) Today's standards calls for an anti tip bracket for stoves. The buyer should consider updating to today's standards. A qualified licensed contractor is recommended to inspect this system, evaluate all findings, make recommendations, estimate repairs and or maintenance.

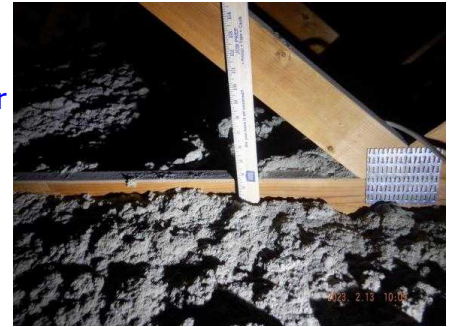
15. Laundry, Bathroom #2 Attic Insulation Depth: 2" - 5":

(Minimum Standard) The minimum standard a home should meet for insulation is R30. Homes that do not meet this standard cannot cool adequately in the summer or consume higher than average energy. A qualified licensed contractor is recommended to inspect this system, evaluate all findings, make recommendations and estimate repairs or maintenance.

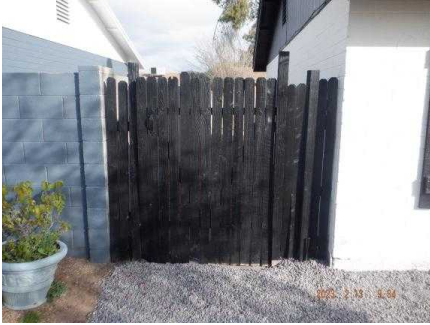
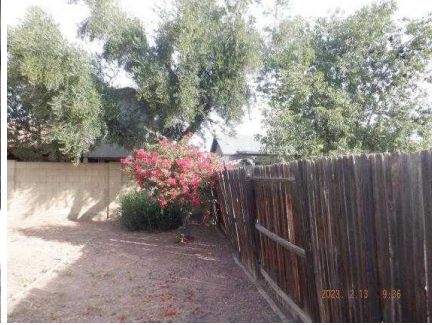
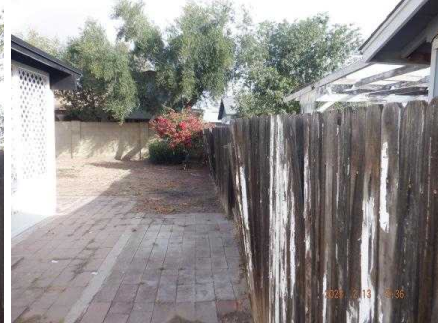
- The wooden fence has loose and has rotten post, is leaning, and the left front gate will not open (rubs the floor). A qualified licensed contractor is recommended to inspect this system, evaluate all findings, make recommendations and estimate repairs or maintenance.

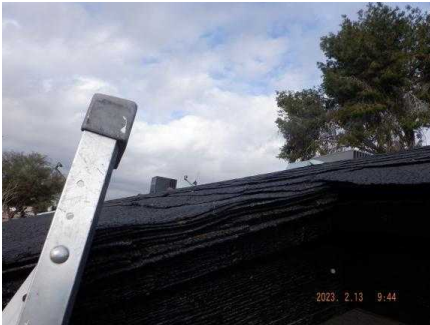
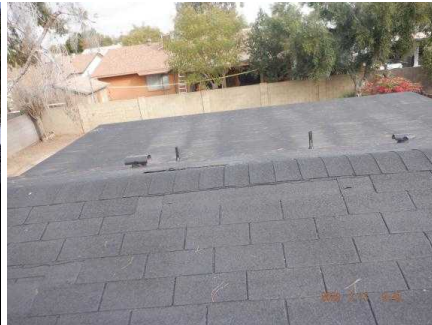
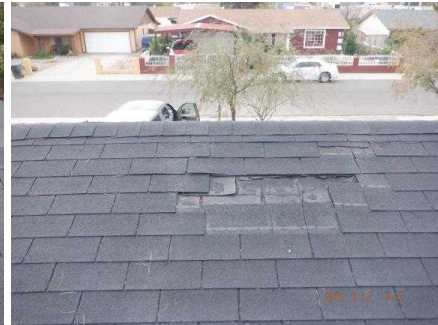
2. Main Roof Roof Surface Roof Covering Material (type & condition) (#25): Asphalt shingle:

- The asphalt shingle roof has more than two layers and has multiple missing areas. A qualified licensed contractor is recommended to inspect this system, evaluate all findings, make recommendations and estimate repairs or maintenance.

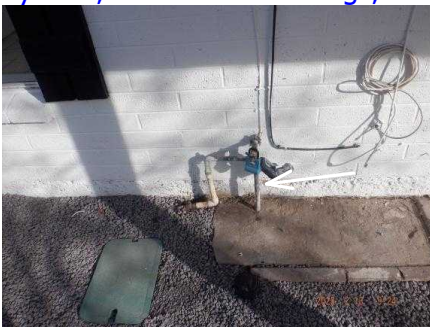
- The main shut off is missing at the front hose bib. A qualified licensed contractor is recommended to inspect this system, evaluate all findings, make recommendations and estimate repairs or maintenance.

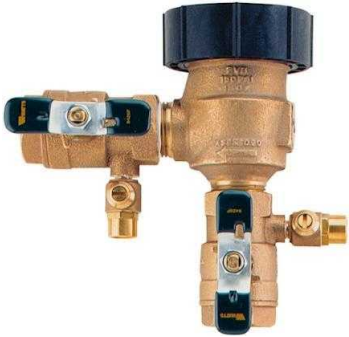
4. Cross Connections (exterior & Interior) (#35) : The potential exists at the following locations: (Sprinkler System) The sprinkler system is missing an anti-siphon valve (needs to be placed before it enters the home). A qualified licensed contractor is recommended to inspect this system, evaluate all findings, make recommendations and estimate repairs or maintenance.

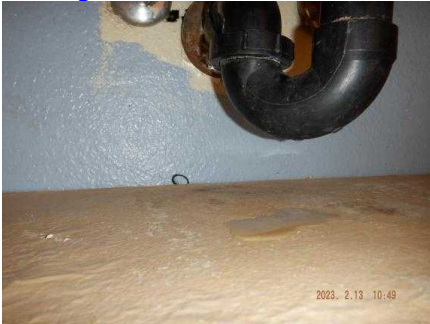
5. *Drain Leaks (#37): Leaks were found:

- The drain pipes are leaking under the -bathroom sink sink (keep in mind the water is allowed to run for 15 minutes as part of the water test). A qualified licensed contractor is recommended to inspect this system, evaluate all findings, make recommendations and estimate repairs or maintenance.

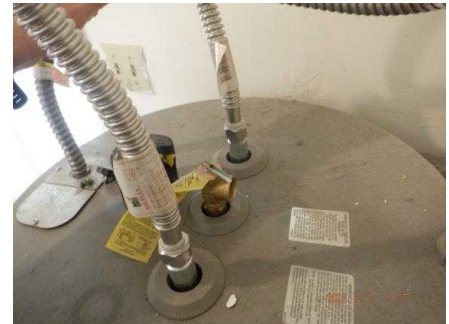
6. Auto Safety Controls (#40): TPR Valve and Piping:

- Improper installation (missing pipe connection). The TPR pipe cannot be reduced in size, has to be routed downhill after it leaves the TPR valve, terminate 6 to 24 inches from the ground and should only be made out of hard-drawn copper, CPVC, or galvanized steel. A qualified licensed contractor is recommended to inspect this system, evaluate all findings, make recommendations and estimate repairs or maintenance.

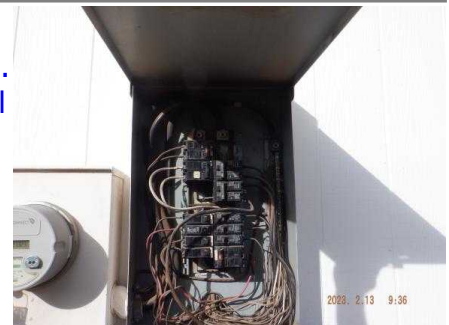
- The dead front cover (main panel inner cover) is missing. This is a safety hazard. A qualified licensed contractor is recommended to inspect this system, evaluate all findings, make recommendations and estimate repairs or maintenance.

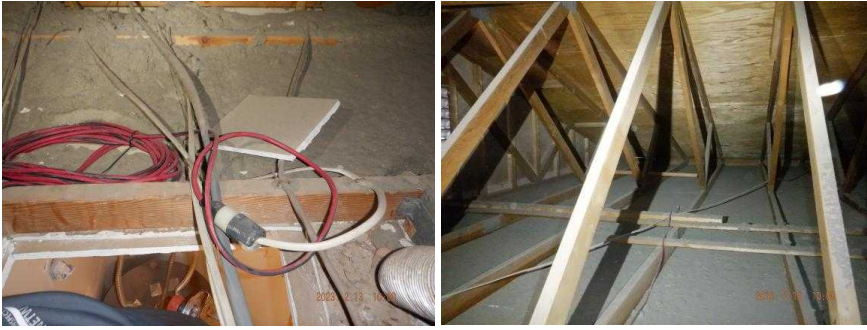
8. Branch Circuit Conductors (#49): Copper Wire 110 VAC circuits - Non-metallic sheathed cable:

- An extension cord is being used as permanent wiring in the attic. A qualified licensed contractor is recommended to inspect this system, evaluate all findings, make recommendations and estimate repairs or maintenance.

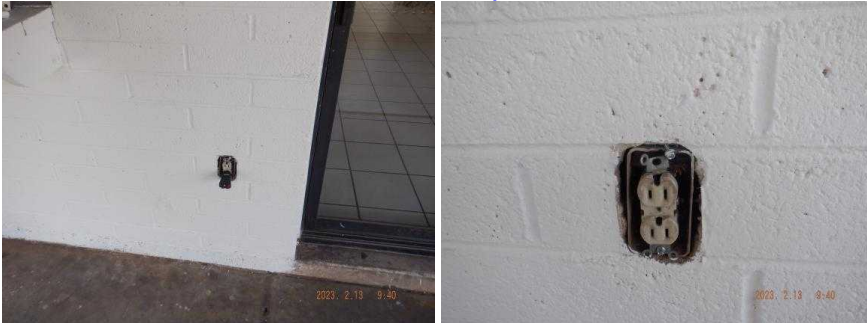
9. Outlets [RN] Operation, Polarity & Ground [RN] (#53): Exterior & Interior:

- The exterior patio outlet tested missing ground, is missing a moisture cover and the outlet is damaged. A qualified licensed contractor is recommended to inspect this system, evaluate all findings, make recommendations and estimate repairs or maintenance.

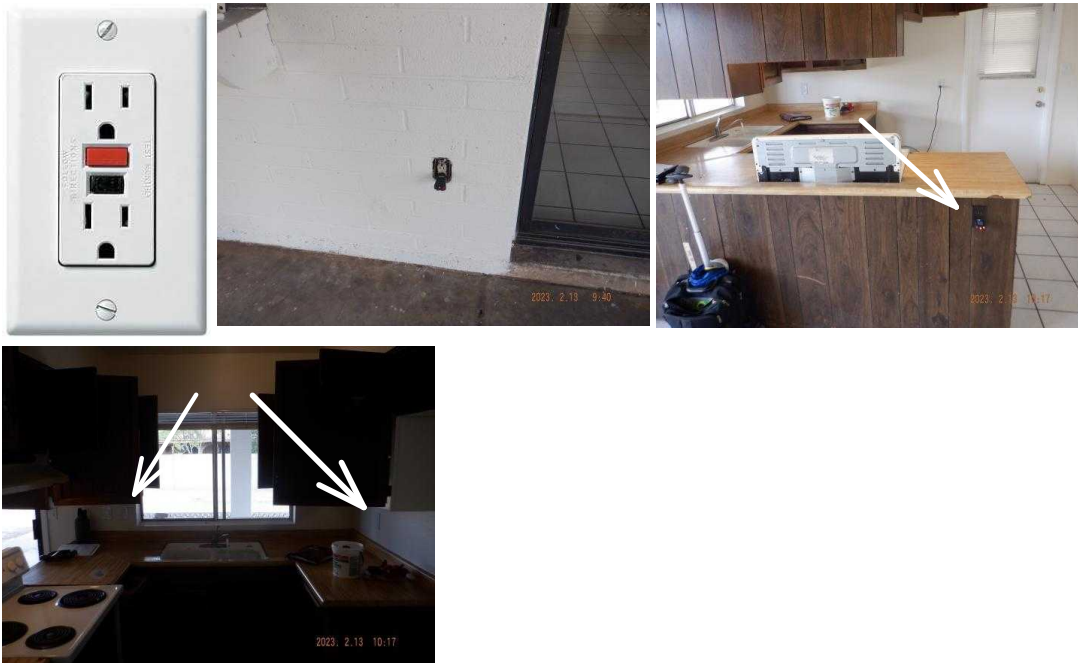
10. GFCI Outlets Operation (#54): Exterior & Interior:

- GFCI protection is missing at the kitchen outlets. The right of sink outlet also tested missing ground.
- GFCI protection is missing at the exterior outlets.
- GFCI protection is missing at the Bathroom outlet. A qualified licensed contractor is recommended to inspect this system, evaluate all findings, make recommendations and estimate repairs and or maintenance.

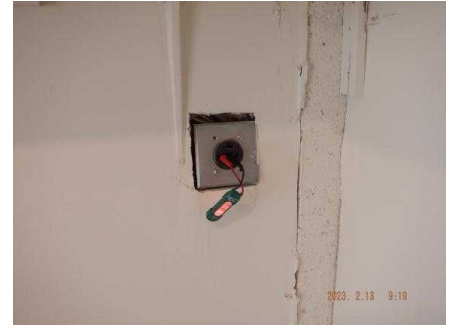
- The outlets is loose in the wall and the opening was cut too big (hole in wall). A qualified licensed contractor is recommended to inspect this system, evaluate all findings and estimate repairs or maintenance.

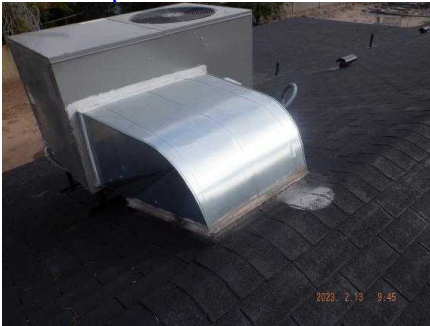
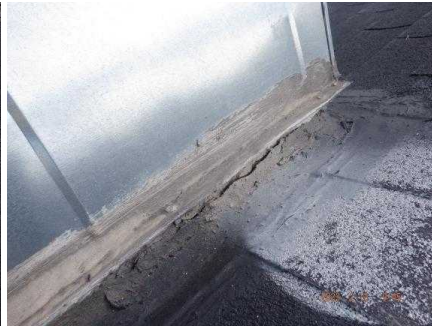
- The tar seal is cracking. A qualified licensed contractor is recommended to inspect this system, evaluate all findings, make recommendations and estimate repairs or maintenance.

Note: A yearly visual inspection of the vent pipes & roof and at the A/C duct & roof is recommended to prevent moisture penetration.

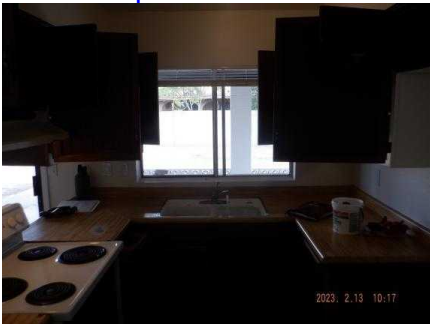
13. All living areas and garage Living Space Windows (operation RN) (#16 & 75): Metal frame single pane windows:

- The kitchen window metal center frame is separated from the glass pane (or improperly installed). A qualified licensed contractor is recommended to inspect this system, evaluate all findings, make recommendations and estimate repairs and or maintenance.

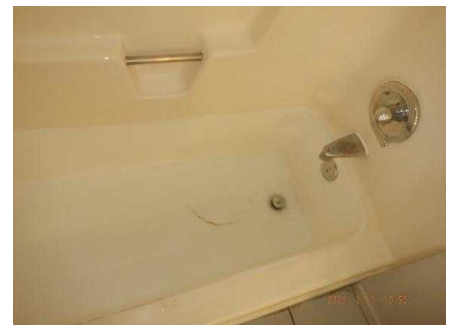
14. All Bathrooms Bathroom Tub/Surround: Fiberglass tub and fiberglass surround:

- The bottom of the bathtub is cracked. A qualified licensed contractor is recommended to inspect this system, evaluate all findings, make recommendations and estimate repairs and or maintenance.

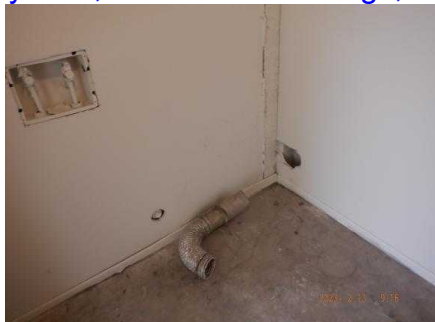
- The dryer vent pipe connection is broken. A qualified licensed contractor is recommended to inspect this system, evaluate all findings, make recommendations and estimate repairs or maintenance.

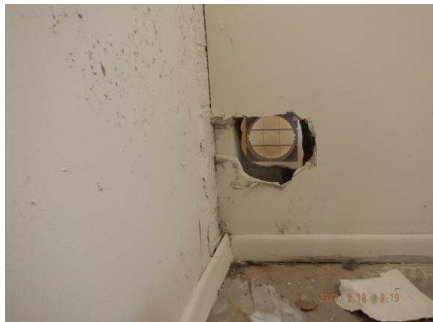
15. Interior Service Area Laundry Room/Area Dryer Vent: Vents through the wall:

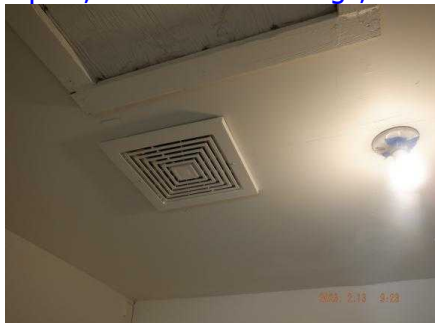
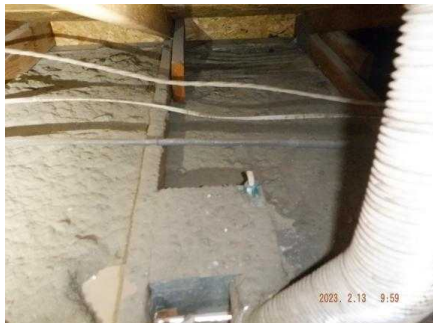
16. Interior Service Area Laundry Room/Area Ventilation (#84): Electric ventilation fan:

- The exhaust fan is inoperative (electrical cut in the attic). A qualified licensed contractor is recommended to inspect, evaluate all findings, make recommendations and estimate repairs or maintenance.

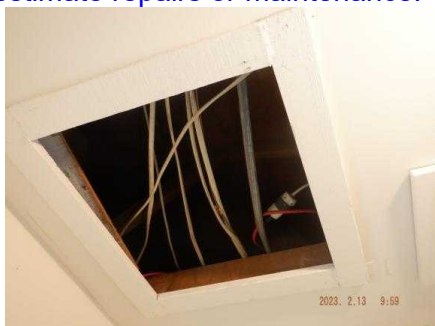
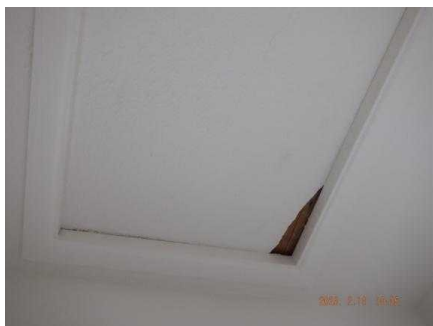
- The attic access in BR #2 has been nail shut and the access in the Laundry is obstructed by wiring. A qualified licensed contractor is recommended to inspect this system, evaluate all findings, make recommendations and estimate repairs or maintenance.

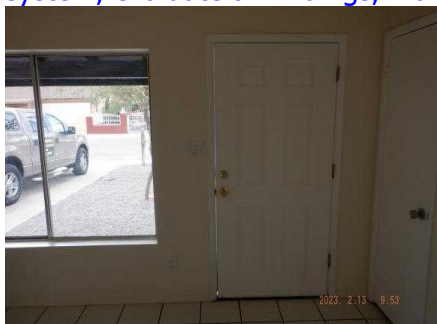
- The kitchen door is missing the threshold (bottom seal).
 - The front door weather-stripping is missing or needs adjustment so that daylight is not seen from the inside when the door are closed.
 - The door to the carport is damaged. A qualified licensed contractor is recommended to inspect this system, evaluate all findings, make recommendations and estimate repairs or maintenance.

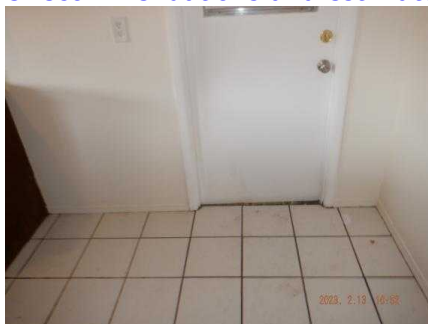
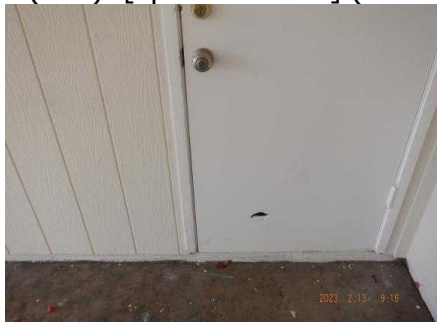
5. **Maintenance** Entryway Doors (#15): [operation of all] **All exterior doors:**

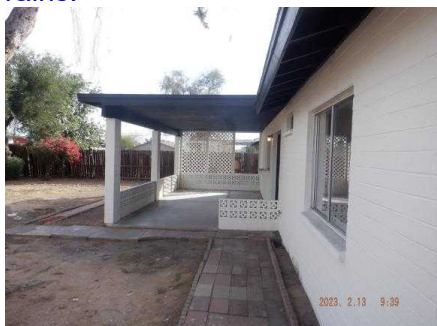
Observe and report on condition and any adverse impact on the structure.

(Proper Grade) As a general rule a proper grade makes water run to the sides of the home, away from the foundation and runs out toward the front of the home and onto the street. It is not always possible to determine proper grade and the buyers is advised to monitor for proper grade when it rains.

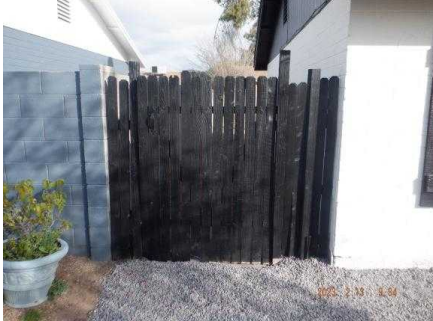
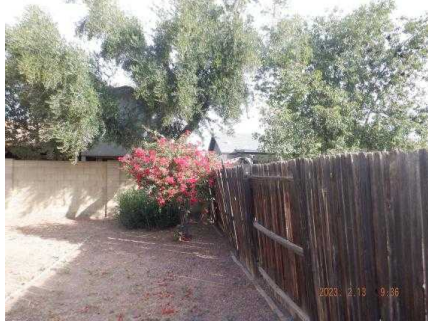
Fences: Block & Wood Fence:

- The wooden fence has loose and has rotten post, is leaning, and the left front gate will not open (rubs the floor). A qualified licensed contractor is recommended to inspect this system, evaluate all findings, make recommendations and estimate repairs or maintenance.

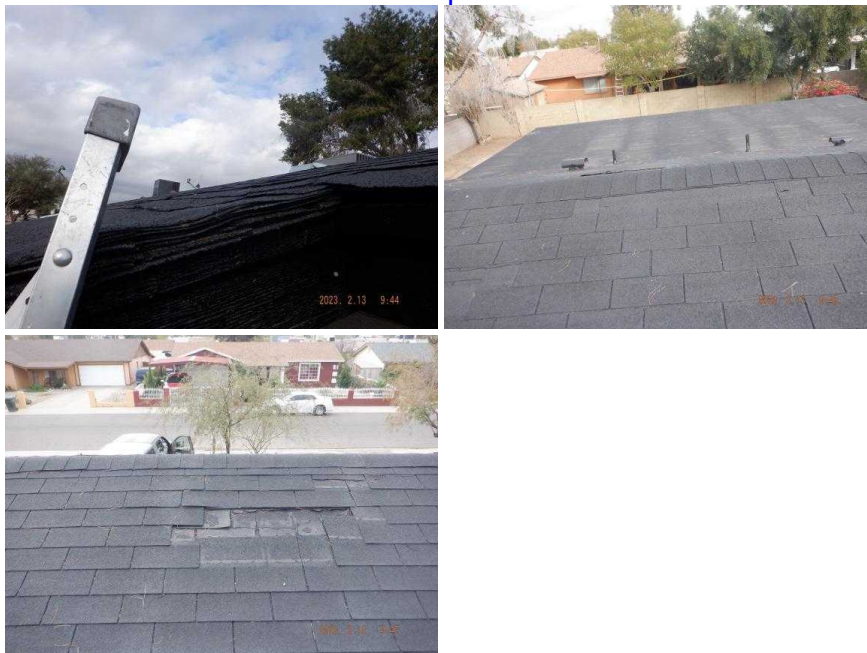
3. **Defective** Roof Covering Material (type & condition) (#25): **Asphalt shingle:**
 - The asphalt shingle roof has more than two layers and has multiple missing areas. A qualified licensed contractor is recommended to inspect this system, evaluate all findings, make recommendations and estimate repairs or maintenance.

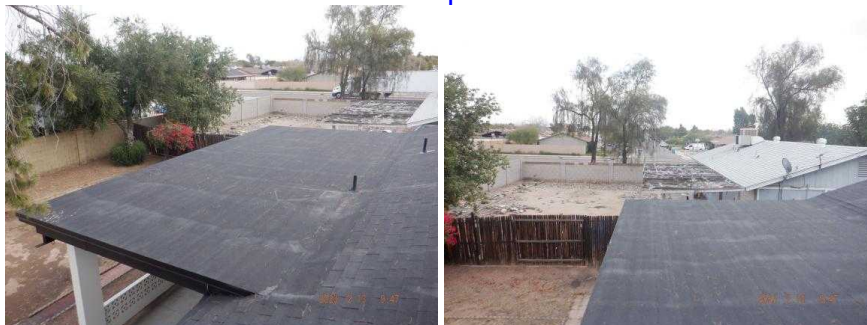
7. Method used to Inspect Roofing: (#29) **Walked the roof**
8. **Maintenance** Roof Covering Material (#25): **Rolled Roof:**
 - The patio rolled roof needs was painted in black paint (should be coated with an Elastomeric coat - unknow what effects regular paint will have - unprofessional work to say the least). A qualified licensed contractor is recommended to inspect this system, evaluate all findings, make recommendations and estimate repairs or maintenance.

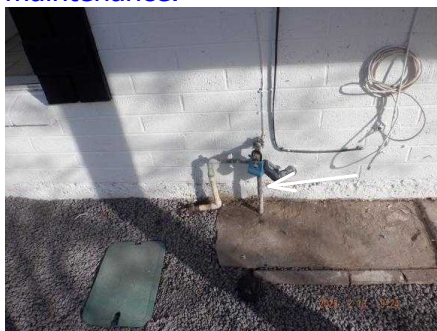
2. Defective Water Supply Materials: Copper Pipes:

- The main shut off is missing at the front hose bib. A qualified licensed contractor is recommended to inspect this system, evaluate all findings, make recommendations and estimate repairs or maintenance.

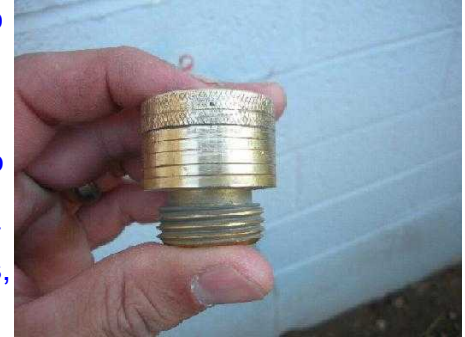
Exterior Fixtures (#32): [attached to the home] Operated with no major flaws:

(Recommended Update) Recommend vacuum breakers/back flow valves at the exterior hose bibs to prevent cross contamination. This information is provided so that the buyer understand that the standards have changed for health or safety concerns. A qualified licensed contractor is recommended to inspect this system, evaluate all findings, make recommendations and estimate repairs or maintenance.

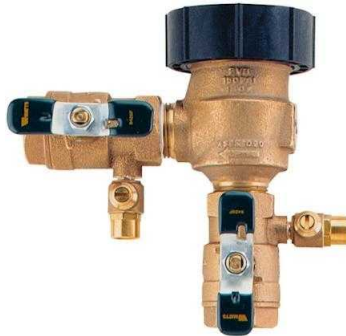
7. **Defective, Unsafe** Cross Connections (exterior & Interior) (#35) : The potential exists at the following locations: (Sprinkler System) The sprinkler system is missing an anti-siphon valve (needs to be placed before it enters the home). A qualified licensed contractor is recommended to inspect this system, evaluate all findings, make recommendations and estimate repairs or maintenance.

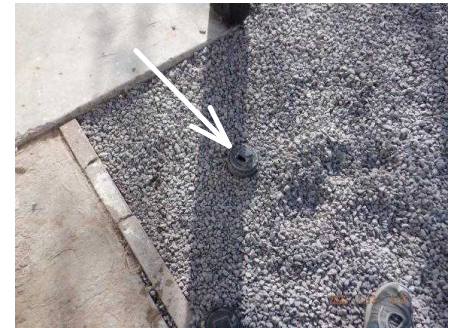
- One of the access covers is damaged. A qualified licensed contractor is recommended to inspect this system, evaluate all findings, make recommendations and estimate repairs or maintenance.

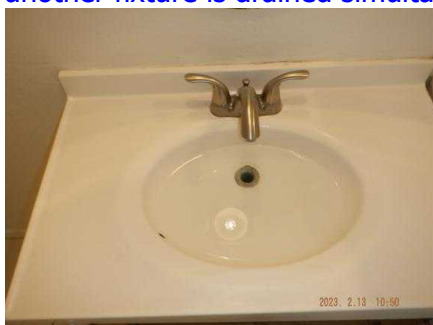
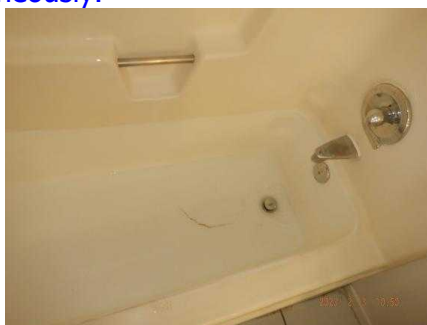
- The bathroom sink and tub have what is considered a slow drain (hair in the traps?). A qualified licensed contractor is recommended to inspect this system, evaluate all findings, make recommendations and estimate repairs and or maintenance.

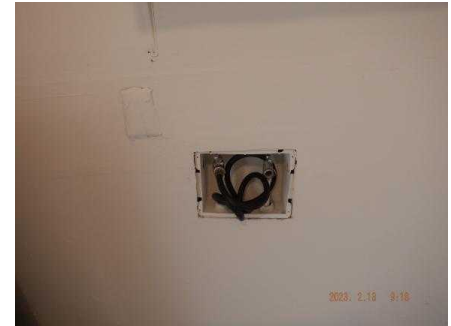
16. **Maintenance** Laundry Washer Hose Bibs (#32): **Rotary Hose Bibs:**

- **The moisture cover is missing. A qualified licensed contractor is recommended to inspect this system, evaluate all findings, make recommendations and estimate repairs or maintenance.**

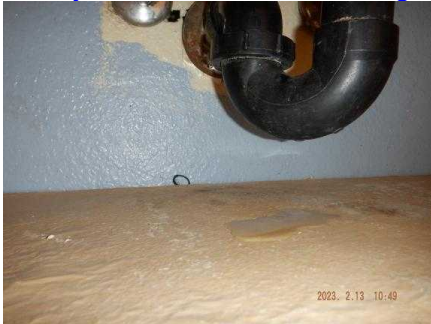
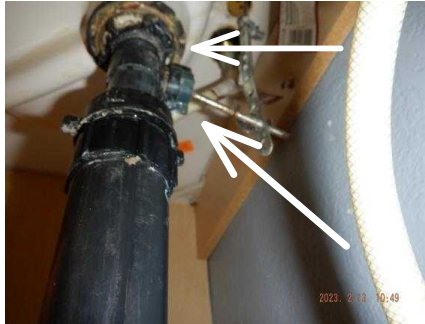
20. **Defective** *Drain Leaks (#37): **Leaks were found:**

- **The drain pipes are leaking under the -bathroom sink (keep in mind the water is allowed to run for 15 minutes as part of the water test). A qualified licensed contractor is recommended to inspect this system, evaluate all findings, make recommendations and estimate repairs or maintenance.**

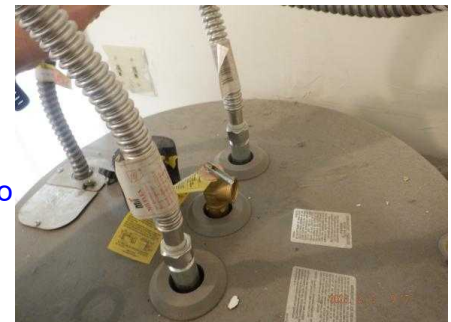
26. **Defective** Auto Safety Controls (#40): **TPR Valve and Piping:**

- **Improper installation (missing pipe connection). The TPR pipe cannot be reduced in size, has to be routed downhill after it leaves the TPR valve, terminate 6 to 24 inches from the ground and should only be made out of hard-drawn copper, CPVC, or galvanized steel. A qualified licensed contractor is recommended to inspect this system, evaluate all findings, make recommendations and estimate repairs or maintenance.**

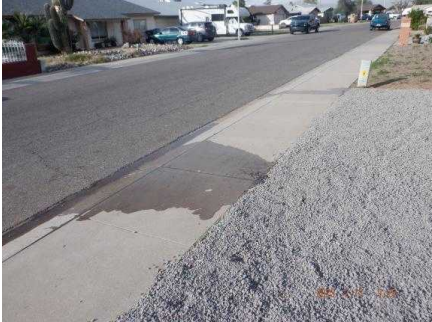
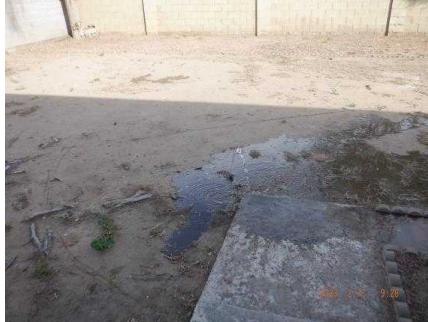
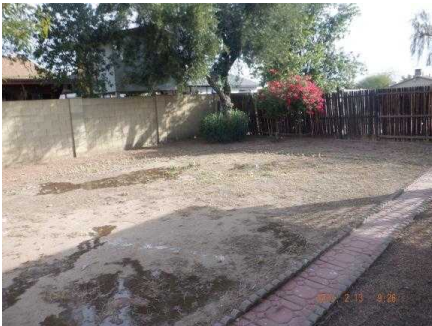
31. **Maintenance** Sprinklers/Drip System: **Front and back yard:**

- The sprinkler system appears to have a broken under ground pipe (water coming up from the dirt). A qualified licensed contractor is recommended to inspect this system, evaluate all findings, make recommendations and estimate repairs or maintenance.

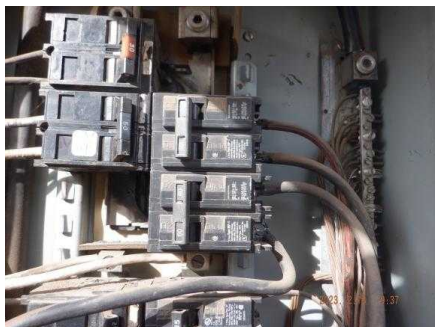
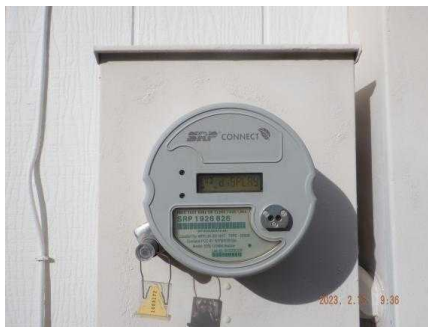
- (Main Disconnect) This does not have a main breaker - The top four breakers need to be turned off for all power to the home to be cut off.

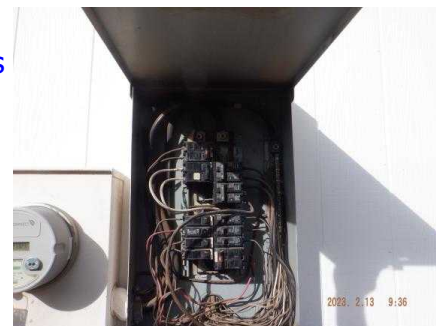
6. **Acceptable** Service Amperage & Voltage (#48): **200 Amps Service, 240 Volts**
7. **Defective, Unsafe** Main Panel Location (#47): **Exterior Side Wall:**
 - The dead front cover (main panel inner cover) is missing. This is a safety hazard. A qualified licensed contractor is recommended to inspect this system, evaluate all findings, make recommendations and estimate repairs or maintenance.

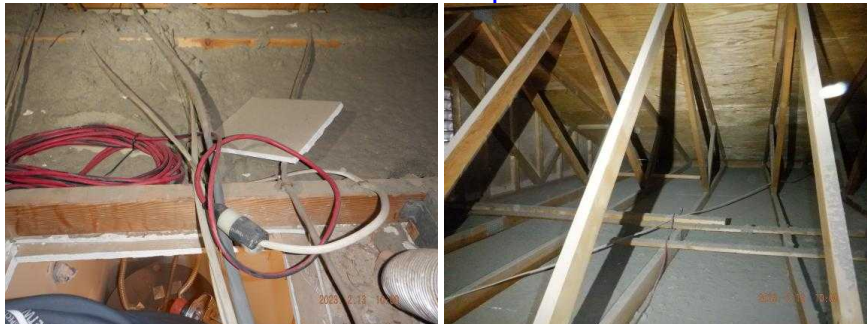
8. Defective Branch Circuit Conductors (#49): Copper Wire 110 VAC circuits - Non-metallic sheathed cable:
- An extension cord is being used as permanent wiring in the attic. A qualified licensed contractor is recommended to inspect this system, evaluate all findings, make recommendations and estimate repairs or maintenance.

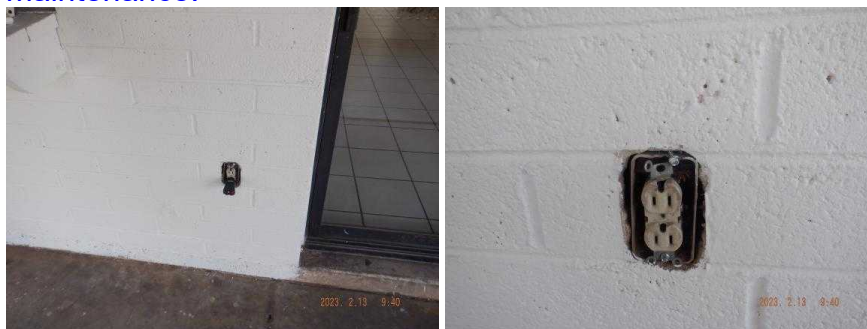
9. Acceptable *Aluminum Branch Circuit Wiring (#50): Localized 220 VAC circuits
10. Acceptable Compatibility of Amps & Voltages (#51): No Over Fusing was found
11. Acceptable Light Fixtures [RN] Operation (#52): Exterior & Interior
12. Acceptable Light Switches[RN] Operation (#52): Exterior & Interior
13. Defective, Unsafe Outlets [RN] Operation, Polarity & Ground [RN] (#53): Exterior & Interior:
- The exterior patio outlet tested missing ground, is missing a moisture cover and the outlet is damaged. A qualified licensed contractor is recommended to inspect this system, evaluate all findings, make recommendations and estimate repairs or maintenance.

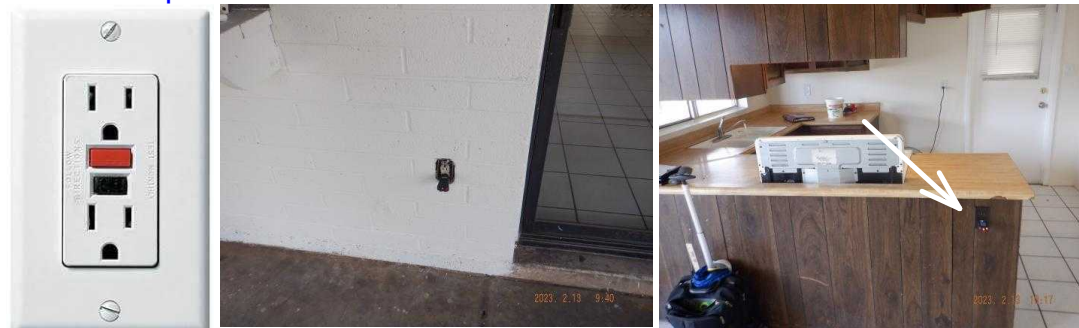
14. Defective, Unsafe GFCI Outlets Operation (#54): Exterior & Interior:
- GFCI protection is missing at the kitchen outlets. The right of sink outlet also tested missing ground.
- GFCI protection is missing at the exterior outlets.
- GFCI protection is missing at the Bathroom outlet. A qualified licensed contractor is recommended to inspect this system, evaluate all findings, make recommendations and estimate repairs and or maintenance.

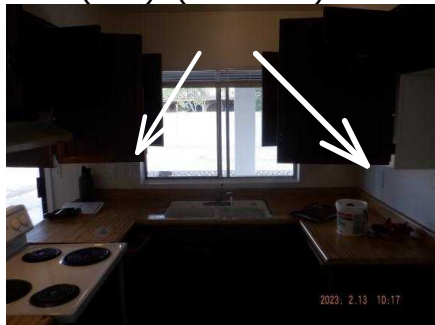
GFCI Outlets Operation (#54): (continued)

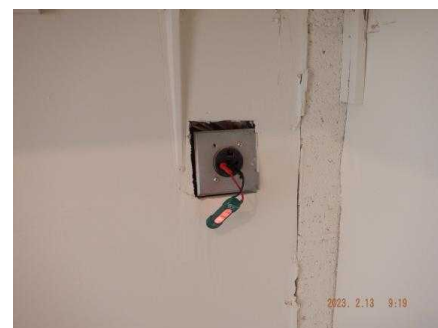
17. [Defective](#)

Washer & Dryer Electrical: [110-240 VAC Grounded:](#)

- The outlets is loose in the wall and the opening was cut too big (hole in wall). A qualified licensed contractor is recommended to inspect this system, evaluate all findings and estimate repairs or maintenance.

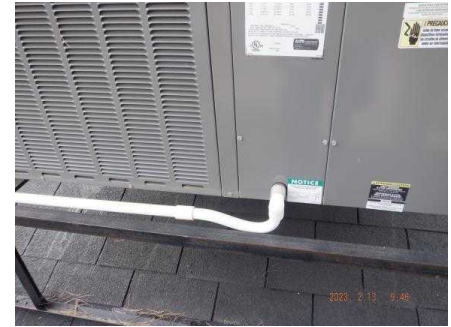
13. **Maintenance** Condensate Removal: **Plastic Piping:**
- The pipe is missing an air gap. A qualified licensed contractor is recommended to inspect this system, evaluate all findings, make recommendations and estimate repairs or maintenance.

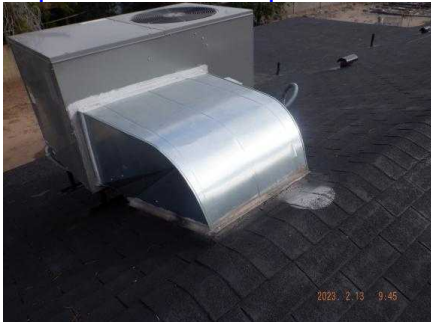
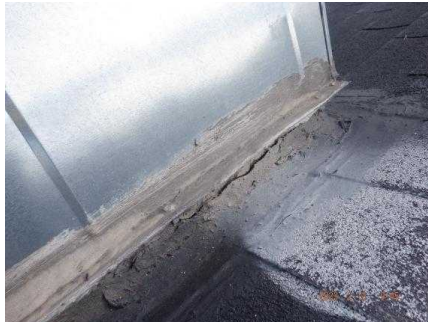
14. **Defective** Exposed Ductwork: **Metal Case for Ductwork:**
- The tar seal is cracking. A qualified licensed contractor is recommended to inspect this system, evaluate all findings, make recommendations and estimate repairs or maintenance.

Note: A yearly visual inspection of the vent pipes & roof and at the A/C duct & roof is recommended to prevent moisture penetration.

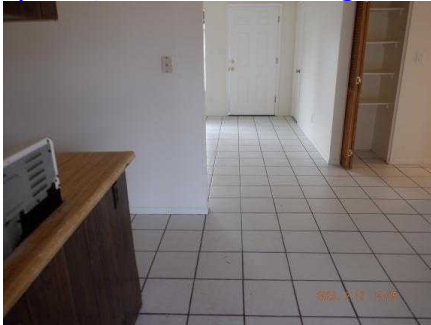
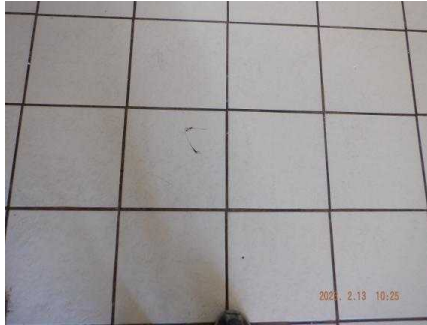
4. **Maintenance** Interior Floors (#70): **Tile Floors:**

- Minor defects were found as shown. A qualified licensed contractor is recommended to inspect this system, evaluate all findings, make recommendations and estimate repairs or maintenance.

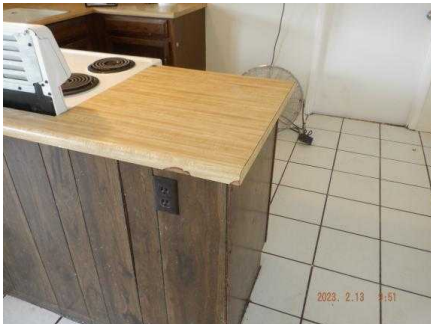
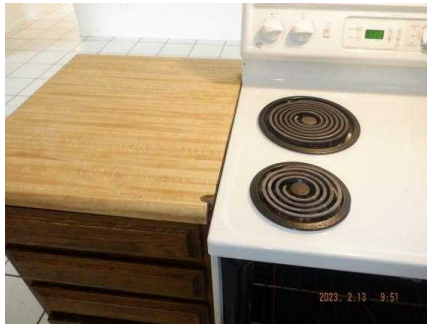
5. **Maintenance** Counters (#73): **Laminate:**

- Multiple flaws were found on the surface as shown. A qualified licensed contractor is recommended to inspect this system, evaluate all findings, make recommendations and estimate repairs and or maintenance.

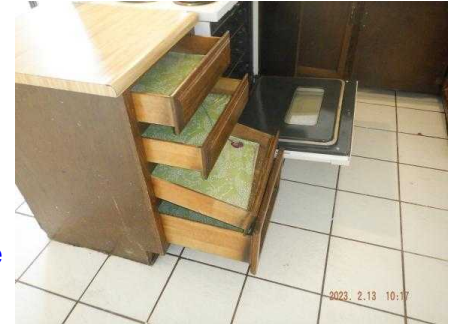
6. Maintenance

Cabinets (RN) (#73): Wood & Composite Wood materials:
 - One of the kitchen drawers falls when opened. A qualified licensed contractor is recommended to inspect, evaluate all findings, make recommendations and estimate repairs or maintenance.

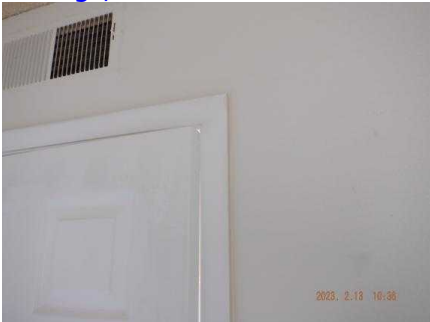
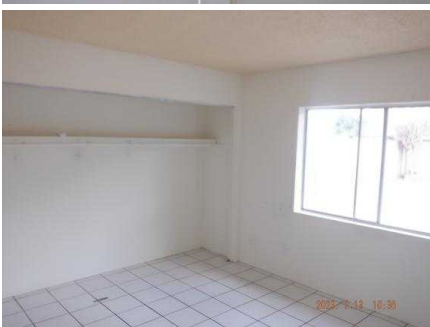
Doors (operation RN) (#74): Hollow core doors:

- Some of the closet doors are missing or need adjustment.
 - The master bedroom door does not close properly (sagging and hits the frame and is missing the strike plate). A qualified licensed contractor is recommended to inspect this system, evaluate all findings, make recommendations and estimate repairs and or maintenance.

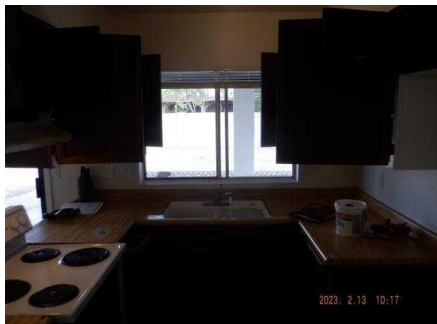
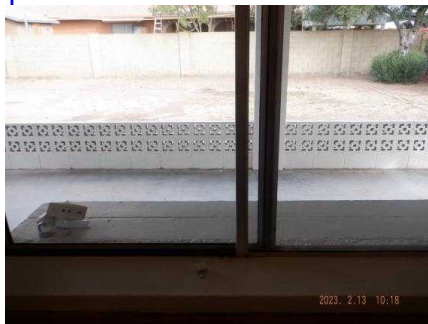
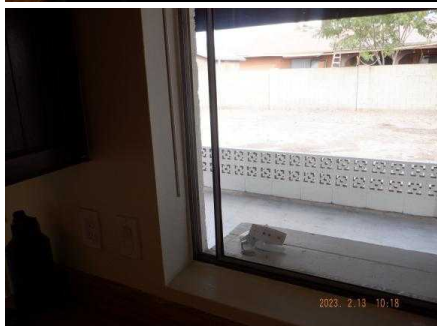
9. Defective

Windows (operation RN) (#16 & 75): Metal frame single pane windows:

- The kitchen window metal center frame is separated from the glass pane (or improperly installed). A qualified licensed contractor is recommended to inspect this system, evaluate all findings, make recommendations and estimate repairs and or maintenance.

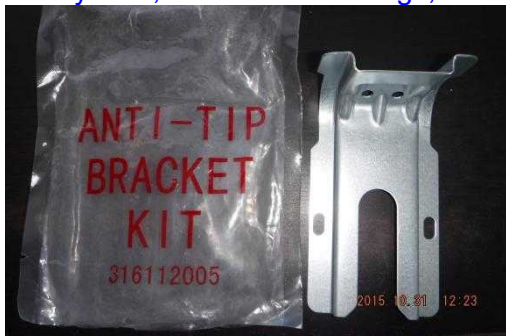
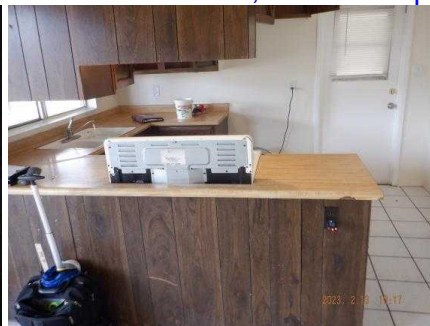
- The wrong type of stove was installed for the opening (no back).

(Recommended Update) Today's standards calls for an anti tip bracket for stoves. The buyer should consider updating to today's standards. A qualified licensed contractor is recommended to inspect this system, evaluate all findings, make recommendations, estimate repairs and or maintenance.

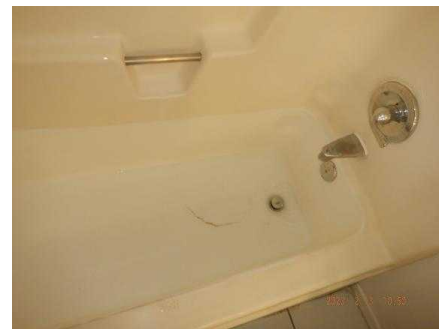
18. **Defective** Tub/Surround: Fiberglass tub and fiberglass surround:
- The bottom of the bathtub is cracked. A qualified licensed contractor is recommended to inspect this system, evaluate all findings, make recommendations and estimate repairs and or maintenance.

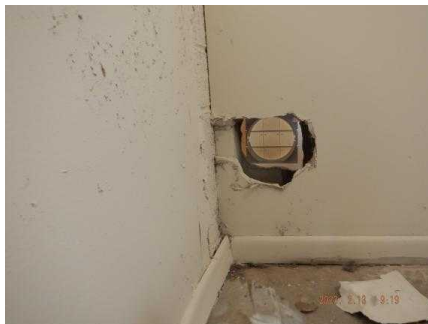
23. **Defective** Dryer Vent: Vents through the wall:

- The dryer vent pipe connection is broken. A qualified licensed contractor is recommended to inspect this system, evaluate all findings, make recommendations and estimate repairs or maintenance.

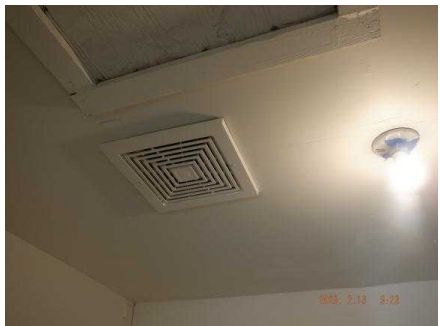
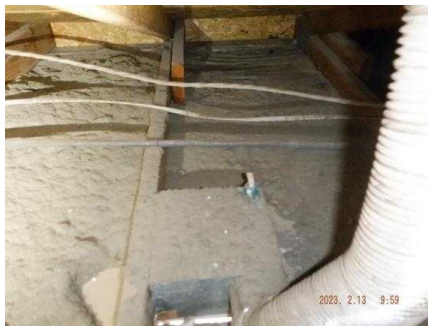
24. **Defective** Ventilation (#84): Electric ventilation fan:

- The exhaust fan is inoperative (electrical cut in the attic). A qualified licensed contractor is recommended to inspect, evaluate all findings, make recommendations and estimate repairs or maintenance.
