Home Inspection Report

4240 N 63rd Ave
Phoenix, Arizona 85033

Inspected by:
Mark Stephens
Arizona Premier Home and Property Inspections

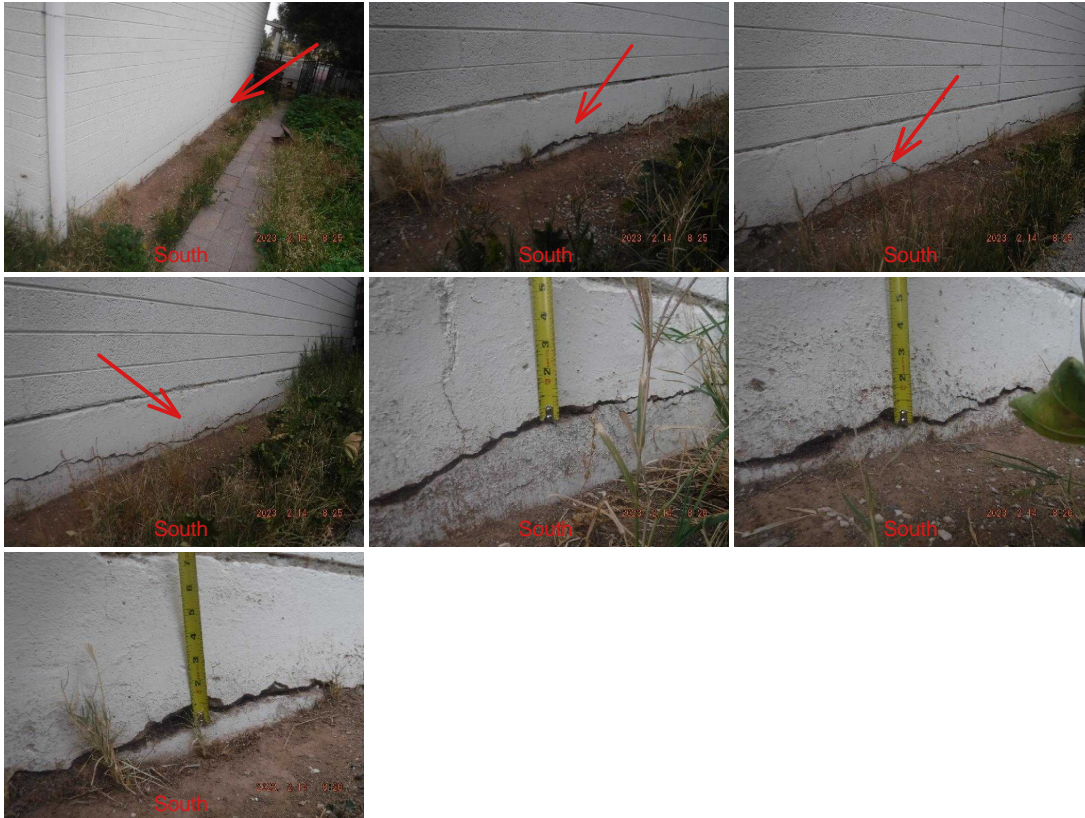
1. Foundation: Poured Concrete slab - More than typical cracking noted at several areas around the home. A structural engineer is recommended to inspect this system, evaluate all findings, make recommendations and estimate repairs.

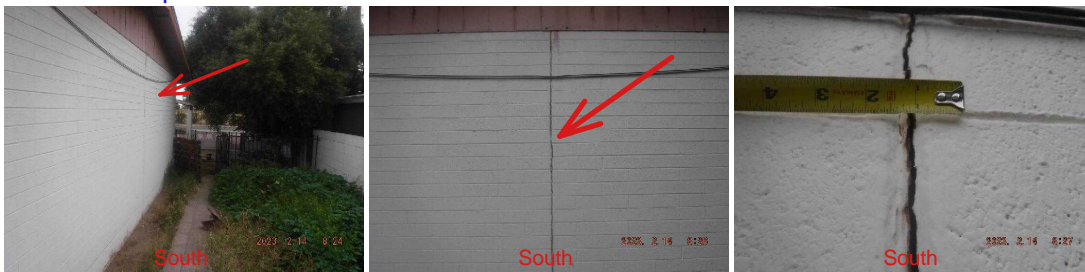
2. Wall Structure: Block, Wood Frame - (a) South: Cracking with displacement noted. A qualified licensed contractor is recommended to inspect this system, evaluate all findings, make recommendations and estimate repairs.

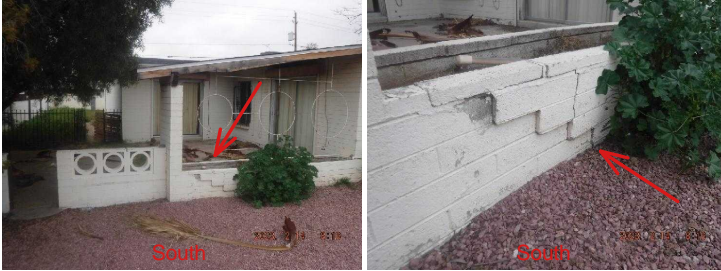
4. Exterior walls Exterior Surface Wall Cladding Materials: **Block** - (a) South: Detail wall is cracked and displaced. (b) Other Areas: Common typical minor cracking and defects noted. Plan and Prepare that the home will need typical maintenance and painting in the near future. A qualified licensed contractor is recommended to inspect this system, evaluate all findings, make recommendations and estimate repairs.

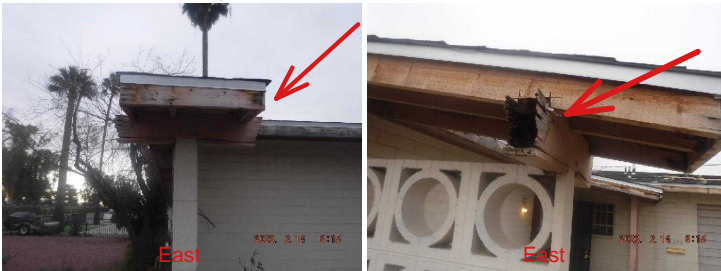
5. Exterior walls Exterior Surface *Eaves, Soffits & Fascias: **Wood & Plywood** - (a) Rotting wood noted in several areas. (b) Rest of the Home: Typical wear and damage noted: Consistent with the age of the home. Plan and prepare to paint the eaves and fascia in the near future to maintain the system. A qualified licensed contractor is recommended to inspect this system, evaluate all findings, make recommendations and estimate repairs.

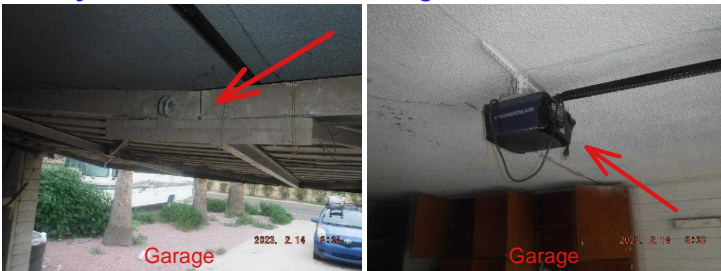
6. Front of the home. Garage *Garage Door(s)/Openers: **Metal Fold Up w/ Chamberlin Opener** - (a) Door is damaged. (b) Opener inoperable/disconnected. A qualified licensed contractor is recommended to inspect this system, evaluate all findings, make recommendations and estimate repairs.

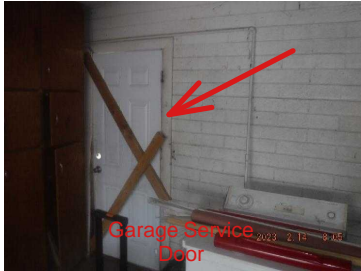
7. Front of the home. Garage Service Doors: **Metal Door** - Missing dead bolt set. Blocked by framing. A qualified licensed contractor is recommended to inspect this system, evaluate all findings, make recommendations and estimate repairs.

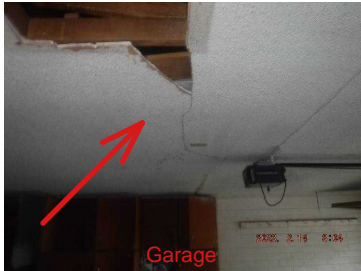
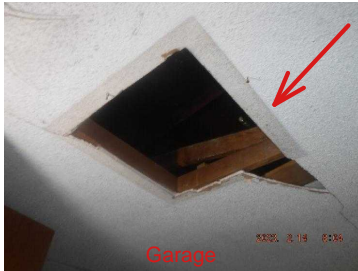
8. Front of the home. Garage Fire Separation Walls & Ceilings: Drywall, Texture-Paint - Ceiling damaged. No cover on attic access. A qualified licensed contractor is recommended to inspect this system, evaluate all findings, make recommendations and estimate repairs.

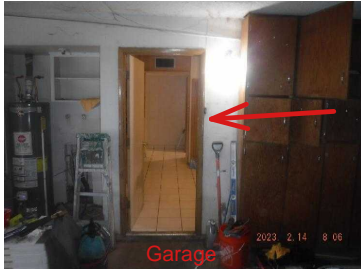
9. Front of the home. Garage Fire Separation Doors: Improper Door. Garage access doors are required to have a 20 minute fire rating and be self closing. A qualified licensed contractor is recommended to inspect this system, evaluate all findings and estimate repairs.

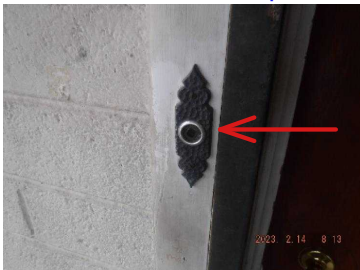
10. Door Bell: Hard Wired - - Inoperative at the time of my inspection. A qualified licensed contractor is recommended to inspect, evaluate all findings, make recommendations and estimate repairs.

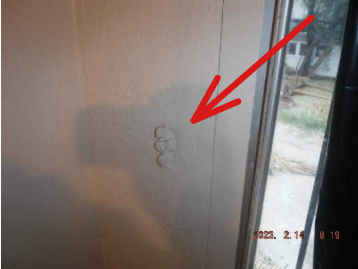
11. Window Security Bars: Wrought iron - Pulls/locks painted closed or damaged. A qualified licensed contractor is recommended to inspect this system, evaluate all findings and estimate repairs.

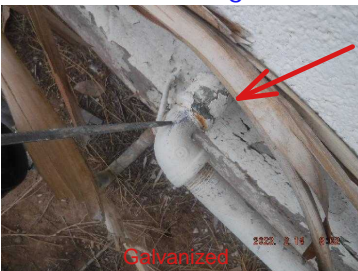
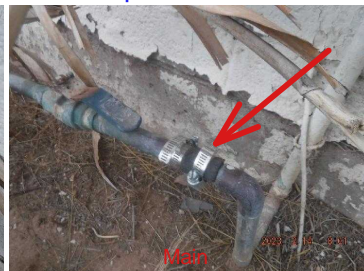
12. Piping Materials including supports and insulation: AquaPex and Copper Piping, Copper Pipes - (a) Main: (1) Galvanized pipe were found-- this is no longer allowed without cross contamination protection (deterioration caused by rust will contaminate the potable water as well as the possibility of lead contamination). Total extent of galvanized piping in the home is not fully determined. (2) Rubber patch inline on piping. (b), Water service shut off valves under sinks and at toilets have a recommended life span of 10-12 years and are considered a maintenance item. It is recommended that these valves be updated to provide security and peace of mind with regards to the water system, as well as guarantee the valve will operate properly when needed. A qualified licensed contractor is recommended to inspect, evaluate all findings and estimate repairs.

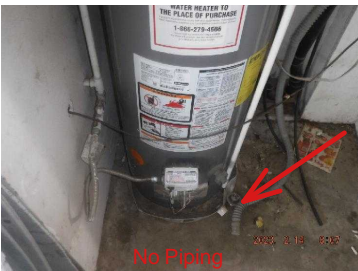
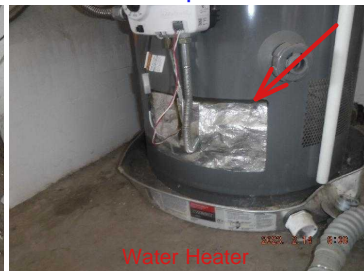
13. Water Heating Equipment: Natural Gas Water Heater, 40 Gallons - 2019 is the estimated MFD for this unit. Water heater appears to be functioning correctly. (a) The catch pan is missing the proper piping to divert water away to an acceptable location. (b), Unit is missing burner access cover plate. This is a safety concern. A qualified licensed contractor is recommended to inspect this system, evaluate all findings, make recommendations and estimate repairs.

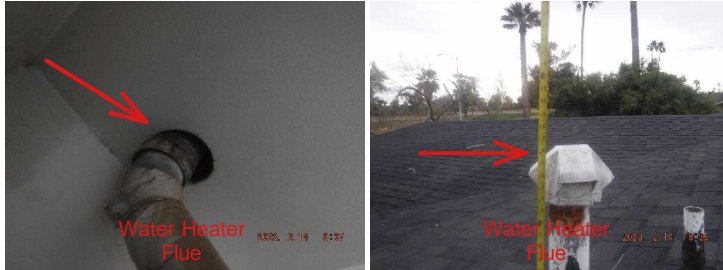
14. Flues: Single Wall Pipe at unit, Double Wall Pipe - (a) Double wall vent piping requires a minimum clearance of 1 inch from any combustible material. (b), Standards typically recommend a minimum of 24 inches clearance above the existing roofline within 10 feet for the flue cap(known as the 2/10 rule). A

qualified licensed contractor is recommended to inspect this system, evaluate all findings, make recommendations and estimate repairs.

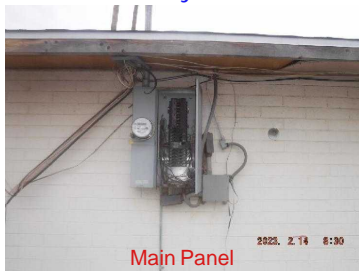
16. Main Panel Location: Exterior Wall - (a) Missing dead man cover(interior). No Labeling/Illegible Labeling of the breakers. Breakers are required to be labeled to identify each circuit. (b), No permits found for electrical updates. No final inspection label/certification found, recommend inquiring with the seller or contacting the local building department for verification. Building and Construction Permits in Phoenix can be searched at: <https://apps-secure.phoenix.gov/PDD/Search/Permits>. A qualified licensed contractor is recommended to inspect this system, evaluate all findings, make recommendations and estimate repairs. Due to the general condition/age of the electrical system, it is recommended that a qualified electrician evaluate the system as a whole for latent defects.

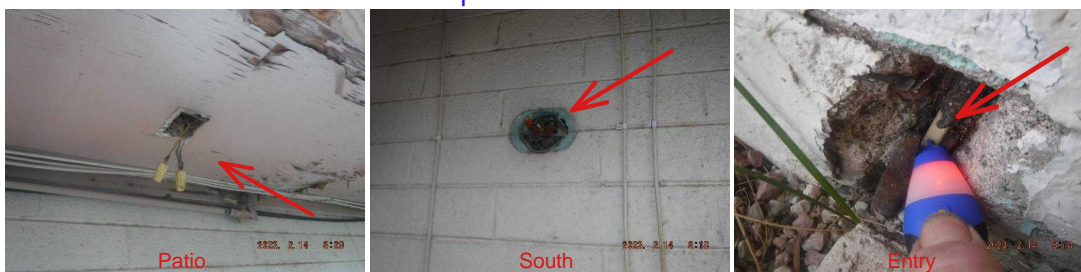
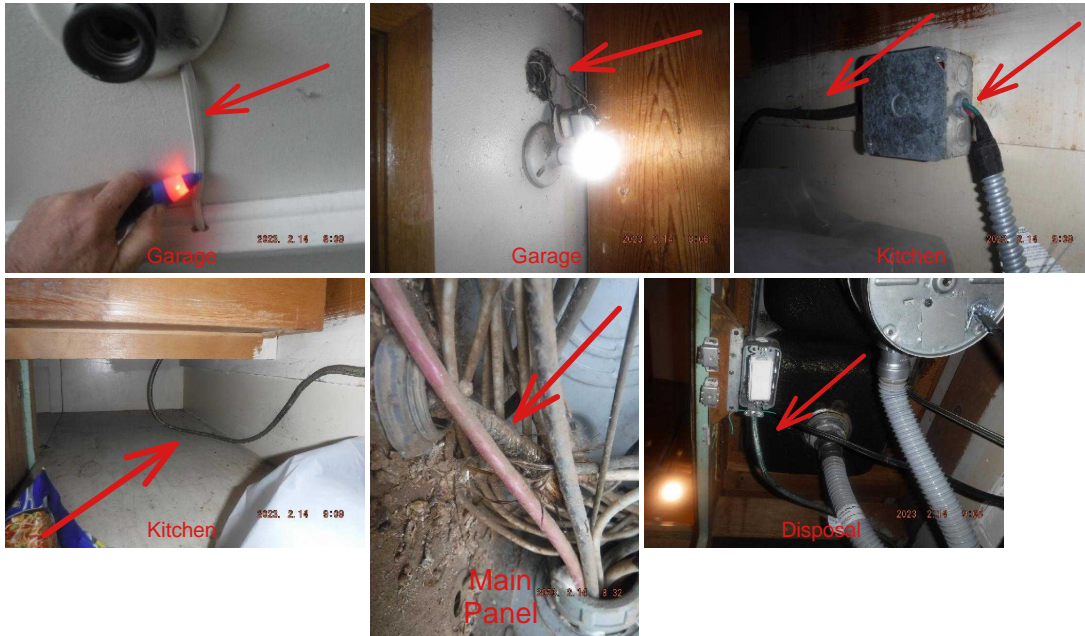
17. Branch Circuit Conductors: Copper Wire 110 VAC circuits - Non-metallic sheathed cable - (a), Exposed wiring present. All wiring needs to be covered, in the wall, or inside proper conduit. (b), Cloth coated wiring is still present in the home. This is aged and should be tested for proper viability and latent damage. A qualified licensed contractor is recommended to inspect this system, evaluate all findings, make recommendations and estimate repairs.

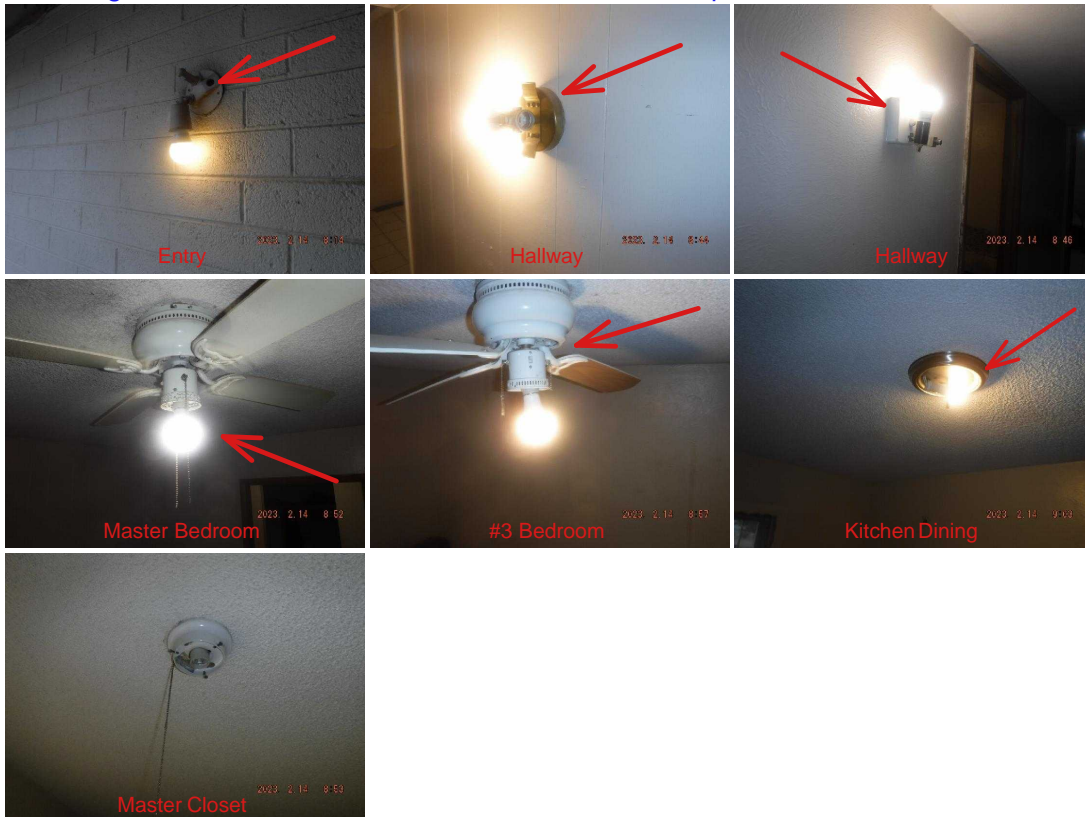
18. Ligh Fixtures [RN] Operation: Exterior & Interior - (a) Damaged/inoperable fixtures found. (b) Light bulbs are out in several locations around the home. Recommend requesting seller to install all bulbs to verify functions of the fixtures. A qualified licensed contractor is recommended to inspect this system, evaluate all findings, make recommendations and estimate repairs.

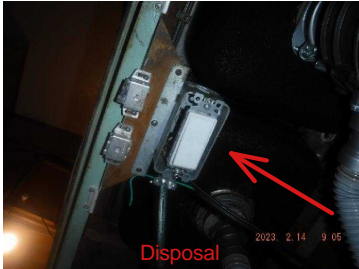
19. Ligh Switches[RN] Operation: Exterior & Interior - Missing cover plate. A qualified licensed contractor is recommended to inspect this system, evaluate all findings, make recommendations and estimate repairs.

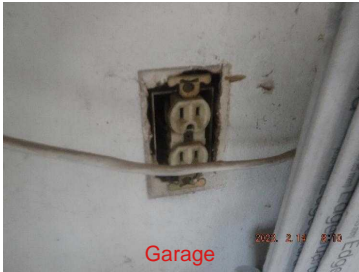
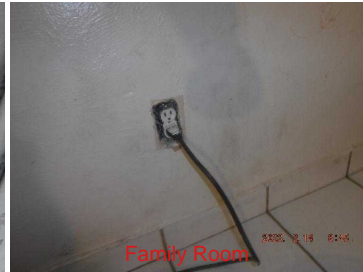
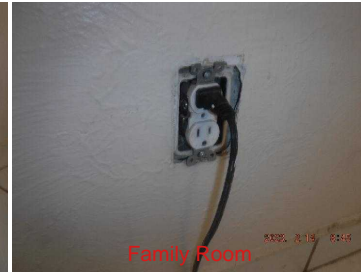
20. Outlets [RN] Operation: Exterior & Interior - Missing/damaged cover plates. A qualified licensed contractor is recommended to inspect this system, evaluate all findings, make recommendations and estimate repairs.

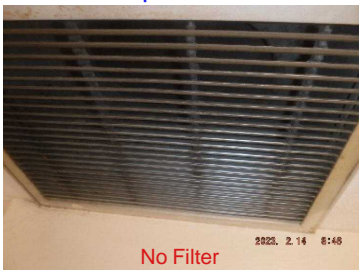
21. Roof Heating System Air Filters: 20x25x1 - No filters in place at time of inspection. A qualified licensed contractor is recommended to inspect this system, evaluate all findings, make recommendations and estimate repairs.

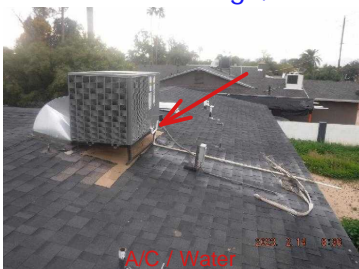
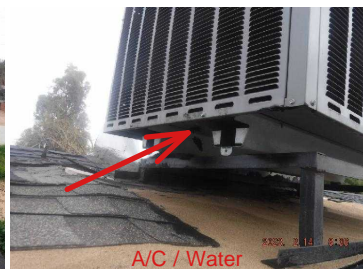
22. Roof AC System Cooling & Air Handling Equipment: Rheem - Water draining from unit may indicate a clogged condensation line. A qualified licensed contractor is recommended to inspect this system, evaluate all findings, make recommendations and estimate repairs.

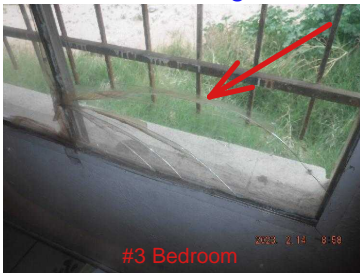
23. All living areas and garage Living Space Windows (operation RN): Metal frame single pane windows - (a) #3 Bedroom: Broken window. (b) Other Areas: Windows show wear typical to the age of the home (loose locks, minor plastic trim damage, etc.). Dirty tracks are making the windows hard to open at several locations. Recommend cleaning. A qualified licensed contractor is recommended to inspect this system, evaluate all findings, make recommendations and estimate repairs.

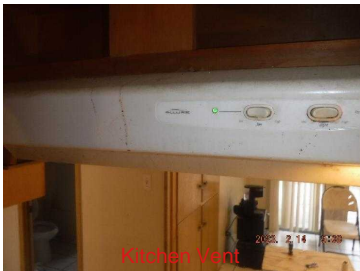
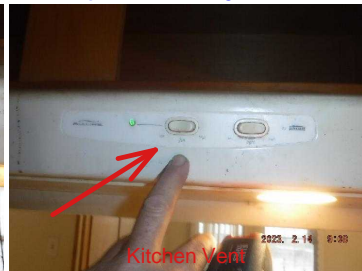
24. Main living area Kitchen Ventilator: Allure, Built in - Allure: Fan inoperative. A qualified licensed contractor is recommended to inspect this system, evaluate all findings and estimate repairs.

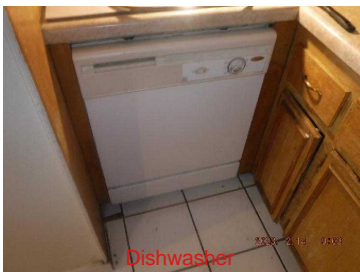
25. Main living area Kitchen Dishwasher: Whirlpool - Inoperative at time of inspection. Grinding noise. A qualified licensed contractor is recommended to inspect this system, evaluate all findings, make recommendations and estimate repairs.

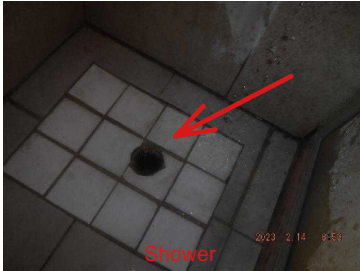
26. All Bathrooms Bathroom Shower/Surround: All Tile - Missing drain cover. Repairs noted. A qualified licensed contractor is recommended to inspect this system, evaluate all findings, make recommendations and estimate repairs.

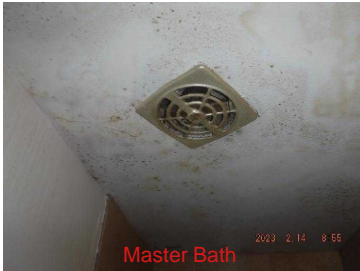
27. All Bathrooms Bathroom Ventilation: Electric fan and window - Fan inoperative. A qualified licensed contractor is recommended to inspect this system, evaluate all findings, make recommendations and estimate repairs.

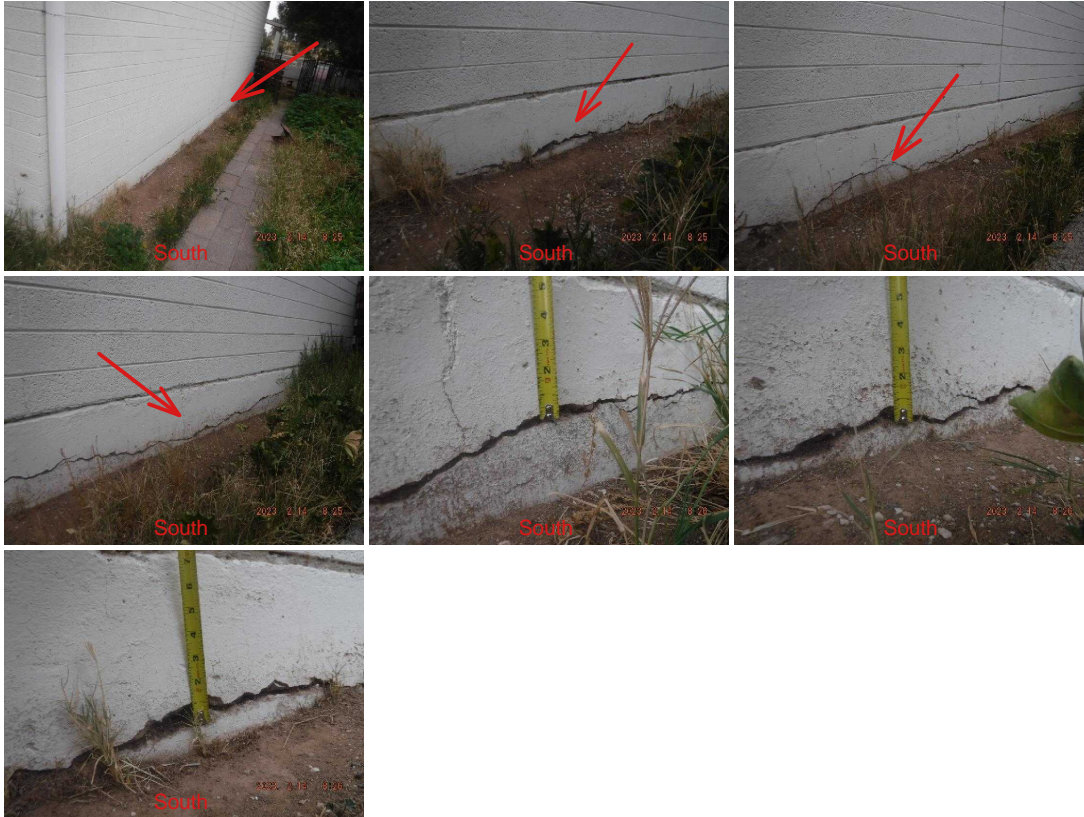
Foundation: Poured Concrete slab - More than typical cracking noted at several areas around the home. A structural engineer is recommended to inspect this system, evaluate all findings, make recommendations and estimate repairs.

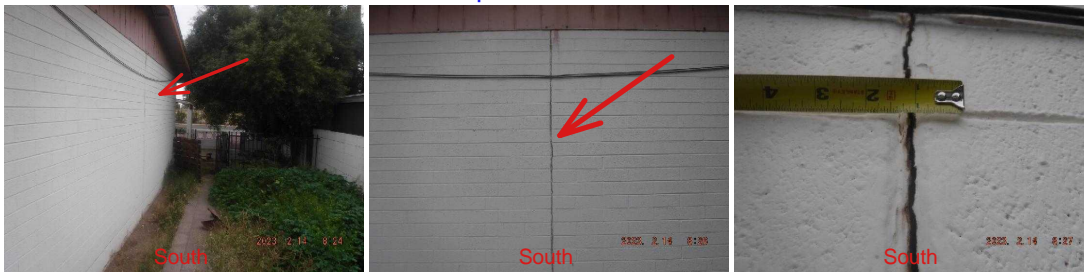
Wall Structure: Block, Wood Frame - (a) South: Cracking with displacement noted. A qualified licensed contractor is recommended to inspect this system, evaluate all findings, make recommendations and estimate repairs.

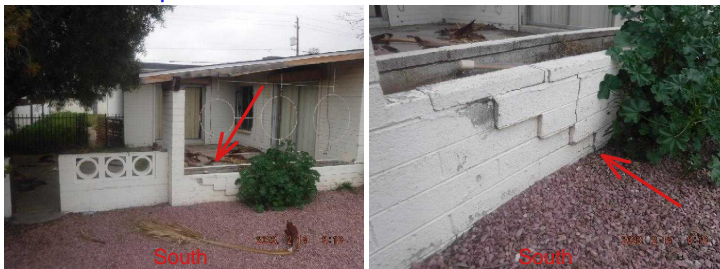
- Other, Defective** Wall Cladding Materials: **Block - (a) South: Detail wall is cracked and displaced. (b) Other Areas: Common typical minor cracking and defects noted. Plan and Prepare that the home will need typical maintenance and painting in the near future. A qualified licensed contractor is recommended to inspect this system, evaluate all findings, make recommendations and estimate repairs.**

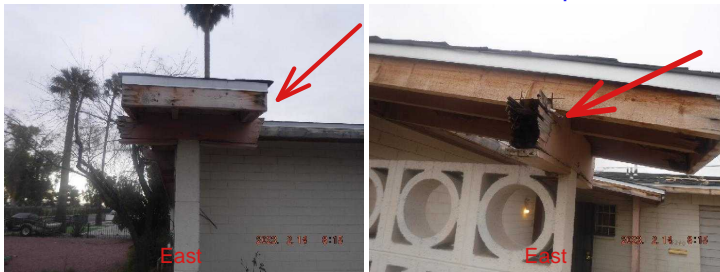
Other, Defective *Eaves, Soffits & Fascias: Wood & Plywood - (a) Rotting wood noted in several areas. (b) Rest of the Home: Typical wear and damage noted: Consistent with the age of the home. Plan and prepare to paint the eaves and fascia in the near future to maintain the system. A qualified licensed contractor is recommended to inspect this system, evaluate all findings, make recommendations and estimate repairs.

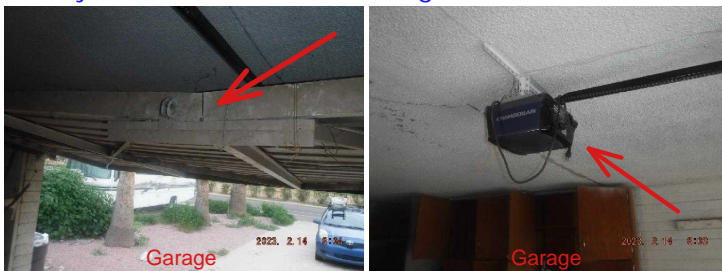
Defective *Garage Door(s)/Openers: Metal Fold Up w/ Chamberlin Opener - (a) Door is damaged. (b) Opener inoperable/disconnected. A qualified licensed contractor is recommended to inspect this system, evaluate all findings, make recommendations and estimate repairs.

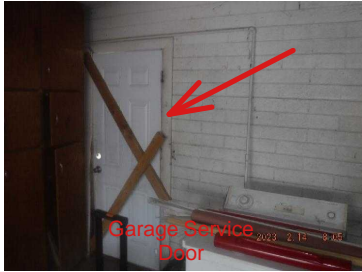
Defective Service Doors: **Metal Door - Missing dead bolt set.** Blocked by framing. A qualified licensed contractor is recommended to inspect this system, evaluate all findings, make recommendations and estimate repairs.

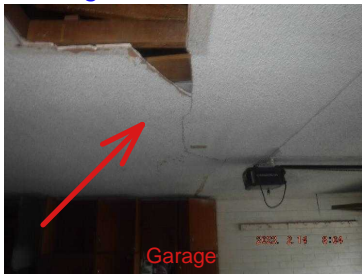
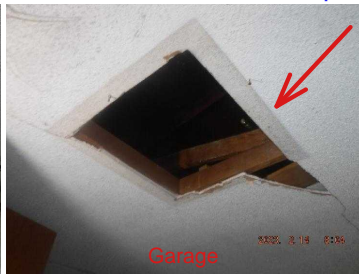
Defective Fire Separation Walls & Ceilings: **Drywall, Texture-Paint - Ceiling damaged.** No cover on attic access. A qualified licensed contractor is recommended to inspect this system, evaluate all findings, make recommendations and estimate repairs.

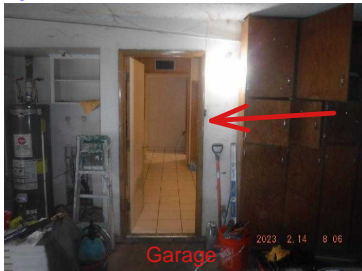
Defective Fire Separation Doors: **Improper Door.** Garage access doors are required to have a 20 minute fire rating and be self closing. A qualified licensed contractor is recommended to inspect this system, evaluate all findings and estimate repairs.

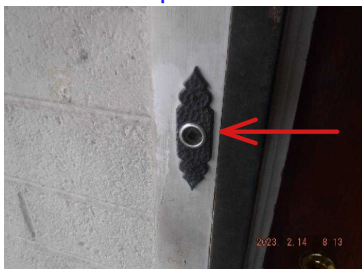
Defective Door Bell: **Hard Wired - Inoperative at the time of my inspection.** A qualified licensed contractor is recommended to inspect, evaluate all findings, make recommendations and estimate repairs.

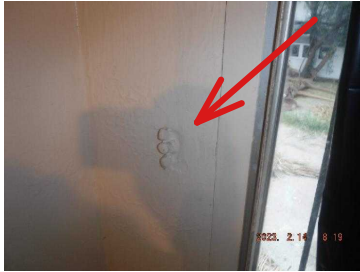
Defective Window Security Bars: **Wrought iron - Pulls/locks painted closed or damaged. A qualified licensed contractor is recommended to inspect this system, evaluate all findings and estimate repairs.**

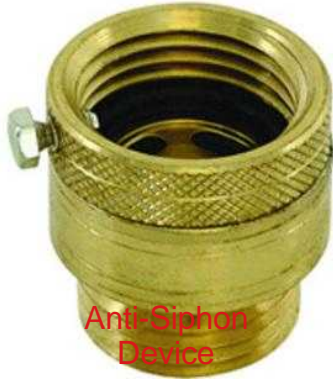
Update Exterior Fixtures: [attached to the home] Operated with no major flaws - (Recommended Update) Recommend anti-siphon/back flow valves at the exterior hose bibs to prevent cross contamination. This information is provided so that the buyer understand that the standards have changed for health or safety concerns. A qualified licensed contractor is recommended to inspect this system, evaluate all findings, make recommendations and estimate repairs.

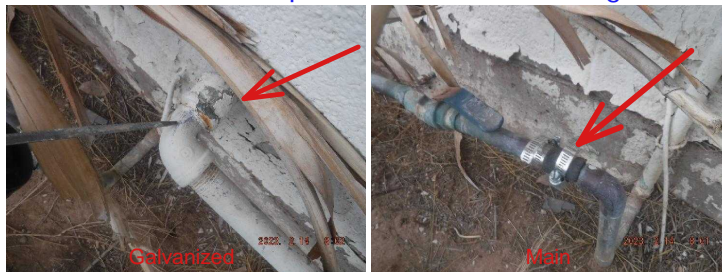
Defective, Update Piping Materials including supports and insulation: AquaPex and Copper Piping, Copper Pipes - (a) Main: (1) Galvanized pipe were found-- this is no longer allowed without cross contamination protection (deterioration caused by rust will contaminate the potable water as well as the possibility of lead contamination). Total extent of galvanized piping in the home is not fully determined. (2) Rubber patch inline on piping. (b), Water service shut off valves under sinks and at toilets have a recommended life span of 10-12 years and are considered a maintenance item. It is recommended that these valves be updated to provide security and peace of mind with regards to the water system, as well as guarantee the valve will operate properly when needed. A qualified licensed contractor is recommended to inspect, evaluate all findings and estimate repairs.

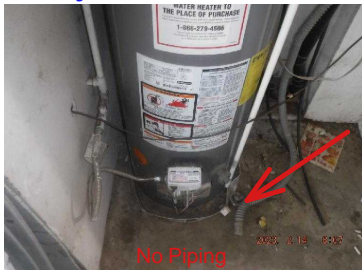
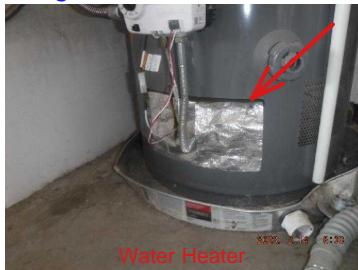
- Acceptable** Toilets: Manufacturer not determined
- Hot Water System Including:**
- Defective** Water Heating Equipment: Natural Gas Water Heater, 40 Gallons - 2019 is the estimated MFD for this unit. Water heater appears to be functioning correctly. (a) The catch pan is missing the proper piping to divert water away to an acceptable location. (b), Unit is missing burner access cover plate. This is a safety concern. A qualified licensed contractor is recommended to inspect this system, evaluate all findings, make recommendations and estimate repairs.

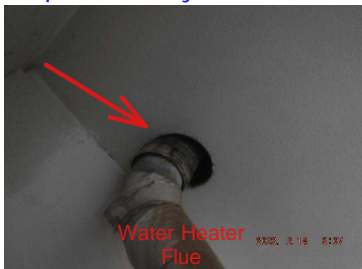
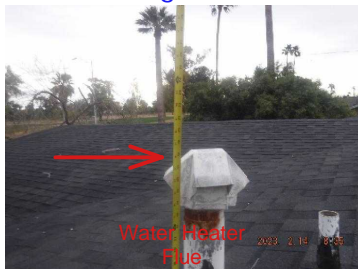
- Not Inspected** Normal Operating Controls: None Provided
- Acceptable** Auto Safety Controls: TPR Valve
- Defective** Flues: Single Wall Pipe at unit, Double Wall Pipe - (a) Double wall vent piping requires a minimum clearance of 1 inch from any combustible material. (b), Standards typically recommend a minimum of 24 inches clearance above the existing roofline within 10 feet for the flue cap(known as the 2/10 rule). A qualified licensed contractor is recommended to inspect this system, evaluate all findings, make recommendations and estimate repairs.

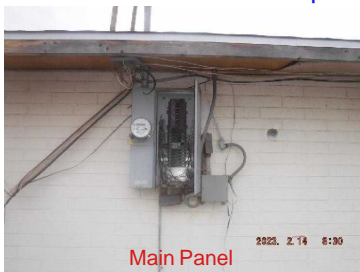
Other, Defective Main Panel Location: Exterior Wall - (a) Missing dead man cover(interior). No Labeling/Illegible Labeling of the breakers. Breakers are required to be labeled to identify each circuit. (b), No permits found for electrical updates. No final inspection label/certification found, recommend inquiring with the seller or contacting the local building department for verification. Building and Construction Permits in Phoenix can be searched at: <https://apps-secure.phoenix.gov/PDD/Search/Permits>. A qualified licensed contractor is recommended to inspect this system, evaluate all findings, make recommendations and estimate repairs. Due to the general condition/age of the electrical system, it is recommended that a qualified electrician evaluate the system as a whole for latent defects.

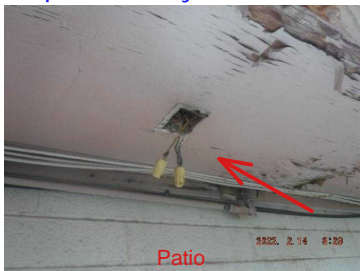
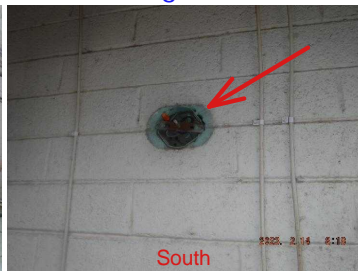
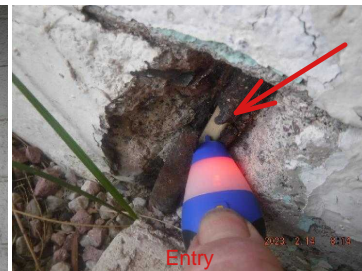
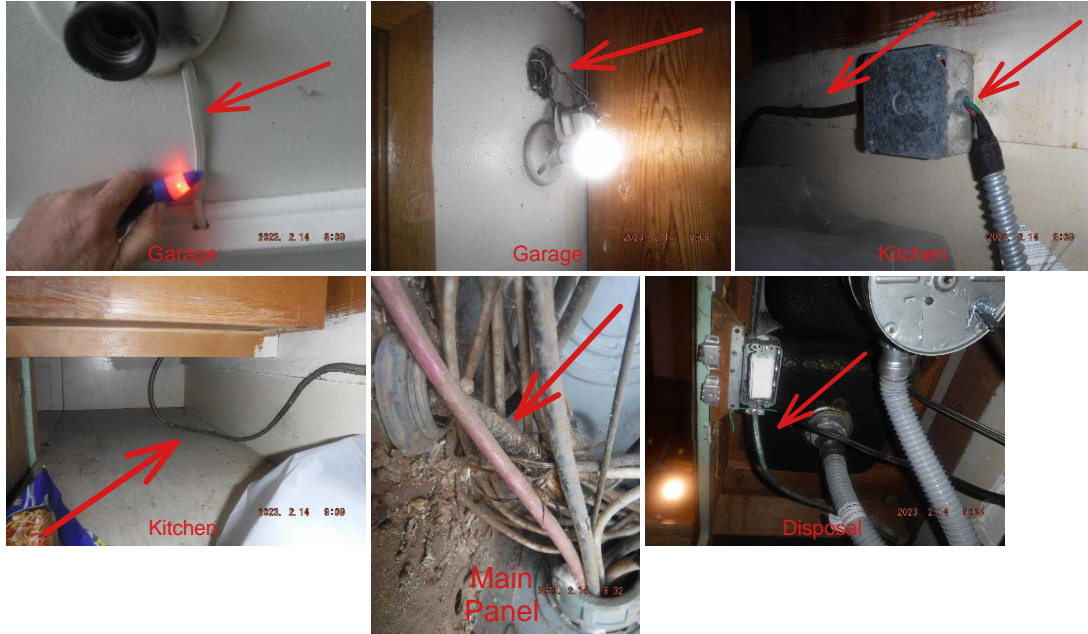
Other, Defective Branch Circuit Conductors: Copper Wire 110 VAC circuits - Non-metallic sheathed cable - (a), Exposed wiring present. All wiring needs to be covered, in the wall, or inside proper conduit. (b), Cloth coated wiring is still present in the home. This is aged and should be tested for proper viability and latent damage. A qualified licensed contractor is recommended to inspect this system, evaluate all findings, make recommendations and estimate repairs.

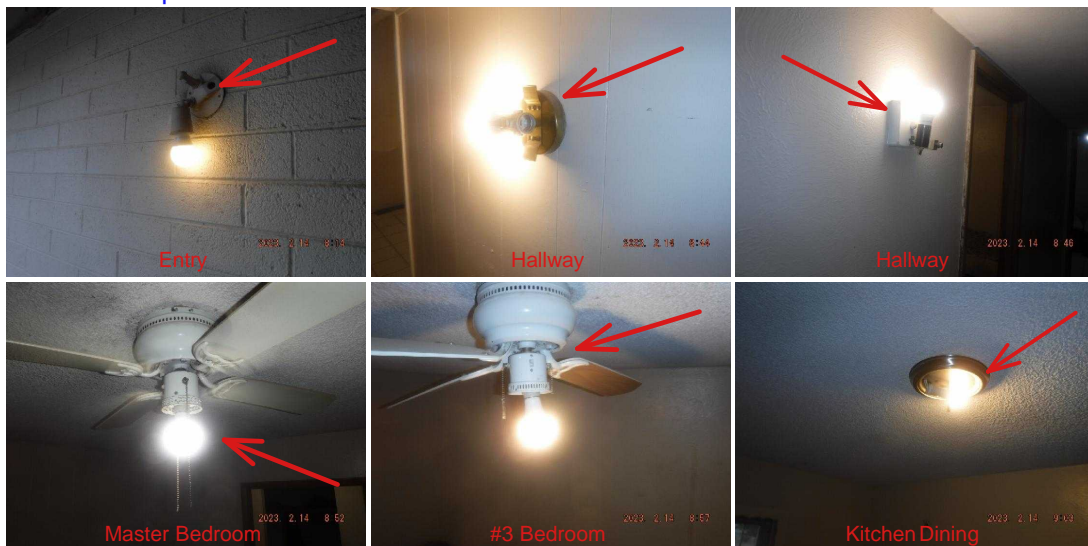
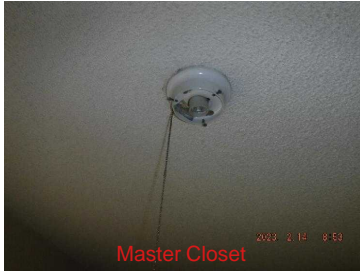
Other, Defective Ligh Fixtures [RN] Operation: Exterior & Interior - (a) Damaged/inoperable fixtures found. (b) Light bulbs are out in several locations around the home. Recommend requesting seller to install all bulbs to verify functions of the fixtures. A qualified licensed contractor is recommended to inspect this system, evaluate all findings, make recommendations and estimate repairs.

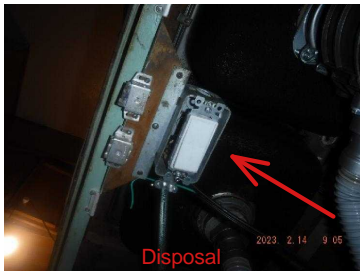
Light Switches[RN] Operation: Exterior & Interior - Missing cover plate. A qualified licensed contractor is recommended to inspect this system, evaluate all findings, make recommendations and estimate repairs.

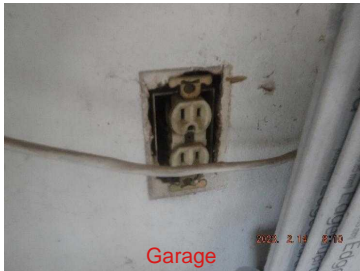
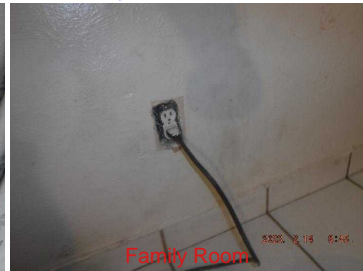
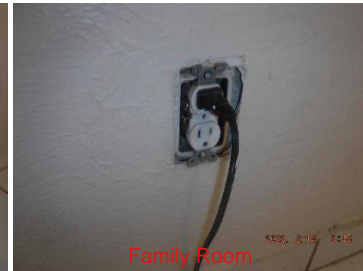
Outlets [RN] Operation: Exterior & Interior - Missing/damaged cover plates. A qualified licensed contractor is recommended to inspect this system, evaluate all findings, make recommendations and estimate repairs.

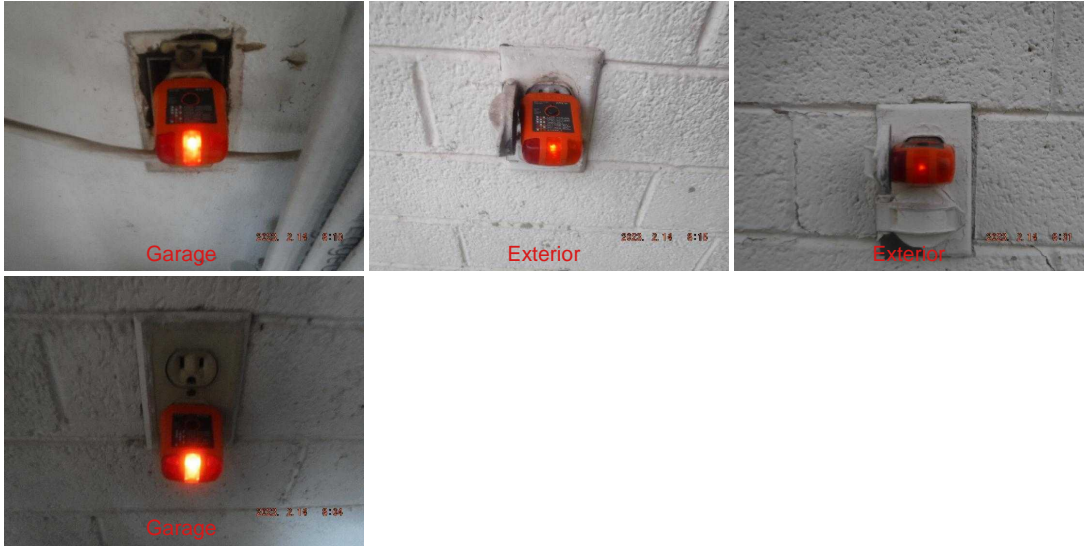
Acceptable 240 VAC A/C Connection: [Secure Conduit](#)

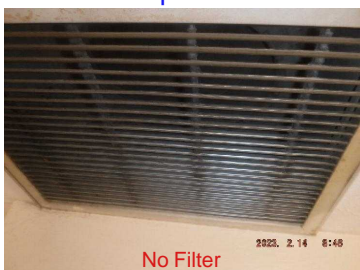
Defective Air Filters: **20x25x1 - No filters in place at time of inspection. A qualified licensed contractor is recommended to inspect this system, evaluate all findings, make recommendations and estimate repairs.**

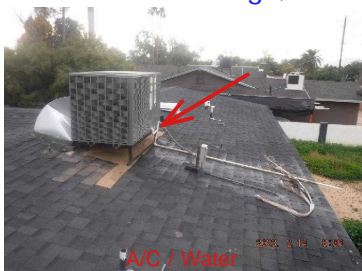
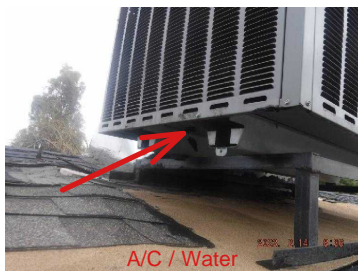
Cooling & Air Handling Equipment: **Rheem** - Water draining from unit may indicate a clogged condensation line. A qualified licensed contractor is recommended to inspect this system, evaluate all findings, make recommendations and estimate repairs.

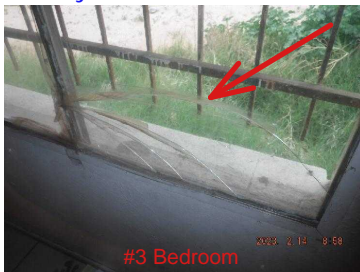
Other, Defective Windows (operation RN): **Metal frame single pane windows** - (a) #3 Bedroom: Broken window. (b) Other Areas: Windows show wear typical to the age of the home (loose locks, minor plastic trim damage, etc.). Dirty tracks are making the windows hard to open at several locations. Recommend cleaning. A qualified licensed contractor is recommended to inspect this system, evaluate all findings, make recommendations and estimate repairs.

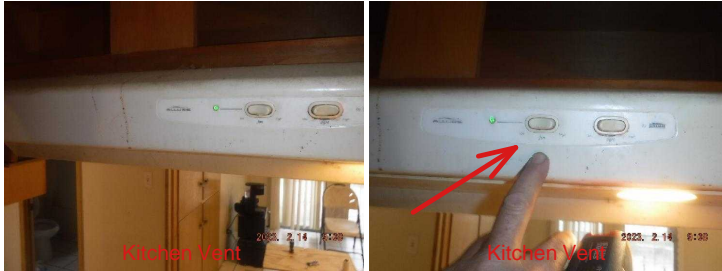
Defective Ventilator: Allure, Built in - Allure: Fan inoperative. A qualified licensed contractor is recommended to inspect this system, evaluate all findings and estimate repairs.

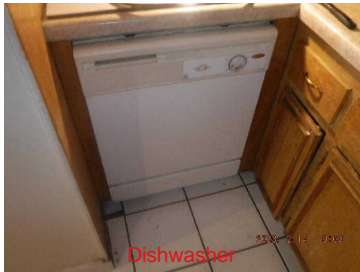
Defective Dishwasher: Whirlpool - Inoperative at time of inspection. Grinding noise. A qualified licensed contractor is recommended to inspect this system, evaluate all findings, make recommendations and estimate repairs.

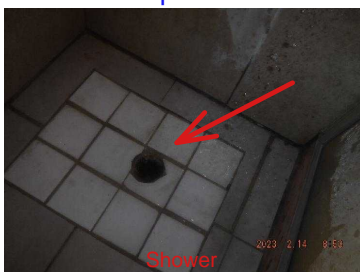
Defective Shower/Surround: All Tile - Missing drain cover. Repairs noted. A qualified licensed contractor is recommended to inspect this system, evaluate all findings, make recommendations and estimate repairs.

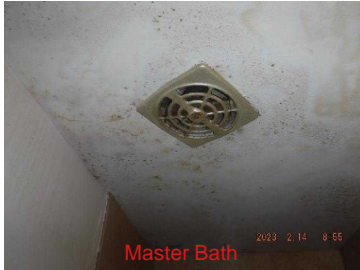
Defective Ventilation: Electric fan and window - Fan inoperative. A qualified licensed contractor is recommended to inspect this system, evaluate all findings, make recommendations and estimate repairs.

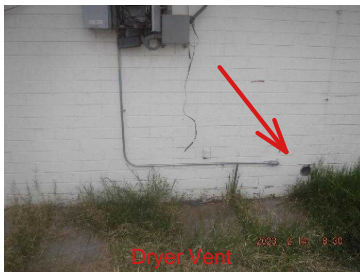
Acceptable Dryer Vent: Vents to the exterior - - Missing a small animal cover on the exterior. A qualified licensed contractor is recommended to inspect this system, evaluate all findings, make recommendations and estimate repairs.
