Home Inspection Report

Prepared for: Joseph Markowicz

827 N 61st Ave
Phoenix, Arizona 85043

Inspected by:
Mark Stephens
Arizona Premier Home and Property Inspections

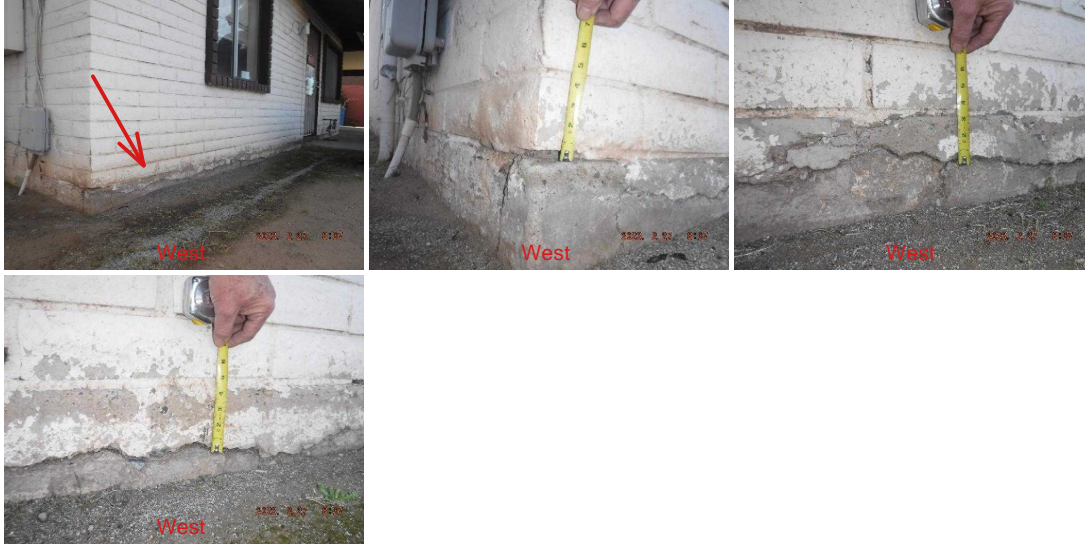
1. Foundation: Poured Concrete slab - West: More than typical cracking noted. Undetermined depth of cracks(filled with dirt). A qualified licensed contractor is recommended to inspect this system, evaluate all findings, make recommendations and estimate repairs.

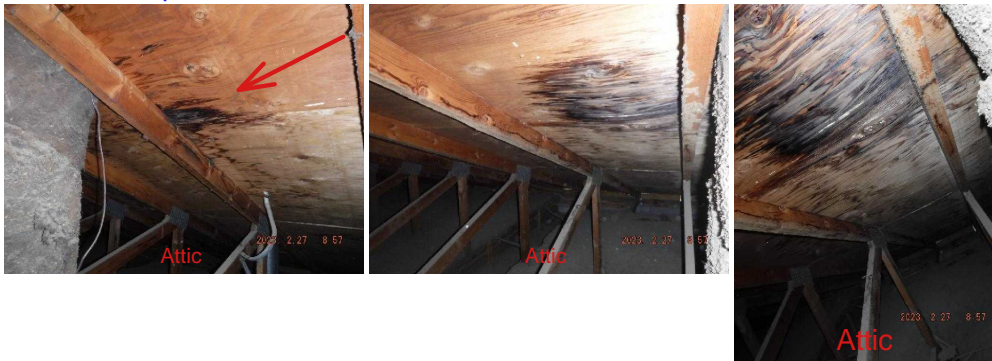
2. Water Penetration or Condensation: Evidence of moisture penetration was found - A qualified licensed contractor is recommended to inspect this system, evaluate all findings, make recommendations and estimate repairs.

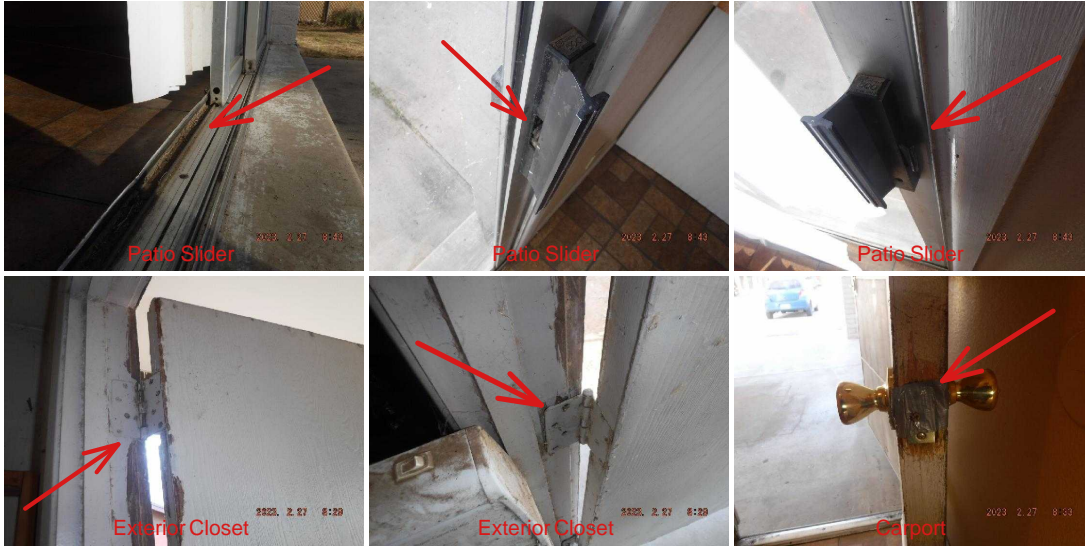
4. Exterior walls Exterior Surface Entryway Doors: [operation of all] All Exterior Doors - (a) Patio Slider: Tracks are worn and damaged. Door lock is broken, door will not secure. (b) Exterior Closet: Hinges stripped of the jam. (c) Carport: Throw is missing, door will not secure. A qualified licensed contractor is recommended to inspect this system, evaluate all findings, make recommendations and estimate repairs.

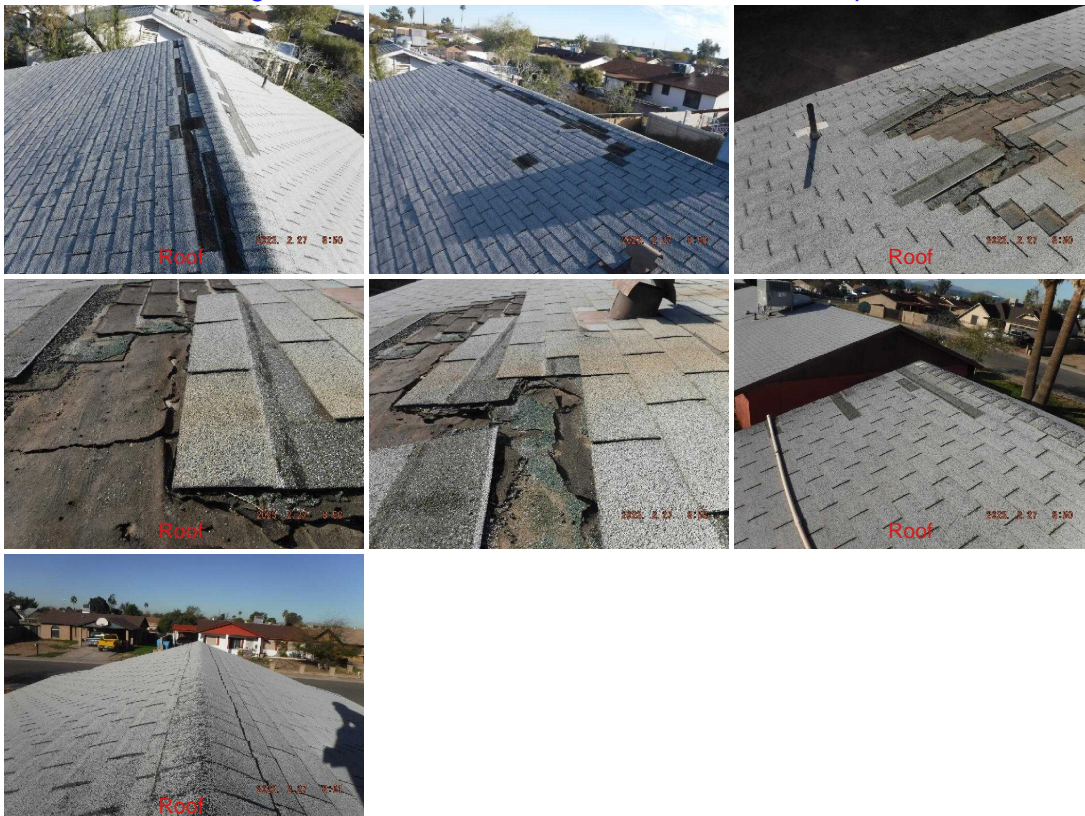
5. Main Roof Roof Surface Roof Covering Material (type & condition): **Asphalt Shingle - Damaged and worn.** Past life expectancy. A qualified licensed contractor is recommended to inspect this system as a whole, evaluate all findings, make recommendations and estimate repairs.

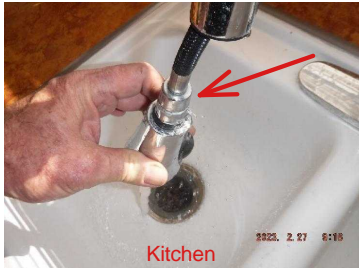
6. Kitchen Fixture(s): **Flaw found** - The faucet is leaking at the handle connection. A qualified licensed contractor is recommended to inspect this system, evaluate all findings, make recommendations and estimate repairs.

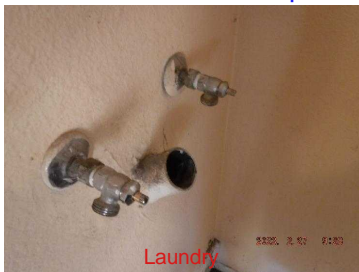
7. Laundry Washer Hose Bibs: **Stem Valves - Missing handles**. A qualified licensed contractor is recommended to inspect this system, evaluate all findings, make recommendations and estimate repairs.

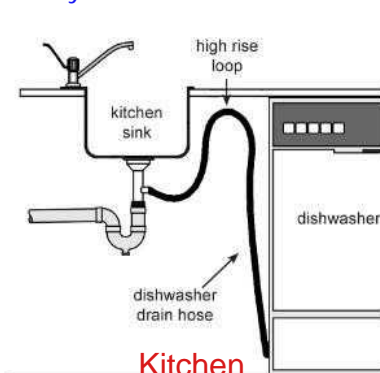
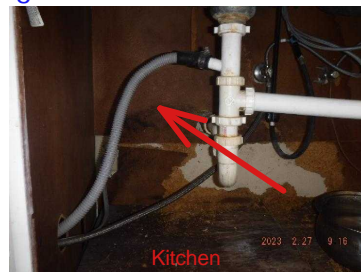
8. *Cross Connections (exterior & Interior): **Risk found**. Kitchen: Improperly routed drain hose. The drain hose should be routed over the bottom of the lowest part of the sink creating what is known as a "High Loop". The purpose of the loop is to prevent the contents of the sink/disposal from draining into the dishwasher, possibly creating a cross-contamination issue. A qualified licensed contractor is recommended to inspect this system, evaluate all findings, make recommendations and estimate repairs.

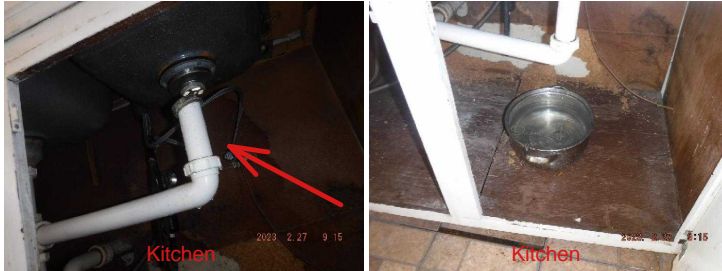
9. *Drain Leaks: **Leaks were found** - Kitchen: Piping detached at the drains. Limited inspection of connected services due to condition. Leaking into pan. A qualified licensed contractor is recommended to inspect this system, evaluate all findings, make recommendations and estimate repairs.

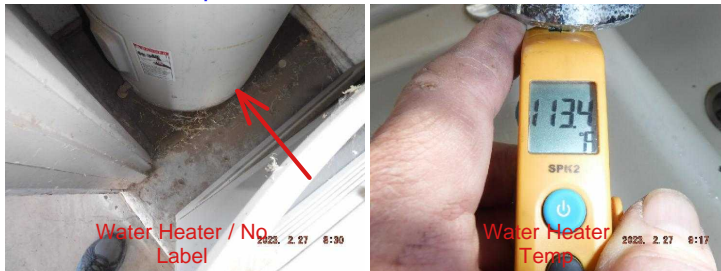
10. Water Heating Equipment: Capacity and age undetermined - No label present. The water temperature output is low by standards, typical setting at approximately 122-130 degrees per manufacturers. This may be a fault in the water heater or that the owners/occupants have the temperature set low. A qualified licensed contractor is recommended to inspect this system, evaluate all findings, make recommendations and estimate repairs.

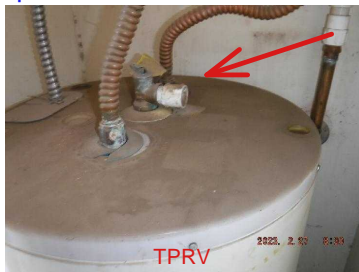
11. Auto Safety Controls: TPR Valve - - Improper installation (no piping). The TPR pipe cannot be reduced in size, has to be routed downhill after it leaves the TPR valve, terminate 6 to 24 inches from the ground and should only be made out of hard-drawn copper, CPVC, or galvanized steel. A qualified licensed contractor is recommended to inspect this system, evaluate all findings, make recommendations and estimate repairs.

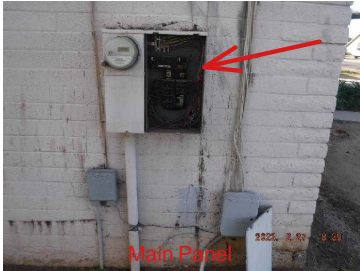
12. Main Panel Location: Exterior Wall - Missing dead man interior cover. No labeling available. Due to the general condition of the electrical system, it is recommended that a qualified electrician evaluate the system as a whole for latent defects. A qualified licensed contractor is recommended to inspect this system, evaluate all findings, make recommendations and estimate repairs.

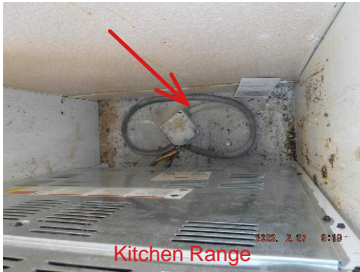
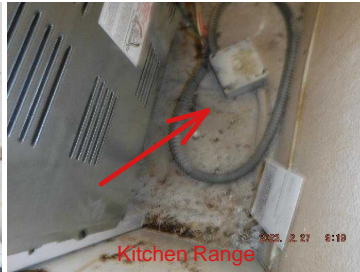
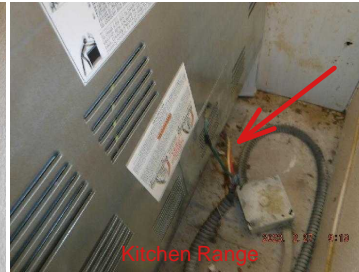
13. Branch Circuit Conductors: Copper Wire 110 VAC circuits - Non-metallic sheathed cable - Kitchen Range: Exposed wiring present. Outlet is loose and on the floor. Wiring is exposed at the range. A qualified licensed contractor is recommended to inspect this system, evaluate all findings, make recommendations and estimate repairs.

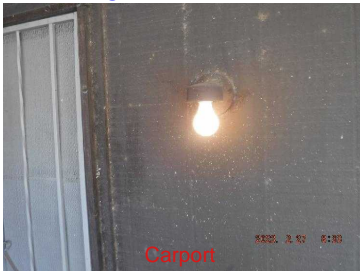
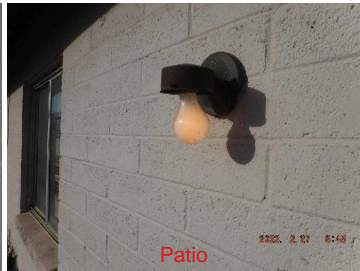
14. Light Fixtures [RN] Operation: Exterior & Interior - (a), Fixtures are missing globes/covers. (b) Light bulbs are out in several locations around the home. Recommend requesting seller to install all bulbs to verify functions of the fixtures. A qualified licensed contractor is recommended to inspect this system, evaluate all findings, make recommendations and estimate repairs.

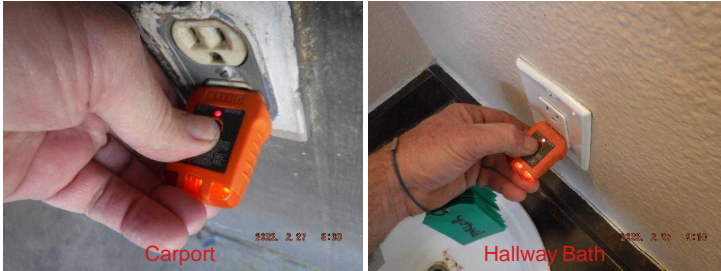
15. GFCI Outlets Operation: Exterior & Interior - (a) Exterior: GFCI protection is missing at exterior outlets. (GFCI protection was mandated for the exterior of homes in 1971). (b) Bathroom: Today's standards require GFCI protection for all the bathroom outlets (became the standard in 1975). (c), Recommend updating to current standards at locations missing GFCI protection(Kitchen, Laundry). A qualified licensed contractor is recommended to inspect this system, evaluate all findings, make recommendations and estimate repairs. Noted: Visible red light on tester indicates no GFCI protection at the outlet.

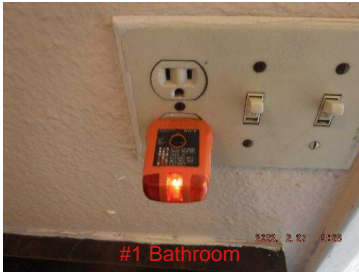
16. Polarity & Ground of all: Exterior & Interior - #1 Bathroom: Open grounds found at the outlet. This location should also be GFCI protected once wiring is corrected. A qualified licensed contractor is recommended to inspect this system, evaluate all findings, make recommendations and estimate repairs. **Noted: Single center light on tester indicates open ground.**

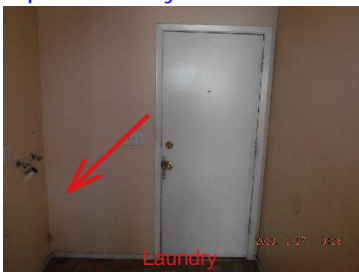
17. All living areas and garage Living Space Interior Walls: Paint-Texture - (a) Laundry: Minor wall damage around the drain clean-out. May have minor leaking. (b) Other Areas: Common typical cracking and damage noted. Consistent with the age of the home. Mismatched paint and unfinished repairs are present. The home is very dirty and in unkempt condition. A qualified licensed contractor is recommended to inspect this system, evaluate all findings, make recommendations and estimate repairs.

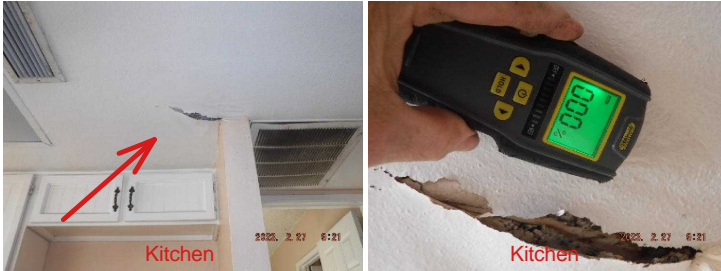
18. All living areas and garage Living Space Interior Ceilings: Texture-Paint - (a) Kitchen: - Evidence of moisture penetration (staining and inconsistencies in the texture) was found on the ceiling. (b) Other Areas: Common cracks noted at various places of the home. Repairs evident in several locations. A qualified licensed contractor is recommended to inspect, evaluate all findings, make recommendations and estimate repairs.

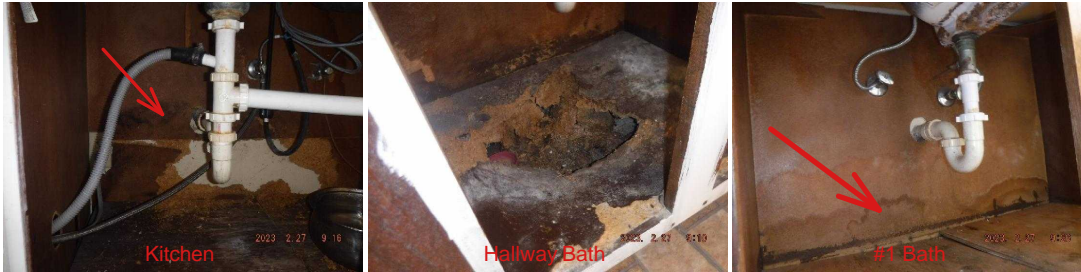
19. All living areas and garage Living Space Cabinets (RN): Wood & Composite Wood materials - (a) Damaged cabinets found. (b) Other Areas: Typical wear to the cabinets. Several of the cabinets need adjustment to the hinges to open/close properly. A qualified licensed contractor is recommended to inspect this system, evaluate all findings, make recommendations and estimate repairs.

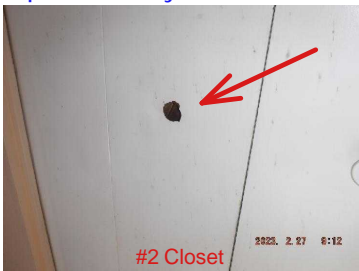
20. All living areas and garage Living Space Doors (operation RN): Hollow Core Doors - (a) #2 Closet: Hole in the door. (b) Other Areas: Doors need minor adjustment to the hinges to open and close properly. Typical wear and damage consistent with the age of the home. A qualified licensed contractor is recommended to inspect this system, evaluate all findings, make recommendations and estimate repairs.

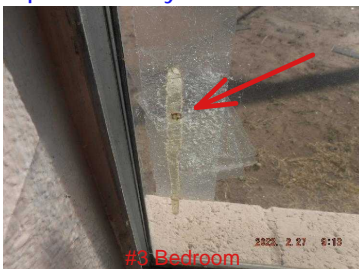
21. All living areas and garage Living Space Windows (operation RN): Metal frame single pane windows - (a) #3 Bedroom: Broken window (patched with tape). (b) Rest of the Home: Windows show wear typical to the age of the home (loose locks, minor plastic trim damage, etc.). Dirty tracks are making the windows hard to open at several locations. Recommend cleaning. A qualified licensed contractor is recommended to inspect this system, evaluate all findings, make recommendations and estimate repairs.

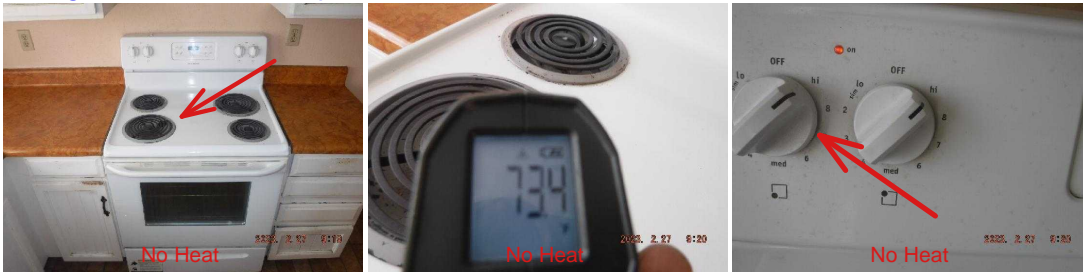
22. Main living area Kitchen Cooking Appliances: Frigidaire - (a) Burner will not heat(LF). (b) (Recommendation) Today's standards calls for an anti tip bracket for stoves. The buyer should consider upgrading to today's standards. A qualified licensed contractor is recommended to inspect, evaluate all findings and estimate repairs.

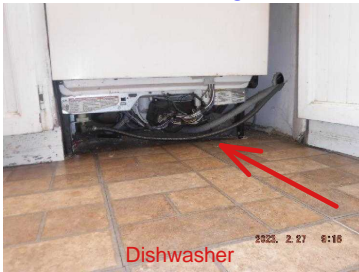
23. Main living area Kitchen Dishwasher: Whirlpool - (a) Not run due to drain line concerns at the sink. (b) Missing kick, wiring exposed. A qualified licensed contractor is recommended to inspect this system, evaluate all findings, make recommendations and estimate repairs.

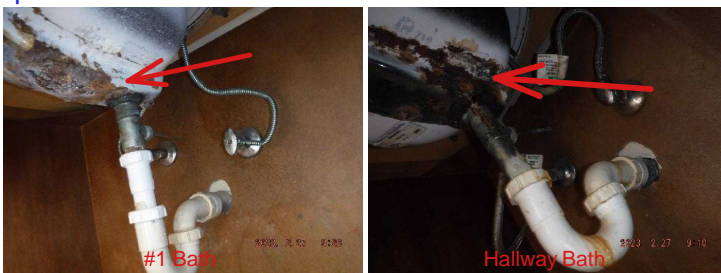
24. All Bathrooms Bathroom Sink/Basin: Molded single bowls - Heavy rust at the base. A qualified licensed contractor is recommended to inspect this system, evaluate the above listed findings, and estimate repairs.

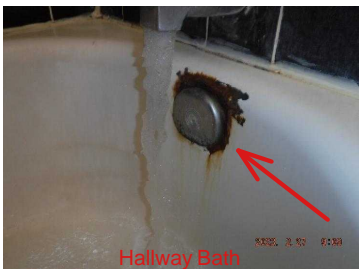
25. All Bathrooms Bathroom Tub/Surround: Porcelain tubs with tile surrounds - Hallway Bath: Heavy rust damage. A qualified licensed contractor is recommended to inspect this system, evaluate all findings, make recommendations and estimate repairs.

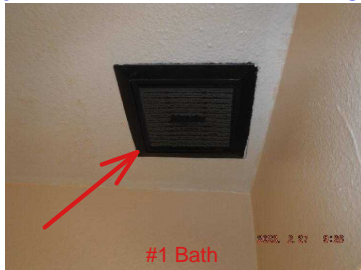
26. All Bathrooms Bathroom Ventilation: Electric fan and or window - #1 Bath: The vent fan is making a rotational noise. This is evidence that the bearings are worn. Worn bearing are a source of heat and a fire concern. Recommend replacement. A qualified licensed contractor is recommended to inspect this system, evaluate all findings, make recommendations and estimate repairs.

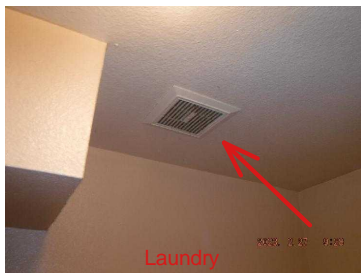
27. Interior Service Area Laundry Room/Area Ventilation: Electric ventilation fan - Fan inoperative. A qualified licensed contractor is recommended to inspect this system, evaluate all findings, make recommendations and estimate repairs.

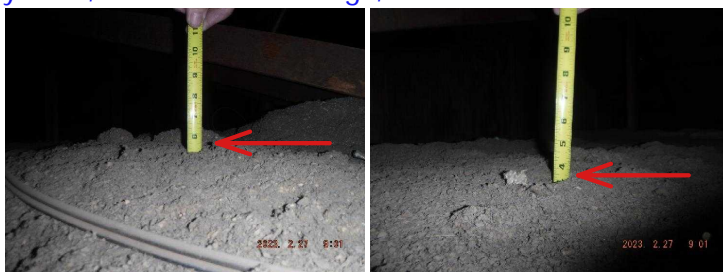
28. Master Bedroom Closet Attic Evidence of leaking:* Clear visible evidence of moisture penetration - See: Systems: Structural Components/Water Penetration or Condensation.
29. Master Bedroom Closet Attic Insulation Depth: 3" - 5" - (a) The insulation appears to have 'settled' and would not meet typical standards of the time of construction(8 inches/R-30). (b) IECC standards adopted in 2015 recommend 10 inches(R-38) depth of insulation for Climate Zone 2 areas such as Maricopa and Pima counties in Arizona. Adding insulation to the attic areas if one of the most effective ways to help conserve energy and lower utility bills. A qualified licensed contractor is recommended to inspect this system, evaluate all findings, make recommendations and estimate repairs.

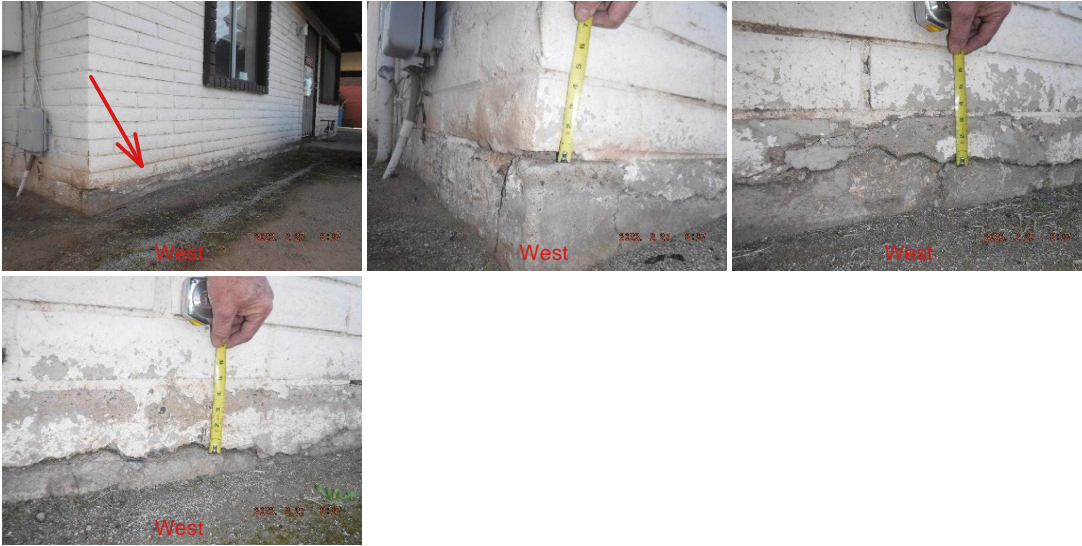
Defective Foundation: Poured Concrete slab - West: More than typical cracking noted. Undetermined depth of cracks(filled with dirt). A qualified licensed contractor is recommended to inspect this system, evaluate all findings, make recommendations and estimate repairs.

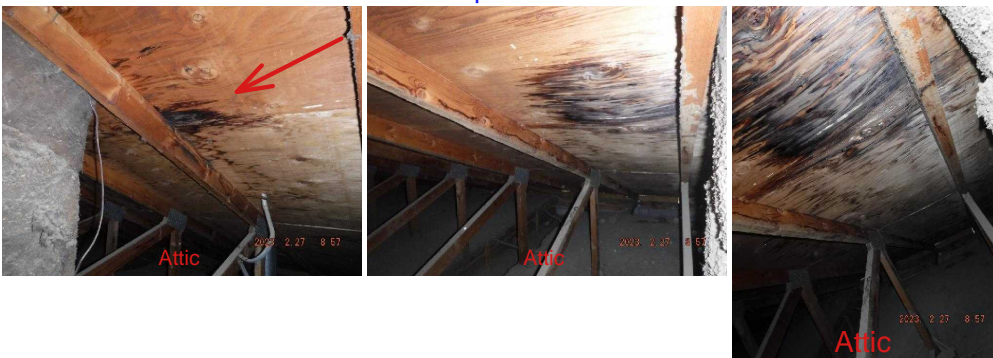
Defective Water Penetration or Condensation: Evidence of moisture penetration was found - A qualified licensed contractor is recommended to inspect this system, evaluate all findings, make recommendations and estimate repairs.

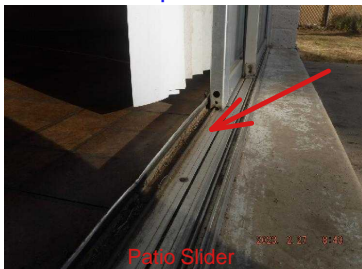
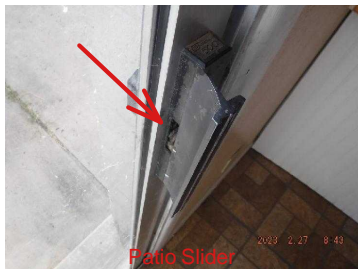
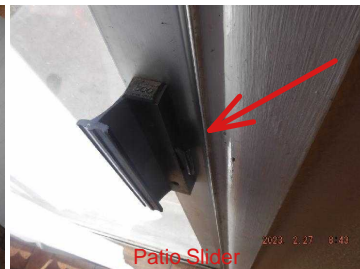
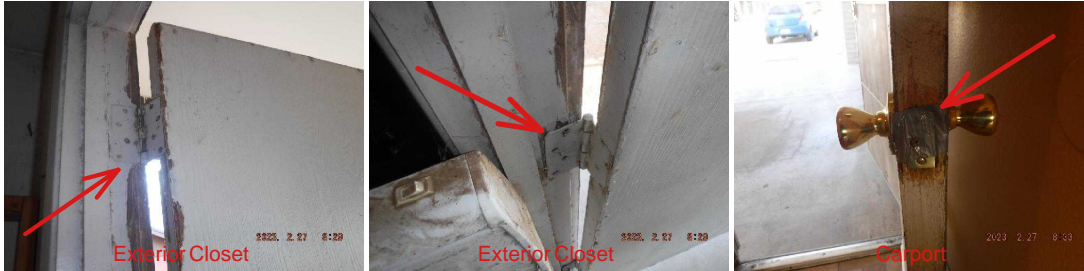
Defective Entryway Doors: [operation of all] [All Exterior Doors - \(a\) Patio Slider: Tracks are worn and damaged. Door lock is broken, door will not secure. \(b\) Exterior Closet: Hinges stripped of the jam. \(c\) Carport: Throw is missing, door will not secure. A qualified licensed contractor is recommended to inspect this system, evaluate all findings, make recommendations and estimate repairs.](#)

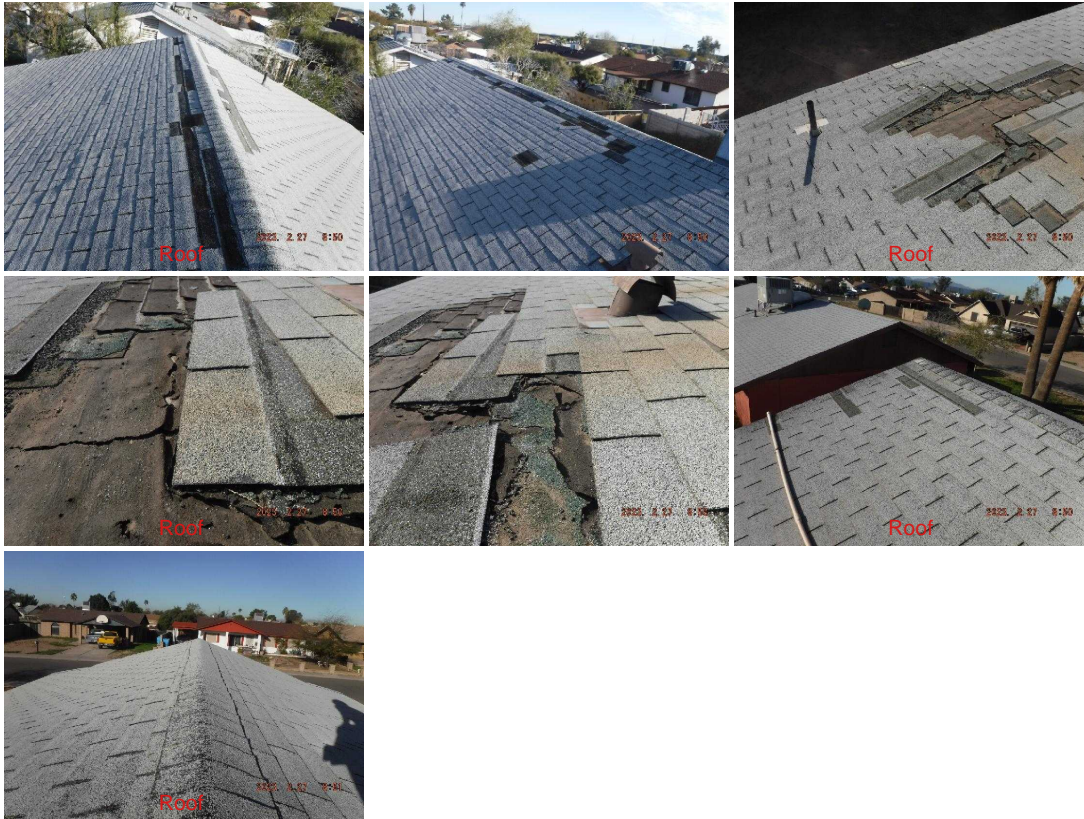
Acceptable Unable to Inspect what % of the roof: [The entire Roof was accessible](#)
Defective Roof Covering Material (type & condition): [Asphalt Shingle - Damaged and worn. Past life expectancy. A qualified licensed contractor is recommended to inspect this system as a whole, evaluate all findings, make recommendations and estimate repairs.](#)

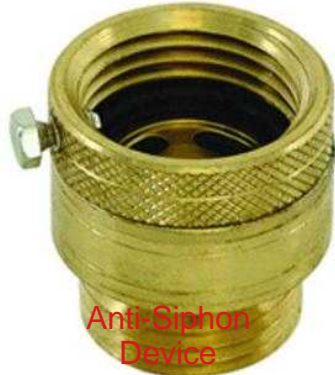
Exterior Fixtures: [attached to the home] Operated with no major flaws - (Recommended Update) Recommend anti-siphon/back flow valves at the exterior hose bibs to prevent cross contamination. This information is provided so that the buyer understand that the standards have changed for health or safety concerns. A qualified licensed contractor is recommended to inspect this system, evaluate all findings, make recommendations and estimate repairs.

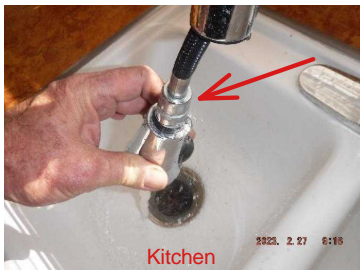
Kitchen Fixture(s): Flaw found - The faucet is leaking at the handle connection. A qualified licensed contractor is recommended to inspect this system, evaluate all findings, make recommendations and estimate repairs.

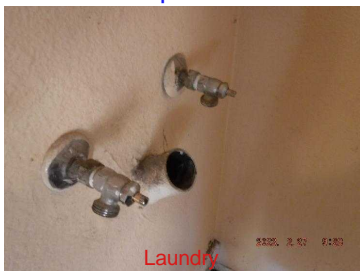
Laundry Washer Hose Bibs: Stem Valves - Missing handles. A qualified licensed contractor is recommended to inspect this system, evaluate all findings, make recommendations and estimate repairs.

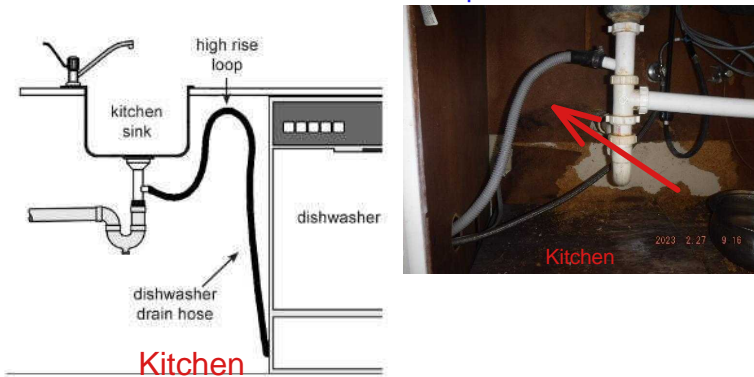
*Cross Connections (exterior & Interior): Risk found. Kitchen: Improperly routed drain hose. The drain hose should be routed over the bottom of the lowest part of the sink creating what is known as a "High Loop". The purpose of the loop is to prevent the contents of the sink/disposal from draining into the dishwasher, possibly creating a cross-contamination issue. A qualified licensed contractor is recommended to inspect this system, evaluate all findings, make recommendations and estimate repairs.

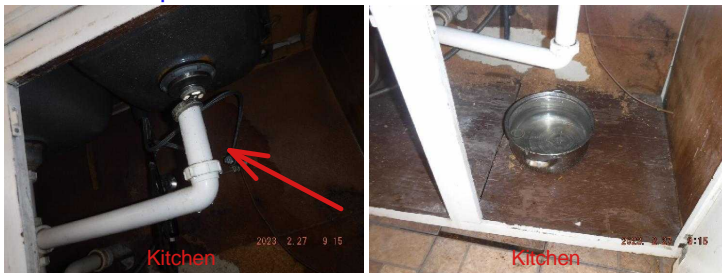
*Drain Leaks: Leaks were found - Kitchen: Piping detached at the drains. Limited inspection of connected services due to condition. Leaking into pan. A qualified licensed contractor is recommended to inspect this system, evaluate all findings, make recommendations and estimate repairs.

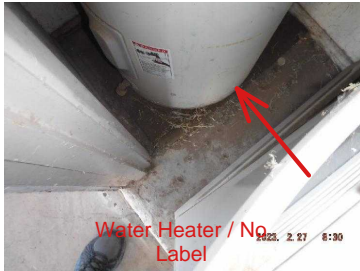
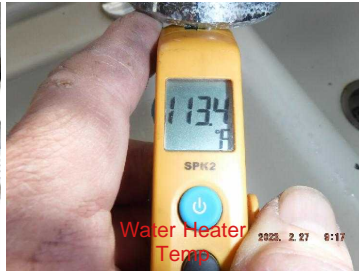
Defective Water Heating Equipment: Capacity and age undetermined - No label present. The water temperature output is low by standards, typical setting at approximately 122-130 degrees per manufacturers. This may be a fault in the water heater or that the owners/occupants have the temperature set low. A qualified licensed contractor is recommended to inspect this system, evaluate all findings, make recommendations and estimate repairs.

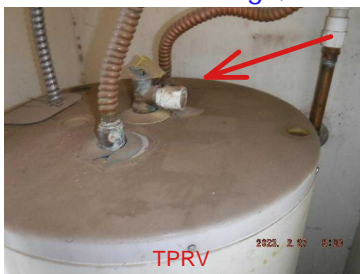
Defective Auto Safety Controls: TPR Valve - - Improper installation (no piping). The TPR pipe cannot be reduced in size, has to be routed downhill after it leaves the TPR valve, terminate 6 to 24 inches from the ground and should only be made out of hard-drawn copper, CPVC, or galvanized steel. A qualified licensed contractor is recommended to inspect this system, evaluate all findings, make recommendations and estimate repairs.

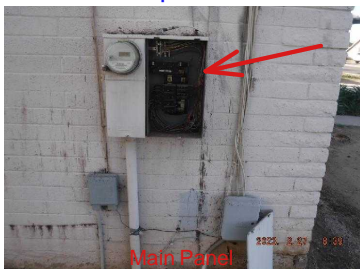
Due to the general condition of the electrical system, it is recommended that a qualified electrician evaluate the system as a whole for latent defects. A qualified licensed contractor is recommended to inspect this system, evaluate all findings, make recommendations and estimate repairs.

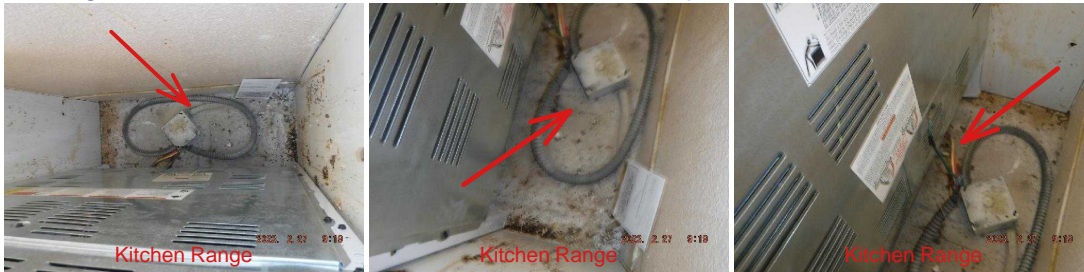
Branch Circuit Conductors: Copper Wire 110 VAC circuits - Non-metallic sheathed cable - Kitchen Range: Exposed wiring present. Outlet is loose and on the floor. Wiring is exposed at the range. A qualified licensed contractor is recommended to inspect this system, evaluate all findings, make recommendations and estimate repairs.

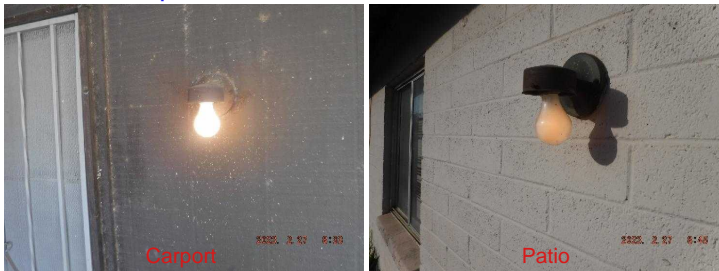
Ligh Fixtures [RN] Operation: Exterior & Interior - (a), Fixtures are missing globes/covers. (b) Light bulbs are out in several locations around the home. Recommend requesting seller to install all bulbs to verify functions of the fixtures. A qualified licensed contractor is recommended to inspect this system, evaluate all findings, make recommendations and estimate repairs.

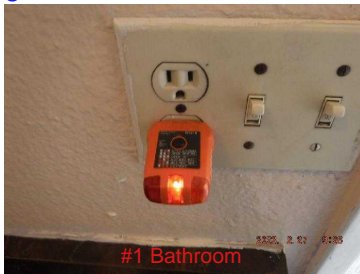
Polarity & Ground of all: Exterior & Interior - #1 Bathroom: Open grounds found at the outlet. This location should also be GFCI protected once wiring is corrected. A qualified licensed contractor is recommended to inspect this system, evaluate all findings, make recommendations and estimate repairs. Noted: Single center light on tester indicates open ground.

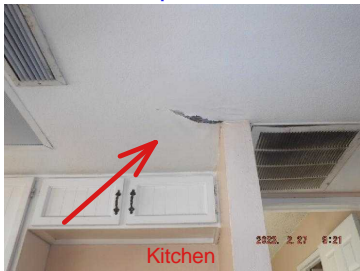
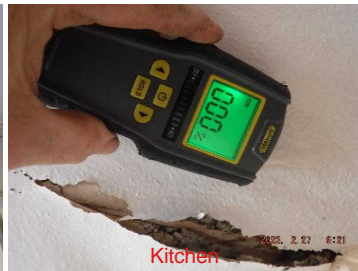
Other, Defective Interior Ceilings: Texture-Paint - (a) Kitchen: - Evidence of moisture penetration (staining and inconsistencies in the texture) was found on the ceiling. (b) Other Areas: Common cracks noted at various places of the home. Repairs evident in several locations. A qualified licensed contractor is recommended to inspect, evaluate all findings, make recommendations and estimate repairs.

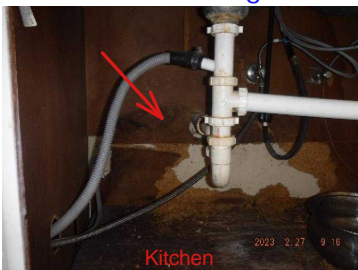
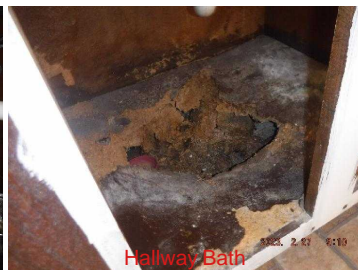
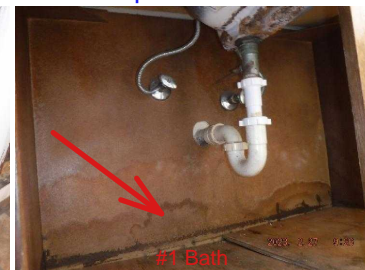
Defective Cabinets (RN): Wood & Composite Wood materials - (a) Damaged cabinets found. (b) Other Areas: Typical wear to the cabinets. Several of the cabinets need adjustment to the hinges to open/close properly. A qualified licensed contractor is recommended to inspect this system, evaluate all findings, make recommendations and estimate repairs.

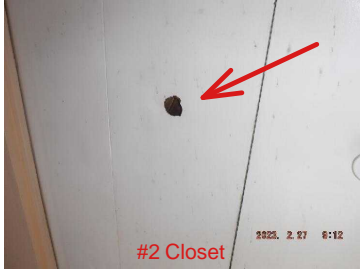
Other, Defective Doors (operation RN): **Hollow Core Doors** - (a) #2 Closet: Hole in the door. (b) Other Areas: Doors need minor adjustment to the hinges to open and close properly. Typical wear and damage consistent with the age of the home. A qualified licensed contractor is recommended to inspect this system, evaluate all findings, make recommendations and estimate repairs.

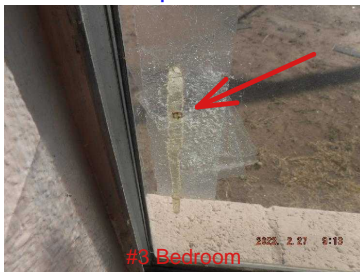
Other, Defective Windows (operation RN): **Metal frame single pane windows** - (a) #3 Bedroom: Broken window(patched with tape). (b) Rest of the Home: Windows show wear typical to the age of the home(loose locks, minor plastic trim damage, etc.). Dirty tracks are making the windows hard to open at several locations. Recommend cleaning. A qualified licensed contractor is recommended to inspect this system, evaluate all findings, make recommendations and estimate repairs.

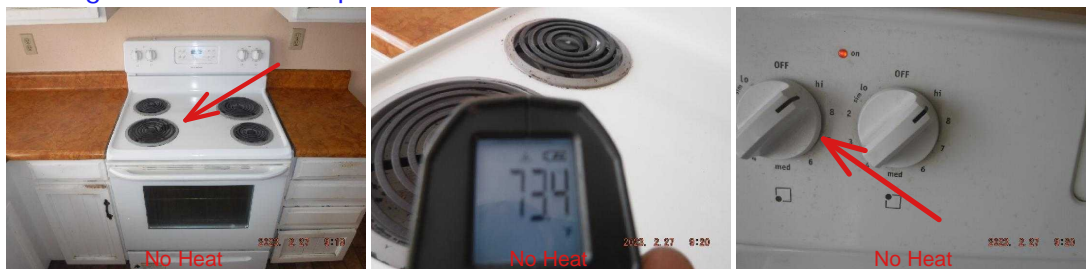
Defective, Update Cooking Appliances: Frigidaire - (a) Burner will not heat(LF). (b) (Recommendation) Today's standards calls for an anti tip bracket for stoves. The buyer should consider upgrading to today's standards. A qualified licensed contractor is recommended to inspect, evaluate all findings and estimate repairs.

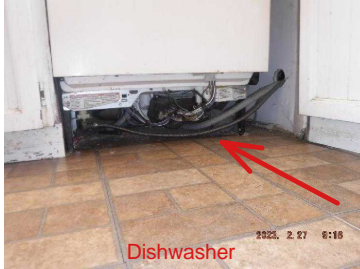
Other, Defective Dishwasher: Whirlpool - (a) Not run due to drain line concerns at the sink. (b) Missing kick, wiring exposed. A qualified licensed contractor is recommended to inspect this system, evaluate all findings, make recommendations and estimate repairs.

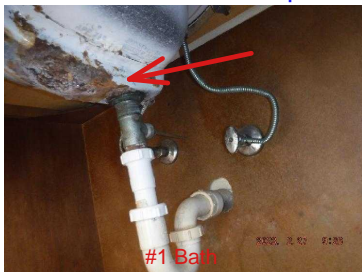
Defective Sink/Basin: Molded single bowls - Heavy rust at the base. A qualified licensed contractor is recommended to inspect this system, evaluate the above listed findings, and estimate repairs.

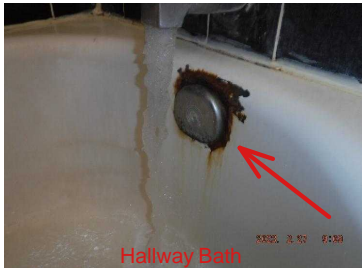
Defective Tub/Surround: Porcelain tubs with tile surrounds - Hallway Bath: Heavy rust damage. A qualified licensed contractor is recommended to inspect this system, evaluate all findings, make recommendations and estimate repairs.

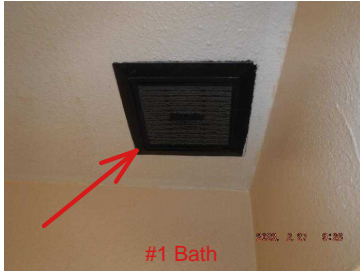
Defective Ventilation: Electric fan and or window - #1 Bath: The vent fan is making a rotational noise. This is evidence that the bearings are worn. Worn bearing are a source of heat and a fire concern. Recommend replacement. A qualified licensed contractor is recommended to inspect this system, evaluate all findings, make recommendations and estimate repairs.

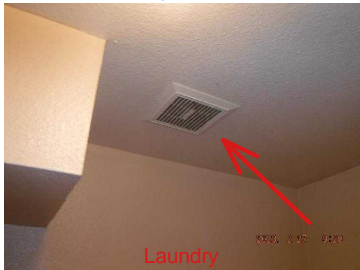
Defective Ventilation: Electric ventilation fan - Fan inoperative. A qualified licensed contractor is recommended to inspect this system, evaluate all findings, make recommendations and estimate repairs.

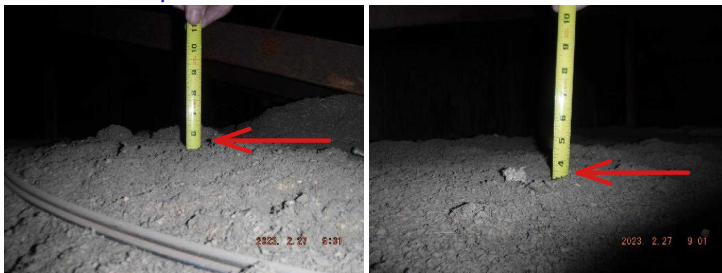
Defective Estimated "R" value. R10 or less - (a) The insulation appears to have 'settled' and would not meet typical standards of the time of construction(8 inches/R-30). (b) IECC standards adopted in 2015 recommend 10 inches(R-38) depth of insulation for Climate Zone 2 areas such as Maricopa and Pima counties in Arizona. Adding insulation to the attic areas if one of the most effective ways to help conserve energy and lower utility bills. A qualified licensed contractor is recommended to inspect this system, evaluate all findings, make recommendations and estimate repairs.
