Home Inspection Report

Prepared for: Joseph Markowicz

6733 N 32nd Ave Phoenix, Arizona 85017

Inspected by:
Mark Stephens
Arizona Premier Home and Property Inspections

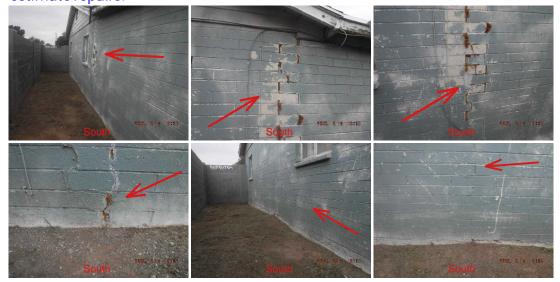
2. Wall Structure: Block, Wood Frame - (a) South: Heavy cracking with displacement noted. Cracking extends into the stem wall. (b) Other Areas: Common cracking and mortar decay noted. A qualified licensed contractor is recommended to inspect this system, evaluate all findings, make recommendations and estimate repairs.

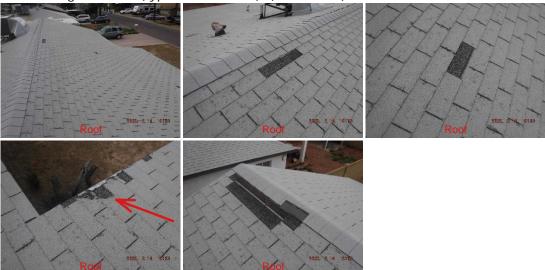
Roof Covering Material (type & condition): (continued)

7. Main Roof Roof Surface Roof Covering Material (type & condition): Asphalt Shingle - Damaged shingles found. The shingles are showing heavy wear. Gravel is off of the shingles and the fiberglass reinforcement is decaying. Roof in this condition is considered at or past it's expected life. A qualified licensed contractor is recommended to inspect this system as a whole, evaluate all findings, make recommendations and estimate repairs.

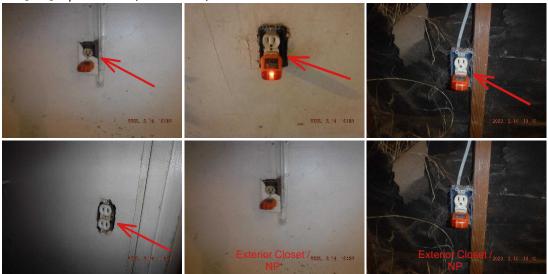
Outlets [RN] Operation: (continued)

22. Outlets [RN] Operation: Exterior & Interior - (a) Missing/broken cover plates. (Pictures may not show all locations). (b) Exterior Closet: No power at the outlets. A qualified licensed contractor is recommended to inspect this system, evaluate all findings, make recommendations and estimate repairs. Noted: 2 prong outlets still present in the home. These have no grounding and electronics plugged into these outlets have a possibility of damage through a power/electrical surge. Plan accordingly.

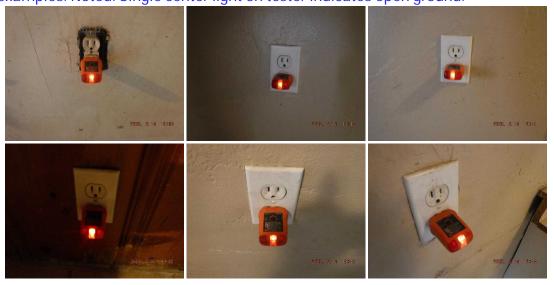
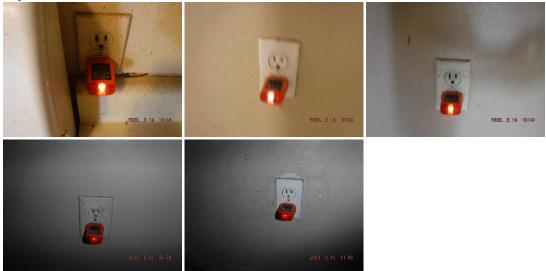
Polarity & Ground of all: (continued)

23. Polarity & Ground of all: Exterior & Interior - Most of the ungrounded outlets were replaced with 3 prong outlets. This is not allowed because it gives a false sense of grounding. When replacing a 2 prong outlet on a non grounded circuit it must be replaced with a 2 prong outlet or a GFCI outlet (GFCI can be 3 prong outlet). Recommend replacing the ungrounded outlets with GFCI outlets as this is the safer of the two options. A qualified licensed contractor is recommended to inspect this system, evaluate all findings, make recommendations and estimate repairs. Noted: Pictures may not show all locations and are for examples. Noted: Single center light on tester indicates open ground.

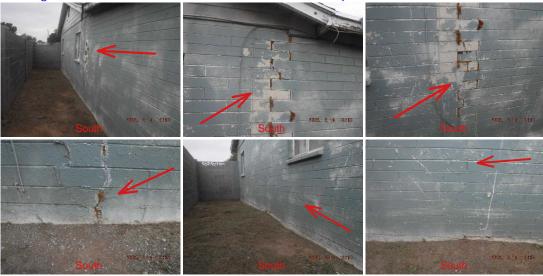
Wall Structure: Block, Wood Frame - (a) South: Heavy cracking with displacement noted. Cracking extends into the stem wall. (b) Other Areas: Common cracking and mortar decay noted. A qualified licensed contractor is recommended to inspect this system, evaluate all findings, make recommendations and estimate repairs.

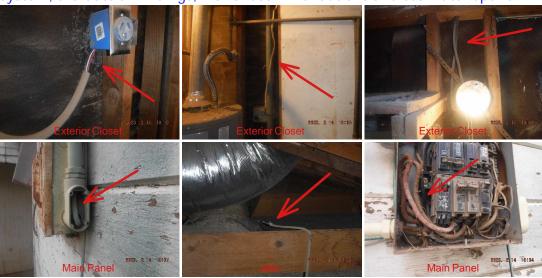
Branch Circuit Conductors: Copper Wire 110 VAC circuits - Non-metallic sheathed cable - (a), Exposed wiring present. All wiring needs to be covered, in the wall, or inside proper conduit. (b), Cloth coated wiring is still present in the home. This is aged and should be tested for proper viability and latent damage. A qualified licensed contractor is recommended to inspect this system, evaluate all findings, make recommendations and estimate repairs.

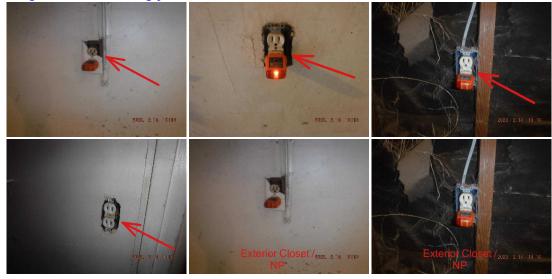
Outlets [RN] Operation: Exterior & Interior - (a) Missing/broken cover plates. (Pictures may not show all locations). (b) Exterior Closet: No power at the outlets. A qualified licensed contractor is recommended to inspect this system, evaluate all findings, make recommendations and estimate repairs. Noted: 2 prong outlets still present in the home. These have no grounding and electronics plugged into these outlets have a possibility of damage through a power/electrical surge. Plan accordingly.

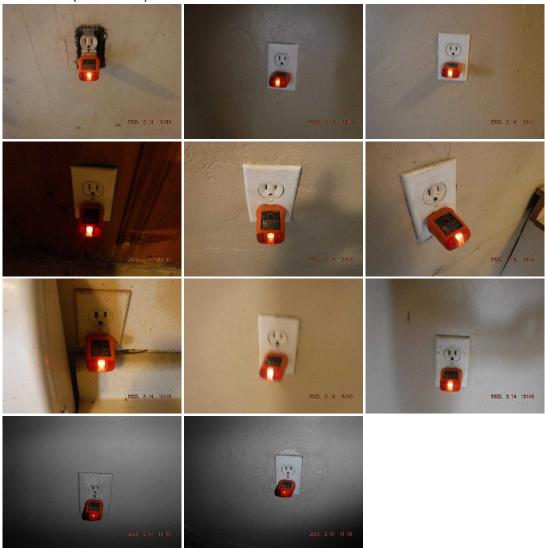
Polarity & Ground of all: (continued)

Polarity & Ground of all: Exterior & Interior - Most of the ungrounded outlets were replaced with 3 prong outlets. This is not allowed because it gives a false sense of grounding. When replacing a 2 prong outlet on a non grounded circuit it must be replaced with a 2 prong outlet or a GFCI outlet (GFCI can be 3 prong outlet). Recommend replacing the ungrounded outlets with GFCI outlets as this is the safer of the two options. A qualified licensed contractor is recommended to inspect this system, evaluate all findings, make recommendations and estimate repairs. Noted: Pictures may not show all locations and are for examples. Noted: Single center light on tester indicates open ground.
