Inspection Report

215 Megan Loop S
Albemarle Plantation
Hertford NC 27944

Home Spec of NC, Inc.

Date: 8/13/2024	Time: 10:00 AM	Report ID: 2408141
Property: 215 Megan Loop S Albemarle Plantation Hertford NC 27944	Customer: Pat and Jeff Winter	Real Estate Professional: Jake Forbes United Country

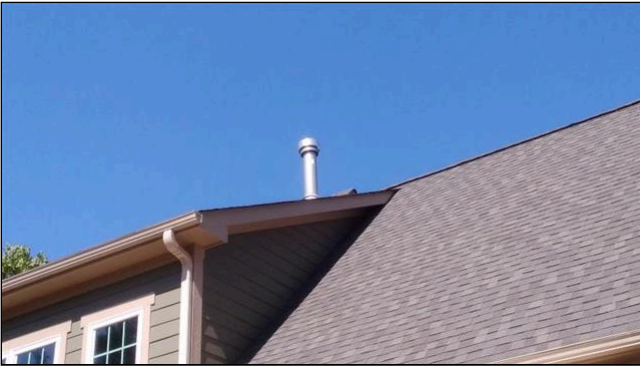
1.2 Item 1(Picture)

1.2 Metal flue for the fireplace. Item 1(Picture)

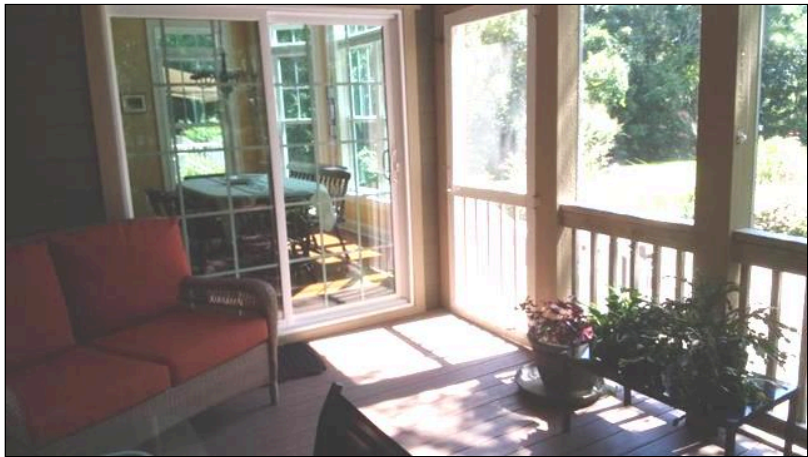
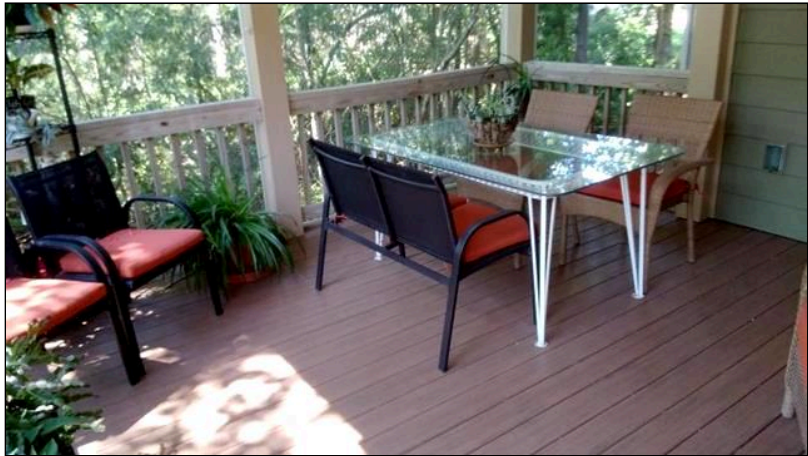
2.3 Item 1(Picture)

2.3 Pictures of the screened porch at right rear section of the home. Item 1(Picture) Item 2(Picture)

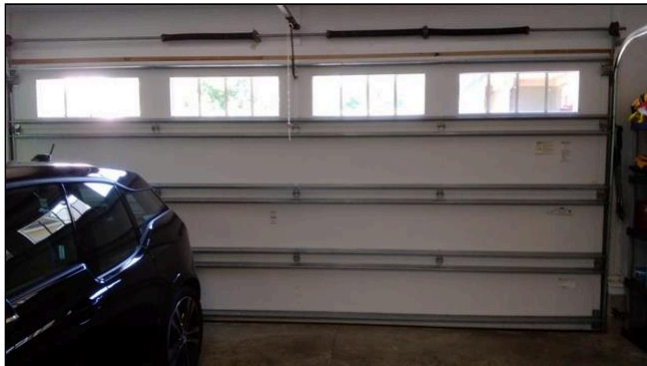
3.3 Item 1(Picture)

3.3 Functioned as intended. Item 1(Picture) Item 2(Picture)

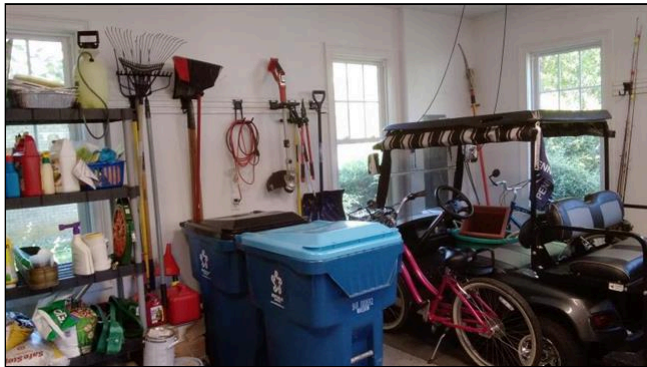
3.5 Item 1(Picture)

3.5 Not reached for opening. Item 1(Picture)

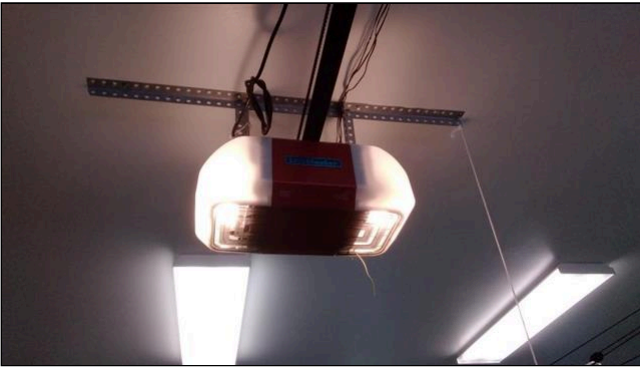
3.6 Item 1(Picture)

3.6 Functioned as intended. Item 1(Picture)

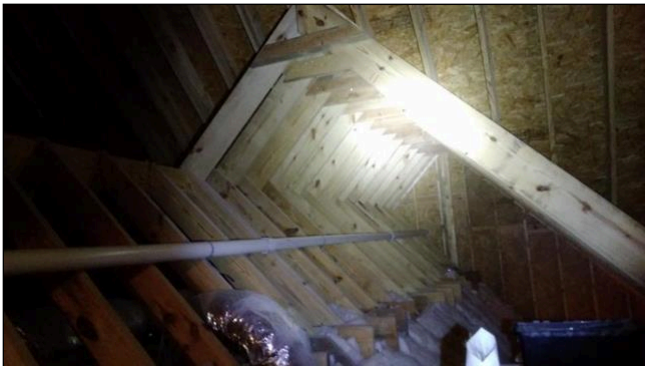
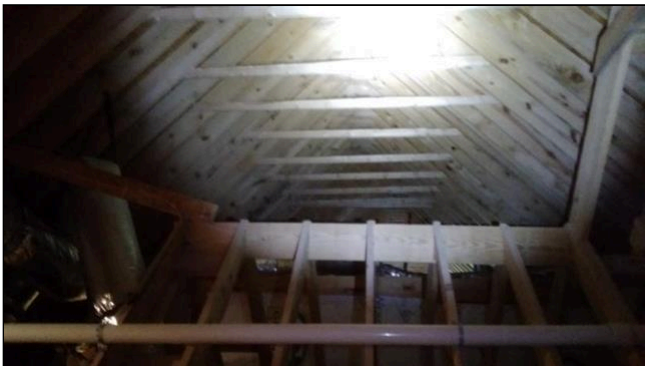
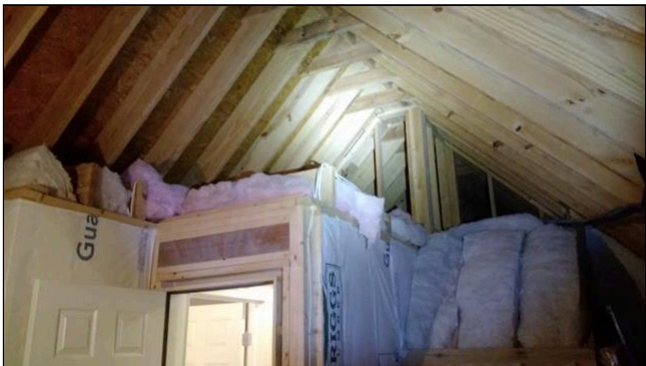
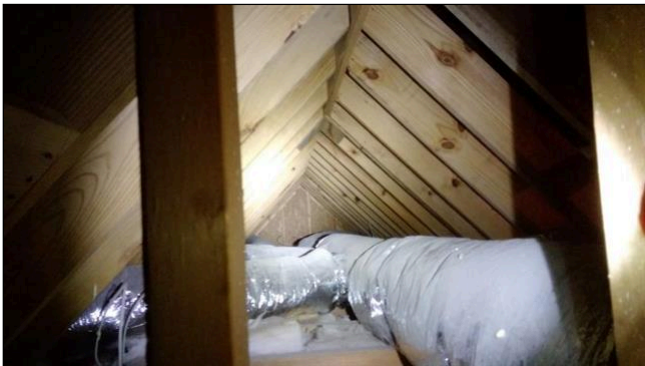
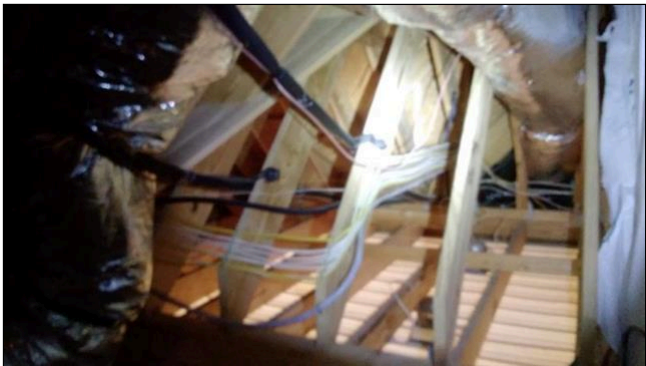
5.4 Roof structure consists of wooden Rafters and OSB sheathing. (Picture1) Item 2(Picture) Item 3(Picture)
Item 4(Picture) Item 5(Picture)

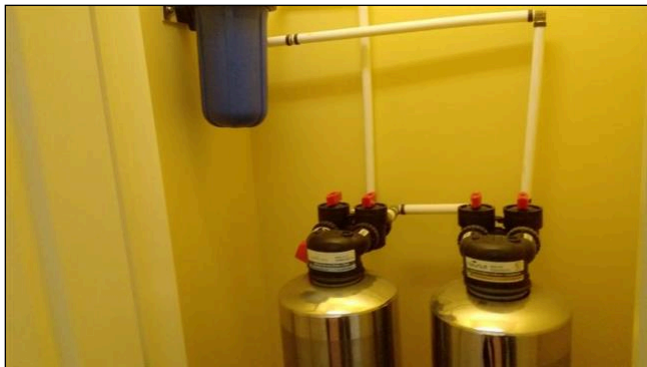
6.1 Item 1(Picture)

6.1 (1) Water treatment system is present. These are not within the scope of a standard home inspection. Item 1(Picture)

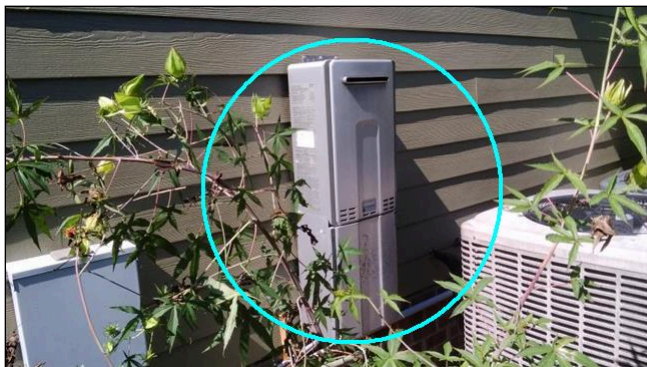
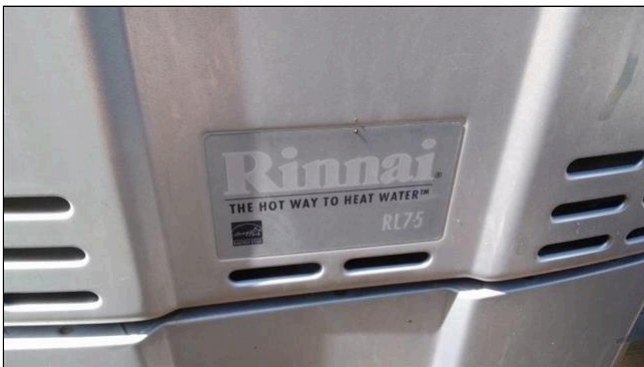
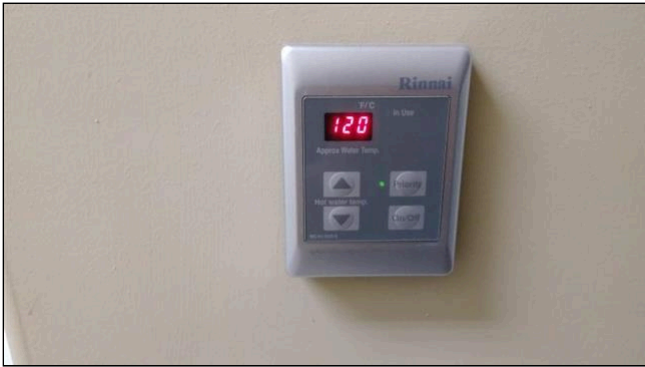
6.3 (1) Rinnai, gas fired, on demand, tankless water heater. 180,000 BTU's.

Original for the house. Item 1(Picture) Item 2(Picture) Item 3(Picture) Item 4(Picture) Item 5(Picture)

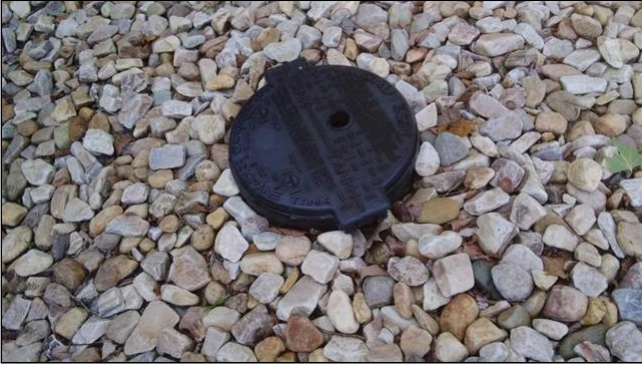
6.5 Item 1(Picture)

6.5 Fuel storage and shut-off are both located at the propane tank buried in the front yard.

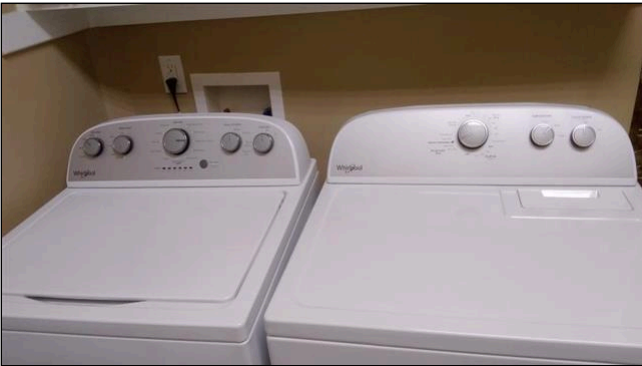
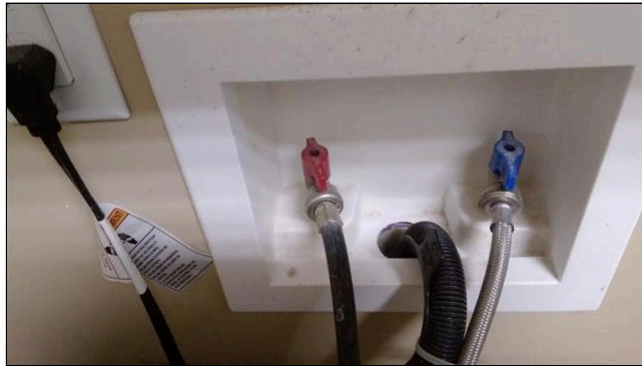
6.6 Basic washer and dryer water and electric connections are present. Item 1(Picture) Item 2(Picture) Item 3(Picture)

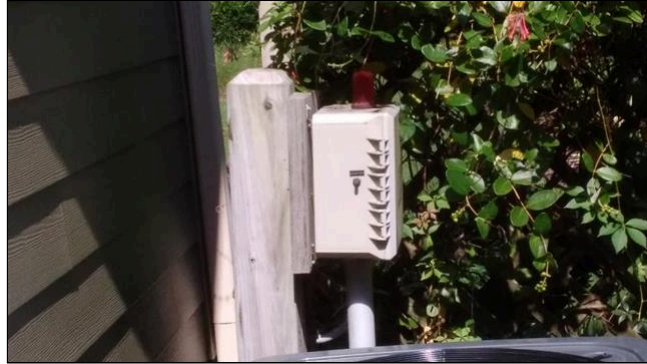
6.8 Item 2(Picture)

6.7 Gas dryer.**6.8** Pictures of the holding tank lids and the alarm box. Item 1(Picture) Item 2(Picture)

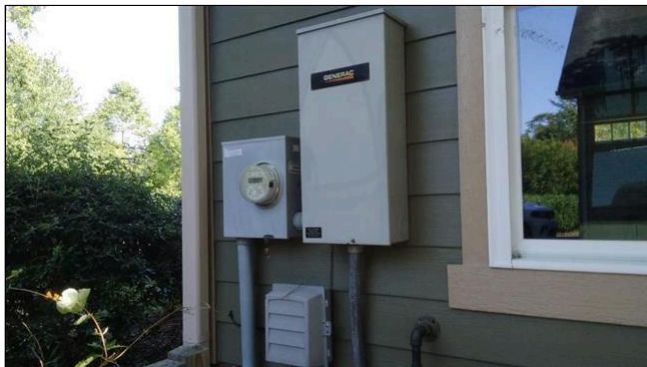
7.0 Item 1(Picture)

7.0 Electrical entrance conductors are underground and located on the right side of the house with the meter base. Item 1(Picture)

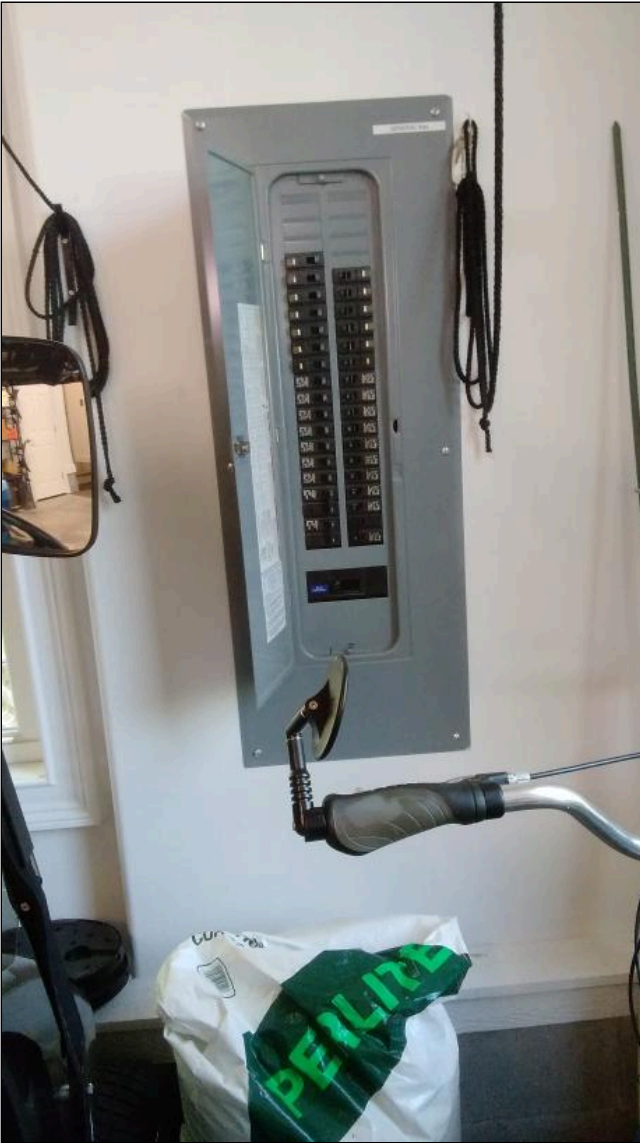
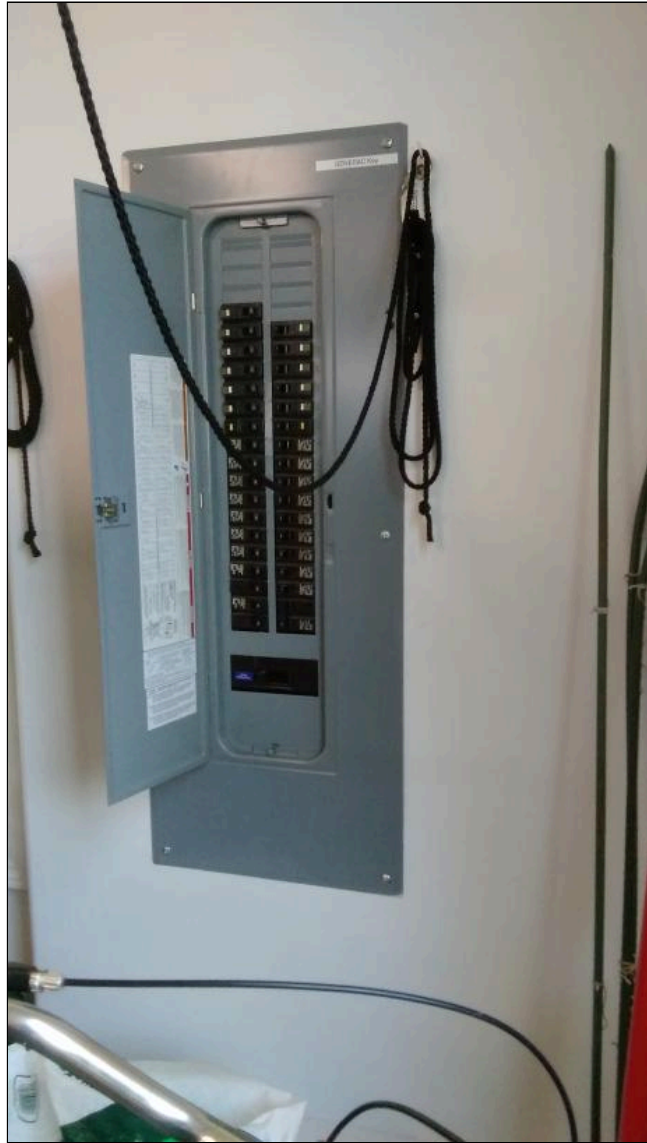
7.1 The main panel box is located in the garage. There were no sub-panels found. The panel was not opened for observation due to stored items. . Item 1(Picture) Item 2(Picture)

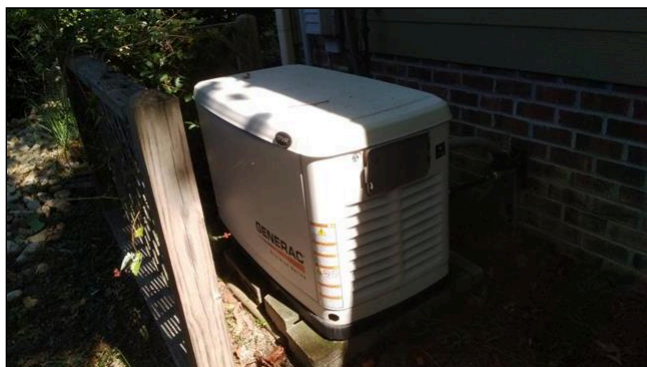
7.7 A generac brand propane fired generator is present. This is beyond the scope of a Home Inspection. Refer

to the manufacturer for information on use and maintenance etc. Item 1(Picture) Item 2(Picture)

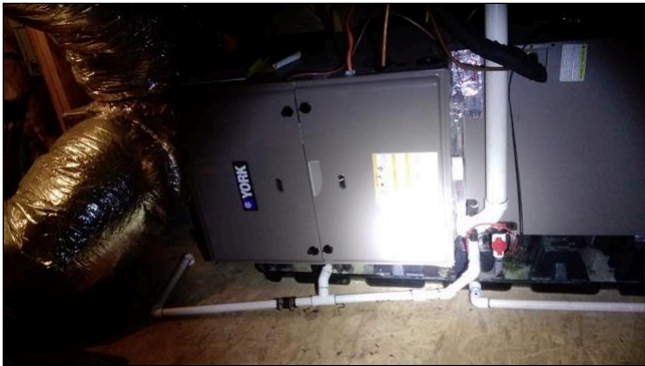
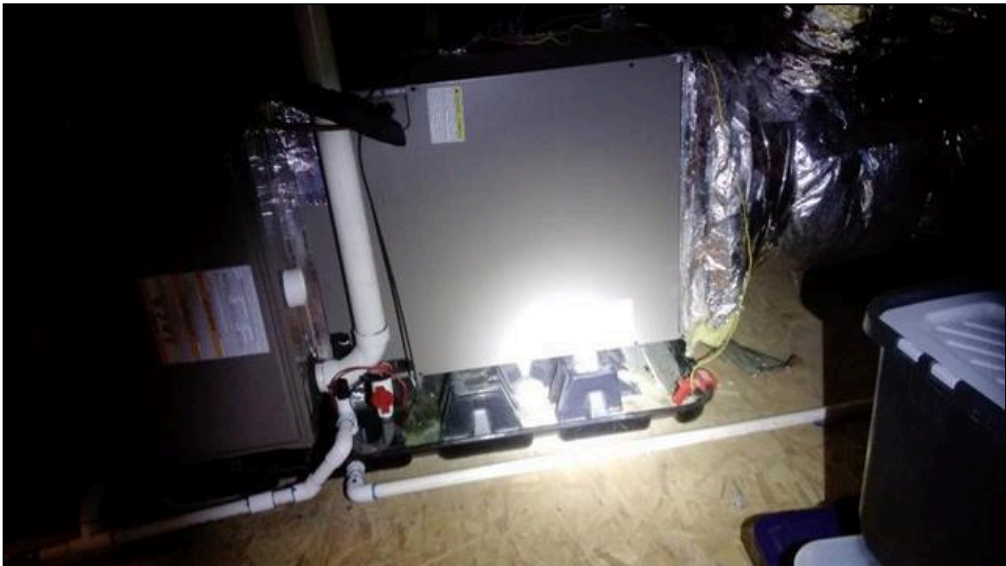
8.0 York Item 1(Picture) Item 2(Picture) Item 3(Picture) Item 4(Picture) 2015, 120,000 BTU's gas fired furnace.

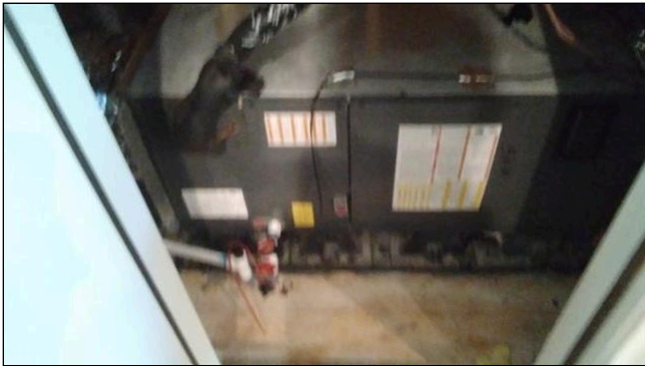
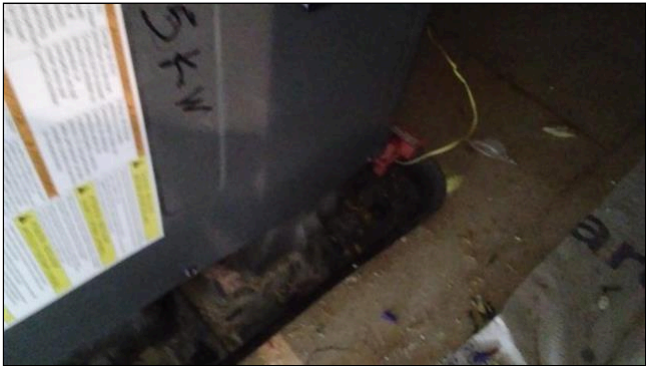
GOODMAN Item 5(Picture) Item 7(Picture) 2024, 2 ton capacity. Split system heat pump.

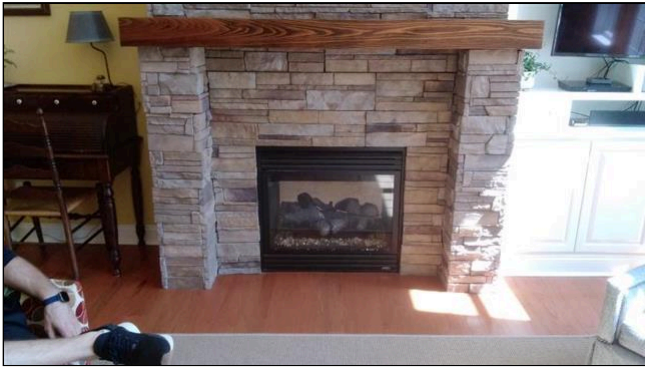
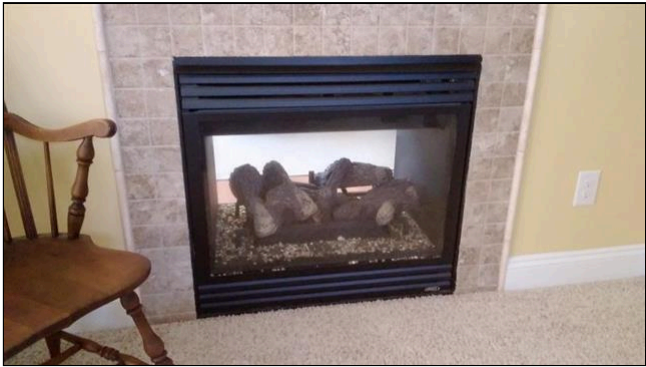
8.7 (1) Two sided gas log fireplace. Item 1(Picture) Item 2(Picture)

(2) No gas leak testing or combustion testing or CO testing was accomplished for this unit. Refer to a qualified technician who will perform these functions at start-up/ move-in.

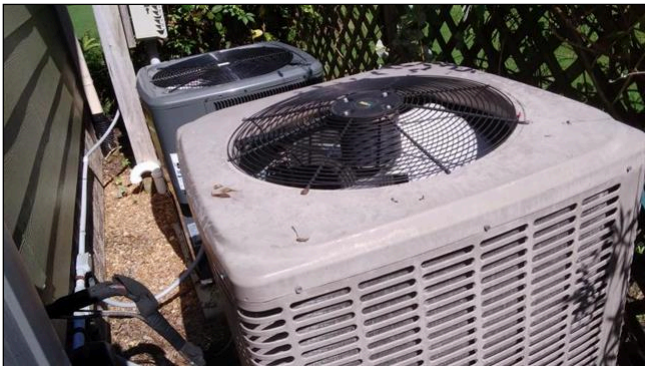
8.8 (1) York brand, 2013, 4 ton capacity. Item 1(Picture) Item 2(Picture)

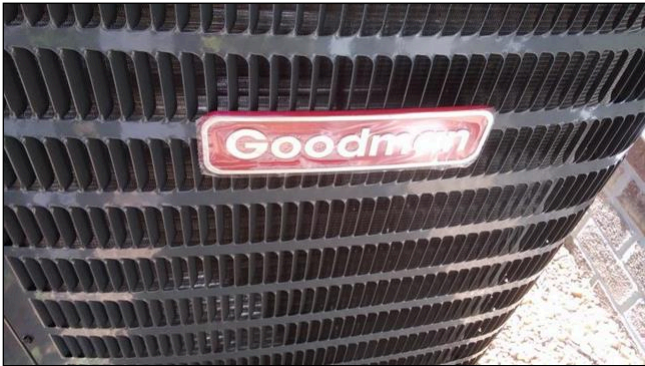
(2) Goodman, 2024, 1 1/2 ton capacity, Item 3(Picture) Item 4(Picture) Split system heat pump.

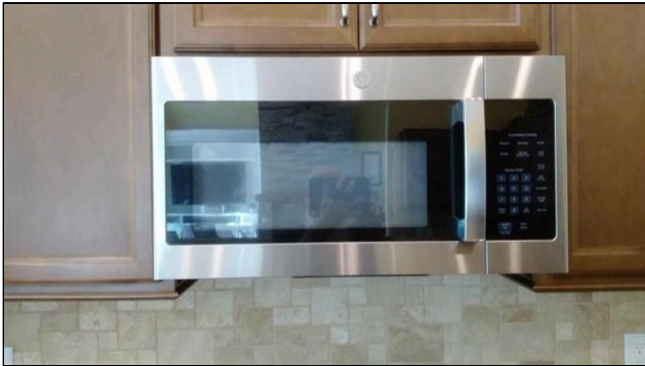
10.2 Item 1(Picture)

10.2 Recirculate type. Item 1(Picture)
