ALLIED HOME INSPECTION

RESIDENTIAL REPORT

80 Ferguson Ln
Bakersville, NC 28705

06/30/2025

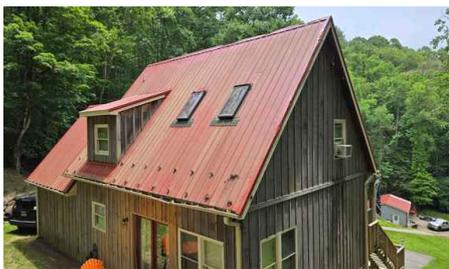
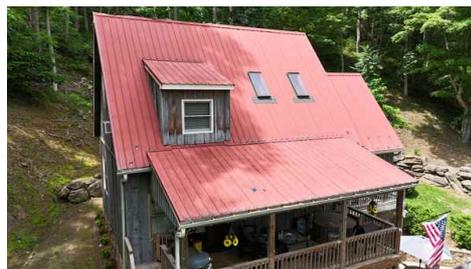
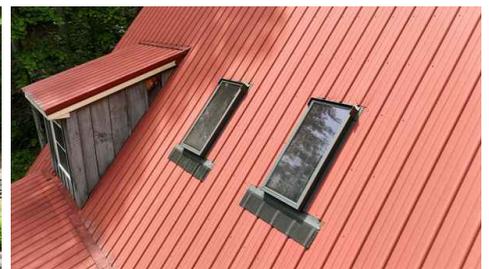
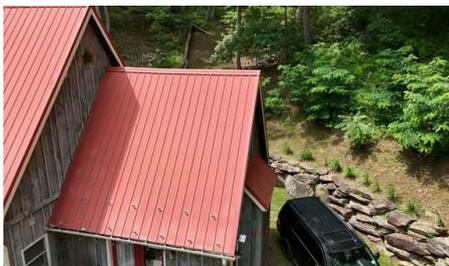
Coverings: Material

Metal

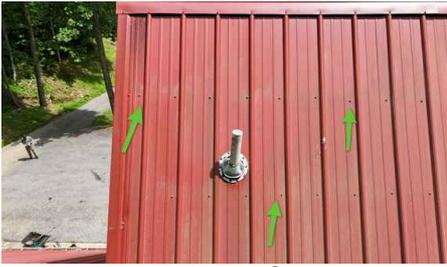
Coverings: Metal Roofing Fasteners

Are recommended to be inspected periodically to prevent future leaks. Consult with a roofing contractor for evaluation and maintenance when needed. This is for your information.

Entire roof.

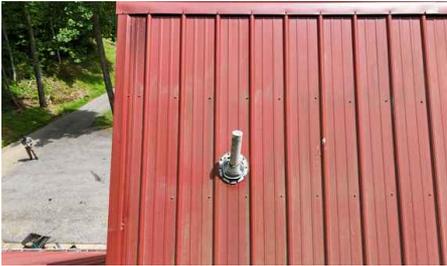
Flashings: Sealant

Sealant around flashings and roof penetrations may need periodic maintenance. Consult with a handyman or roofing contractor to evaluate and correct where needed for preventative maintenance. This is for your information.

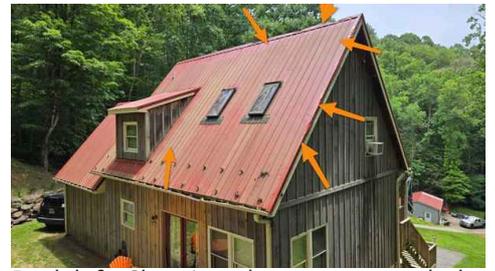
2.3.1 Coverings

DAMAGE NOTED

on the roof covering. These areas may be more prone to potential leaks. Consult with roofing contractor to evaluate and repair as needed.

Back left. Cleaning also recommended.

Recommendation

Contact a qualified roofing professional.

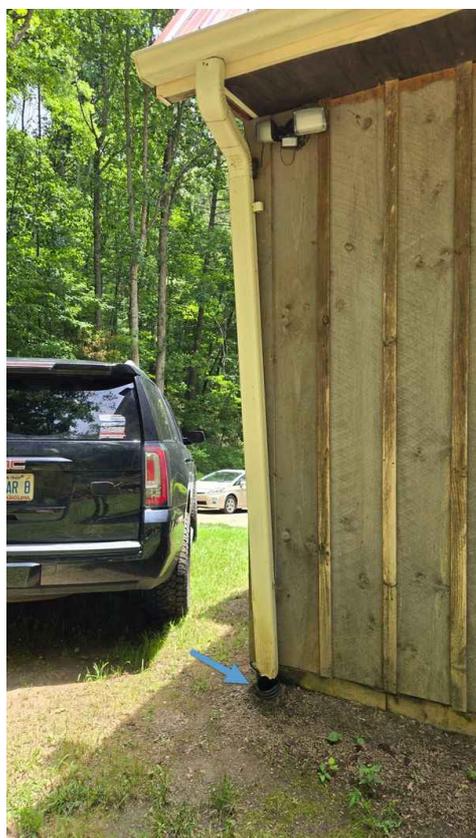
2.5.1 Roof Drainage Systems

SERVICE NEEDED

Downspout not connected at ground, back right.

for the gutter system to promote proper drainage. Consult with a gutter professional for a full evaluation of the gutters and repair or replace as necessary.

Contact a qualified gutter contractor

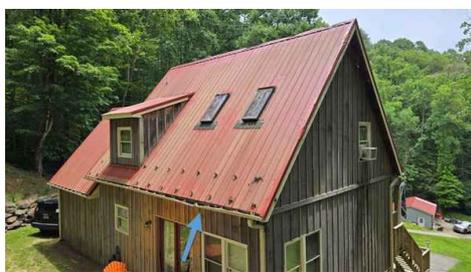
Damage noted / cleaning recommended, back left.

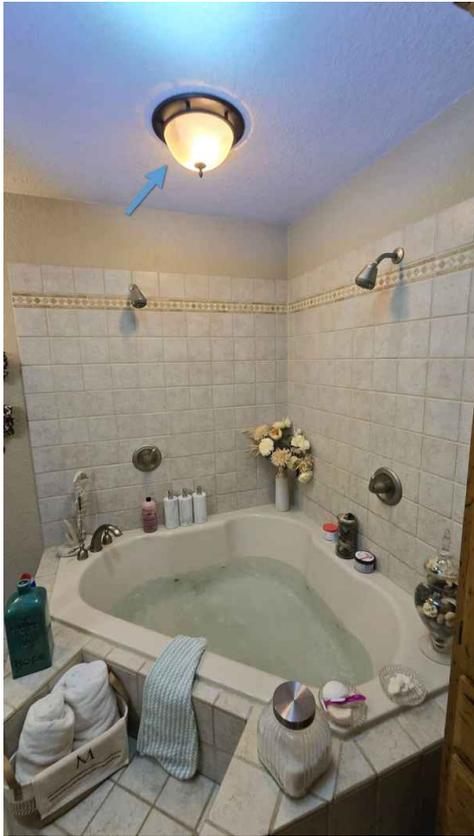
2.7.1 Exhaust Systems

LOUD WHEN ON

Exhaust vent was loud when on. Consult with a handyman to repair or replace as desired.

Main floor bathroom.

Contact a qualified handyman.

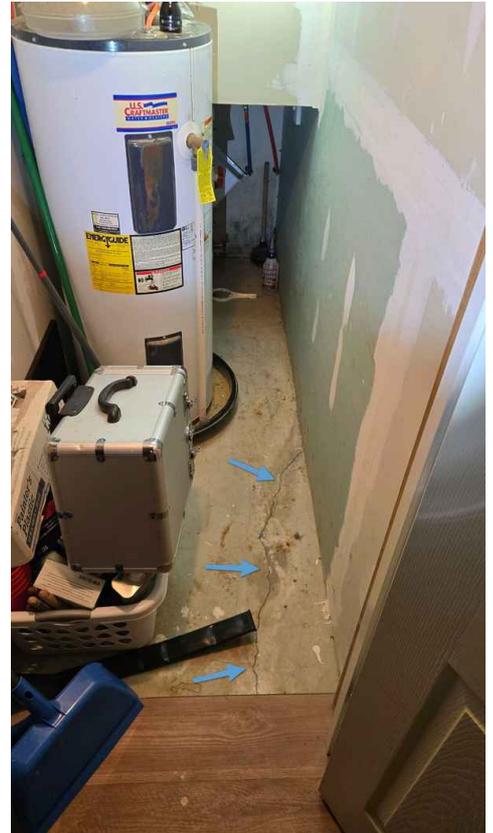
3.1.1 Foundation

CRACKED CONCRETE

noted on the slab. Consider sealing to monitor for significant movement. Consult with a structural engineer if needed for evaluation and proceed as directed.

Basement.

Recommend monitoring.

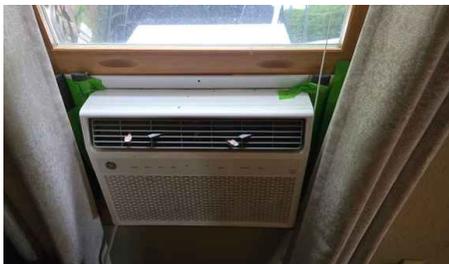
Cooling Equipment: Window/Portable A/C

units are not considered as part of an permanently installed HVAC system and may be considered personal property. Window A/C units were not tested at the time of the inspection. This is for your information.

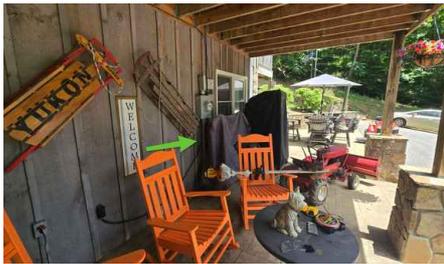
Service Entrance Conductors: Electrical Service Conductors

Below Ground, 120 Volts,
Aluminum, 240

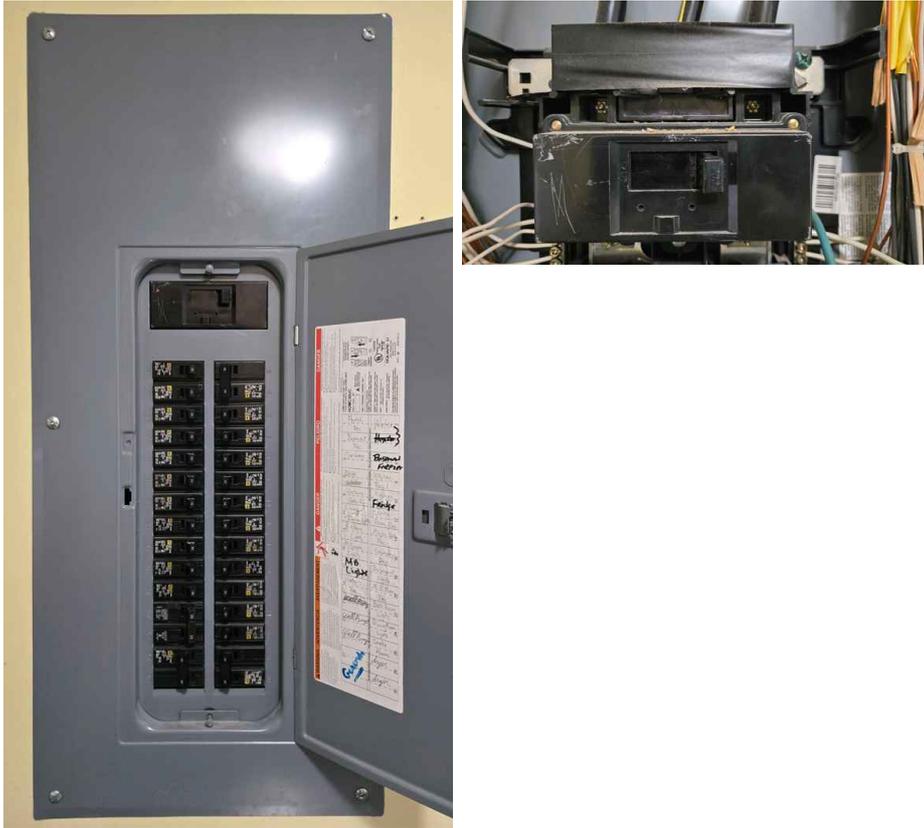
Main & Subpanels, Service & Grounding, Main Overcurrent Device: Main Panel Location Laundry Room

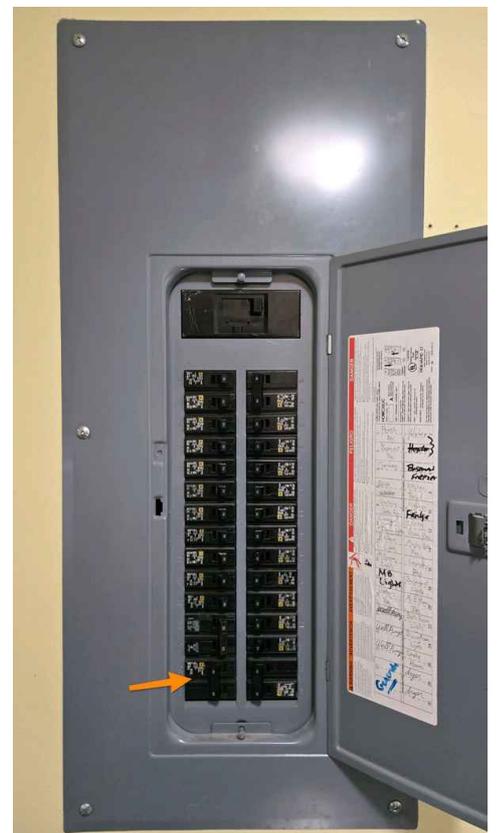
GENERATOR/SOLAR PANEL NOT INSPECTED

Including electrical panels and associated components connected to these systems. These items are not part of the residential home inspection and require a licensed electrical contractor to properly inspect the unit(s). These units often require routine maintenance to function as desired. Consider consulting with an electrical contractor to evaluate the unit further as needed for maintenance.

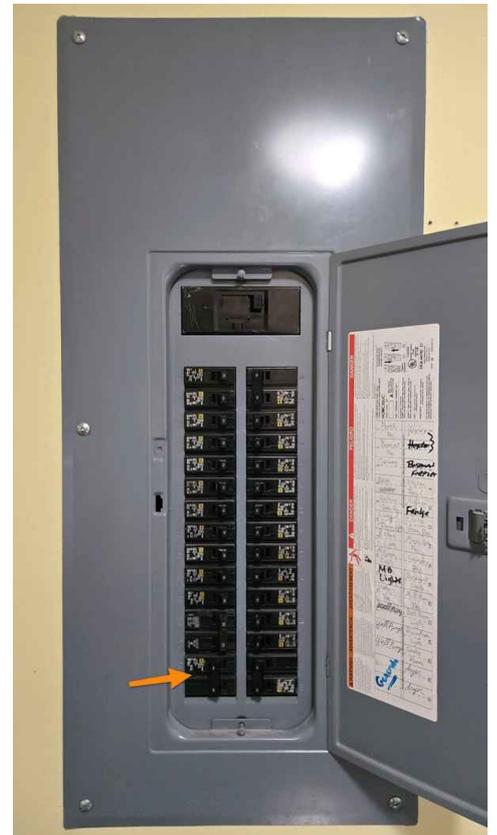
BREAKERS OFF

at the time of the inspection. I do not engage breakers that are in the off or tripped position as it is a liability. Consult with an electrical contractor to evaluate these circuits before engaging.

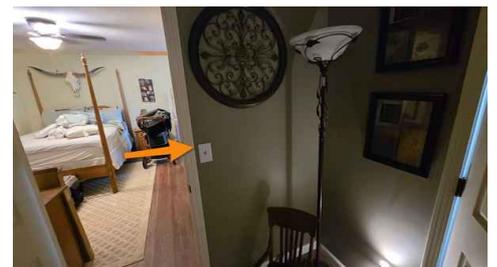
UNEXPLAINED WALL SWITCH(S)

Unexplained wall switch(s) noted. I was unable to determine what circuit the switch(s) are designated for or what they power. Consult with an electrical contractor to determine if desired.

Basement.

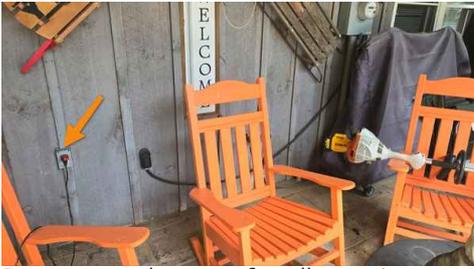
5.4.1 Lighting Fixtures, Switches & Receptacles

ELECTRICAL REPAIRS RECOMMENDED

on one or more outlets/wall switches/fixtures around the property. Consult with a handyman or an electrical contractor for further evaluation of the entire electrical system and repair where advised to prevent future damage and/or reduce the likelihood of being shocked.

Recommend covers for all exterior outlets.

Contact a qualified electrical contractor.

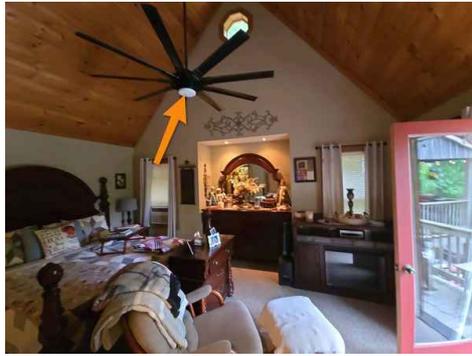
Light / fan not working, master bedroom.

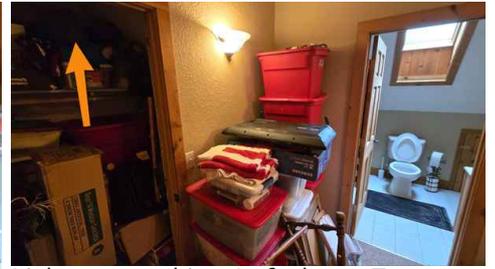
Light not working, Loft closet. Try replacing bulb first.

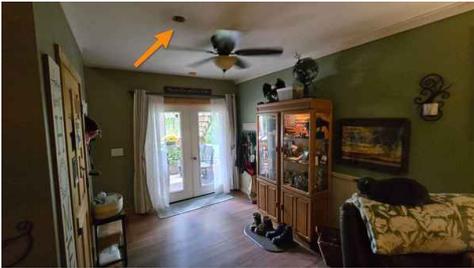
Cover recommended, basement.

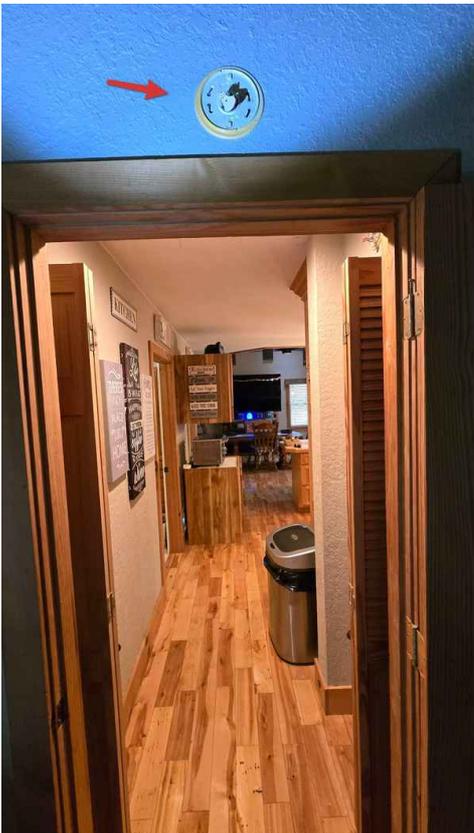
5.6.1 Smoke Detectors

MISSING SMOKE DETECTOR(S)

Missing installed smoke detectors noted on the property. Consult with a handyman or qualified professional to evaluate and replace where needed for safety.

Master Bedroom.

Contact a handyman or DIY project

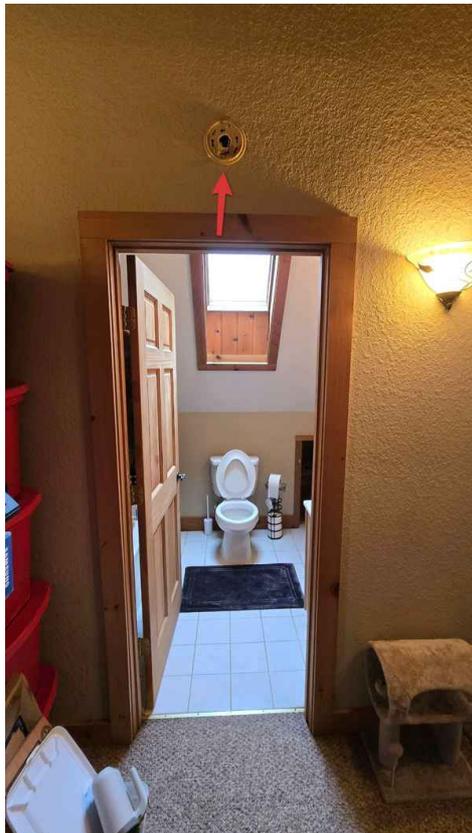
Loft.

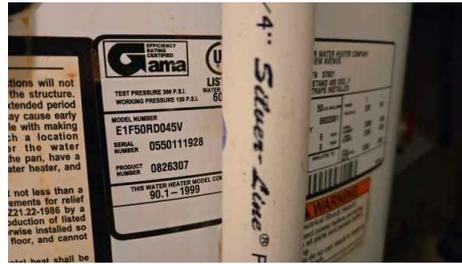
Hot Water Systems, Controls, Flues & Vents: Manufacturer US Craftmaster

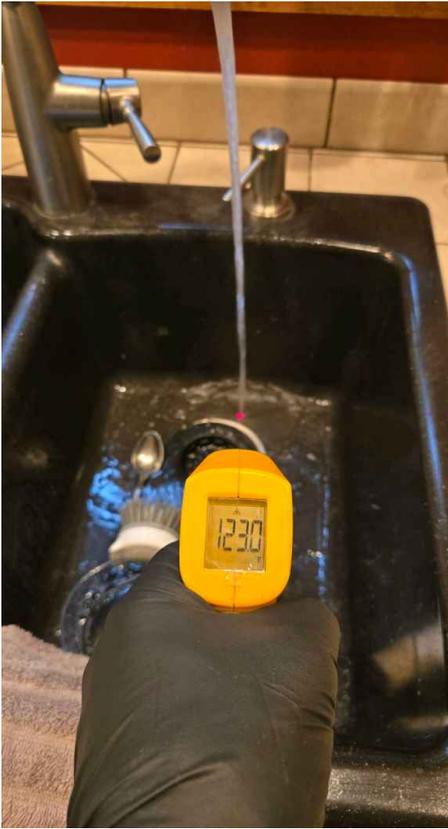
Hot Water Systems, Controls, Flues & Vents: Water Heater Temperature

The water heater(s) is producing temperatures of 110-125 degrees which is an indication that it is working properly. This is for your information only.

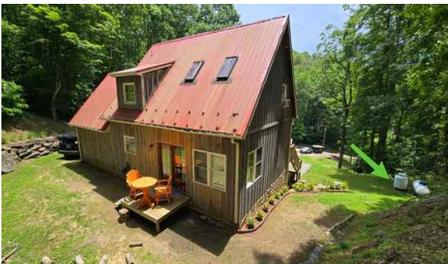
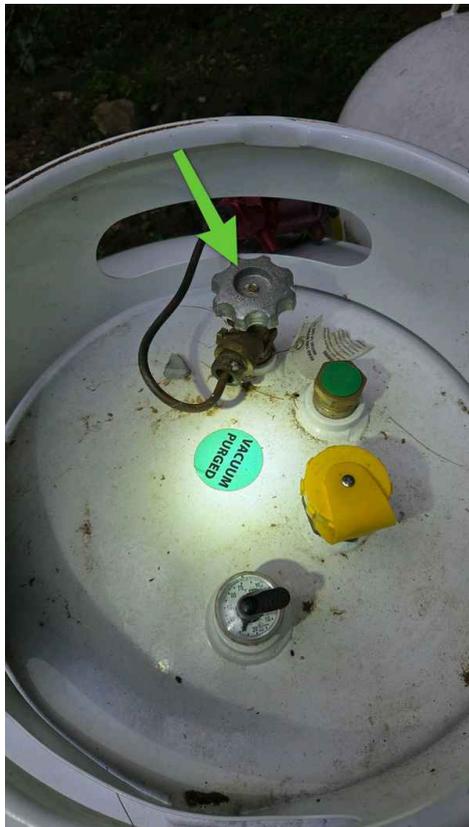
Fuel Storage & Distribution Systems: Main Fuel Shut-off Location At Tank

Closeup for context.

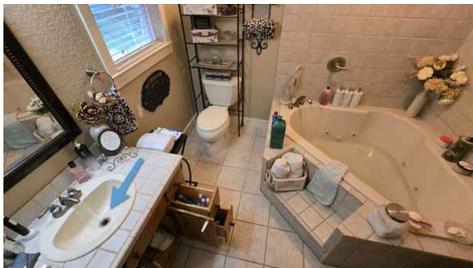
6.2.1 Drain, Waste, & Vent Systems

PLUNGER DOES NOT WORK

Plunger(s) not working. Consult with a handyman or plumbing contractor to correct if desired.

Missing, main floor.

Contact a qualified plumbing contractor.

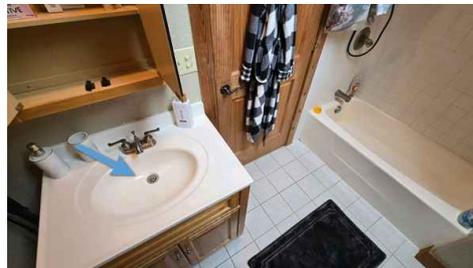
Loft bathroom.

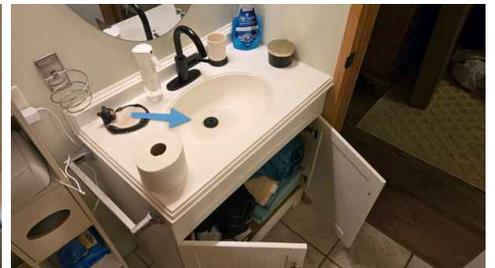
Stuck closed, basement.

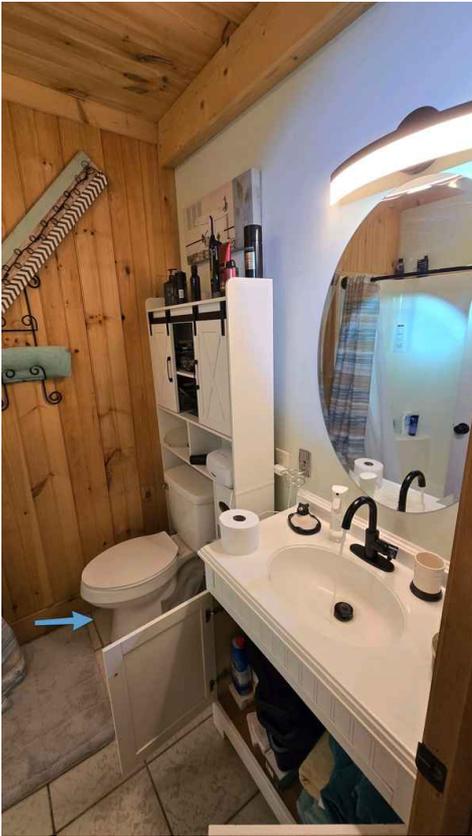
6.2.2 Drain, Waste, & Vent Systems

DAMAGED TOILET

noted in the house. Consult with a plumbing contractor to evaluate and repair as needed.

Loose on base, basement.

Contact a qualified plumbing contractor.

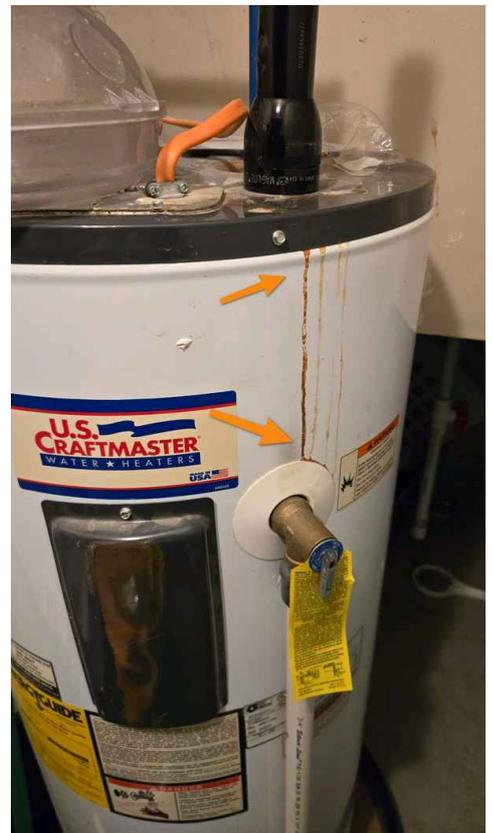
6.5.1 Hot Water Systems, Controls, Flues & Vents

CORROSION

Corrosion noted at the water heater. Any corrosion or damage to a water heater can compromise the efficiency and safety of the appliance. Consult with a plumbing contractor to evaluate further and repair as needed.

Contact a qualified plumbing contractor.

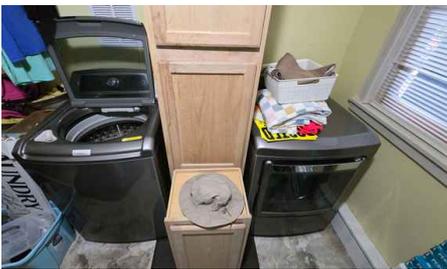
Dryer Type: Washer/Dryer Not Inspected

The washer and dryer appliances are not part of the inspection as they are not considered built-in appliances. Only a visual inspection of the dryer hook-up and dryer duct are inspected. Consult with an appliance professional for any repairs if needed.

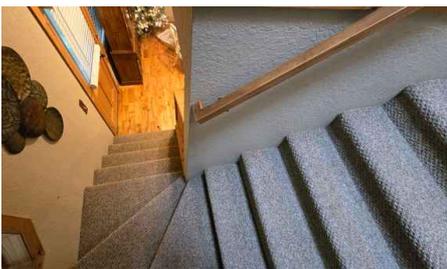
Steps, Stairways & Railings: Spiral Stairs

are not recommend because of the short treads, which could be a fall hazard. Consult with a general contractor to evaluate and correct if desired. This is for your information.

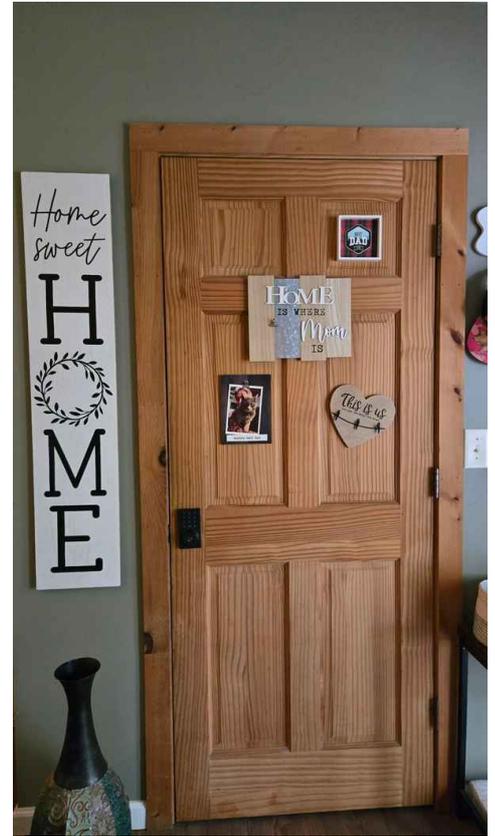
DOORS LOCKED

One or more doors were locked at the time of the inspection. I was unable to inspect the area for any defects.

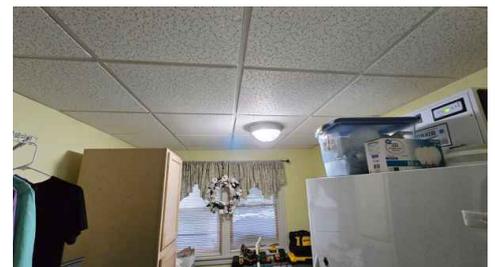
DROP CEILINGS

Drop ceiling tiles were not removed at the time of the inspection as they're prone to being damaged when disturbed. This is for your information.

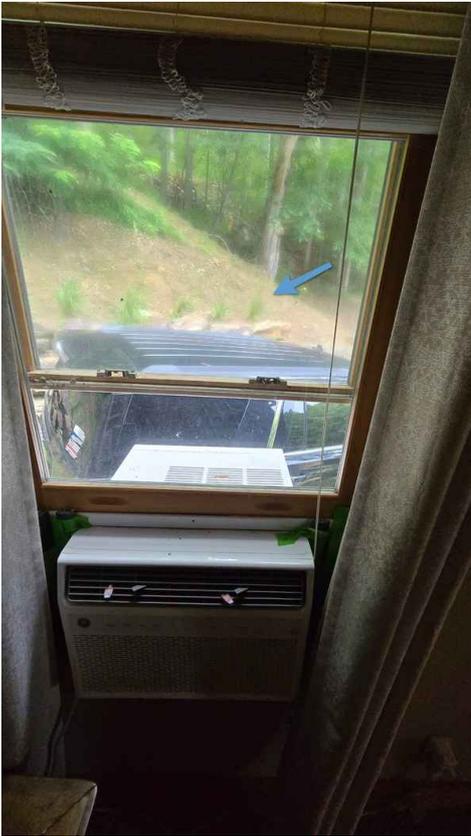
8.2.1 Windows

REPAIRS RECOMMENDED

on one or more windows around the home. Consult with a window professional for further review of all of the windows in the home and repair as needed.

Failed seals, multiple areas.

Contact a qualified window repair/installation contractor.

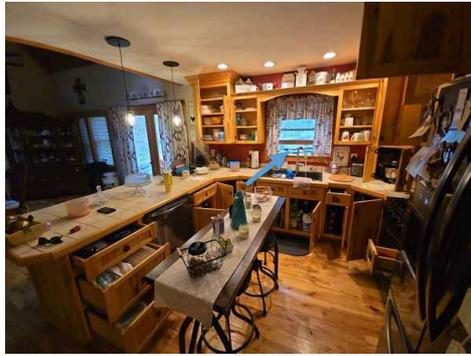
Missing screen, kitchen.

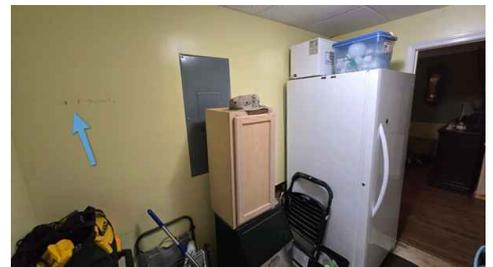
8.4.1 Walls

COSMETIC DEFECTS

noted in multiple areas of the interior of the house/structure. Consider consulting with a drywall contractor or a handyman to evaluate the interior further and correct where needed if desired.

Laundry room.

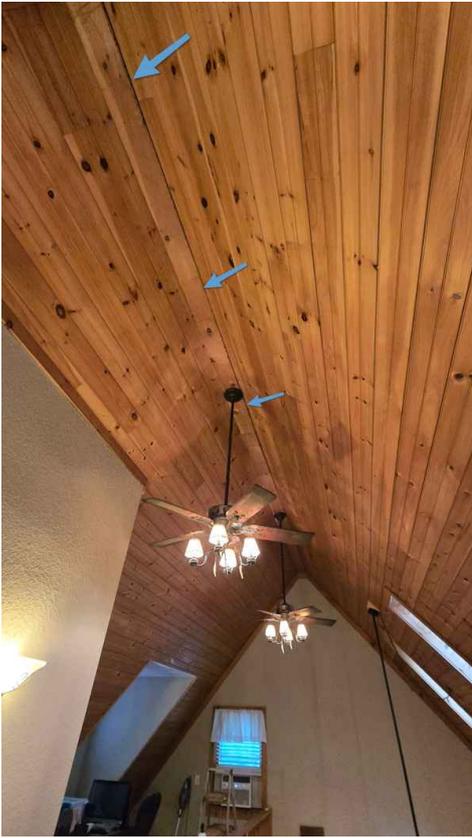
8.5.1 Ceilings

found in the home. This is not recommended as it can allow conditioned air to escape and allow access to wiring and plumbing. Consult with a carpentry contractor to evaluate and repair as needed.

Loft.

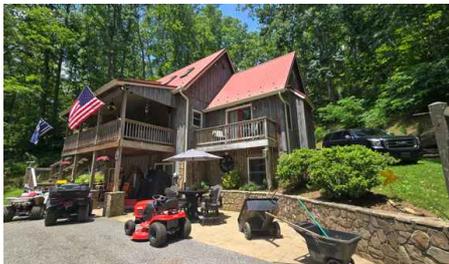
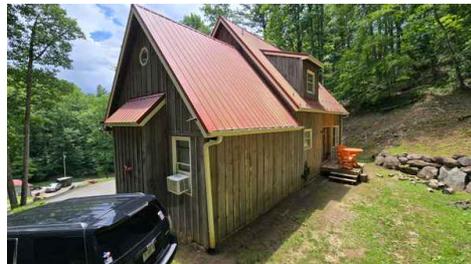
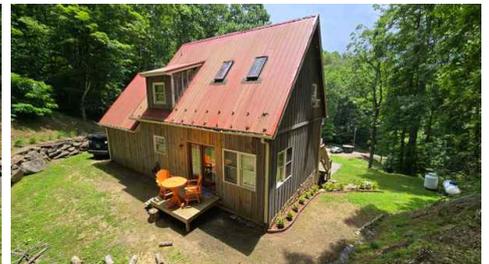
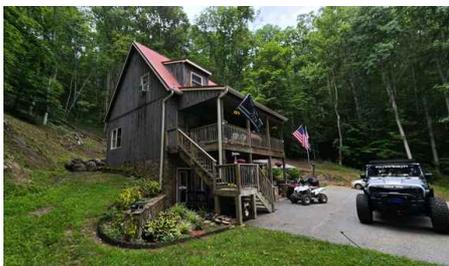
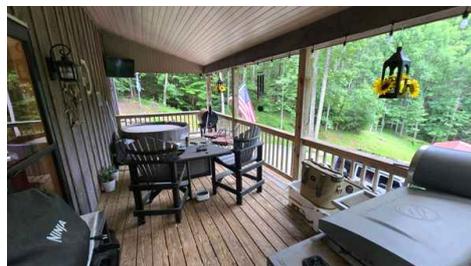
Siding, Flashing & Trim: Siding Material

Wood, Adhered Stone

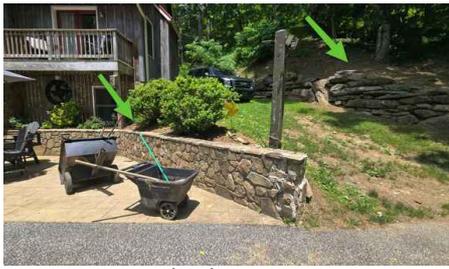
Vegetation, Grading, Drainage & Retaining Walls: Retaining Walls

may need periodic inspections and maintenance to help protect the integrity of the structure. This is for your information.

Multiply areas.

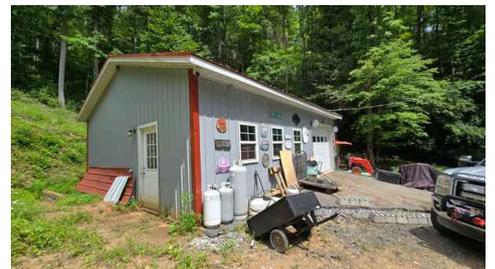
OUTBUILDING(S)/DETACHED STRUCTURES

are not a part of standard home inspection and was not inspected, unless otherwise stated. An inspection of an outbuilding or other unattached feature is recommended especially if it has utilities. We do offer these inspections as an ancillary service.

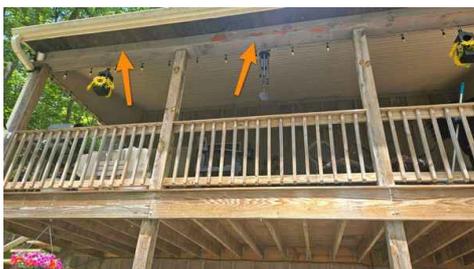
9.1.1 Siding, Flashing & Trim

DAMAGED SIDING/TRIM

noted on the exterior. This will continue to deteriorate until corrected. Consult with a handyman or siding professional for evaluation of all of the siding and correcting where needed to prevent further damage.

Carpenter bee damage, multiple areas.

Contact a qualified siding specialist.

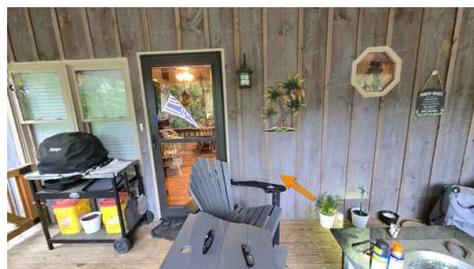
Wasp nest, front porch.

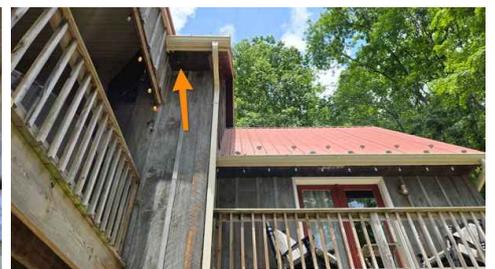
Wasp/Yellow Jacket nests, multiple areas.

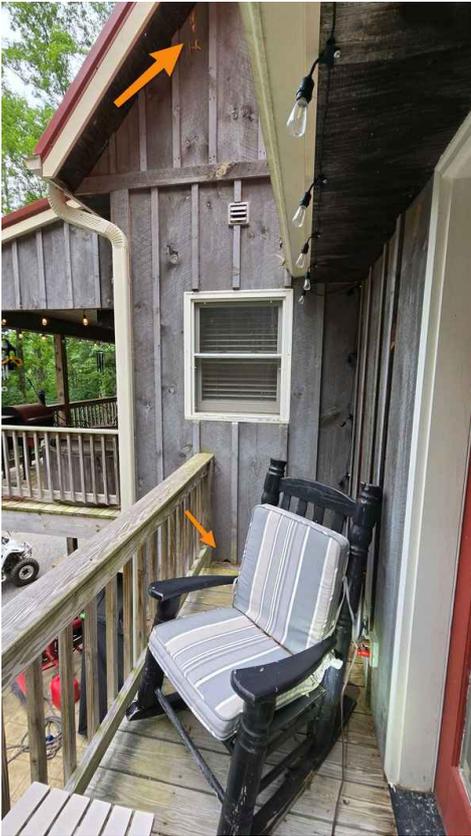
Carpenter bee/general damage, front right.

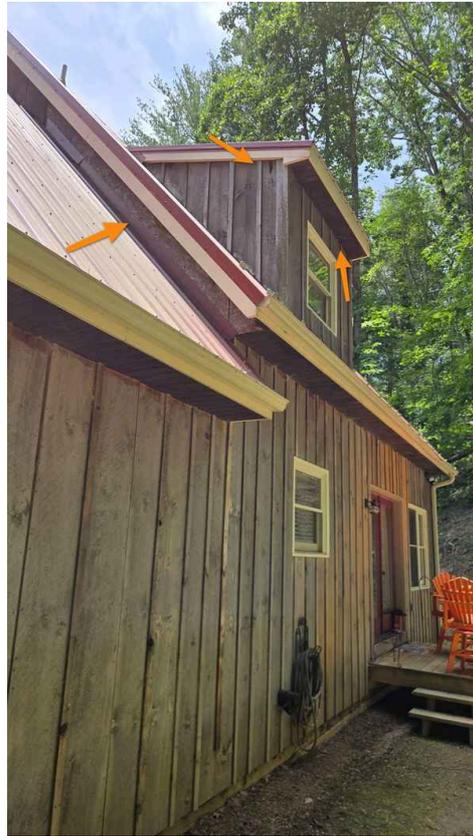
Missing siding, damaged siding, wasp nest, back.

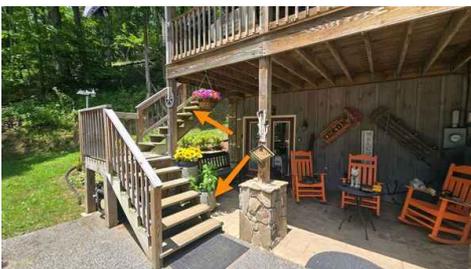
9.4.1 Decks, Balconies, Porches & Steps

REPAIRS RECOMMENDED

on the deck. Consult with a decking contractor or a general contractor for further evaluation of the deck system and correct where needed to prevent further damage and for safety.

Fall hazard, front.

Contact a qualified general contractor.

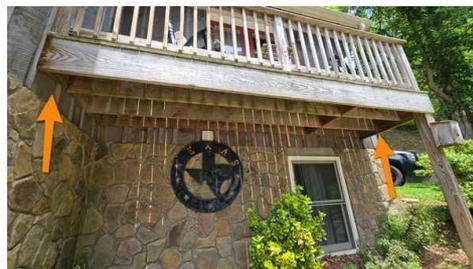
Joist hangers recommended, front.

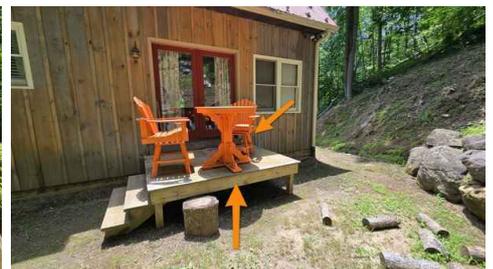
Railing recommended, back.

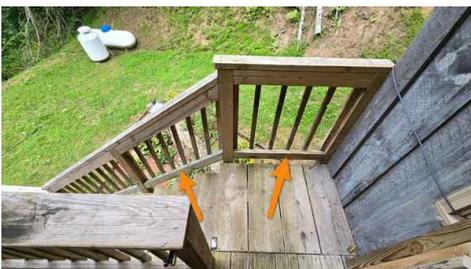
Baluster spacing may exceed recommended width, multiple areas.

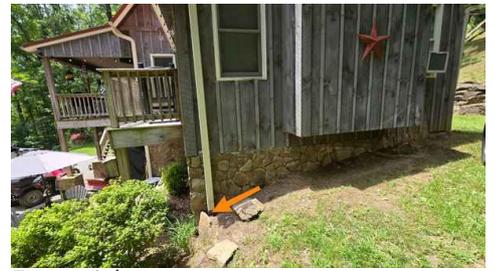
9.6.1 Vegetation, Grading, Drainage & Retaining Walls

NEGATIVE GRADING

noted on the exterior which can lead to several unfavorable conditions. There may be multiple options to correct this issue. Consult with a landscaping contractor or grading contractor for further evaluation and proceed as directed to promote proper drainage.

Front right.
