IRON DOG INSPECTIONS

Visual Mold Inspection performed in the basement of the home at: **436 Heatherby Lane NE, Hartville, Ohio 44632**

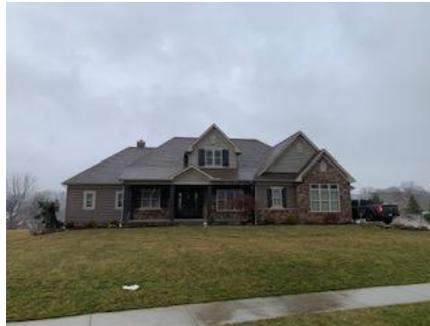
Iron Dog was contacted to provide a mold evaluation at the above address. There was some staining at the base of the foundation walls needing evaluated.

There are moisture stains around the perimeter of the foundation. The stains were not elevated at the time of our evaluation. It was raining at the time of our evaluation and has rained in the previous days. The stains may have been there since the home was constructed. There is some darker discoloration in one of the corners. This discoloration is a non-health risk type of fungal growth, often referred to as a mildew growth. This type of fungal growth does not pose any health risk to human beings and can be cleaned with over-the-counter fungicides. We have included a couple of pictures of products we recommend that can be purchased at local DIY centers or online.

The white powdery discoloration is efflorescence. This is a mineral and not a mold. There are no health risks from efflorescence. It is the presence of soluble salts, such as calcium carbonate, or calcium sulfate, that are naturally present in or migrate from brick, mortar or concrete. They are then carried to the surface by moisture or water. The substance can be cleaned with a stiff bristle brush.

Mold testing or professional remediation is not recommended or necessary.
