Perfection Home Inspections
1042 E. Fairbrook Circle
Mesa, AZ 85203
602-524-2916
perfectionhomeinspections.com

Client Information: Record Number 7507

Genova, John
7800 E. Boulders Parkway #4
Scottsdale, AZ 85266

Inspected 2/12/18 9:00 AM
Built 1992
2262 sf

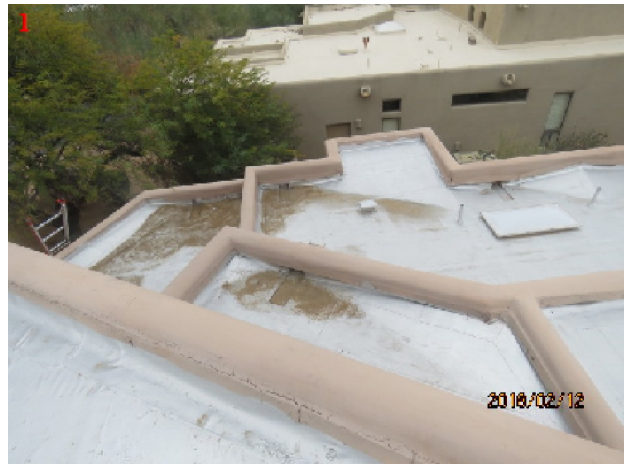
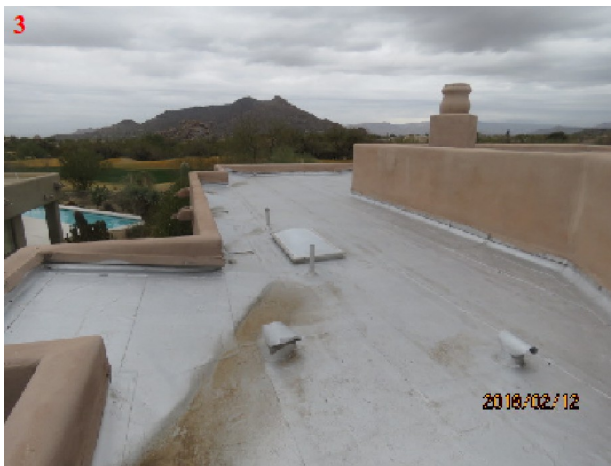
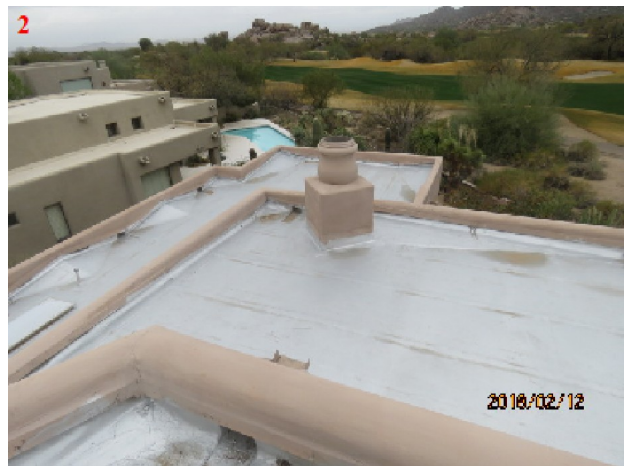
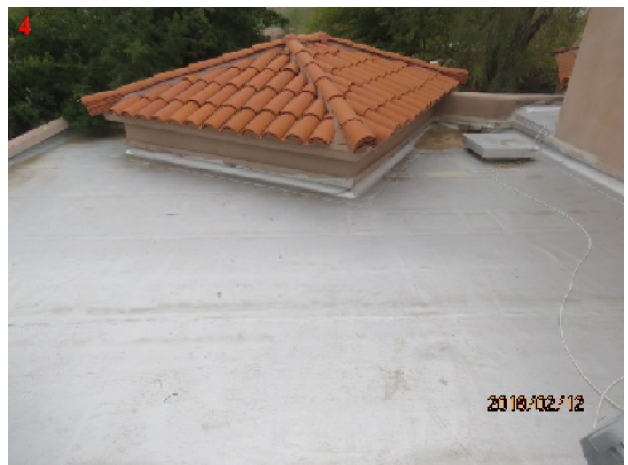
Satisfactory ROOF - Sample

See sample picture of the roof.

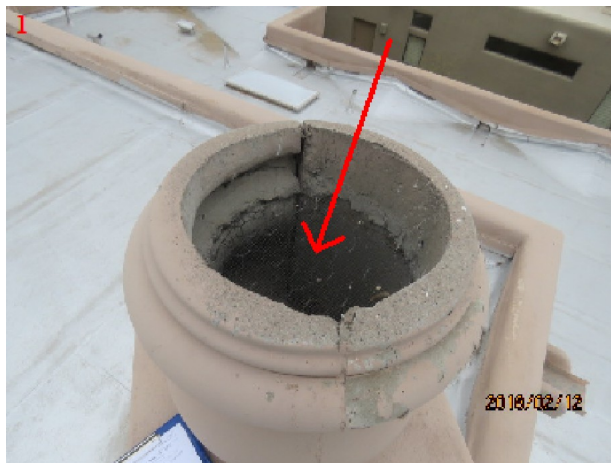
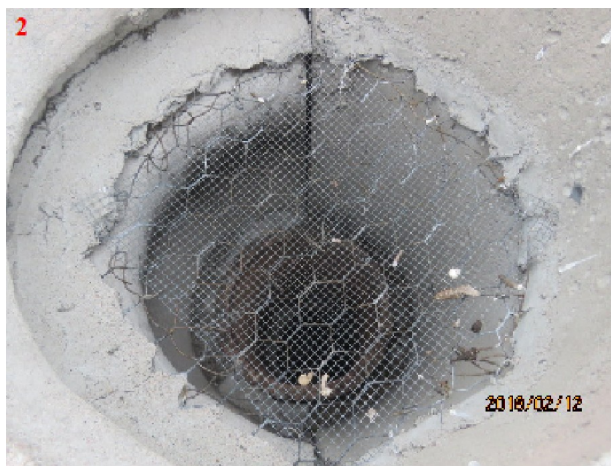
Satisfactory Spark Arrestor - Installed

A metal screen has been installed near the top of the chimney to keep sparks and debris from flying out of the chimney.

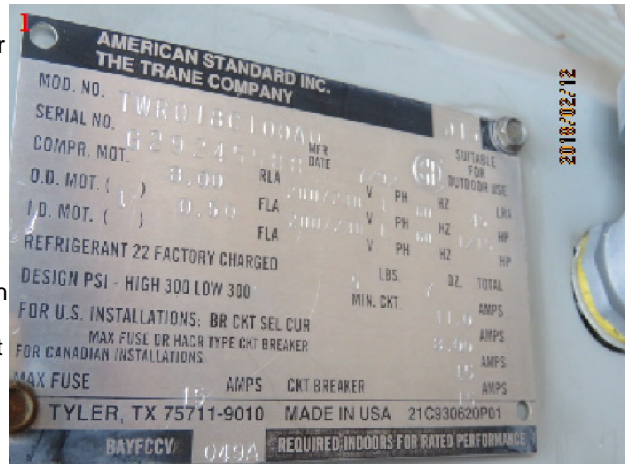
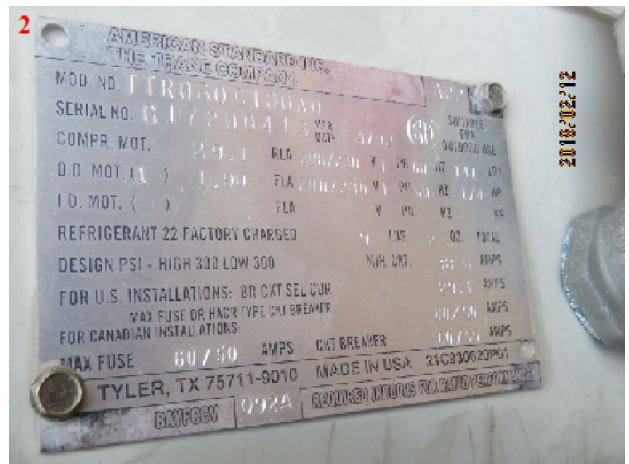
The Federal appliance manufacturing standards (10 CFR 430) will require all residential-sized central air conditioners and heat pumps, manufactured or imported on or after January 23, 2006 to meet a new higher SEER standard. AC units that do not meet these new standards will need to be replaced with AC units up to 50% larger in size when they break and parts may be hard to find for Lower SEER units.

AC units have an average life of 12 to 15 years in the Phoenix area.

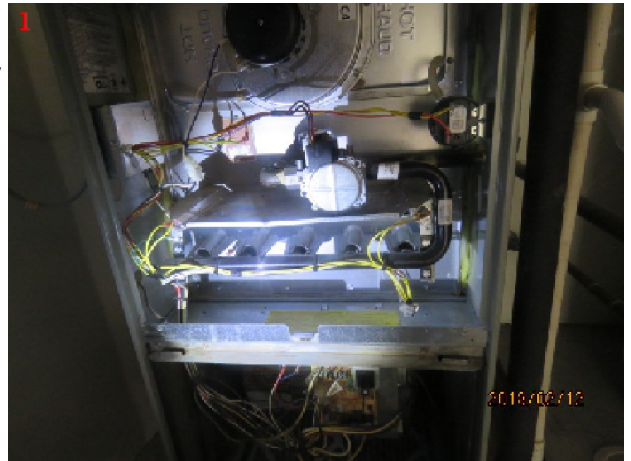
Satisfactory Heat Exchanger Visual - Pass

Even when great care is taken to inspect the heat exchanger visually most of it is not accessible and some problems may not be visible. Home inspectors do not have the tool necessary to properly check for a cracked heat exchanger. Cracked heat exchangers can cause carbon monoxide to enter the home. Recommend all homes with gas appliances have a carbon monoxide tester installed and have the heat exchanger evaluated by a qualified heating contractor.

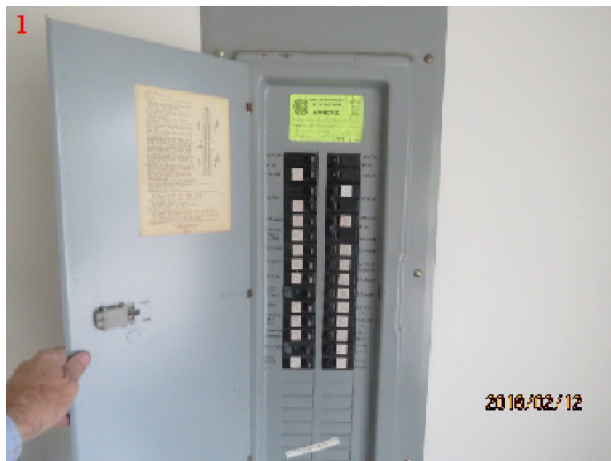
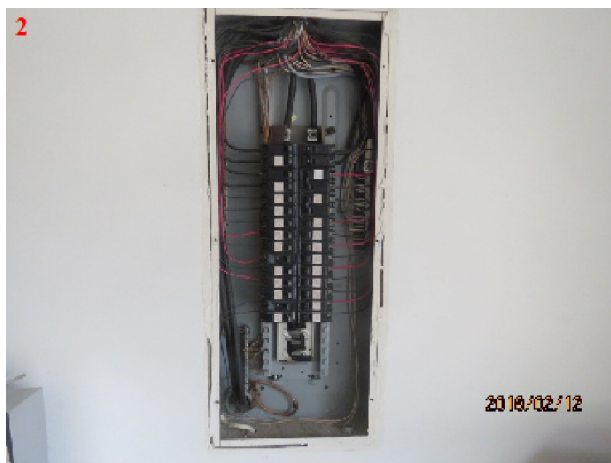
Main Electric Panel - Inspected, Sample Picture

Sample picture of the main electric panel.
