## House Inspection and Repairs

The property was inspected by King Home Inspections on February 15, 2019.

# Property Inspection Report

14016 S. Rockhill Rd., Phoenix, AZ 85048

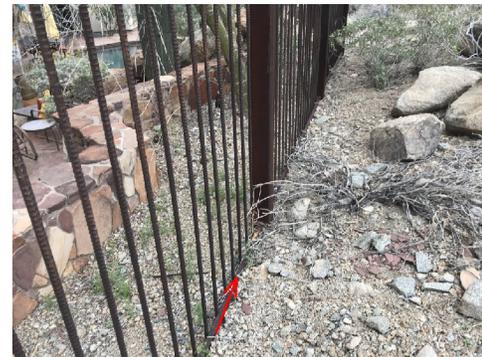
2. Fence Metal The soil covers the bottom rail of the fence in multiple places.

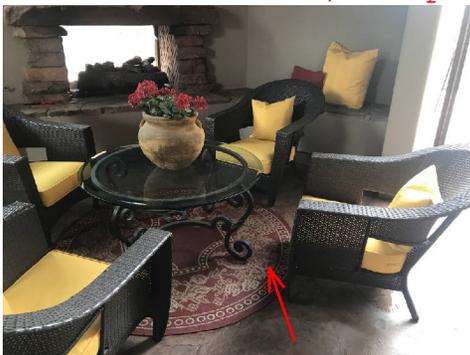
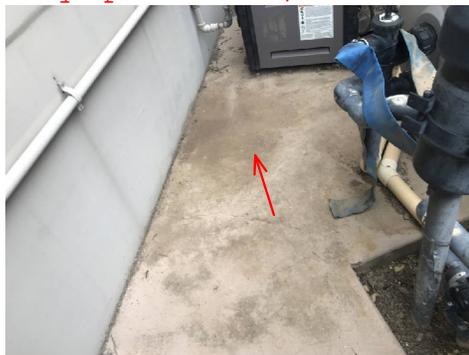
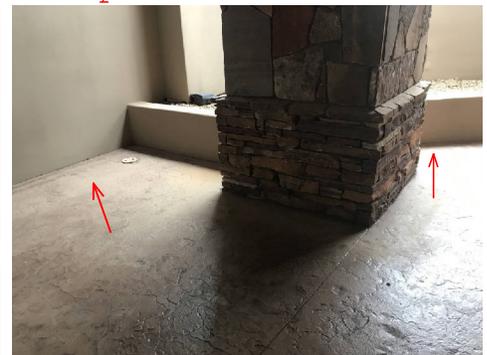
7. Patio/Courtyard Material Concrete There is evidence of water ponding in the outdoor entertainment area, the pool equipment area, the north west patio.

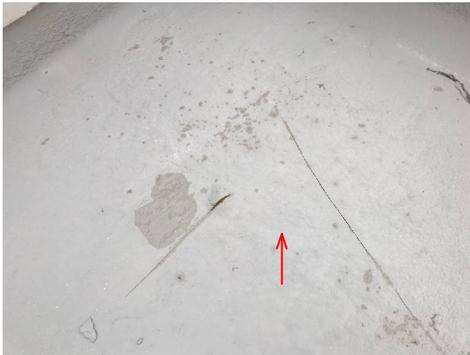
11. Condition of Main Roof **Issue** There is evidence of water ponding in multiple locations on the roof. There are blisters/cracks/openings in the roof surface in multiple places. There is evidence of prior repairs in multiple places.

3. Stem wall cracks do not manifest themselves through to the walls of the house and are normal for age of house.
4. \$6,000 spent on roof repairs and sealing.

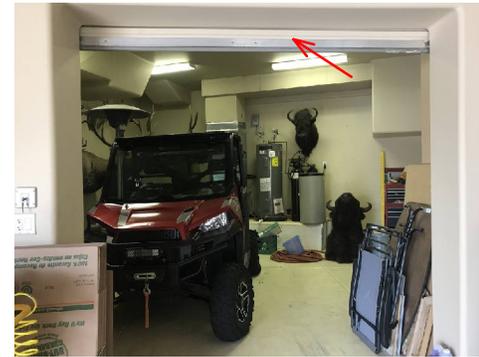
17. Vehicle Door Opener Issue The overhead door to the storage/mechanical room does not function.

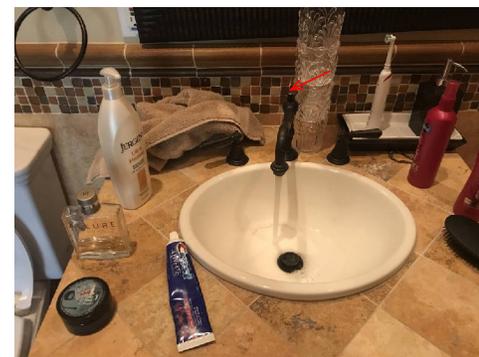
20. Sink Drains Issue The drain stopper is disconnected in the north east secondary bedroom bathroom.

9. Toilet secured in north east bathroom
10. Sink stopper connected in north east bathroom.
11. No evidence of new leakage in pool room....just received 2 inches of rain.

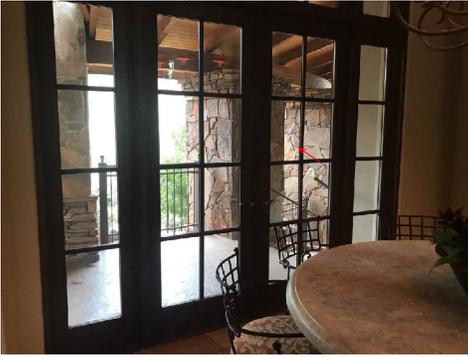
24. Exit Doors/Others Issue The screen door is damaged on the rear of the house. The screws are stripped at the top hinge, the header/threshold pins do not engage on the double door and the door knob does not function for the main electrical service panel closet. The exterior doors difficult to close at the eating nook.

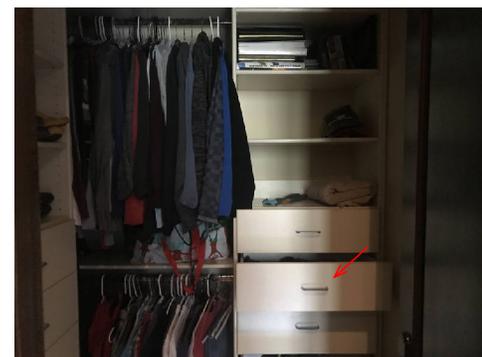
**30. Counter Tops/Cabinets Issue** The drawer guide does not function in the secondary bedroom closet of the north east secondary bedroom.

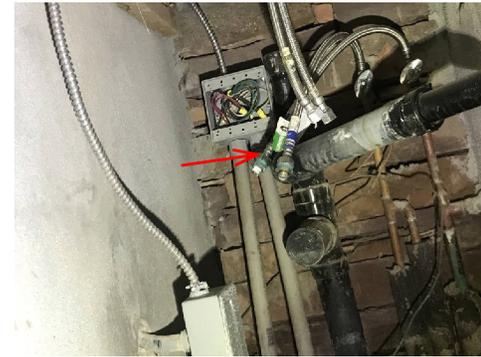
31. Sink Faucet Issue The sink at the outdoor kitchen cannot be tested because the plumbing is disconnected below the sink.

12. New sink fixture installed in outside kitchen
13. Bedroom fuse replaced.
14. Replaced bulbs in house and outdoor fixtures.
15. Blower and "lo" notice on spa to be addressed and fixed on Monday Feb. 25.

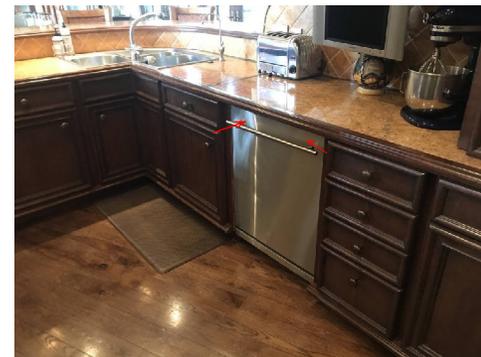
32. Dishwasher Issue The dishwasher is not attached to the cabinetry.

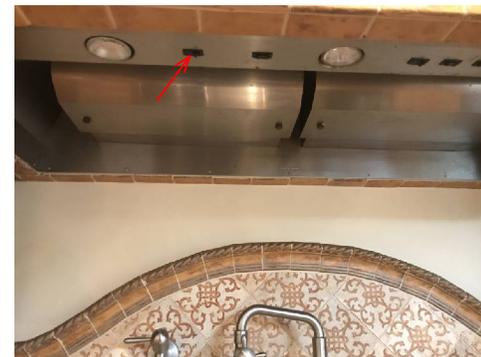
33. Range Exhaust Fan/Duct Operated When Tested The left on/off switch does not appear to function at the range exhaust hood in the kitchen.

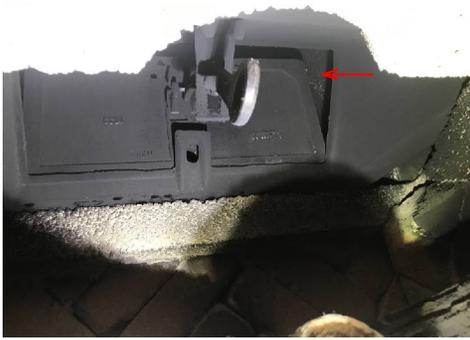
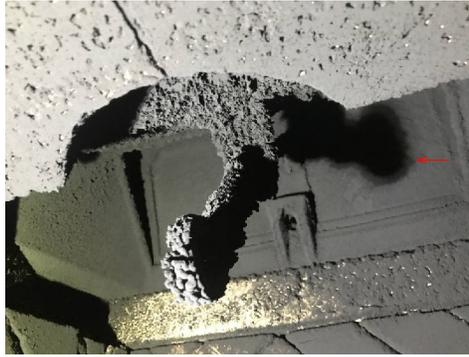
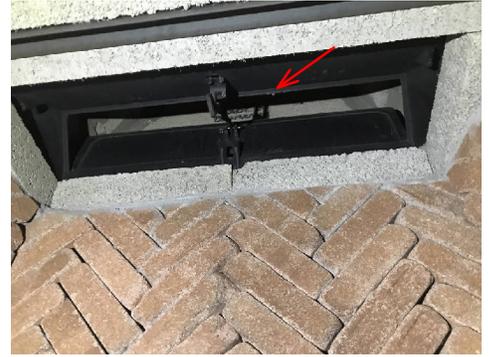
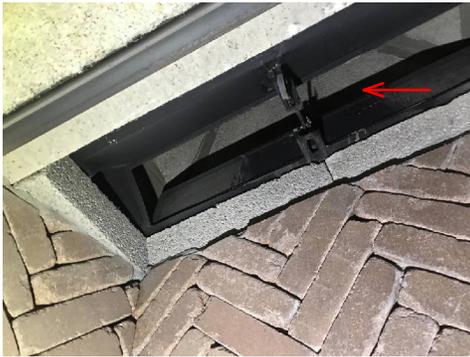
35. Damper Issue The damper is missing the damper clamp in all of the interior fireplaces.

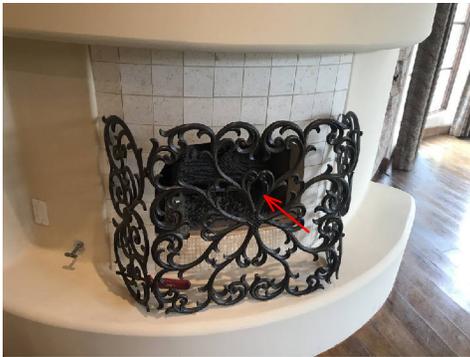
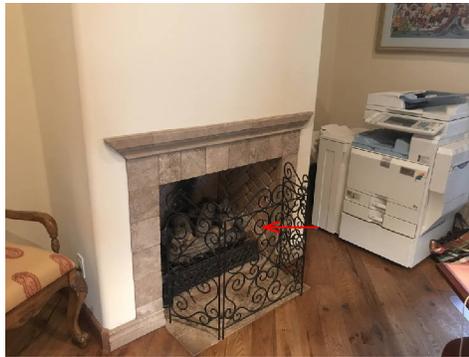
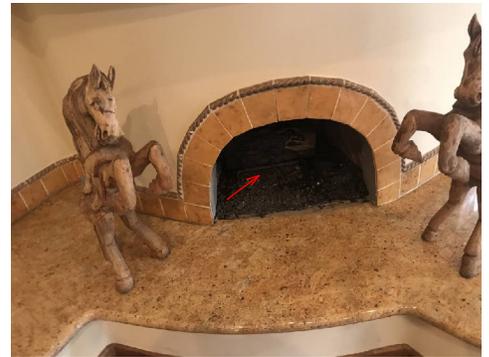
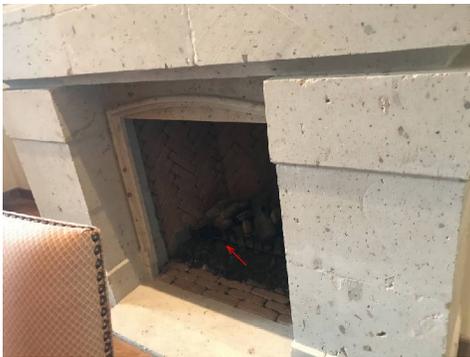
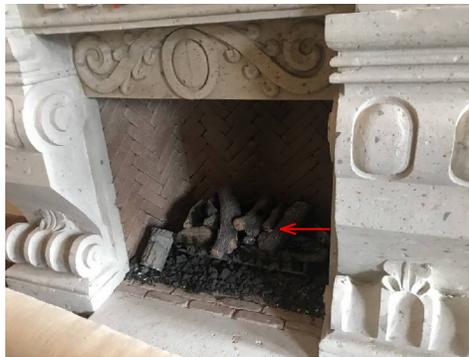
36. Gas Fireplace Function Issue I was on able to light the pilot lights and fireplaces on the interior of the house.

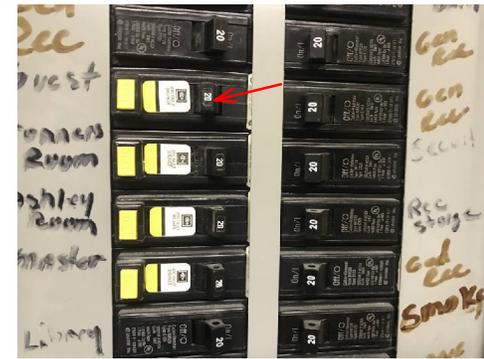
37. Breakers/Fuses Issue The arc fault breaker is in the tripped position and will not reset for the guest room in the upstairs sub-panel.

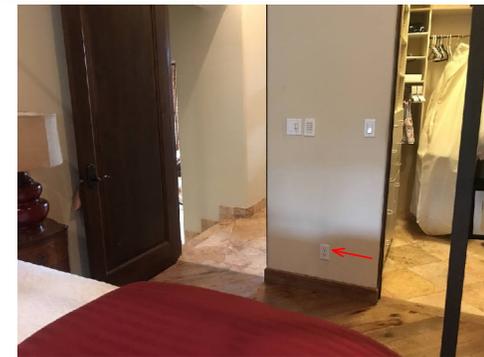
39. Outlets Issue The outlet tested not grounded in the guest bedroom.

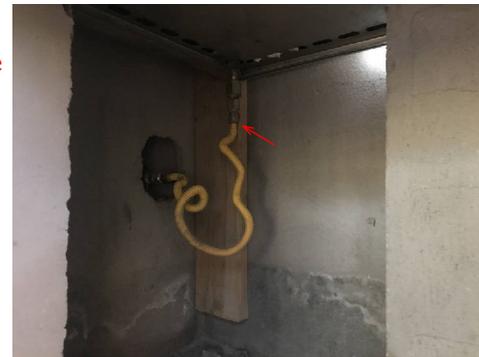
46. Gas Connectors Issue There is no pressure regulator installed in the gas supply between the shut off valve and grill at the outdoor kitchen.

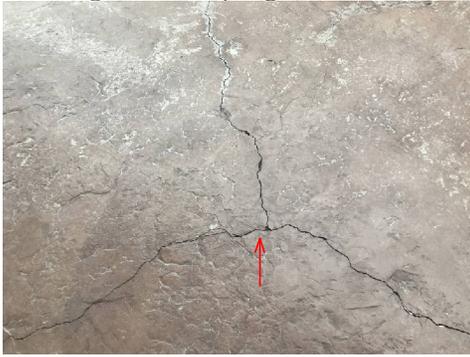
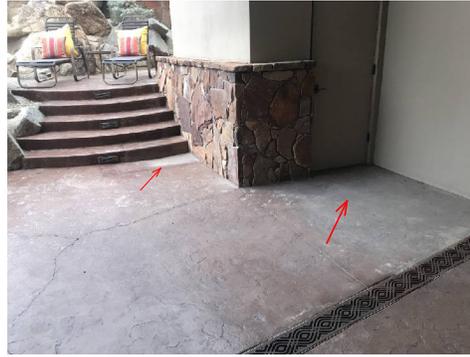
49. Surrounding Deck/Coping Issue There are cracks with separation in the pool deck in multiple places. There is evidence of water ponding on the pool deck.

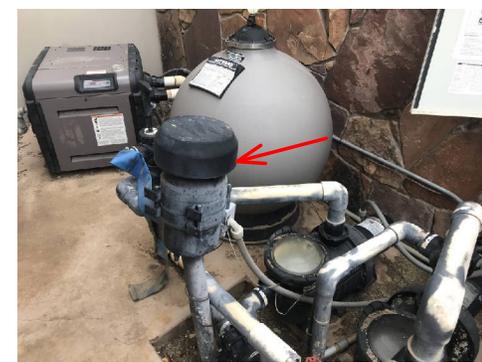
52. Spa Blower Issue The spa blower does not function.

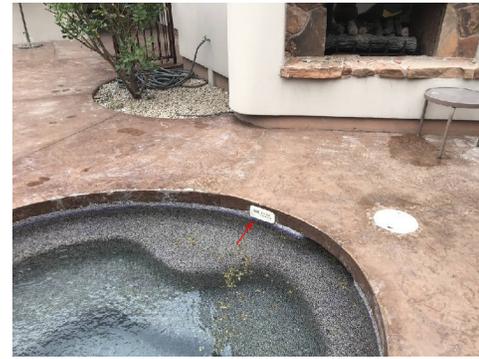
53. Spa air switch .. Issue The air switch at the spa for the blower appears to be connected to the waterfall circulating pump.
