**Perfection Home Inspections**  
**Mesa, AZ 85203**  
**602-524-2916**  
**perfectionhomeinspections.com**

Inspected By:  
**Greg Oswalt Arizona Lic. 38752**

**Trust, M. T.**  
**2357 W. El Moro**  
**Mesa, AZ 85202**

# Inspection Summary

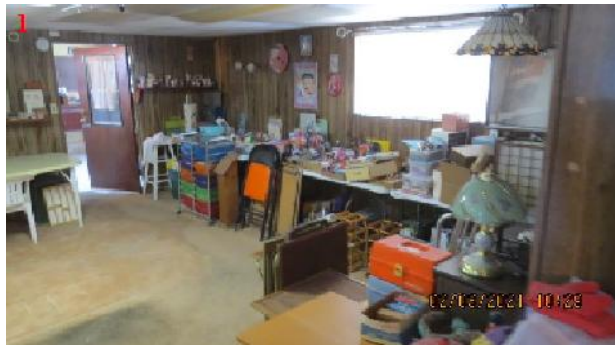
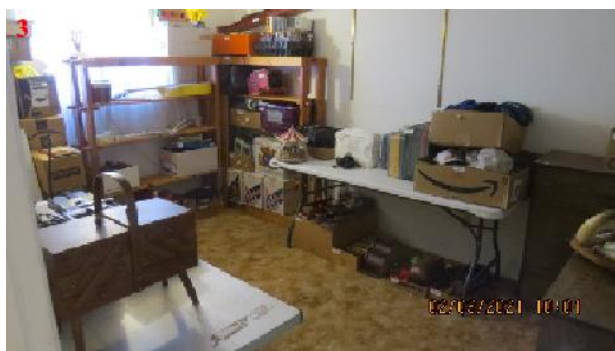
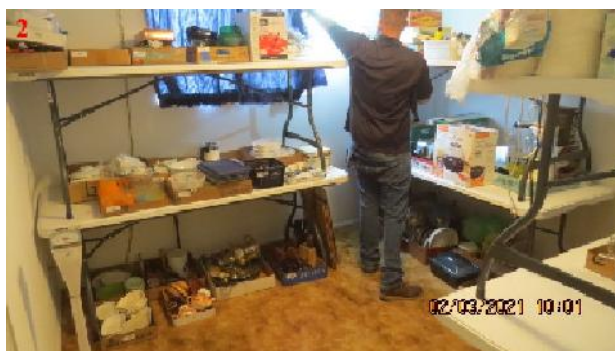
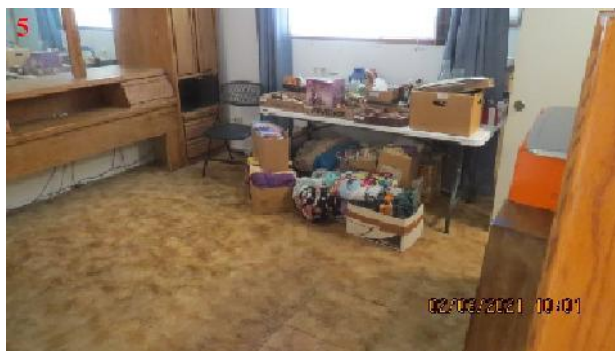
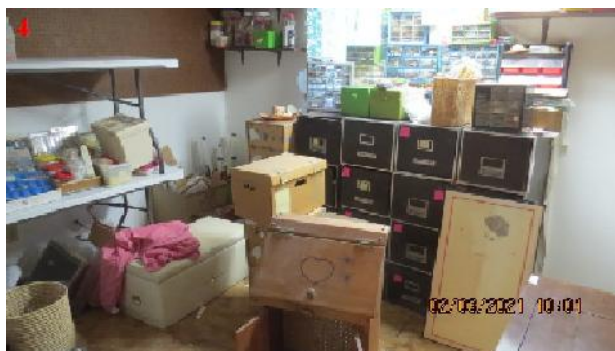
**Occupancy - Occupied**

Occupied homes cannot be inspected as well as vacant homes due to personal belongings unintentionally covering up or hiding existing problems. I recommend a thorough inspection after all personal belongings are removed. See sample pictures of stuff in this home.

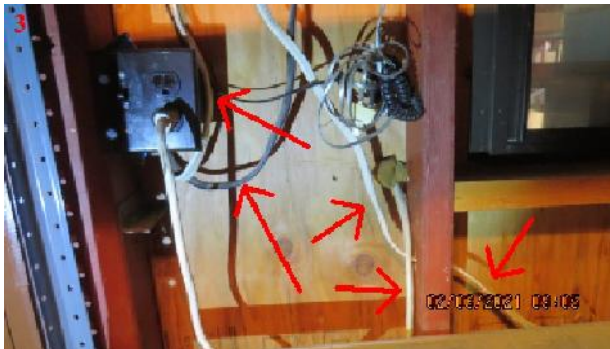
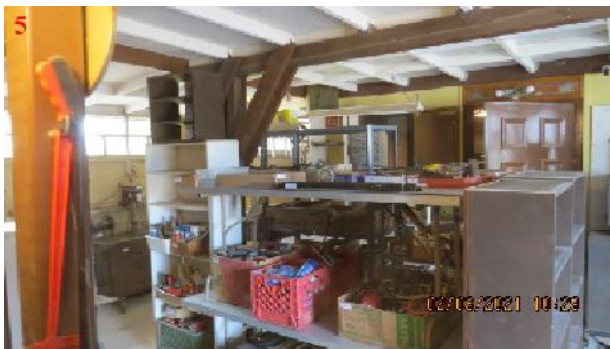
Lots of stuff stored in the shed area. Stored stuff blocks access and ability to view parts of the home;

Recommend a qualified contractor evaluate and make all necessary repairs.

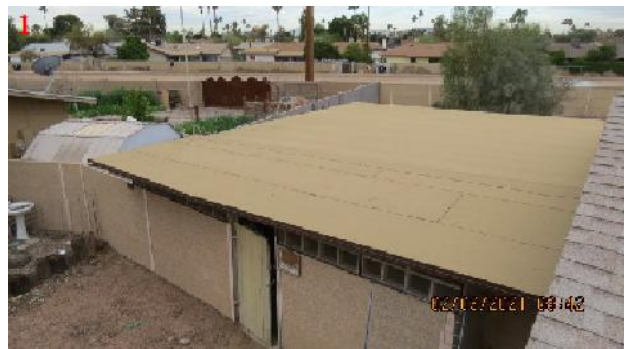
### How Inspected - Walked on Roof

Shed roof and shed addition may be too close to the property line for zoning but this is not a zoning inspection.

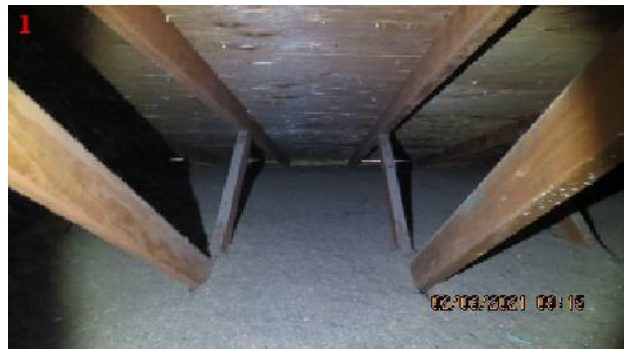
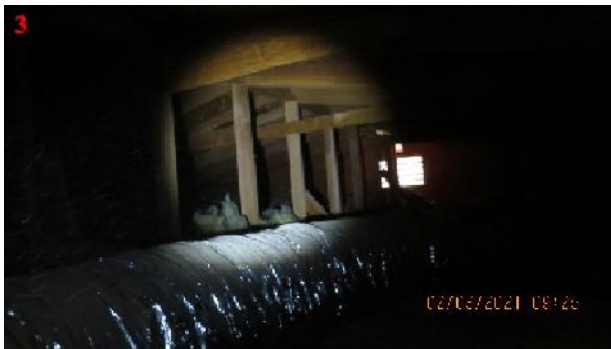
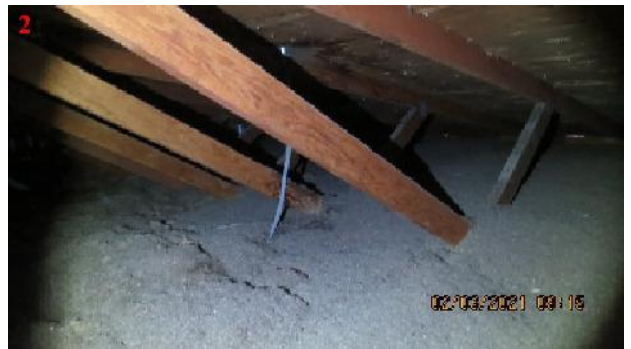
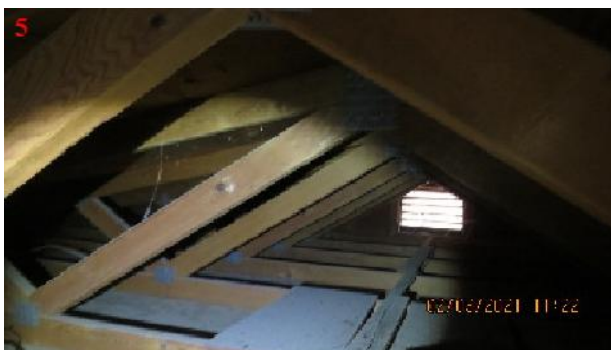
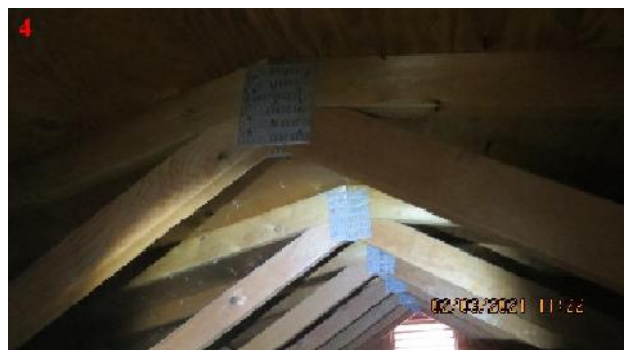
### **Satisfactory** ATTIC - Sample picture

Sample attic picture.

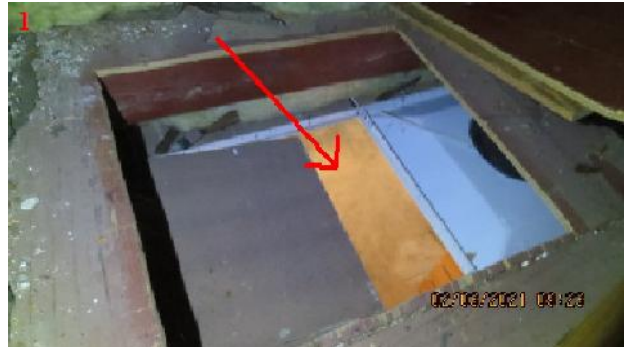
### Attic Access Location - Garage, Closet, Other

The attic access is located in the garage, closet, and in the addition ceiling.

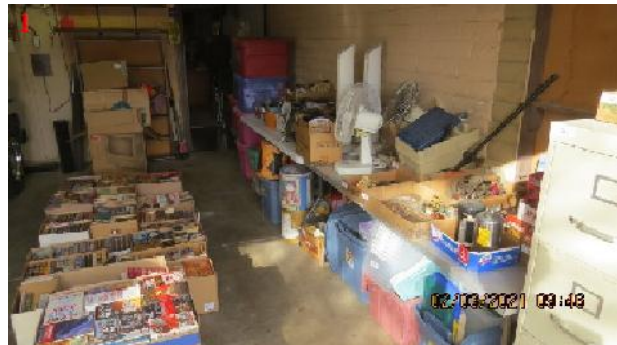
Stuff in the garage blocks view of the interior of the garage.  
Recommend inspecting garage area after the stuff is removed.

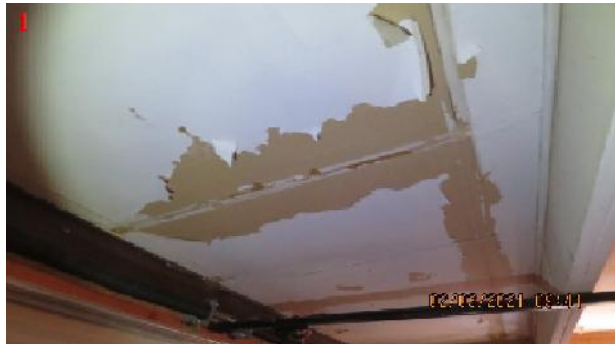
### **Service/Repair** Garage Interior Ceiling - Water Stains

Water stains, water damage and loose drywall tape on the garage ceiling. See picture Recommend a qualified contractor evaluate and make all necessary repairs.

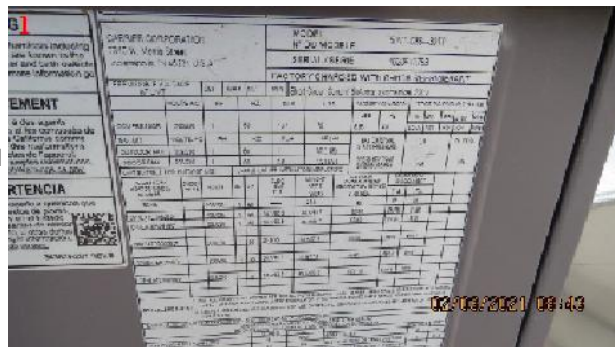
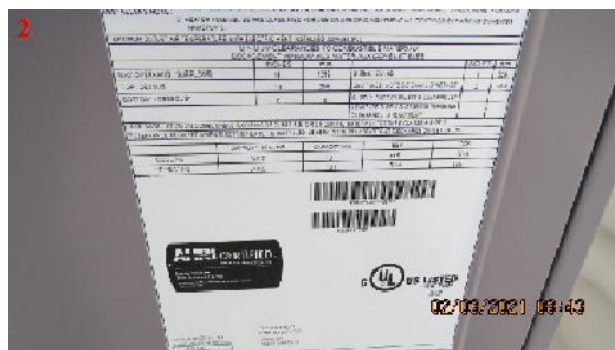
The Federal appliance manufacturing standards (10 CFR 430) will require all residential sized central air conditioners and heat pumps, manufactured or imported on or after January 23, 2006 to meet a new higher SEER standard. AC units that do not meet these new standards will need to be replaced with AC units up to 50% larger in size when they break and parts may be hard to find for Lower SEER units.

AC units have an average life of 12 to 15 years in the Phoenix area.

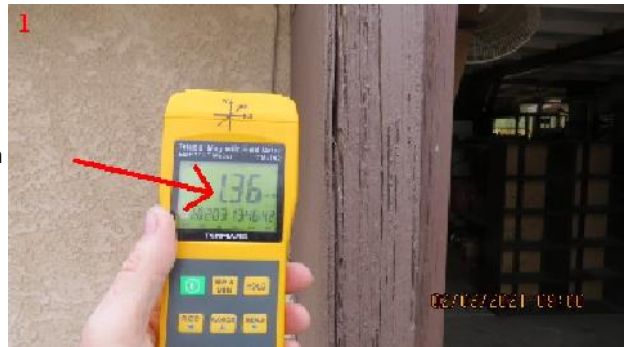
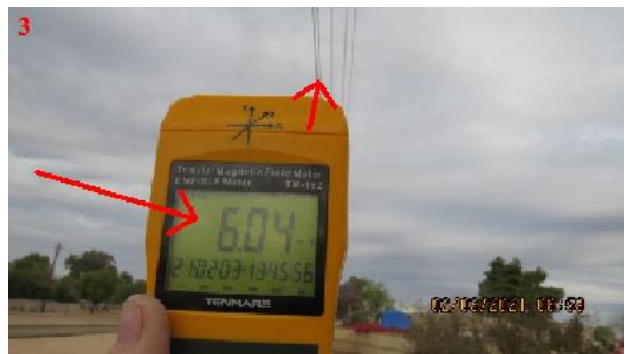
### ELECTRICAL SYSTEM - Electrical Mechanical Waves

Electrical Mechanical Force or Waves are created by high voltage lines. I recommend a meter reading inside the home or 2.5 milli-gauss or lower. The reading I found today in this home is 1.36 milli-gauss at the back of the home and a high of 6.04 under the power lines. If this concerns you I recommend you do more research on EMF waves or high voltage lines. This may be a health hazard. Some think high levels of electrical Mechanical waves could cause childhood leukemia.

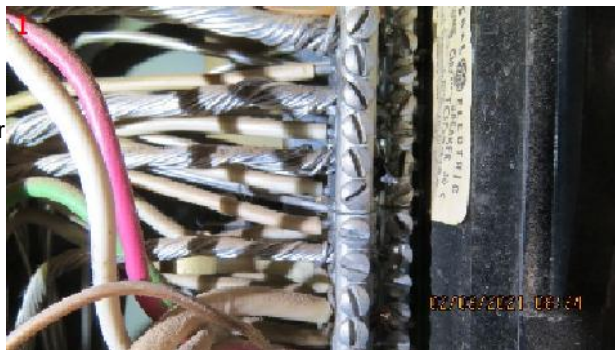
**Recommend Further Investigation** Aluminum Branch Circuits - To Outlets

Between 1964 and 1974 many homes were built using single strand aluminum wire alloy that caused problems. This type of wire tends to oxidize and then overheat and it is incompatible with many electrical fittings. A new type of AL ware was introduced between 1972 and 1974 to solve overheating problems. Homes with the older type single stranded aluminum wires are up to 55 times more likely to have a electrical fire. Recommend an electrician check all connections to ensure proper outlets, switches, and connectors have been used. See [www.cpsc.gov/cpscpub/pubs/516.pdf](http://www.cpsc.gov/cpscpub/pubs/516.pdf) Arc-Fault breakers may help reduce the fire issue.

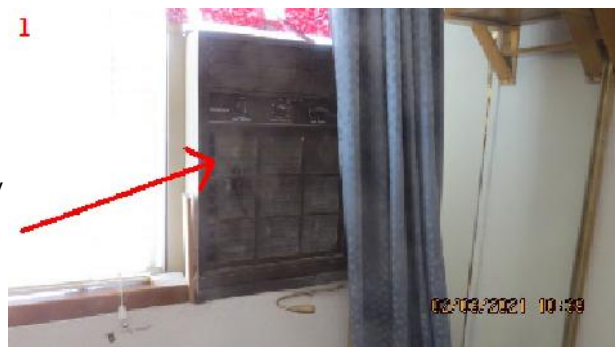
There is a window AC in one window blocking egress and it did not cool air when tested.

Recommend a qualified contractor evaluate and make all necessary repairs.

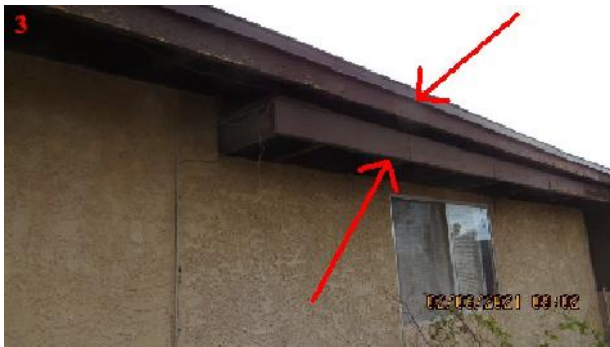
**Recommend  
Further  
Investigation****Other Room - General**

This room is the addition room. Looks like this room was a patio and is now converted to possible living space but there the fire barrier between this room and the garage does not meet current standards and the ceiling looks like it was attached to the laundry room fascia and or rafters. The Main house stops at the kitchen. Looks like a sliding glass door was removed from the kitchen to incorporate the patio as part of the home. Recommend verifying proper permits were obtained and signed off for this addition. A roof has been installed over part of the laundry room roof and extended to the back of the home. This make an odd looking double roof in the back.
