Perfection Home Inspections
Mesa, AZ 85203
602-524-2916
perfectionhomeinspections.com

Client Information: Record Number 8613

Sturgeon, Melanie
1211 S. Barkley
Mesa, AZ 85204
480-881-6717

Inspected 7/24/21 8:00 AM
Built 1980
1688 sf

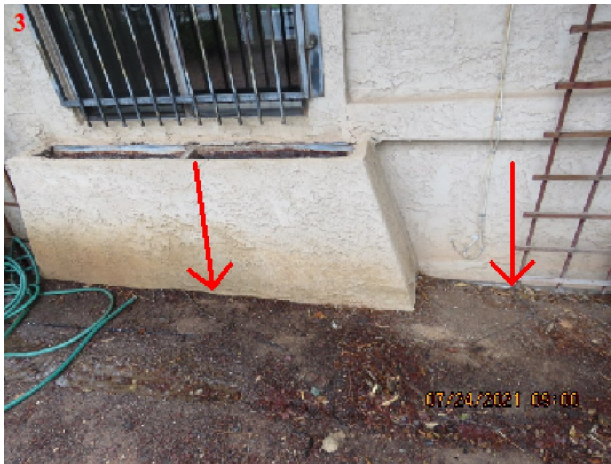
The stucco is too close to the ground in some areas. Recommend a minimum of a 4 inch gap between the bottom of the stucco and the finished grade and a minimum of 2 inches above the cement. Stucco need to be able to drain moisture out of the walls through the bottom of the stucco and termites and other pests may enter the home undetected if this distance is not maintained. Running stucco to the ground is a common practice for masonry homes in this area. Stucco should not go to the ground for framed wall construction.

Crack in the stucco. Recommend repair.

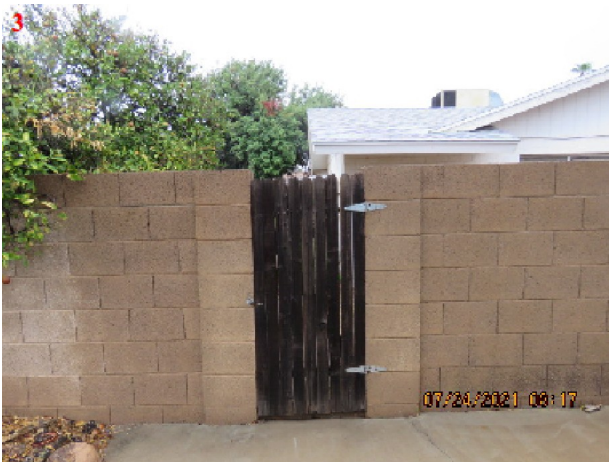
Service/Repair Yard Fences - Masonry, Wood

The fence gate in the front is falling over. There is a fence gate in the side yard to the neighbors back yard. Damage block in the back fence wall. Recommend a qualified contractor evaluate and make all necessary repairs.

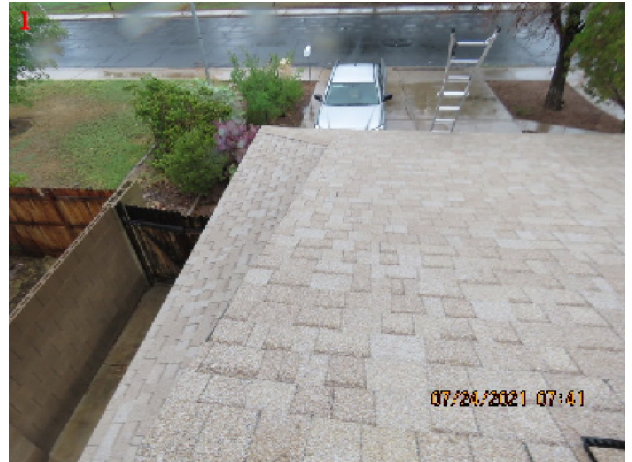
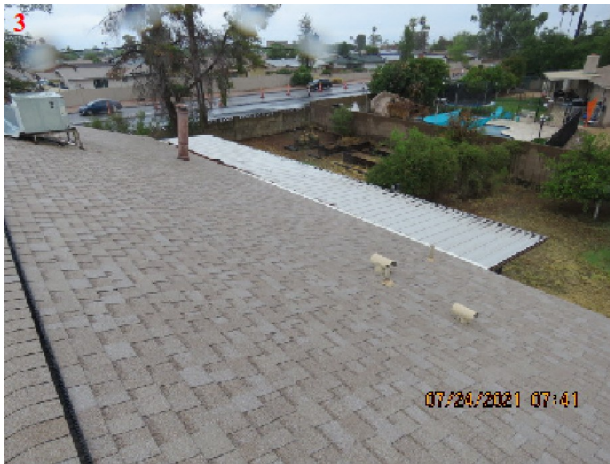
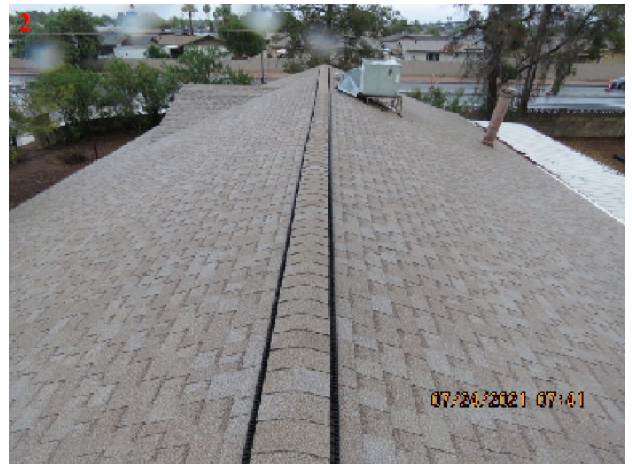
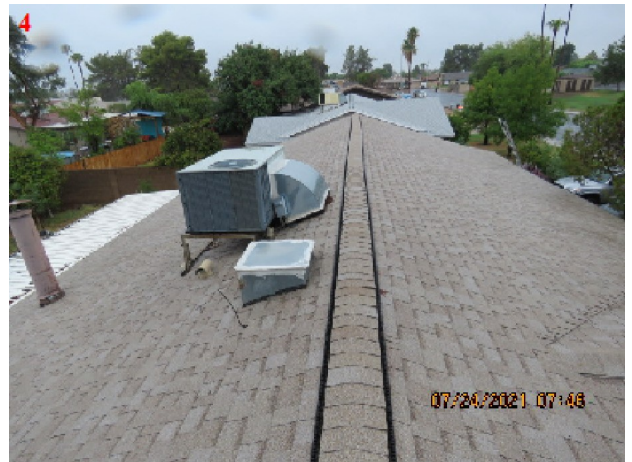
ROOF - Sample

See sample picture of the roof.

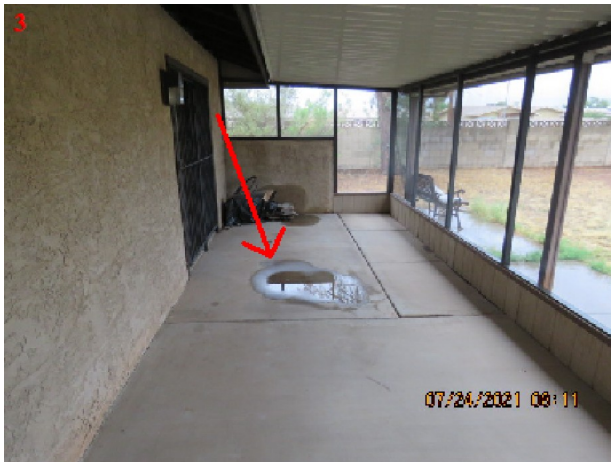
Service/Repair Back Patio Roof - Fascia Attachment, Shed

The back patio roof has been attached to the fascia wood. This is a good indication the patio addition was installed without a permit. Water leaking between the patio roof and the house room in the patio area. Recommend a qualified contractor evaluate and make all necessary repairs. Recommend asking the seller for permits obtained from the city to install the patio roof. Debris on the back patio roof. Recommend removing all debris from the roof.

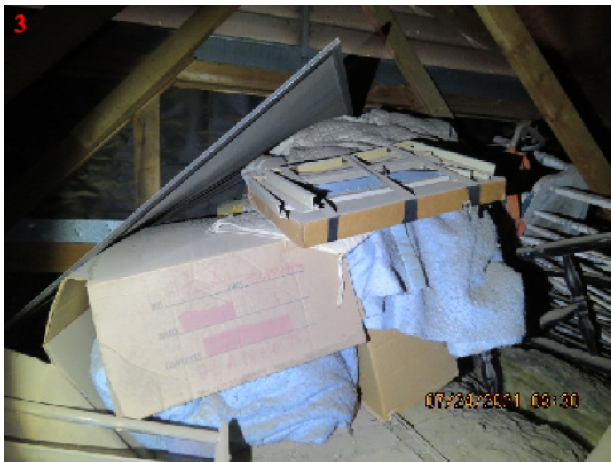
ATTIC - Sample picture

Sample attic picture. Stuff stored in the attic. Recommend removing the stuff.

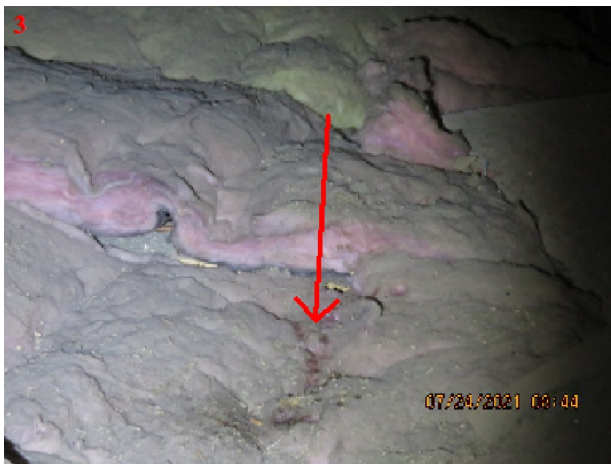
Service/Repair Attic Leaks - Sheathing

Roof leak in the attic at the AC electric line and on the sheathing near the attic hatch above the kitchen area. Sheathing has water stains in several areas. Recommend a qualified contractor evaluate and make all necessary repairs.

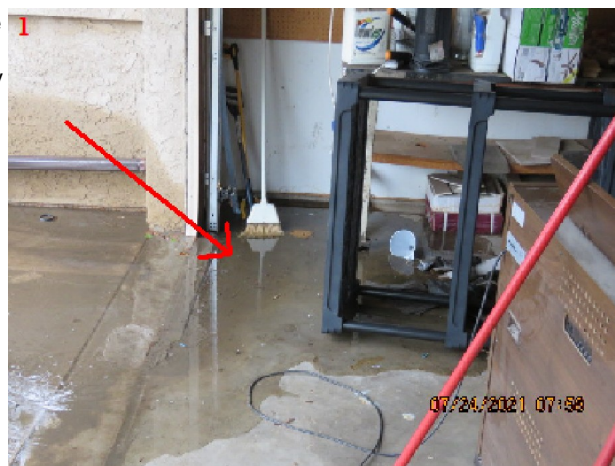
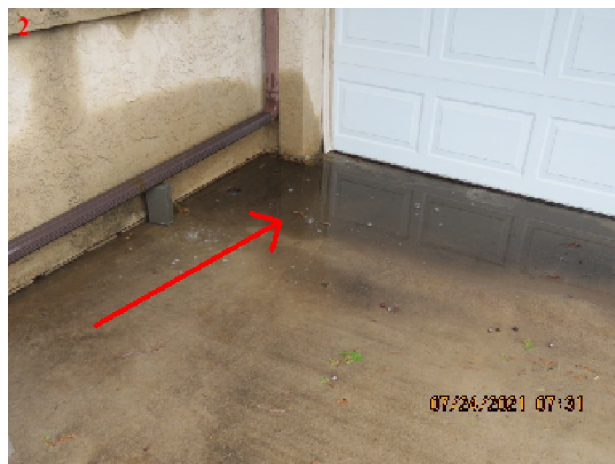
GARAGE - General Comment

The front north corner of the garage gets flooded when it rains. The driveway is sloped toward the garage in this area. Recommend a qualified contractor evaluate and make all necessary repairs.

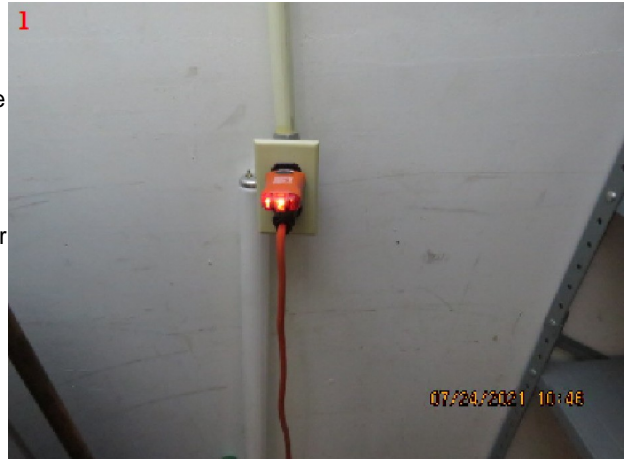
Hot and neutral wires reversed on two outlets near water heater. This outlet is also not GFCI protected. Recommend GFCI protection for all outlets in the garage.

This outlet is also not GFCI protected. Recommend GFCI protection for all outlets in the garage.

This is a shock hazard. Recommend a qualified electrical contractor evaluate and make all necessary repairs. See picture

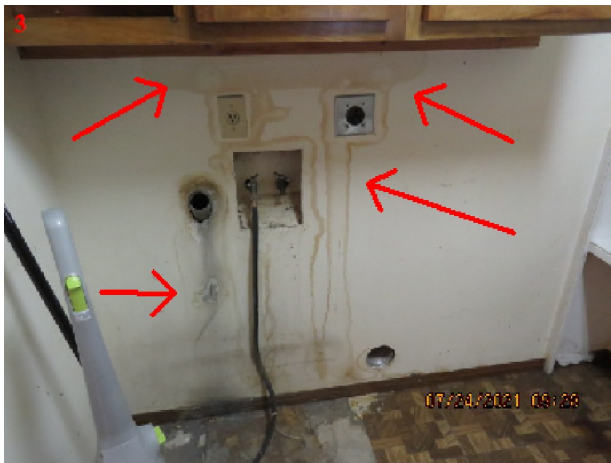
Walls & Ceiling - Inspected

Water stains on the laundry wall at the washer hookup area. Cracks on the ceiling.
Recommend a qualified contractor evaluate and make all necessary repairs.

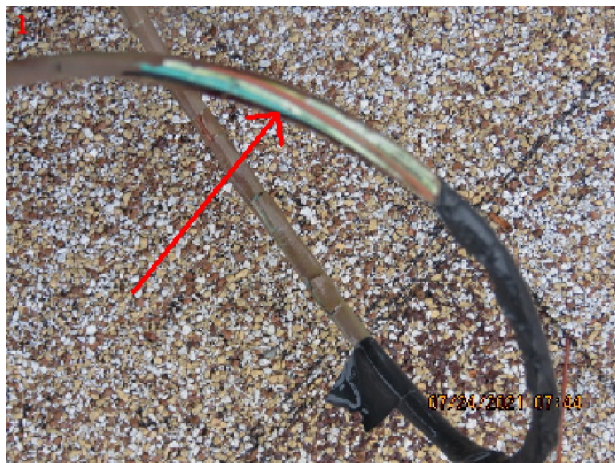
Service/Repair Thermostat wires - Cracked insulation

The low voltage wires from the thermostat to the AC coil on the exterior have damaged insulation. Damage to wire insulation can cause the AC unit to malfunction. Recommend a qualified contractor evaluate and make all necessary repairs.

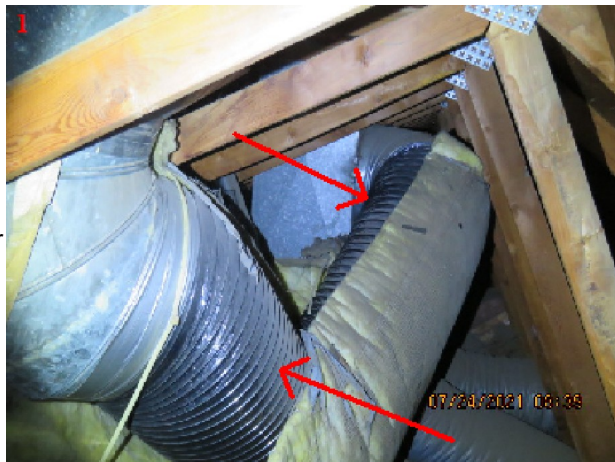
Service/Repair Duct Type - Rigid and Flexible, Vapor Barrier Rip

The outer plaster vapor barrier of one or more of the flexible HVAC ducts in the attic has deteriorated leaving the insulation to the duct loose and falling off the pipe. This allows the hot attic air to warm the cool duct air before it reaches the living space below. When the hot attic air hits the cold AC duct condensation may be formed creating a moisture problem in the attic. Recommend replacing all ducting with a ripped vapor barrier. Recommend a qualified AC contractor evaluate this situation and make all necessary repairs. See picture For all AC repairs and service I recommend Premier Air Solutions Inc. for AC work. 480-940-2351

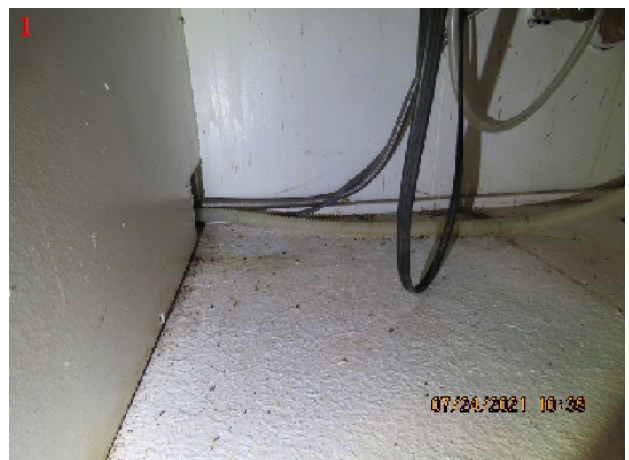
Service/Repair Kitchen Cabinets - Inspected, Cabinet Base Bowd

The base of the kitchen sink cabinet has bowed down from water leaking under the sink. Recommend a qualified contractor evaluate and make all necessary repairs. See picture

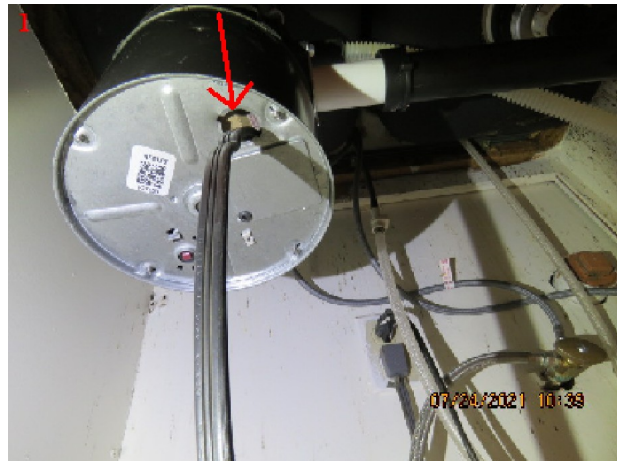
Safety Concern Garbage Disposal - Tested, Power Cord

Electrical cable not properly attached to disposal. Recommend properly attaching cord to disposal. Possible shock hazard. See picture

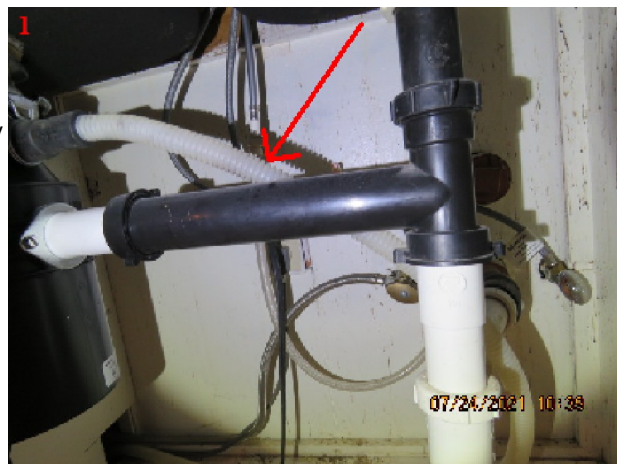
Safety Concern Dishwasher - Drain Hose

The drain hose from the dishwasher to the disposal needs a loop above the disposal drain and most of the sink or a sink air gap to prevent sink drain water from flowing into the dishwasher. See picture
Recommend a qualified contractor evaluate and make all necessary repairs.

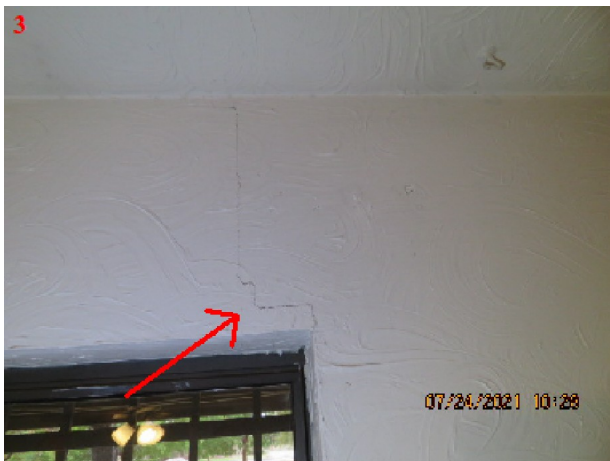
Interior Walls and Ceiling - Inspected

Cracks in the living room walls and water stain on the family room ceiling in the corner.
Recommend a qualified contractor evaluate and make all necessary repairs.

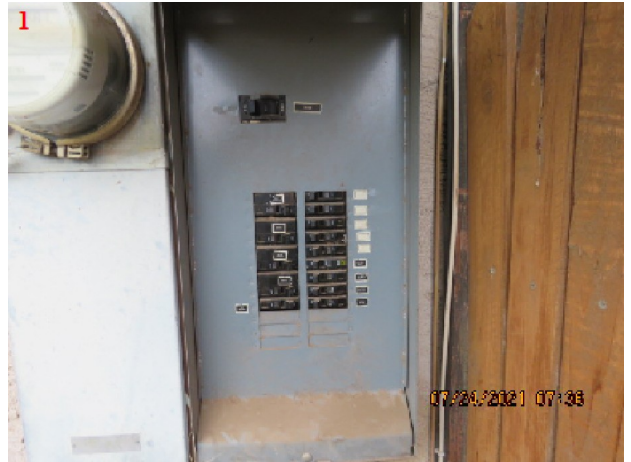
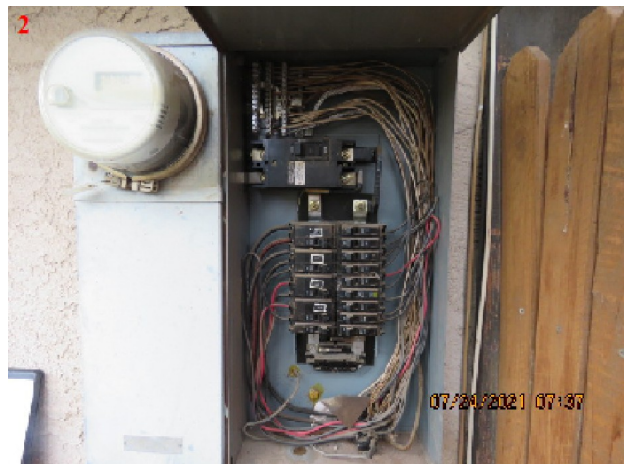
Main Electric Panel - Inspected, Sample Picture

Sample picture of the main electric panel.

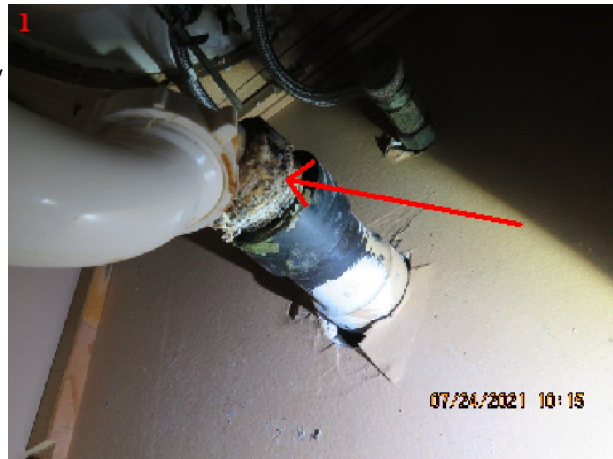
Service/Repair Drain, Trap, Waste and Vent Piping - Tested, Corrosion

Corrosion on the drain pipe for the sink drain in the hall bathroom.
This is an indication of slow leaking.
Recommend a qualified contractor evaluate and make all necessary repairs.

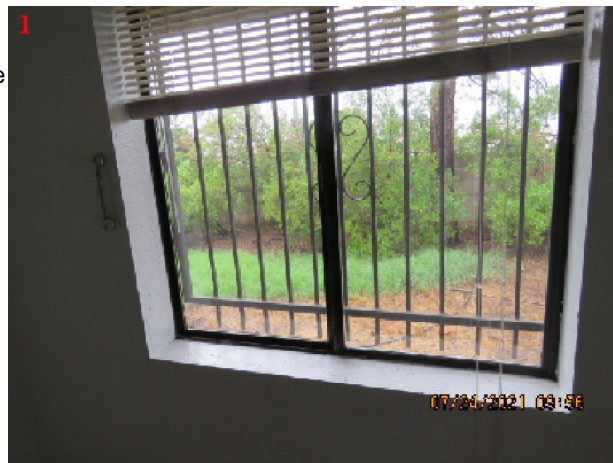
Safety Concern **Windows - Approx. 44" or Less to sill, Bars On Windows**

Bars permanently installed on window with or without a quick release are a fire escape hazard. Recommend removing bars from window before sleeping in room. Bars on windows are a fire escape hazard even if they have a quick disconnect. How can a fireman enter if no one opens the bars??

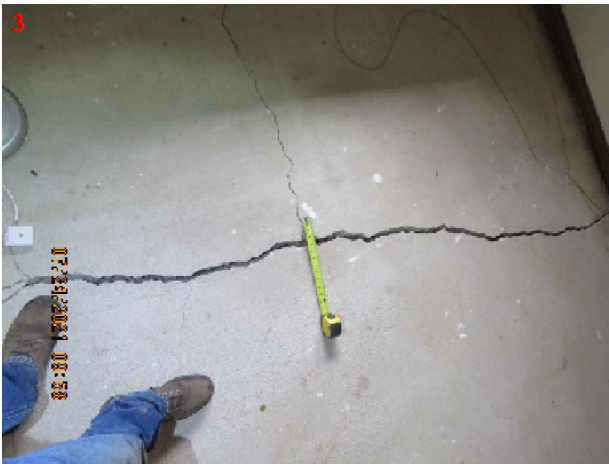
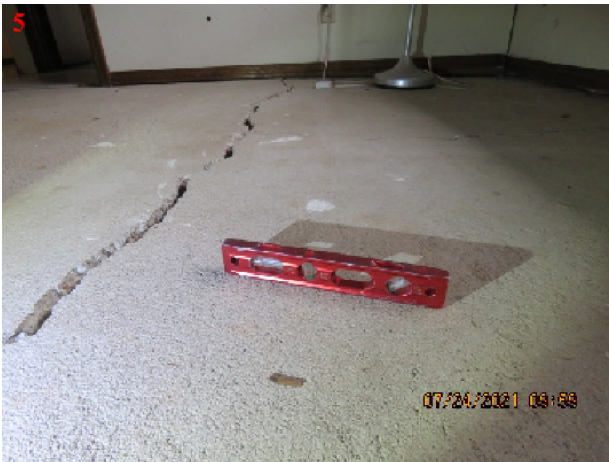
Floor - Concrete

Large crack running across the center of the floor in this bedroom is up to 1 inch wide and a section of the slab has dropped over 2 inches in 5 feet.

Large crack running across the center of the floor in this bedroom is up to 1 inch wide and a section of the slab has dropped over 2 inches in 5 feet.
Recommend a qualified contractor evaluate and make all necessary repairs.

Recommend a qualified contractor evaluate and make all necessary repairs.

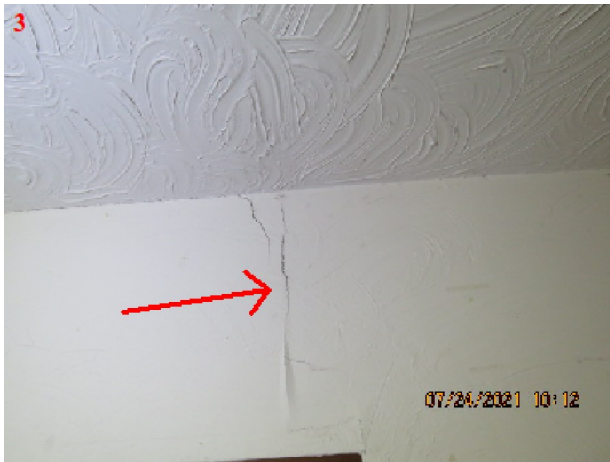
Service/Repair Walls & Ceiling - Inspected

Cracks on the ceiling and wall in this room and water stains on the ceiling and wall but on wet at this time.
Recommend a qualified contractor evaluate and make all necessary repairs.
