Perfection Home Inspections
Mesa, AZ 85203
602-524-2916
perfectionhomeinspections.com

Client Information: Record Number 8680

1615 N. Date Drive
Tempe, AZ 85281

Inspected 10/26/21 8:00 AM
Built 1961
2046 sf

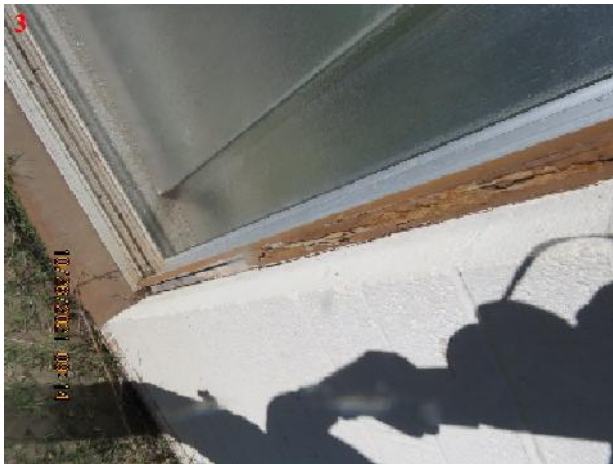
Service/Repair Flashings and Trim - Wood/Imitation Wood

Termite damage to the trim at the front porch and at the back sliding glass door trim.
Recommend a qualified contractor evaluate and make all necessary repairs.

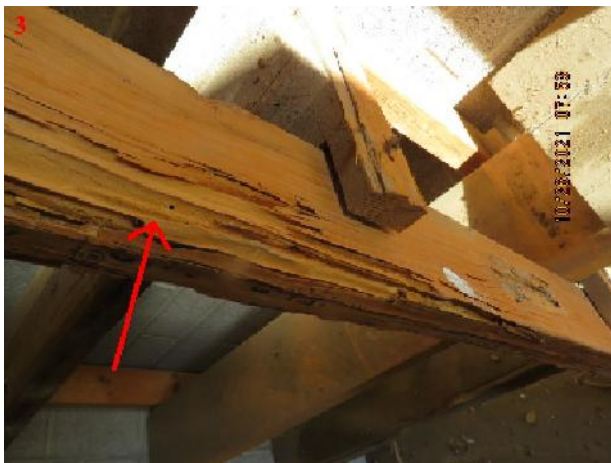
Safety Concern Storage Room - Exposed Romex

Exposed romex in the storage room in a poor location and termite tubes and termite damage. Recommend a qualified contractor evaluate and make all necessary repairs.

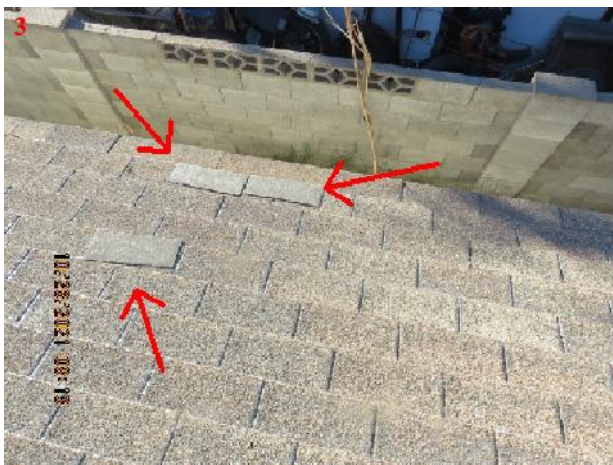
Service/Repair Roof Covering - Asphalt Shingles

This roof is in poor condition and at the end of its useful life. Multiple missing shingle tabs. Recommend a qualified contractor evaluate and make all necessary repairs. A common cause of roof leaks is missing or broken wind blown shingle tabs. Recommend replacing damaged shingles. See picture

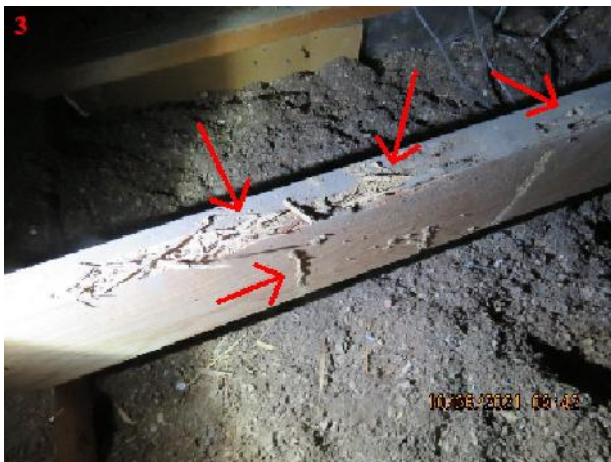
Service/Repair Attic Structural Framing Type - Conventional

Termite damage to support wood and ceiling joists in the attic. Also some fire damage in the attic.
Recommend a qualified contractor evaluate and make all necessary repairs.

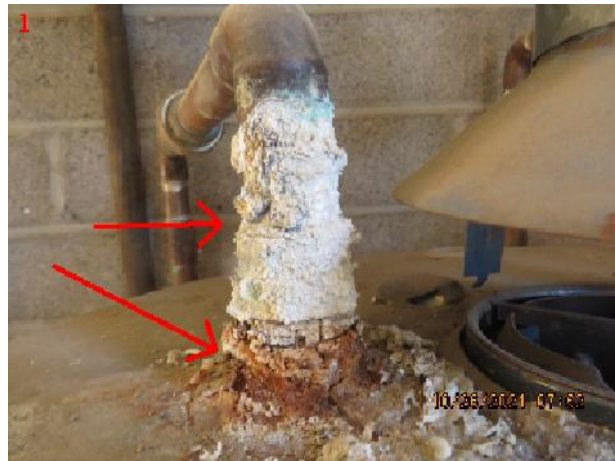
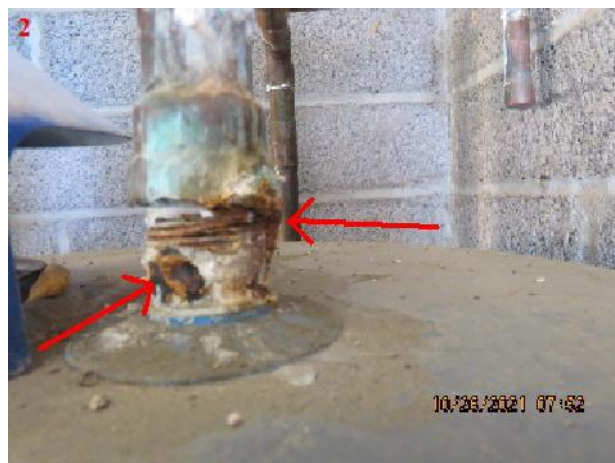
Service/Repair Water Heater Nipples - Heavy Corrosion

Both of the water heater nipples (small pipes attached to top of water heater) are heavily corroded. Nipples in this condition may rupture at any time and create a flood. Recommend replacing corroded galvanized nipples immediately. See picture

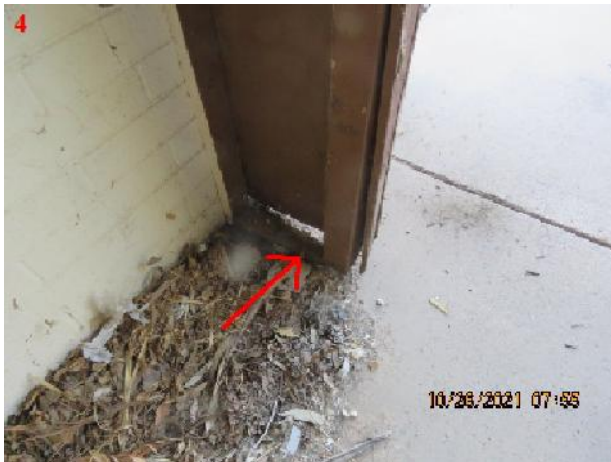
Service/Repair Garage Exterior Walls - Inspected

Termite tubes and termite damage to the exterior garage wall siding. The front facing garage walls are loose at the bottom. Recommend a qualified contractor evaluate and make all necessary repairs.

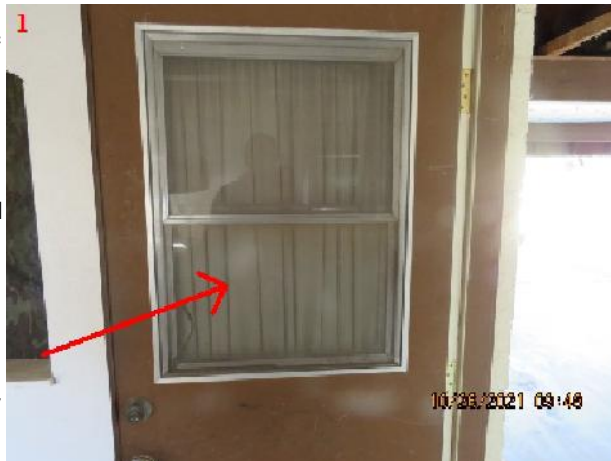
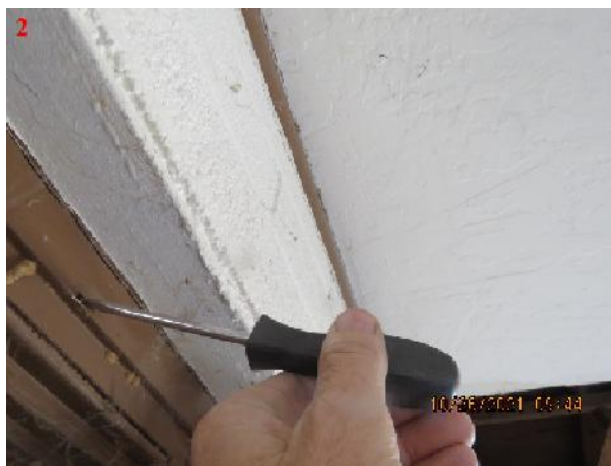
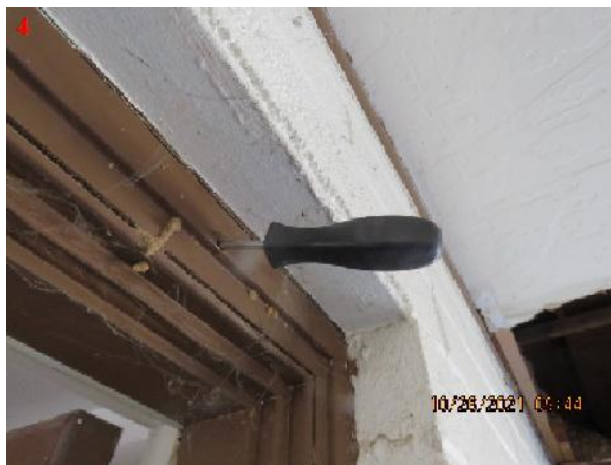
The door to the garage has a windows and windows are not allowed between a garage and the house. This door acts as a fire stop and helps keep carbon monoxide out of the house. Recommend installing a 20 min. or higher rated fire door between house and garage. See picture

Termite tubes and termite damage to this door Jamb. Recommend a qualified contractor evaluate and make all necessary repairs.

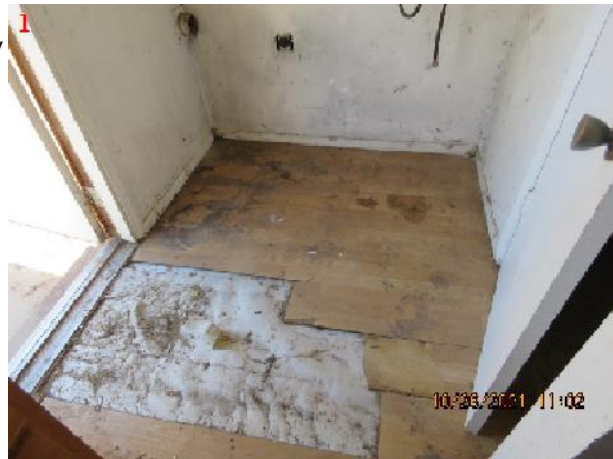
Service/Repair Floor - Wood/imitation wood

Sections of the flooring missing in the laundry.
Recommend a qualified contractor evaluate and make all necessary repairs.

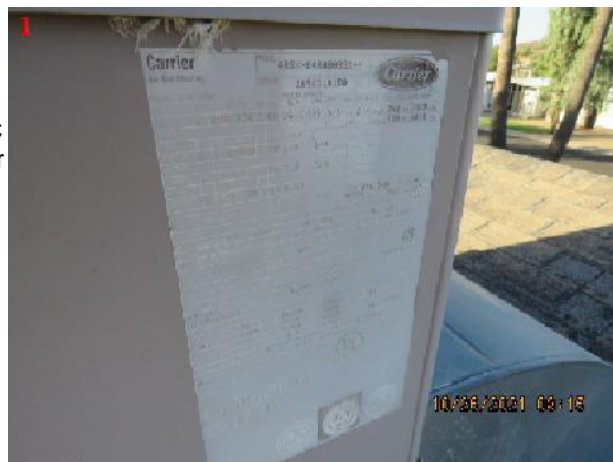
The AC did not work when tested.
Recommend a qualified heating and air conditioning contractor evaluate and make all necessary repairs.

This unit looks like it is over 25 years old. The average life of an AC system in the Phoenix area is 12 to 15 years. This unit may be near the end of its useful life. Typical AC has only 50% of its initial efficiency after 20 years. So a 12 SEER would have a 6 SEER rating.

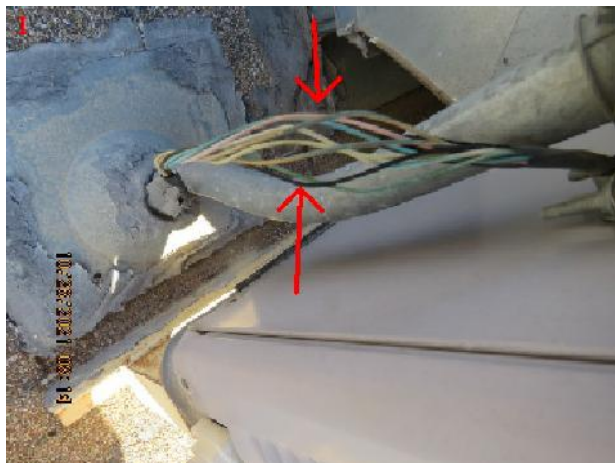
Thermostat wires - Cracked insulation, Damaged wires

The low voltage wires from the thermostat to the AC coil on the exterior have damaged insulation. Damage to wire insulation can cause the AC unit to malfunction. Recommend a qualified contractor evaluate and make all necessary repairs.

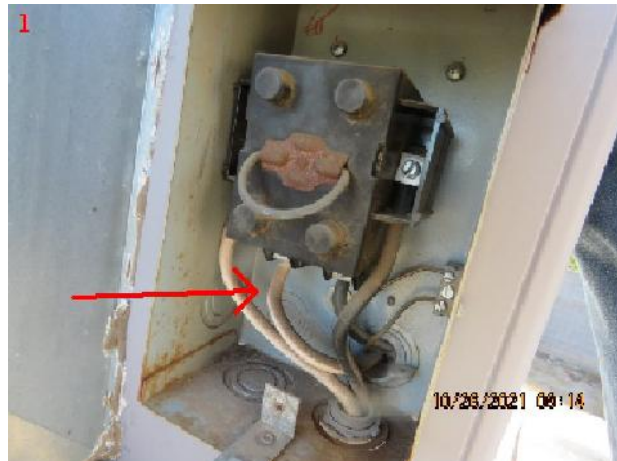
Quick Disconnect - Installed, Missing Cover Plate

The quick disconnect for the AC unit is missing a cover plate inside. This is a shock hazard. Recommend installing cover plate.

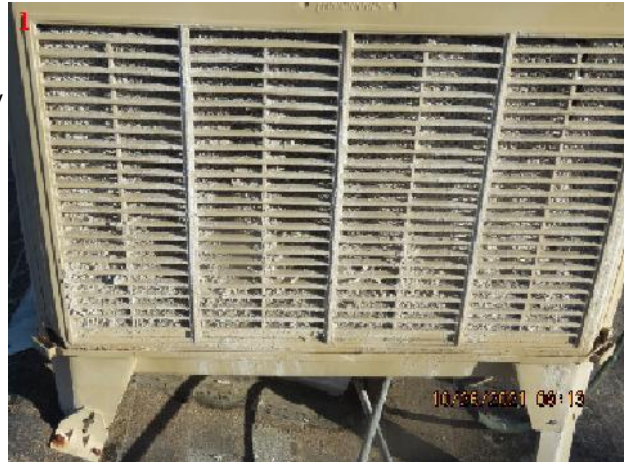
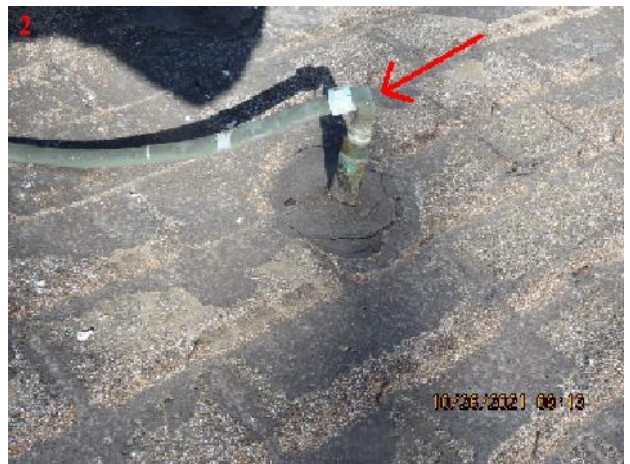
The evaporative cooler did not work when tested and the condensation drain line is kinked.

Recommend a qualified contractor evaluate and make all necessary repairs.

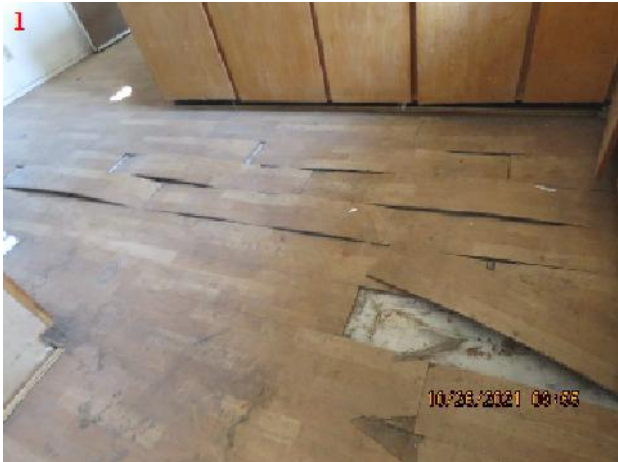
Service/Repair Kitchen Floors - Inspected

Kitchen floor covering poor condition.
Recommend a qualified contractor evaluate and make all necessary repairs.

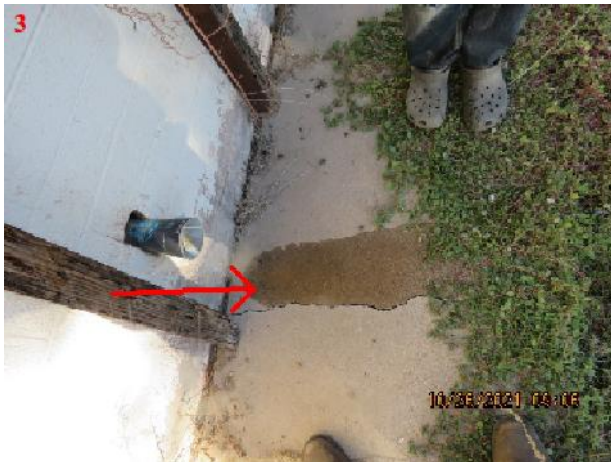
Service/Repair Kitchen Drain and Trap - Tested

The kitchen sink drain drains into the back yard. A cup was installed to keep water from draining in the wall. Recommend a qualified contractor evaluate and make all necessary repairs.

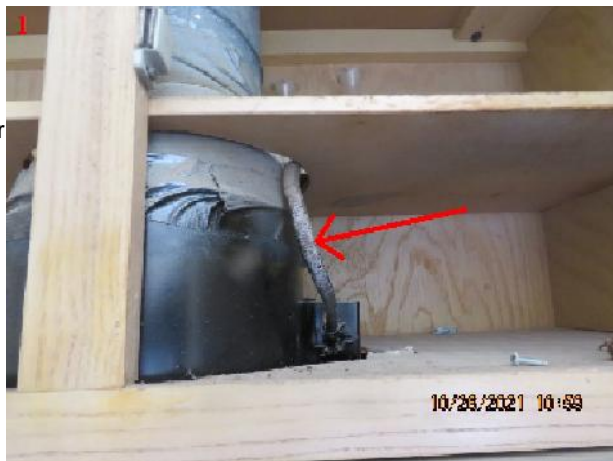
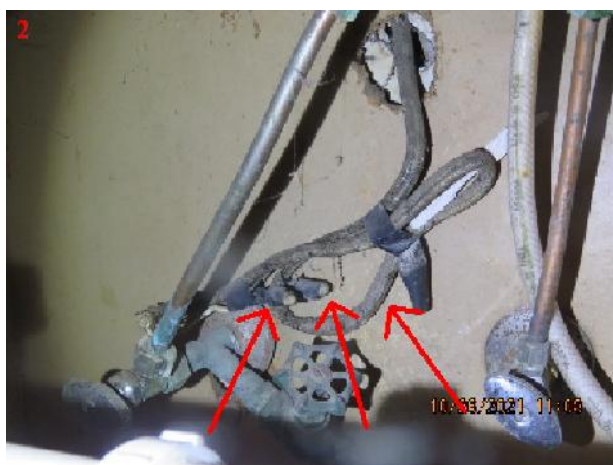
Other - Exposed Romex

Exposed romex type wire found in kitchen cabinets upper and lower with exposed wire nuts on romex wires under the kitchen sink. Recommend all exposed romex type wire less than seven feet above the floor be installed in conduit or properly protected. This is a shock hazard. Recommend a qualified electrical contractor evaluate and make all needed repairs.

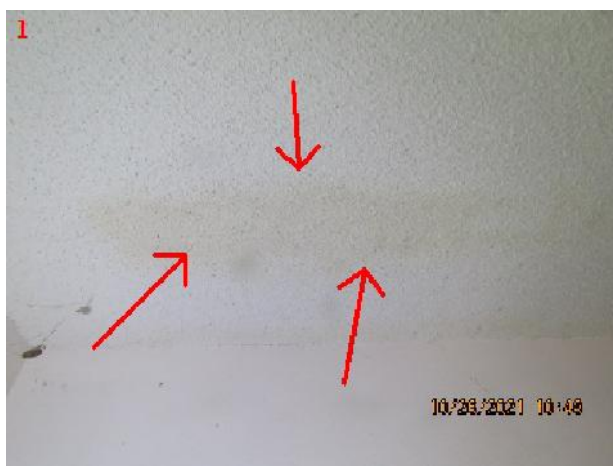
Yellow stains on the living room ceiling. Recommend a qualified contractor evaluate and make all needed repairs.

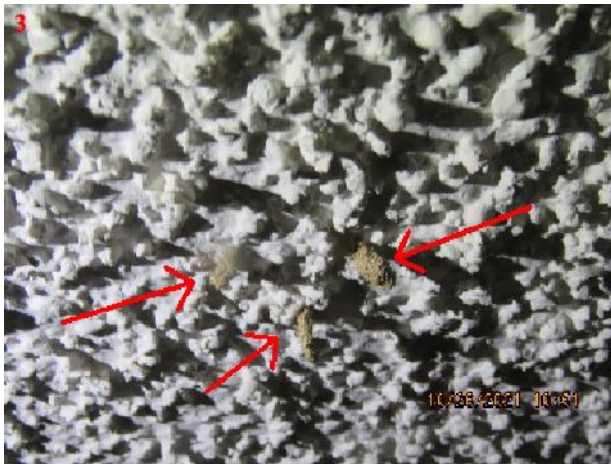
Lots of long termite tubes hanging from the ceiling in the family room. See sample pictures
Recommend a qualified contractor evaluate and make all necessary repairs.

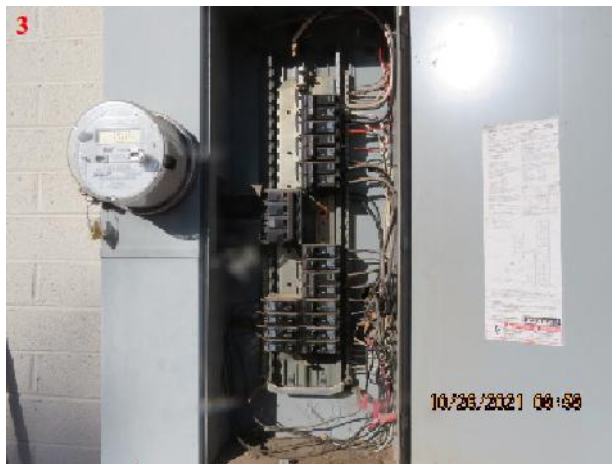
Safety Concern Main Electric Panel - Inspected

Screw missing for the breaker cover plate at the main electric panel. Recommend installing screw to properly hold the breaker cover plate in place.

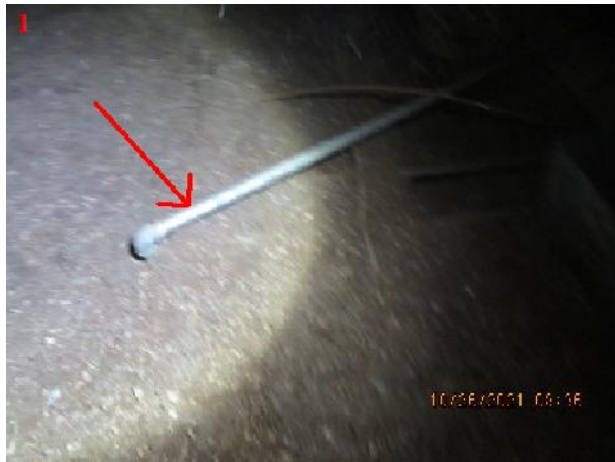
Interior Visible Water Pipes - Other

Copper pipe to the fixture but a galvanized pipe was located in the attic. Galvanized pipes may also be in the walls. Recommend further investigation.

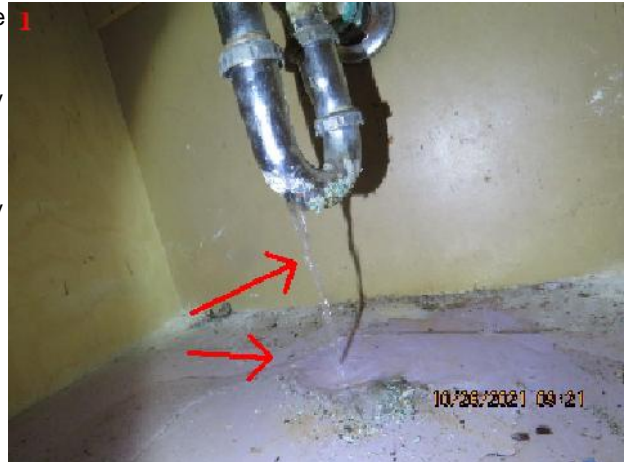
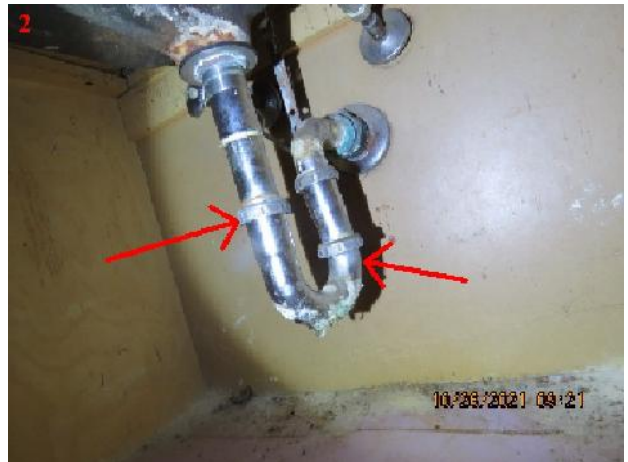
The p-trap leaks.

Recommend a qualified contractor evaluate and make all necessary repairs.

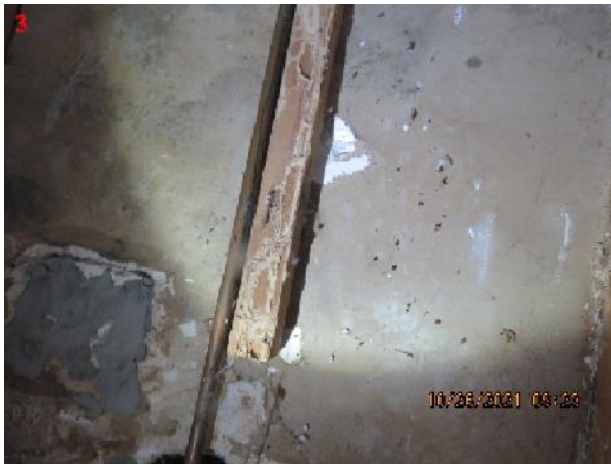
Termite tubes and termite damage to the master shower wall and plaster missing on the living room side of this wall. Recommend a qualified contractor evaluate and make all necessary repairs.

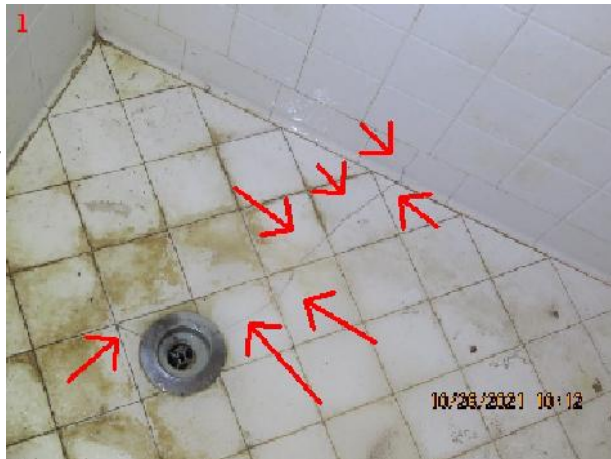
10 or more cracked tile in the shower enclosure.
Recommend a qualified contractor evaluate and make all necessary repairs.

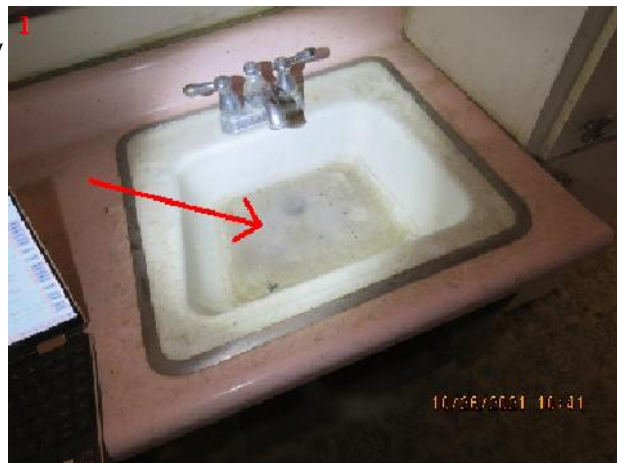
The hall sink drain is clogged.
Recommend a qualified contractor evaluate and make all necessary repairs.
