Perfection Home Inspections
Mesa, AZ 85203
602-524-2916
perfectionhomeinspections.com

Client Information: Record Number 8777

Lawsen, Stewart
16932 E. Monterey Drive
Fountain Hills, AZ 85268
480-861-2530

Inspected 4/5/22 8:00 AM
Built 2002
3070 sf

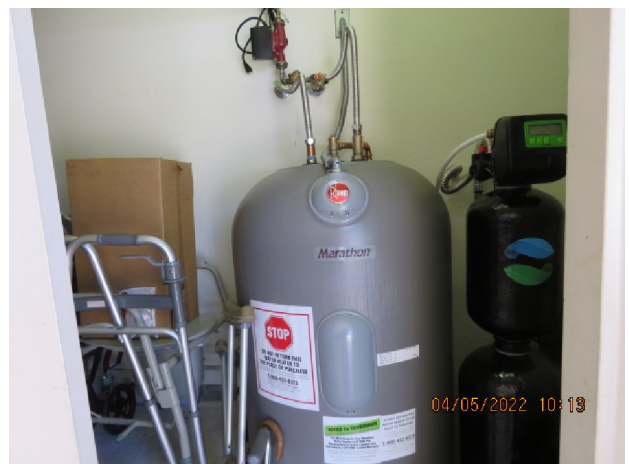
Satisfactory Water Heater 1 Mfg. - Rheem

Water heater built in 2020

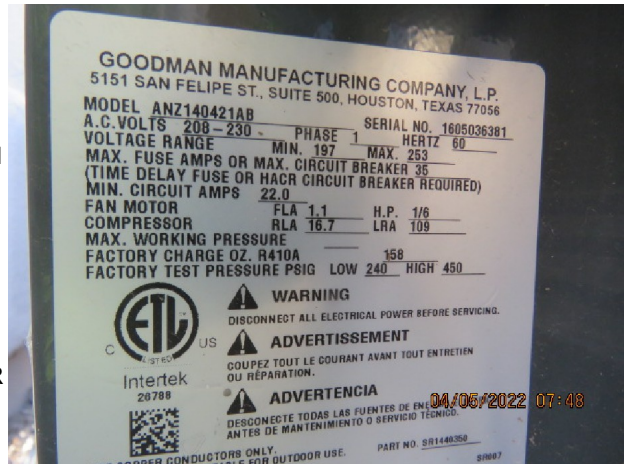
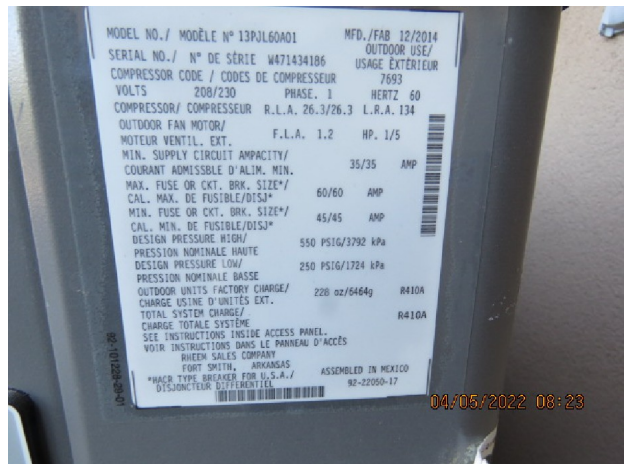
Satisfactory COOLING SYSTEM - Tested

Central cooling system(s) tested using normal operating controls. Dust and other contaminants usually find there way into all heating and cooling duct systems. For all used homes to help protect your health and for better air quality I recommend before moving in or soon thereafter a thorough cleaning of the entire heating and cooling duct system by a qualified professional. For all AC repairs and service I recommend Premier Air Solutions Inc. for AC work. 480-940-2351 The Federal appliance manufacturing standards (10 CFR 430) will require all residential sized central air conditioners and heat pumps, manufactured or imported on or after January 23, 2006 to meet a new higher SEER standard. AC units that do not meet these new standards will need to be replaced with AC units up to 50% larger in size when they break and parts may be hard to find for Lower SEER units. AC units have an average life of 12 to 15 years in the Phoenix area.

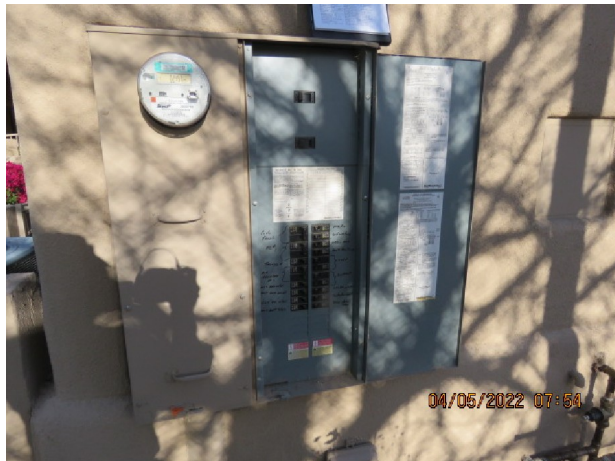
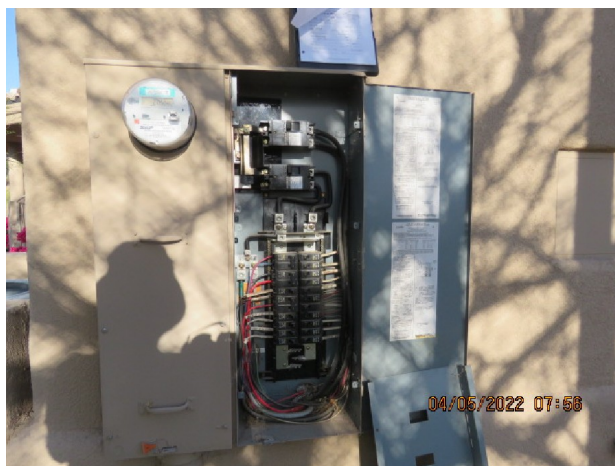
Satisfactory Main Electric Panel - Inspected, Sample Picture

Sample picture of the main electric panel.

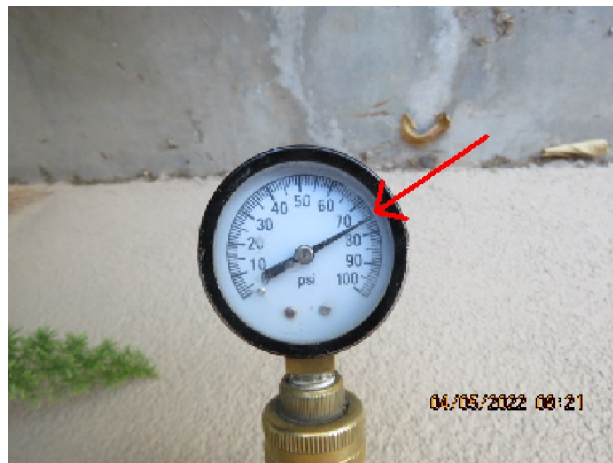
Satisfactory **Water Pressure - 40 to 80 PSI**

Water pressure recorded today was 75 psi.
Recommended water pressure between 40 to 80 PSI.

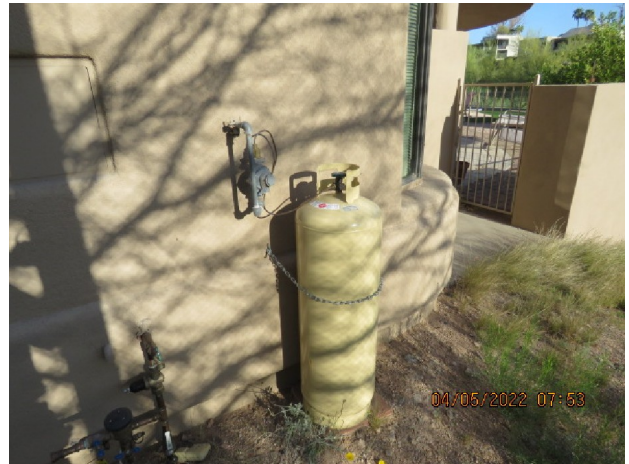
Satisfactory **Fuel Supply Tank Type - Galv. Tank**

Propane tank on the west side of the house is properly strapped.

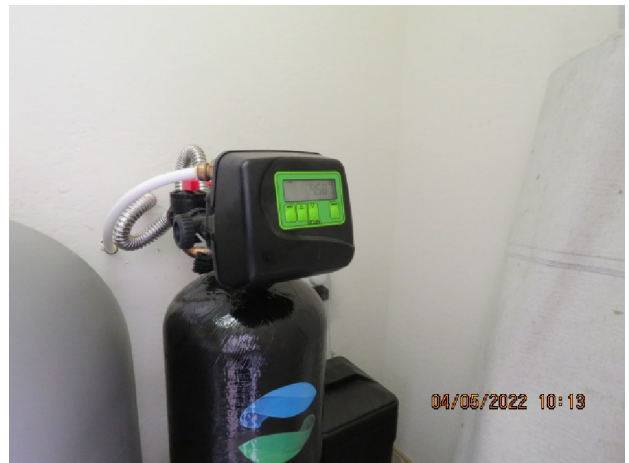
Satisfactory **Water Softener - Installed**

A water softener/purification system has been installed but water softener are not tested by the home inspector. If the function of the water softener is important to you I recommend you have it inspected by a qualified water softener contractor and find out what maintenance is required for proper operation.

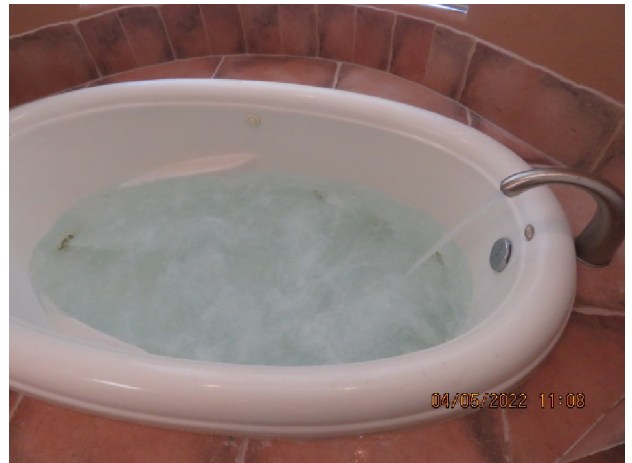
The polarity and the grounding of all accessible bathroom outlets were tested.

Tub overflow drains are not tested during a home inspection because they tend to leak. Recommend not filling a tub to the overflow because this may cause a leak.

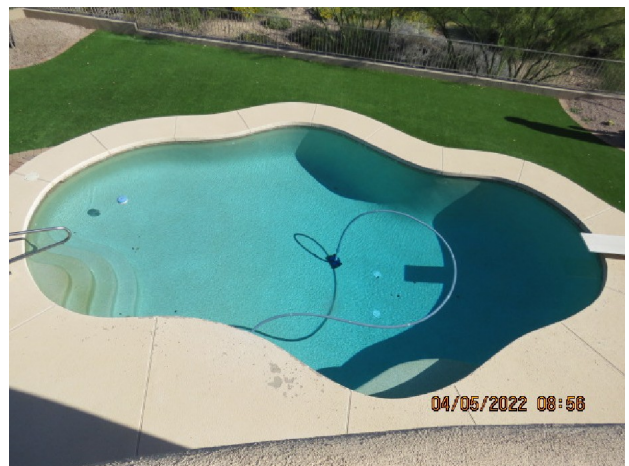
POOL

Satisfactory Type of Pool /Spa - In ground
