Inspection Report

Property Address:
511 Cedar Grove Road
York SC 29745

Carolinas Premier Inspections

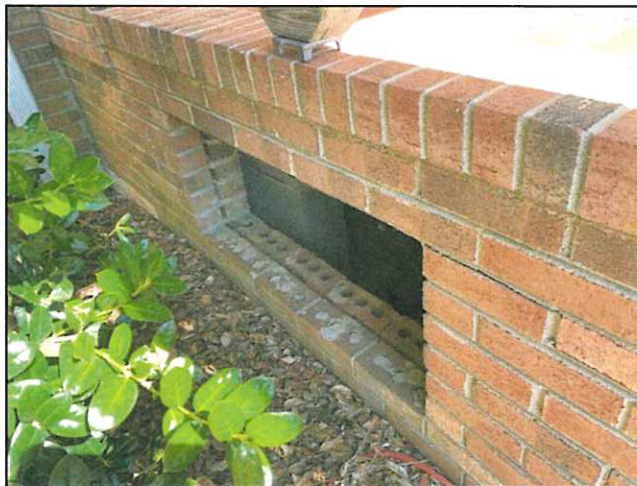
1.7 Crawl Space/Basement Access Findings

The crawl space access door was noted un-installed at the left side of the front porch. Repair/Install as needed for proper function. Contact a qualified professional for repair.

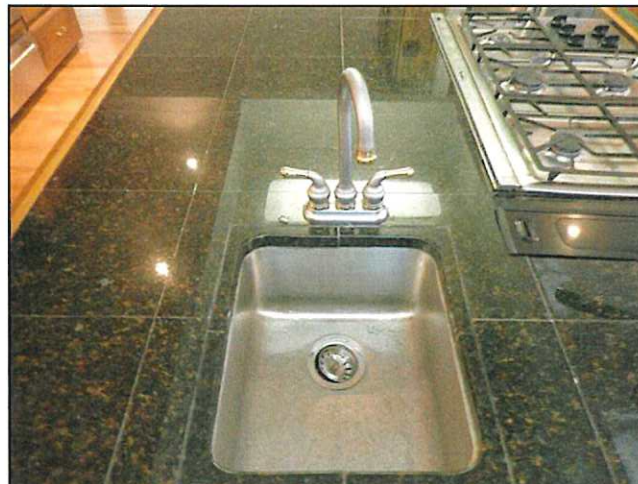
(2) There was low water pressure noted in the following location(s) when multiple fixtures were used. Repairs are needed for proper function. Contact a licensed plumber for repair.

1. kitchen wet bar

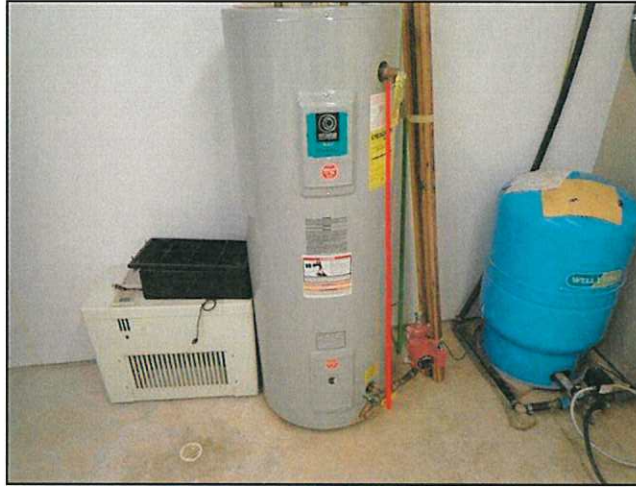
10.4 Water Heater Findings

The temperature pressure relief valve (TPRV) drain line is missing. This is considered a safety hazard and needs correction. The TPRV line should extend to no more than 6" from the floor surface. Contact a licensed plumber for repair.

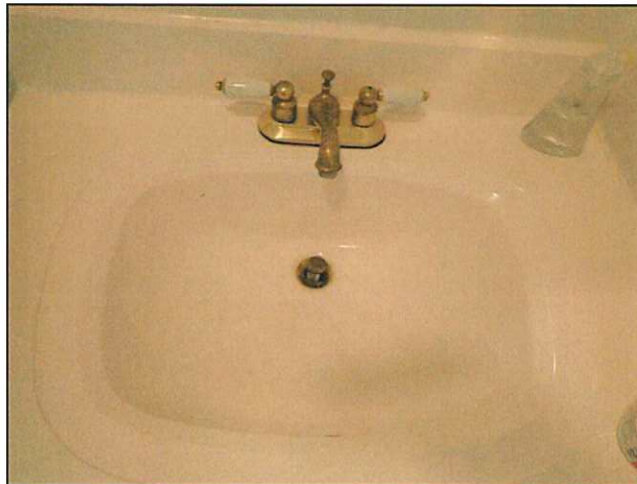
12.0.A Bathroom Sink Findings

The sink stopper did not function properly at the time of inspection. When fully engaged the water still drains. The stopper is not functioning as intended and needs repair or adjustments. Contact a licensed plumber for repair.

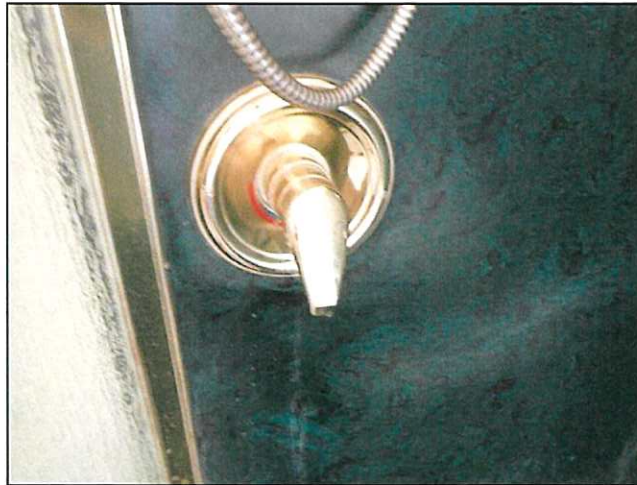
12.3.C Tub/Shower Fixture Findings

The hot and cold water supply lines are reversed at the primary shower. This is a child safety hazard. The hot should be on the left and the cold on the right. Some fixtures can be replaced from the front and other will require removal of drywall at the rear of the fixture. Contact a licensed plumber for repair.

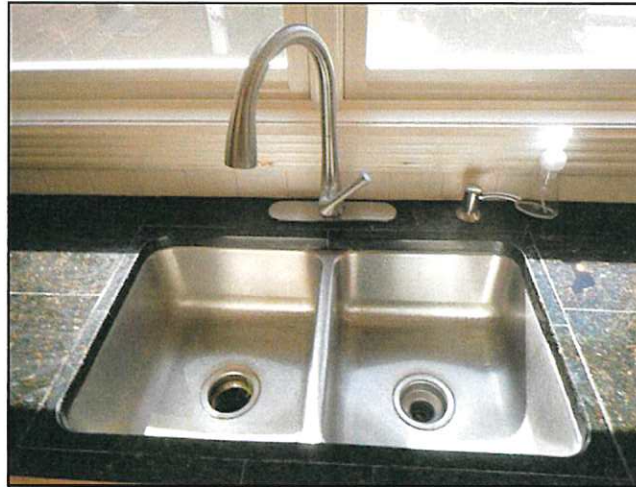
13.0 Sink Findings

The hot and cold are reversed at the kitchen faucet. When pulling the faucet handle towards you the water should be cold. This is needed due to a small child turning on the water. Their initial reaction is to pull the faucet handle forward. Contact a licensed plumber for repair.

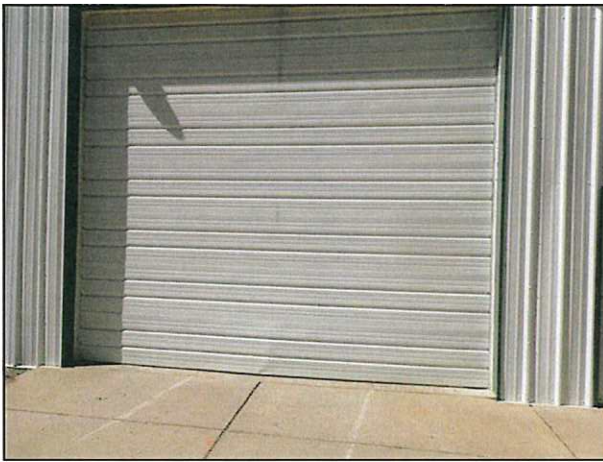
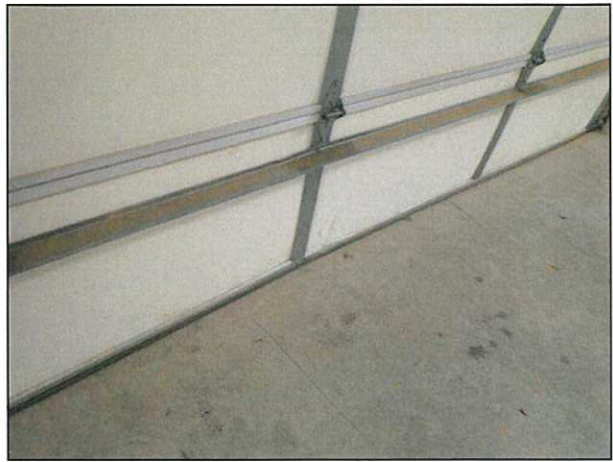
1.3 Garage Findings

(1) Location: the front garage door- The bottom panel of the garage door is dented/damaged and needs repair or replacement. When the top panel of the garage door is damaged the down force sensitivity cannot be tested as it may cause additional damage to the door itself. Contact a qualified garage door company for review and determine the repairs needed.

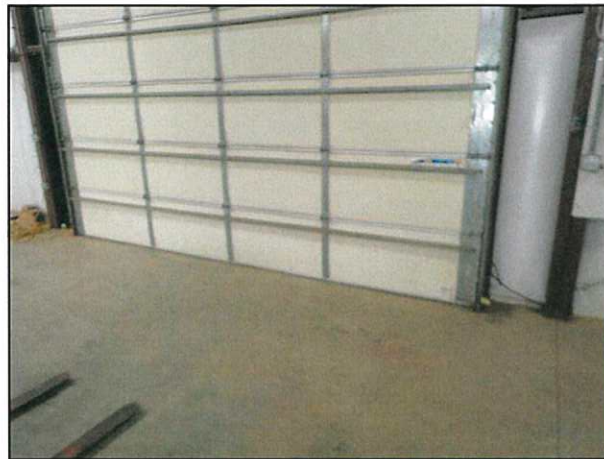
(2) Location: rear garage door- The reverse sensor eyes are not functioning or not installed properly on the garage rails. The eyes need to line up in order for the garage door to close properly. If the eyes are not lined up or functioning properly the garage door will not close unless continually holding down the garage door button. Contact a qualified garage door company for repair.

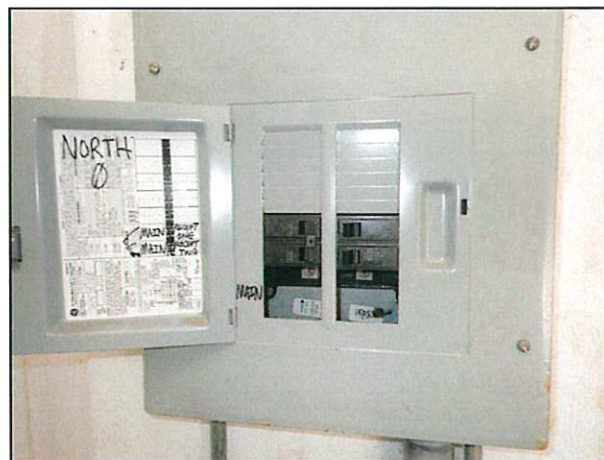
1.4 Electrical Panel(s) Findings

(1) Location: 1st right sub panel- Missing breakers/spacing was noted at the electric panel. This is a safety hazard. Contact a licensed electrician for repair.

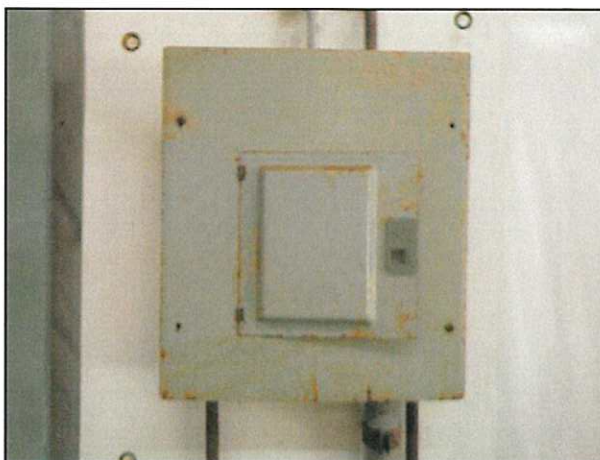
(2) Location: 2nd right panel- There was excessive rusted noted around this panel location. The screws for the cover were rusted which prevented a proper inspection. Contact a licensed electrician for repair.
