Inspection Report

Property Address: 203 W Railroad Ave. Hertford Nc 27910

Home Spec of NC, Inc.

Date: 10/12/2022	Time: 01:00 PM	Report ID: 2210122
Property:	Customer:	Real Estate Professional:
203 W Railroad Ave.	Mr. Jake Forbes	Jake Forbes
Hertford Nc 27910		United Country

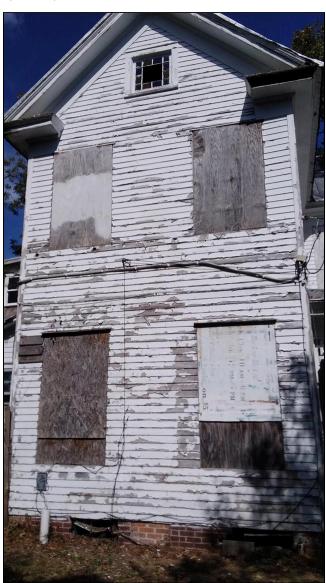
2.6 Other elevations. Item 1(Picture) Item 2(Picture) Item 3(Picture) Item 4(Picture) Item 5(Picture) Item 6(Picture) Item 7(Picture)
