## Summary Only

**Property Address:**  
420 Borderline Rd NW  
Willis VA 24380

**Straight Point Home Inspections LLC**  
**J. Mason Walker 3380001488 NRS exp. 3-31-25**  
**25 S Central Drive**  
**Christiansburg, VA 24073**  
**540-744-6532**

<b>Date:</b> 8/23/2023	<b>Time:</b> 12:00 PM	<b>Report ID:</b> 20230823-420-Borderline-Rd-NW
<b>Property:</b> 420 Borderline Rd NW Willis VA 24380	<b>Customer:</b> Kimberly Quesenberry	<b>Real Estate Professional:</b>

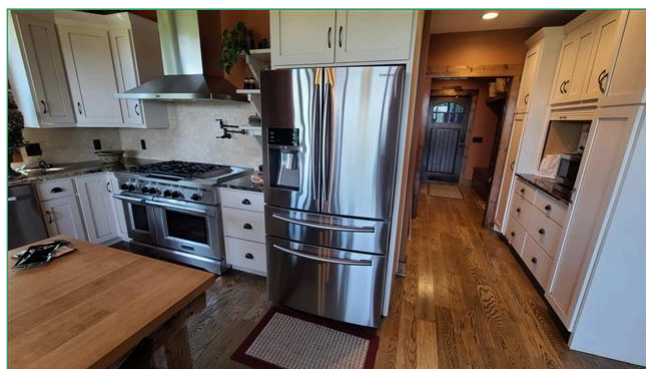
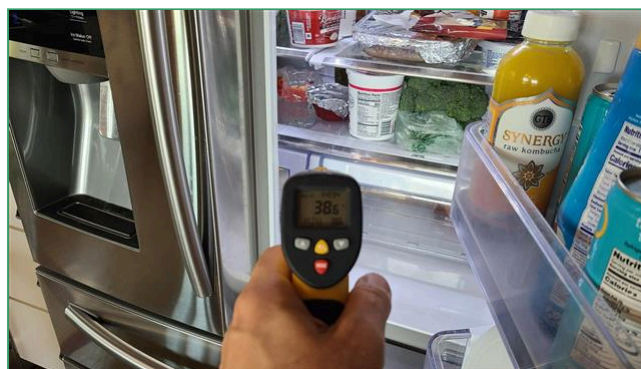
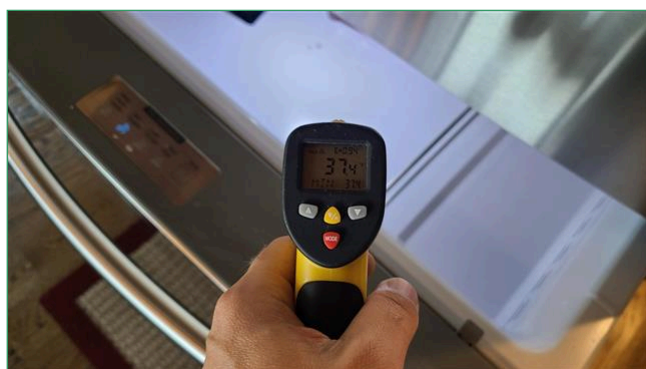
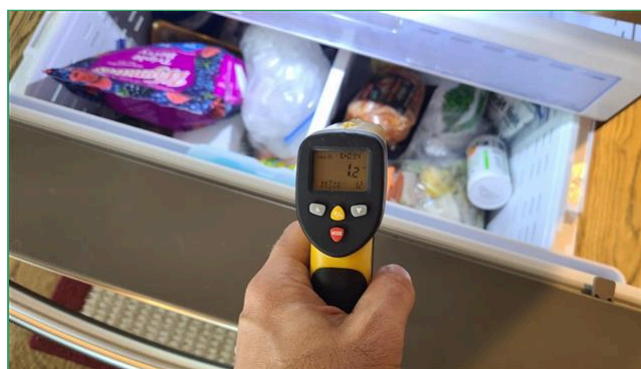
(1) Checked temperatures at time of inspection and found to be cooling adequately.

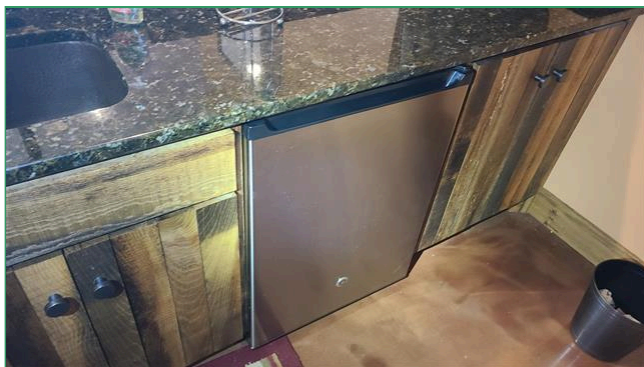
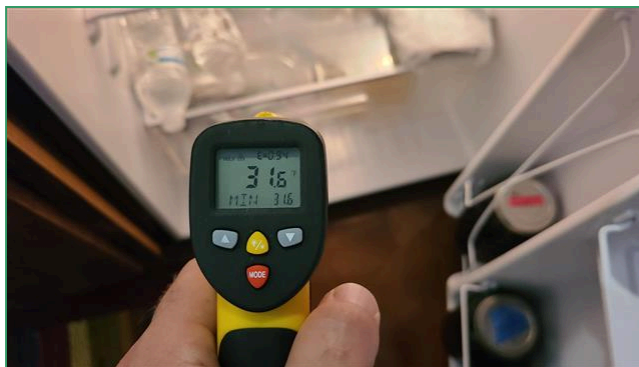
(2) Checked temperatures at time of inspection and found to be cooling adequately.

4.8 Item 5(Picture) basement bar area

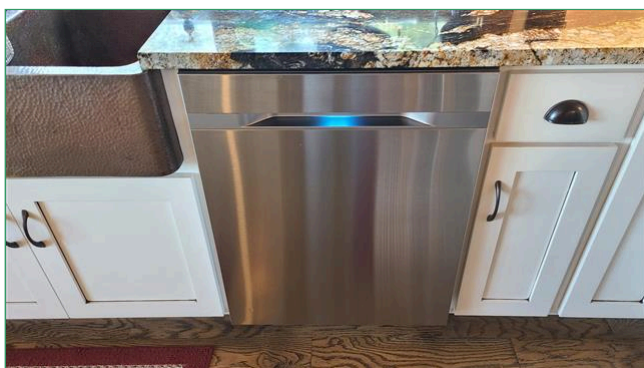
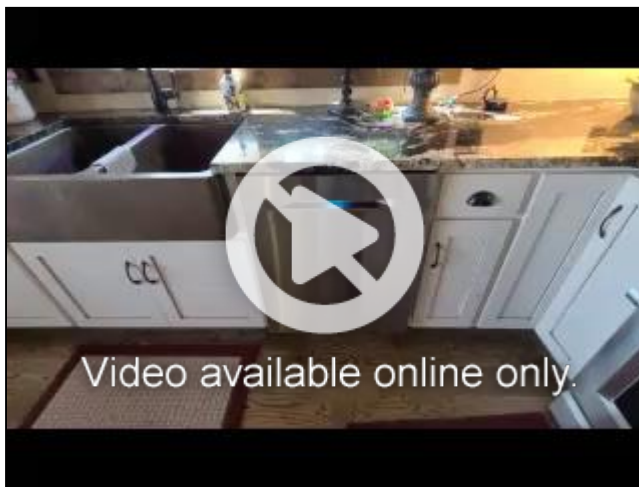
Ran short cycle and no noted water leakage at time of inspection.

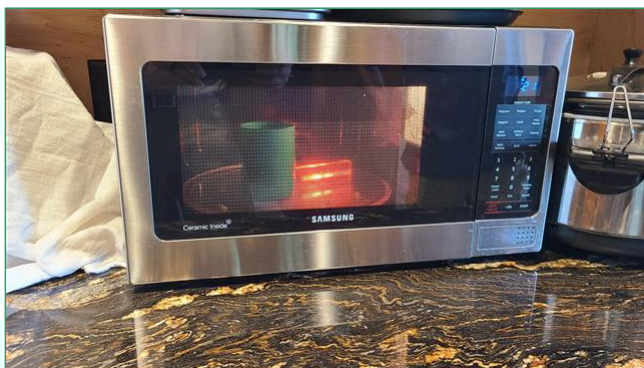
4.12 Item 1(Picture)

Ran microwave with a cool cup of water. Warmed without issues.

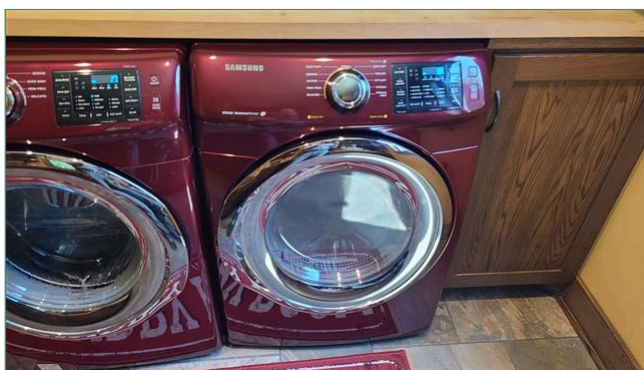
4.15 Item 1(Picture)

Ran a quick cycle and unit heated up during inspection.

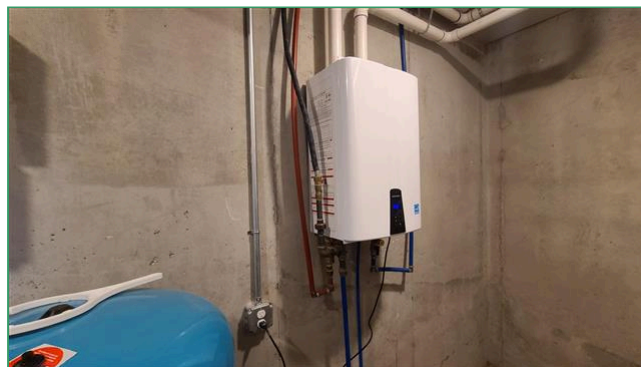
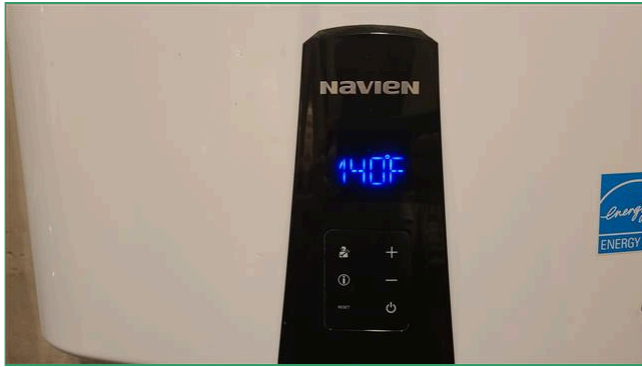
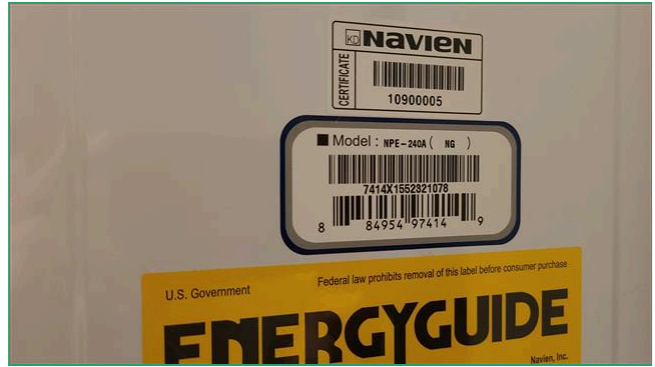
Tankless water heater is a propane gas NAVIEN brand manufactured in 2015. Average life of a tankless water heater is 20 years. Unit heated water to 119 degrees. It is recommended by the EPA that the temperature of your hot water be 120 degrees to kill bacteria but no higher as it can cause burns above 120 degrees in a short period of time.

8.2 Item 1(Picture) Temperature at kitchen sink

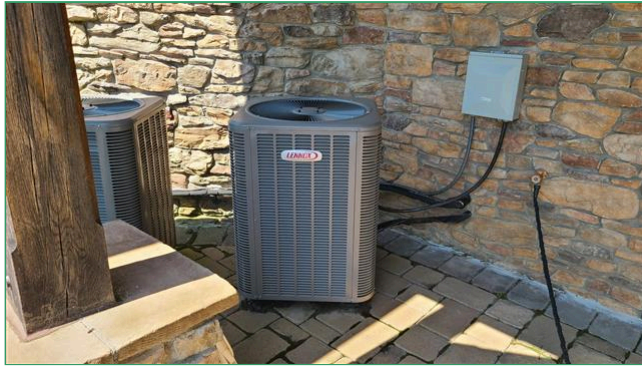
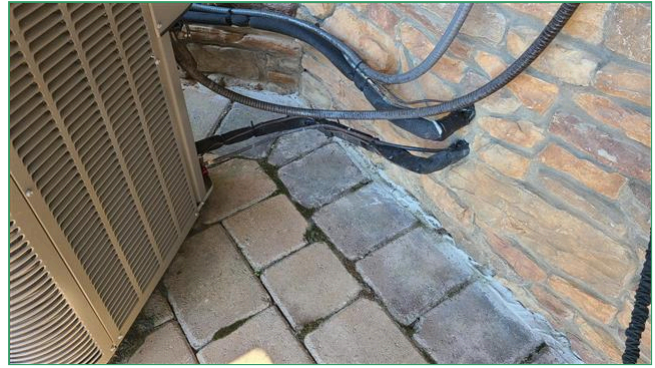
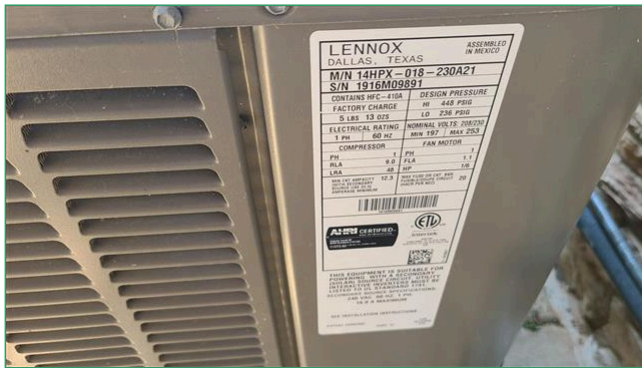
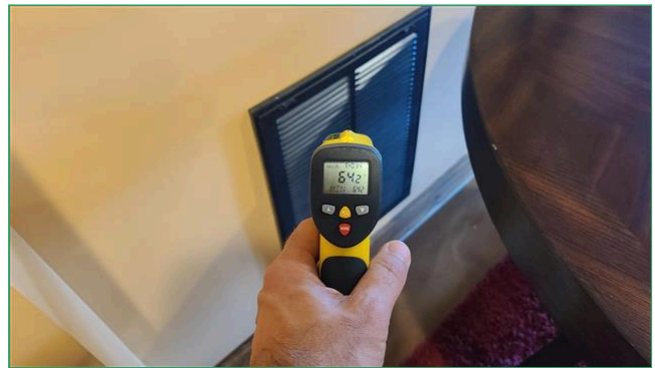
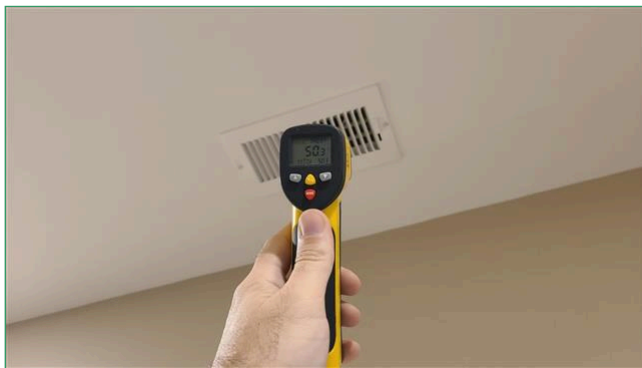
(1) LENNOX heat pump was manufactured in 2016 and supplies air to the basement areas. Average life

span of heat pumps is 14 years. Tested the unit in cooling mode as it was over 60 degrees outside. Delta T (Temperature measured at return air and closest supply to air handler) was within the recommended range of 14-22 degrees.

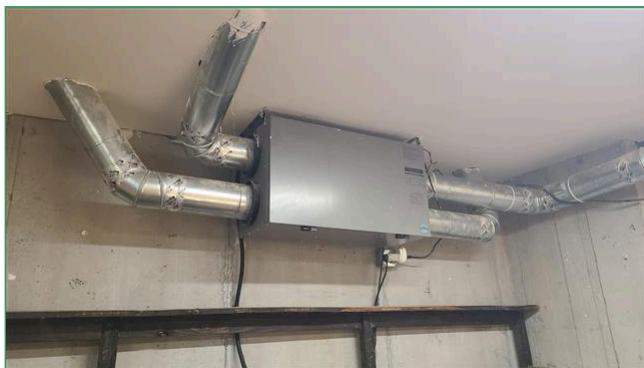
10.7 Item 5(Picture)

(3) Fresh air exchanger is installed in the basement at the right side middle. This unit allows fresh air into the home as the construction has sealed the home so well, that air exchange is necessary to help manage proper moisture and air conditions in the home.

Current air handler has been installed with a smart power plug that can be operated via wireless connection.

Recommend asking current homeowner for more information regarding smart home systems and operation controls.
