# Inspection Report

**Property Address:**  
420 Borderline Rd NW  
Willis VA 24380

**Straight Point Home Inspections LLC**

| <b>Date:</b> 8/23/2023 | <b>Time:</b> 12:00 PM | <b>Report ID:</b><br>20230823-420-Borderline-Rd-NW |

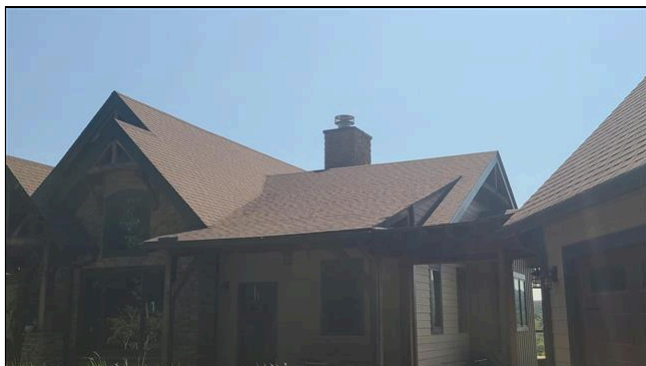
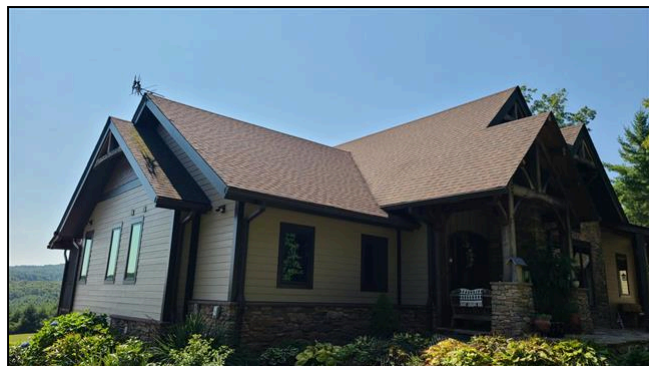
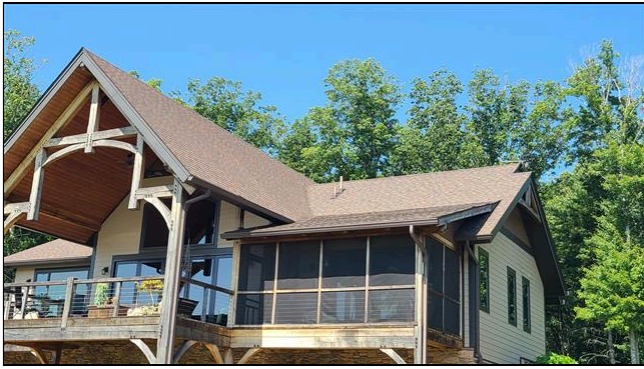
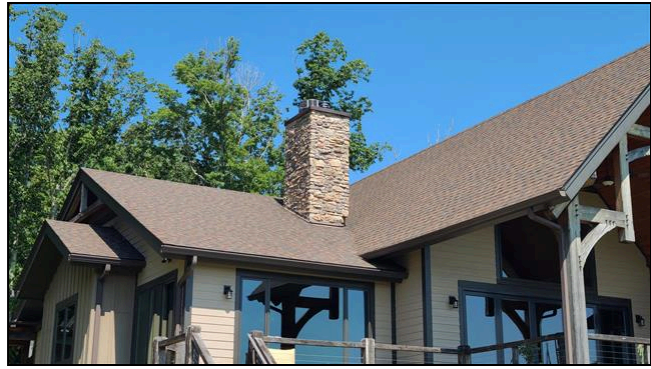
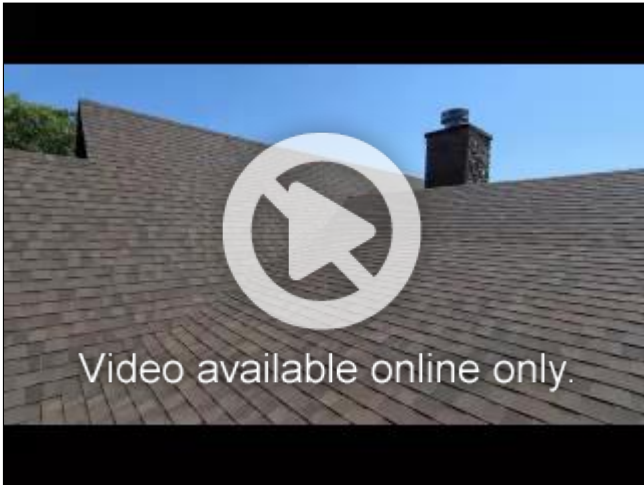
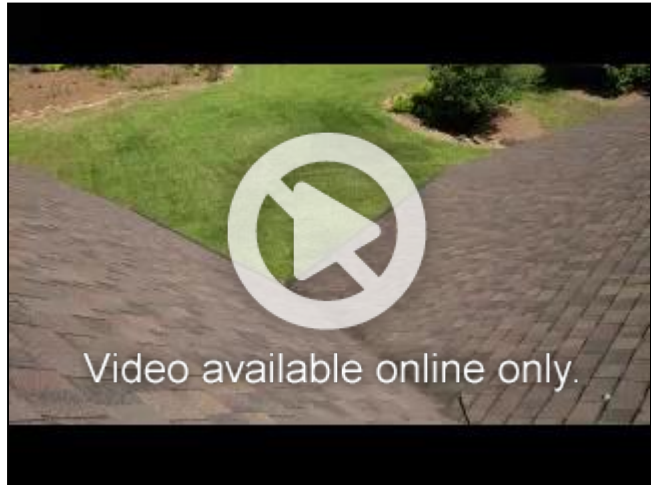
(2) Nail pop(s) appear to be present on the roof covering. There are many possible causes for nails to uplift on roofs.

Recommend further evaluation and repairs as necessary by a competent handy person or a licensed general contractor.

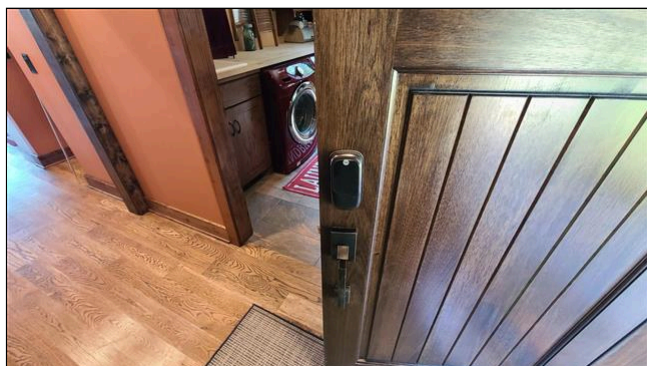
2.1 Item 4(Picture) front right side entrance

(2) Exterior door(s) has/have an electronic dead bolt lock(s). This should be updated as soon as ownership has transferred. Just a courtesy reminder that a lot of people have had access to the home recently.

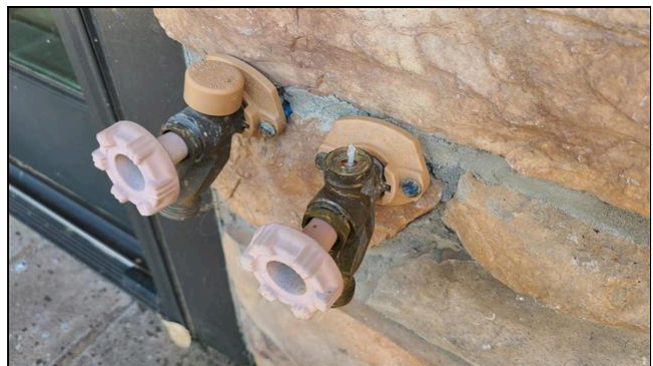
2.6 Item 8(Picture)

(2) Hose bib vacuum breaker cap is missing. Recommend further evaluation and repairs as necessary by a competent handy person or a licensed general contractor.

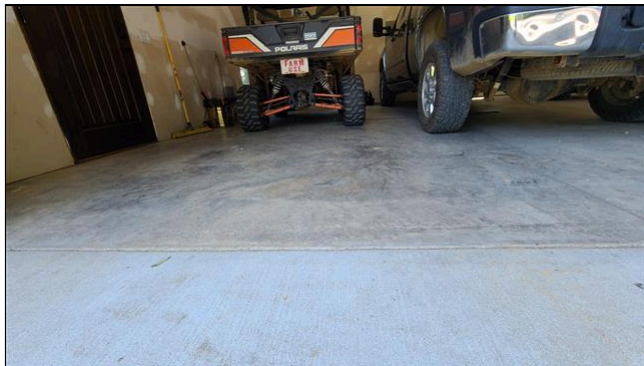
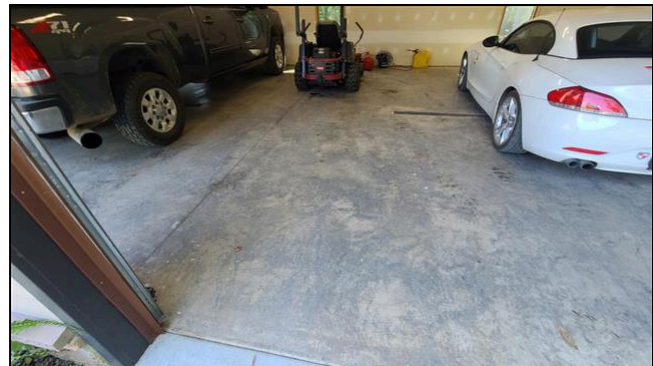
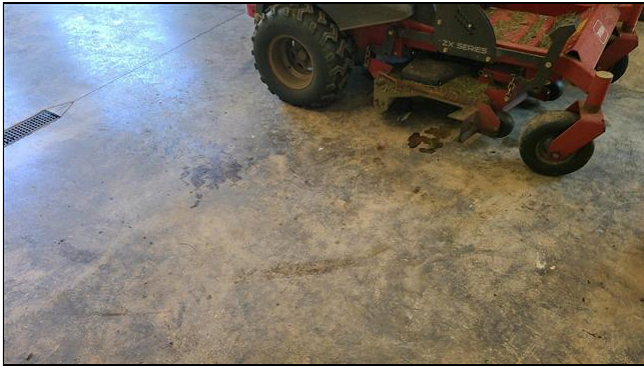
Concrete flooring. Standard condition with minor stains. Recommend maintenance through sealing to prolong life.

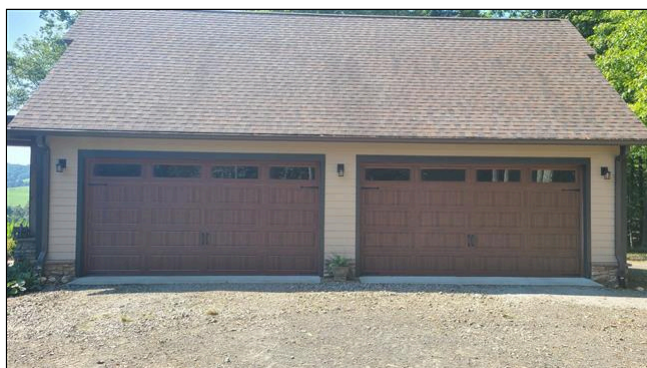
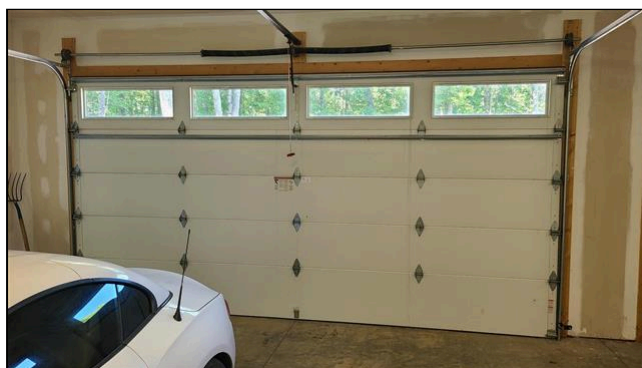
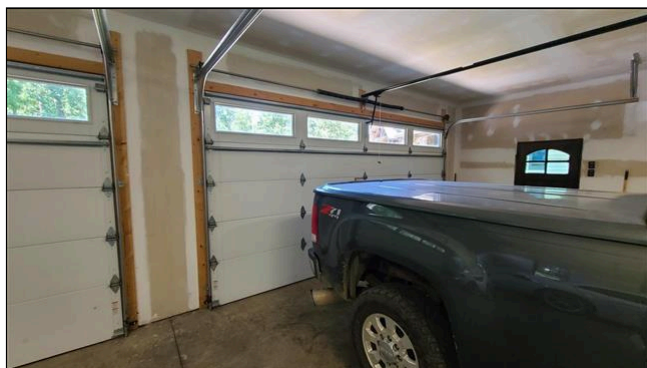
Metal insulated garage door(s).

In standard condition at time of inspection.

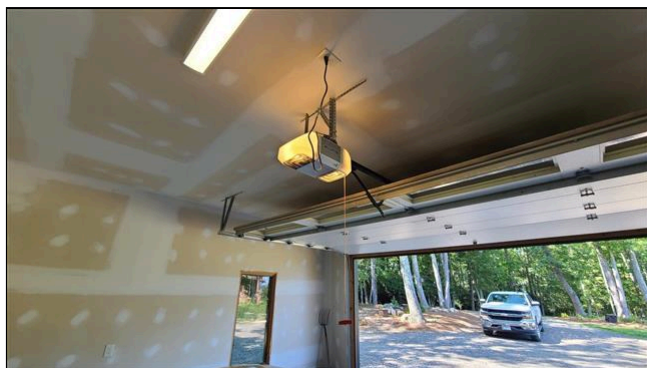
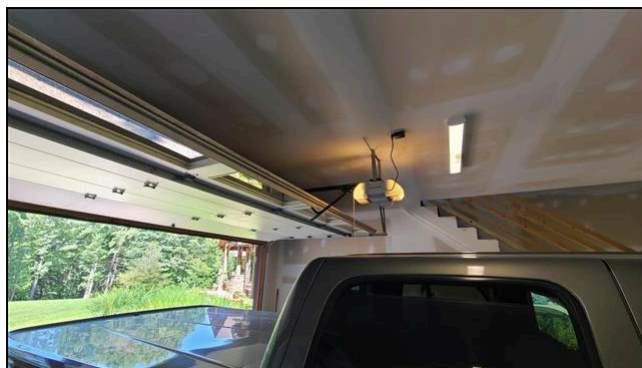
The safety sensors are in place for garage door(s) and will reverse the door.

Both Garage Doors will reverse when met with resistance.

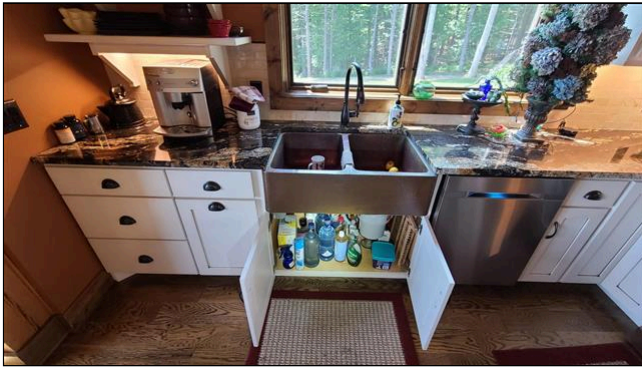
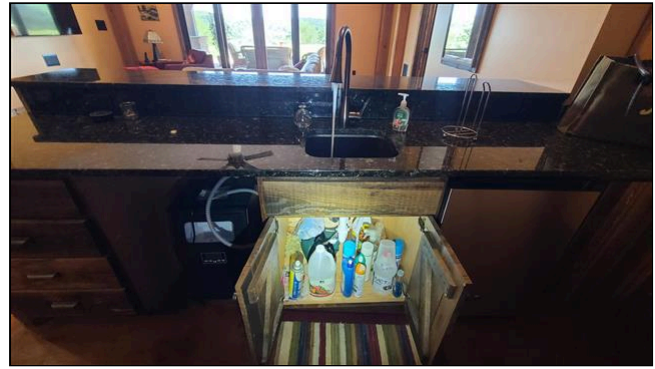
All components working at time of inspection. No leaks noted.

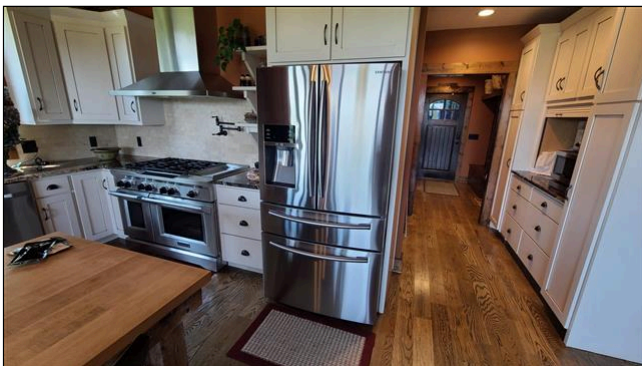
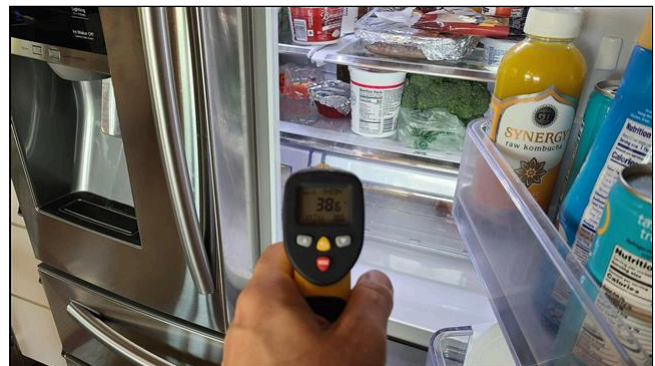
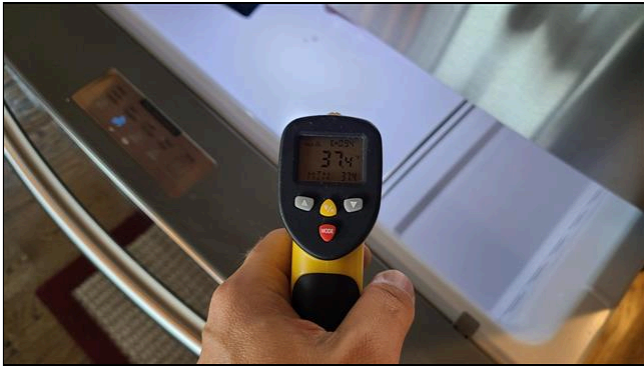
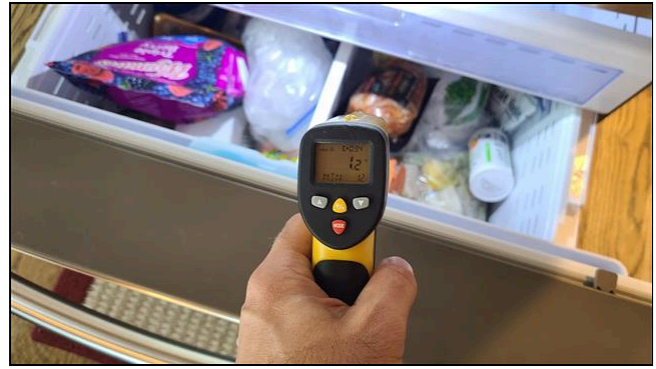
(1) Checked temperatures at time of inspection and found to be cooling adequately.

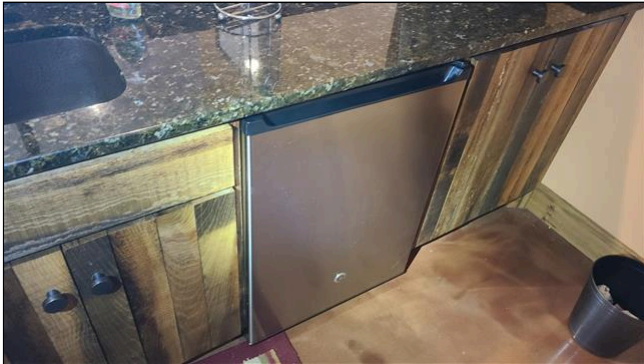
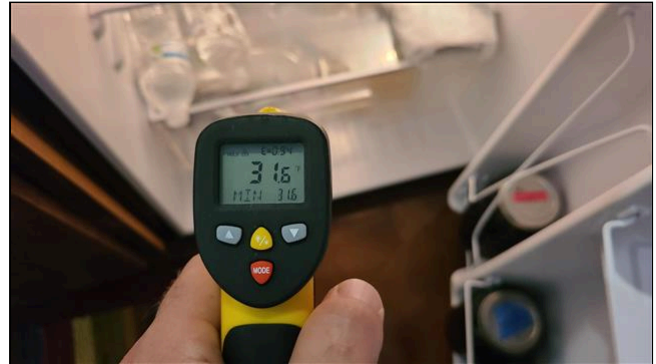
(2) Checked temperatures at time of inspection and found to be cooling adequately.

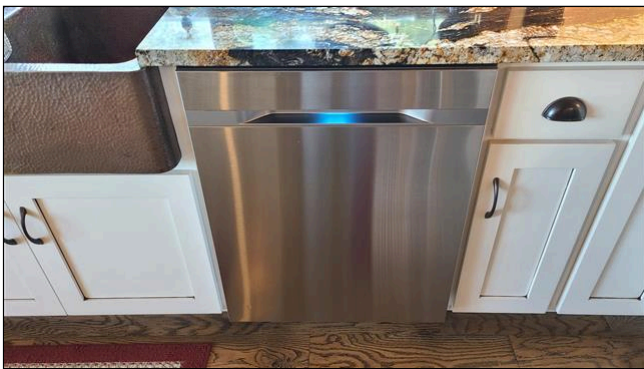
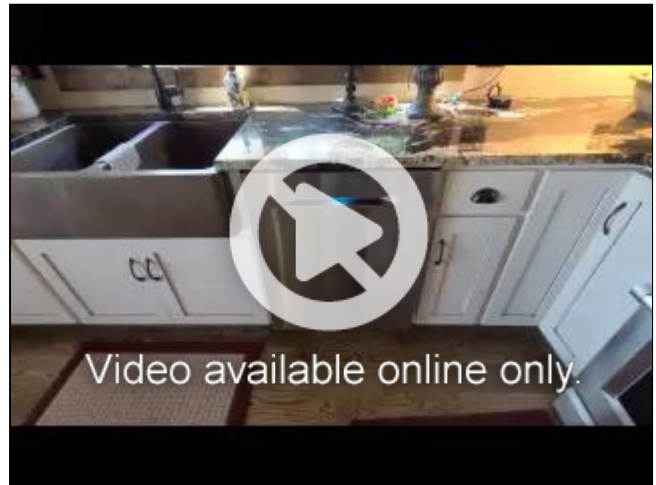
Ran short cycle and no noted water leakage at time of inspection.

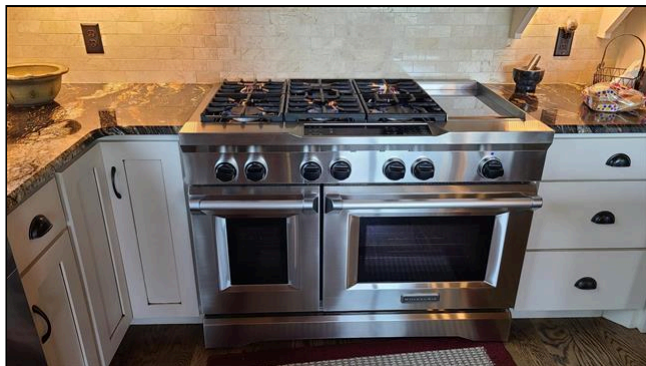
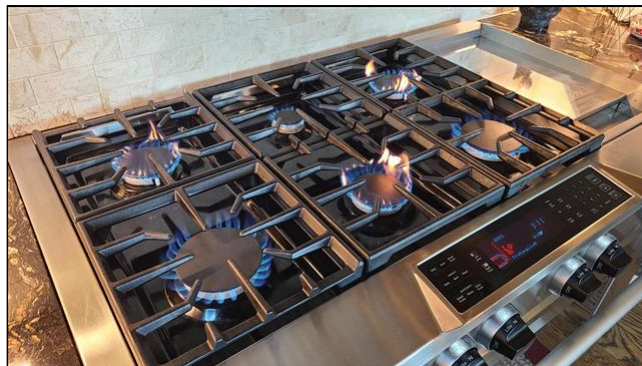
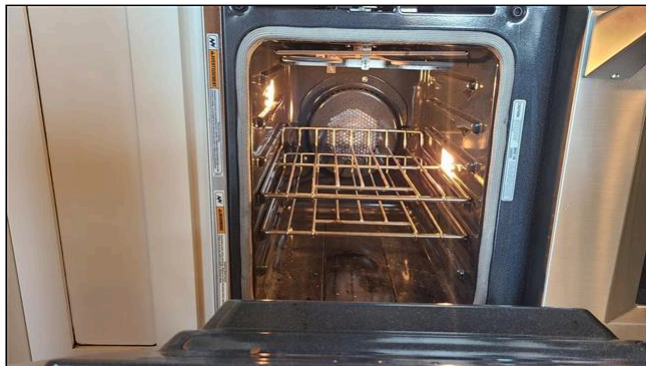
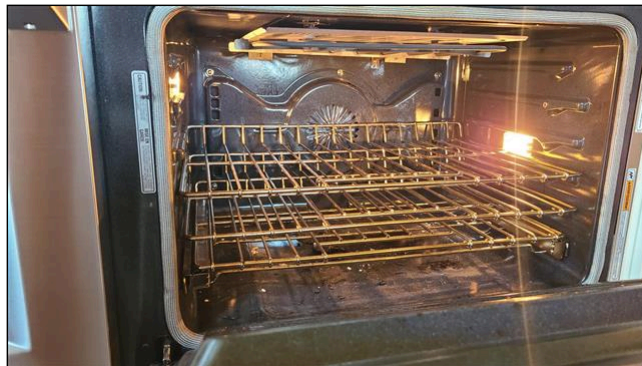
Tested elements/burners and oven in bake mode and all were in working order at time of inspection.

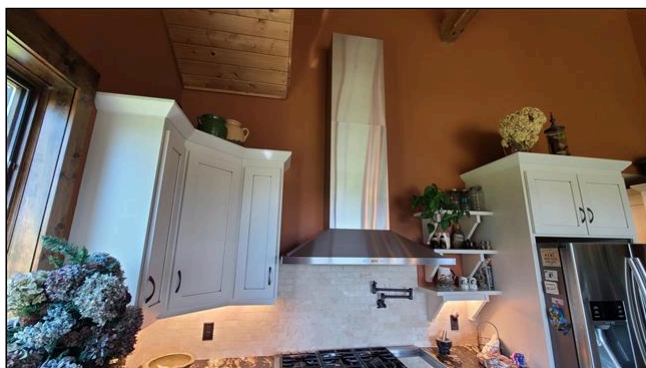
4.11 Item 1(Picture)

Range hood was working properly at time of inspection. Exhausts air to the exterior.

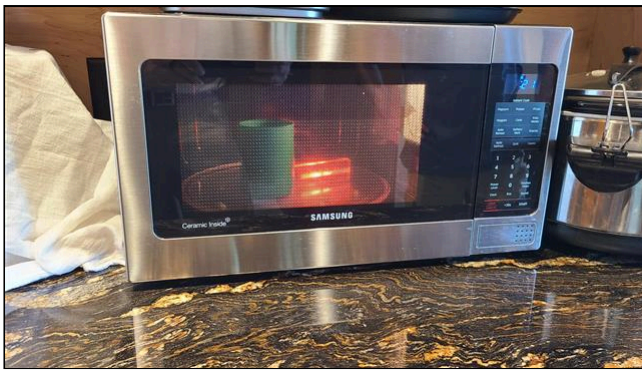
4.12 Item 1(Picture)

Ran microwave with a cool cup of water. Warmed without issues.

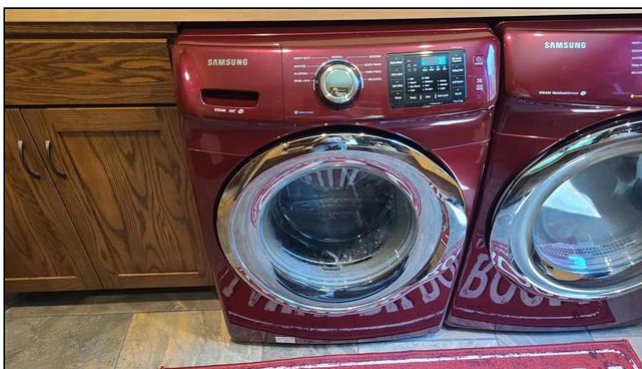
Ran a quick rinse and drain cycle on washer. Filled and drained properly at time of inspection.

4.14 Item 1(Picture) unable to view supply lines and drain due to countertop configuration

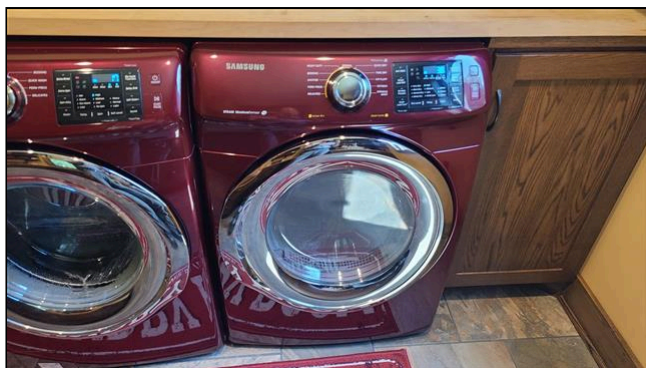
4.15 Item 1(Picture)

Ran a quick cycle and unit heated up during inspection.

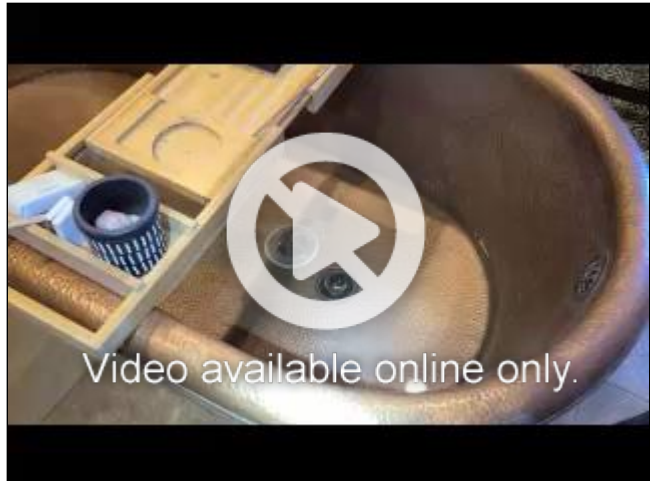
6.10 Item 2(Video)

Slow drain during the inspection. Likely due to build up of debris in the drain at the time of inspection as the plumbing system appeared to be in standard condition at the time of inspection. Recommend drain cleaner be applied and tested before final walk through to confirm cleared condition by a competent handy person.

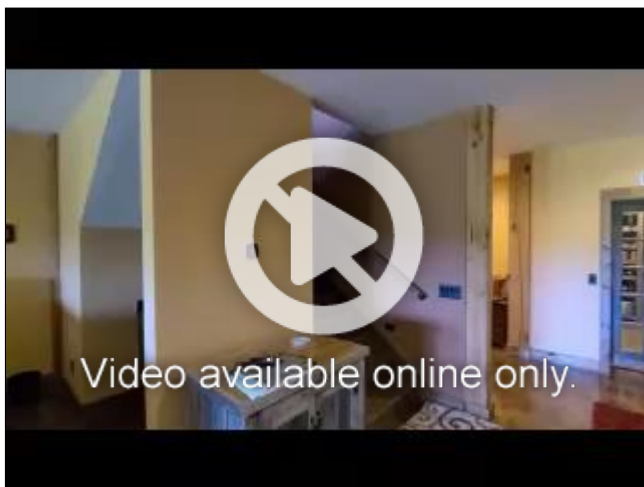
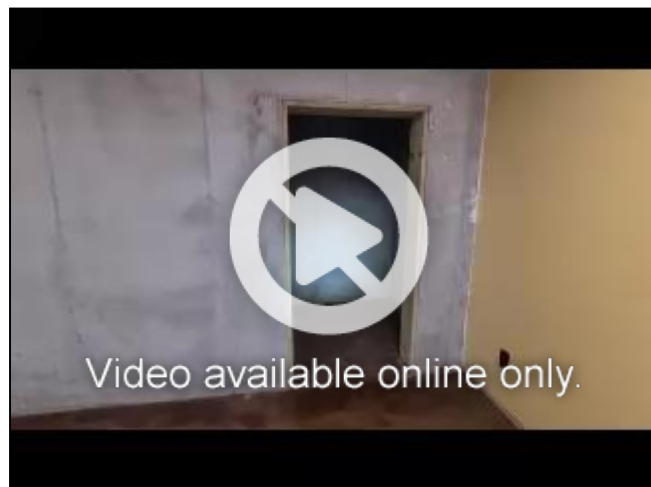
Restrictive views of some areas in basement due to finished areas for foundations. Did not detect any settlement cracks located in home at upper levels at time of inspection.

Appears to be in standard condition for visible areas.

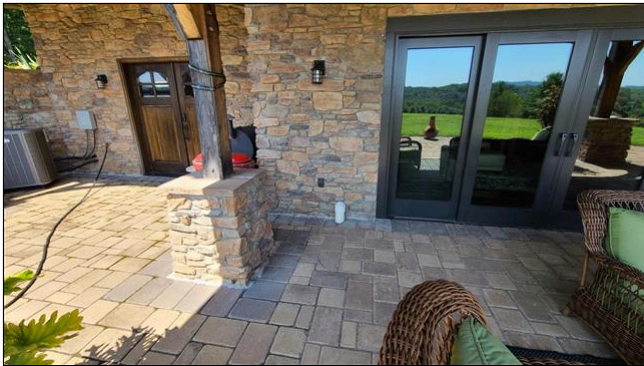
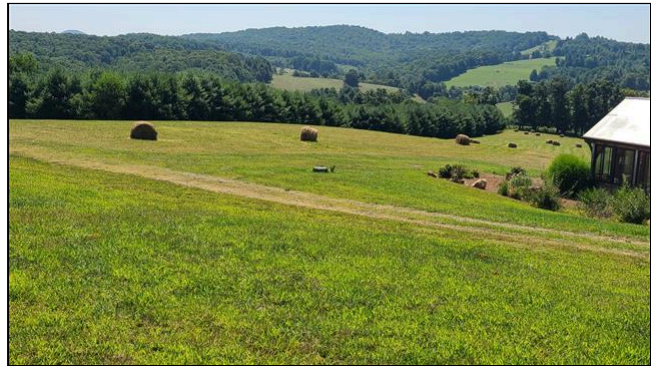
This inspection did not access the tank or determine its location. For a more detailed inspection, I recommend you contact a septic pumping company and have them clean it. At that time the tank could be inspected for proper functioning perhaps by the septic cleaning company.

8.0 Item 1(Picture) clean out for drain located at rear middle right side of home

8.0 Item 2(Picture) rear right corner of the property

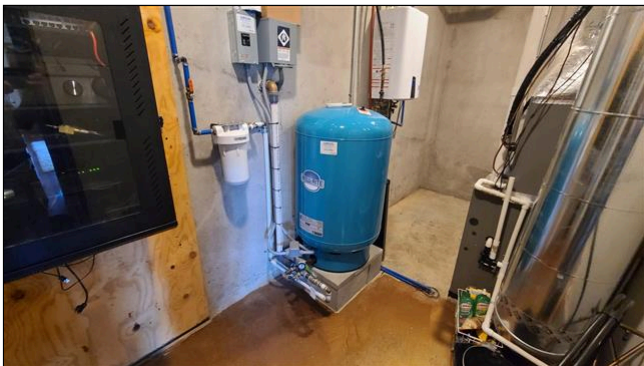
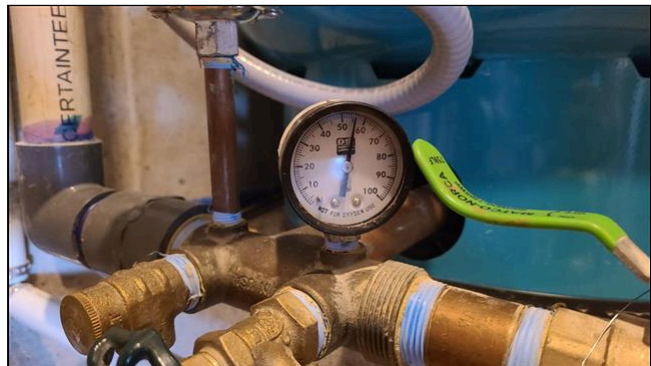
(1) The water pressure tank system was inspected for obvious leaks and that it was plugged in and turned on and that the water valves were in the proper position.

Ideal pressure for well water is between 40-60 PSI.

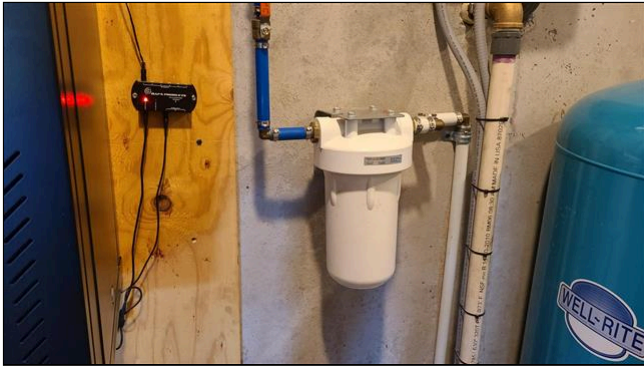
8.1 Item 3(Picture)

(2) The water filtration system was inspected for obvious leaks and that the water valves were in the proper position. No inspection was made to determine the operation of the unit nor it's effectiveness.

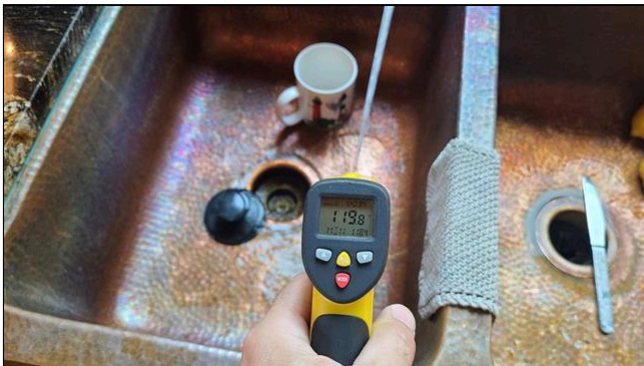
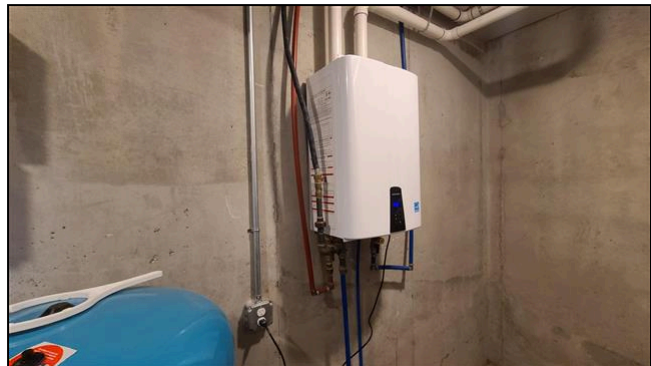
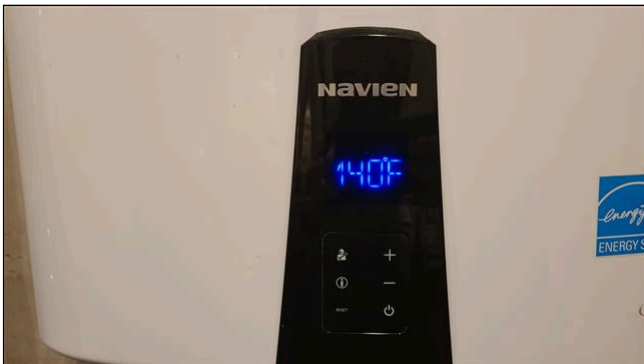
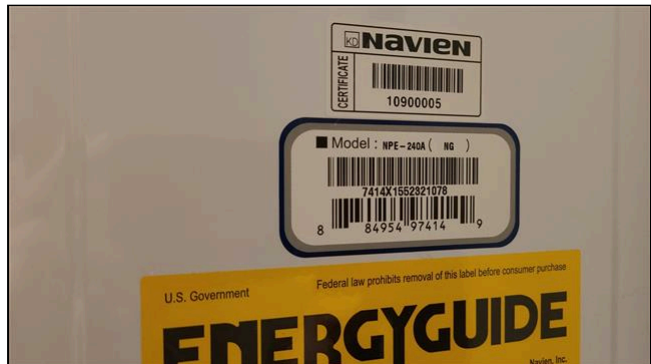
Tankless water heater is a propane gas NAVIEN brand manufactured in 2015. Average life of a tankless water heater is 20 years. Unit heated water to 119 degrees. It is recommended by the EPA that the temperature of your hot water be 120 degrees to kill bacteria but no higher as it can cause burns above 120 degrees in a short period of time.

8.2 Item 1(Picture) Temperature at kitchen sink

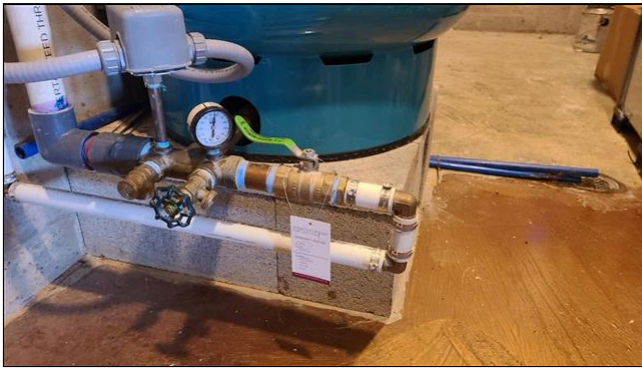
8.3 Item 1(Picture)

Interior water main shut off located at pressure tank system in basement middle left utility room with green turn lever.

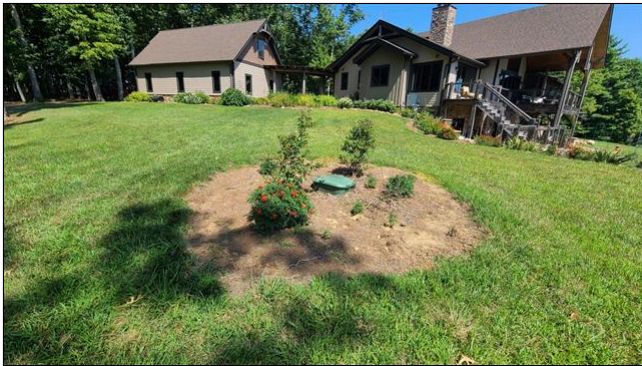
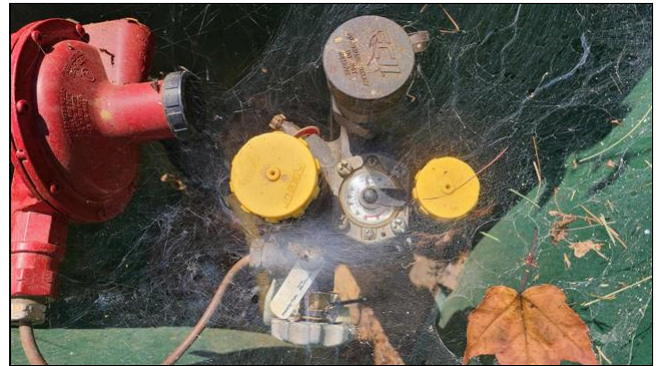
Propane tank located in ground at right side of home.

Tank supply at approximately 80% full with valve in open position at time of inspection.

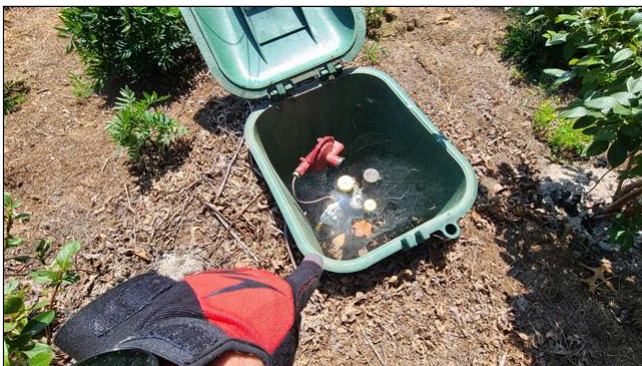
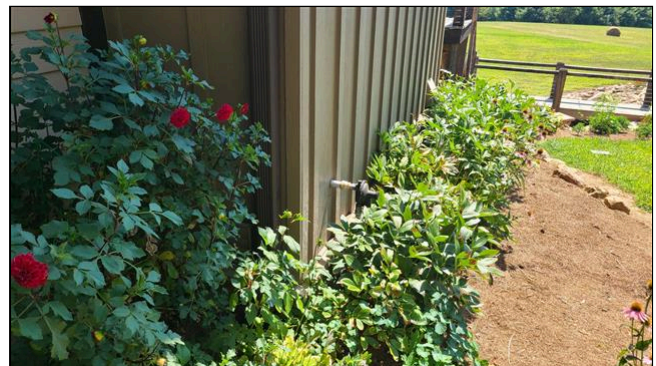
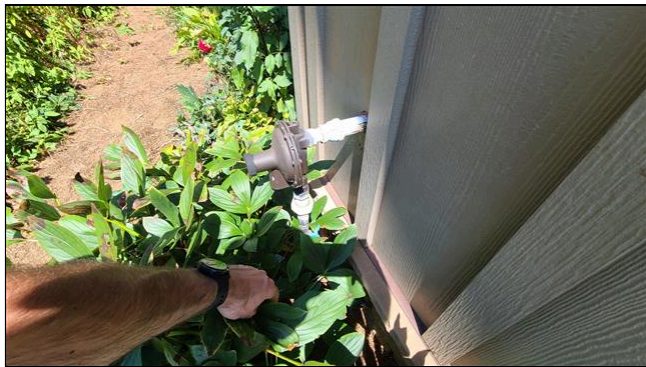
Grey turn knob at top of propane tank for main shut off.

Additional shut off to home located at right side middle with blue turn knob.

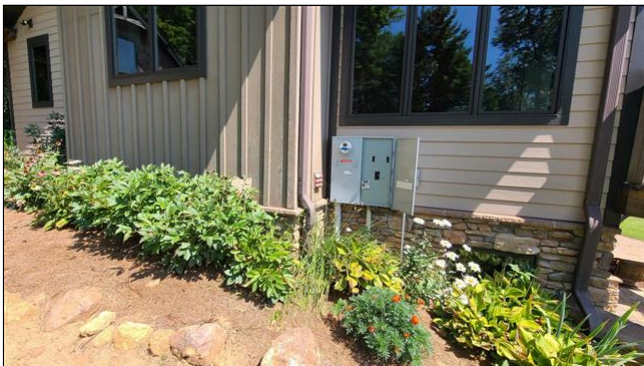
9.0 Item 1(Picture)

Service to the home is a lateral entrance from the ground. Located at the Right rear corner.

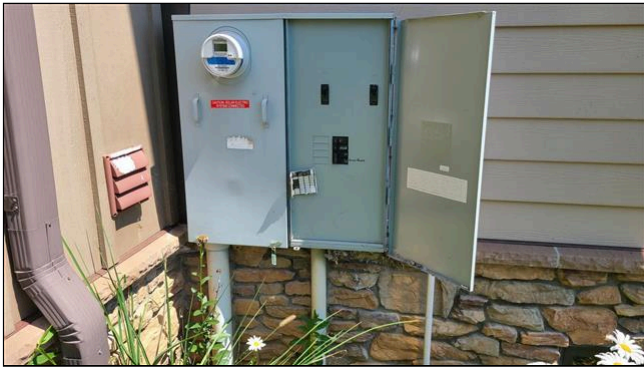
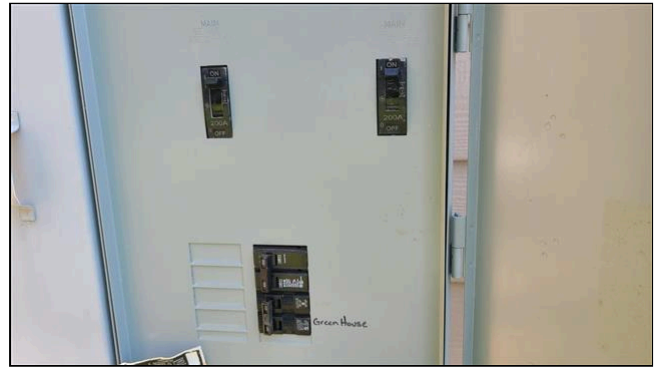
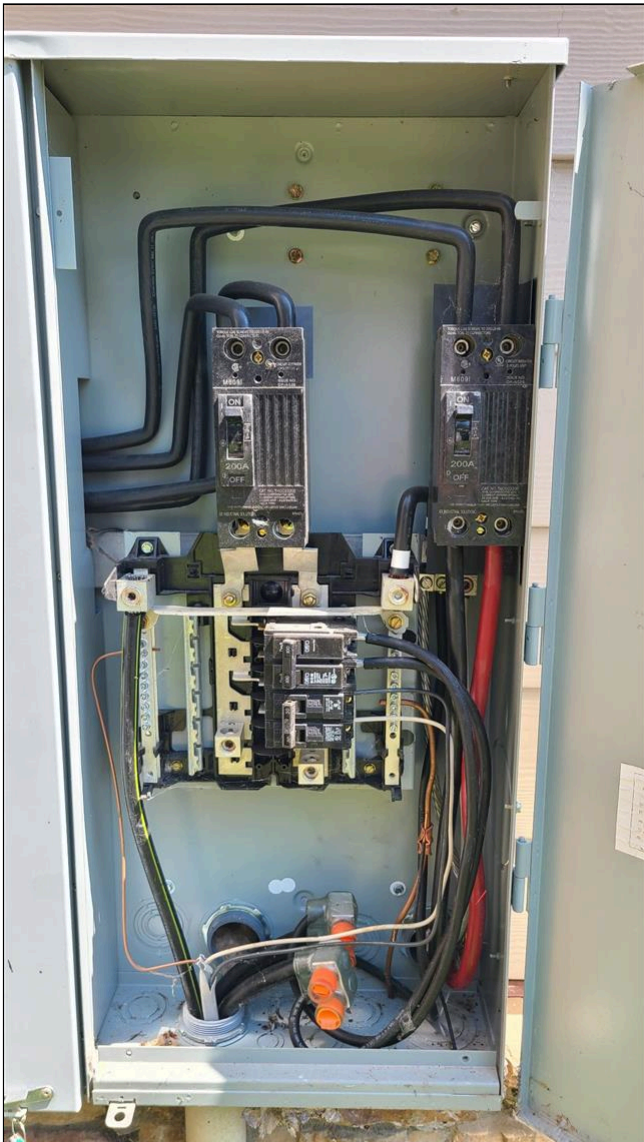
(1) Main disconnects located at right rear corner of home by meter. Two 200 amp services for home.

In standard condition at time of inspection.

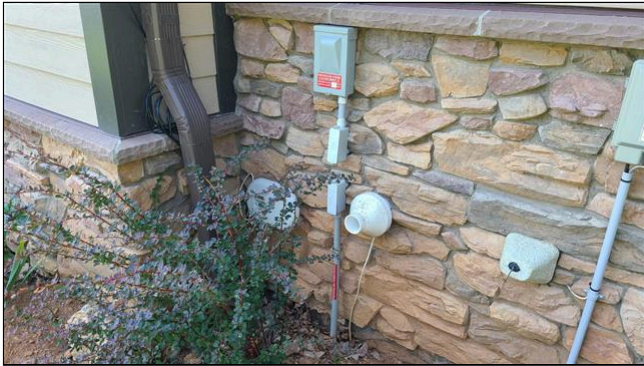
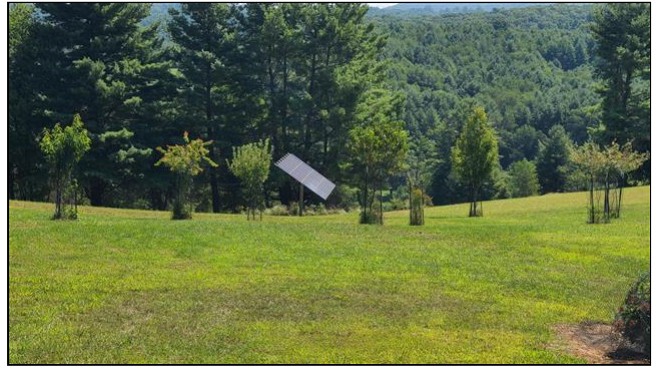
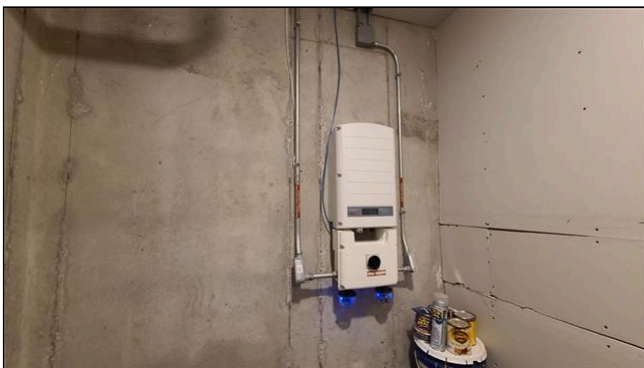
(2) Solar panel system in place to help supply energy for the home. This energy system is outside of the scope of my inspection.

9.1 Item 6(Picture) Solar edge brand unit

I recommend further evaluation and routine service by a professional solar energy system installer.

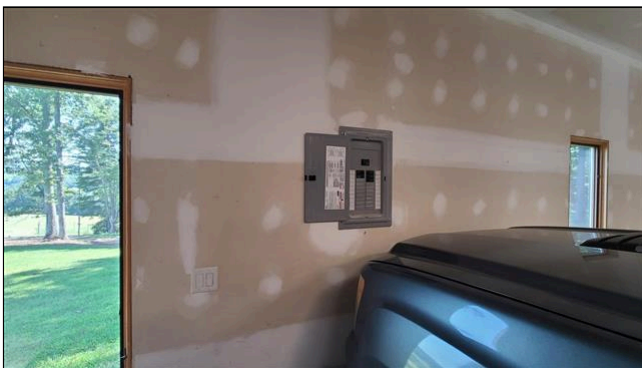
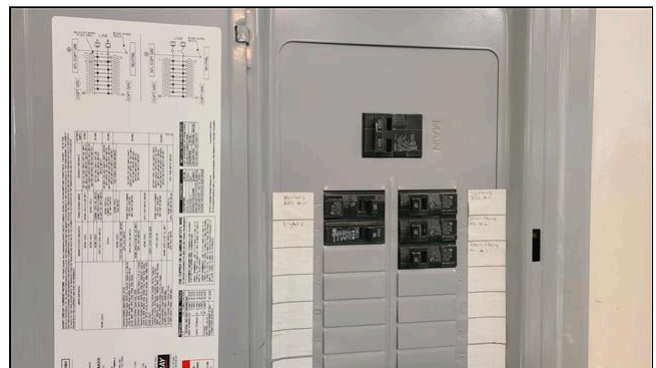
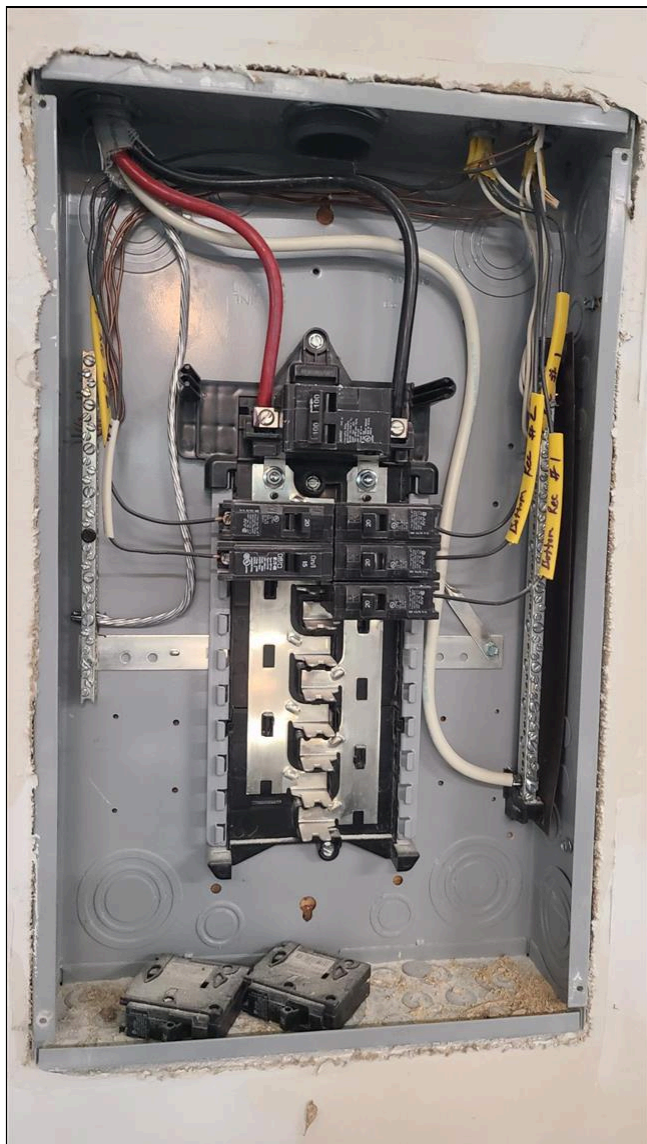
(4) Subpanel disconnect located in garage at rear wall. Murray brand panel with 100 amp service.

In standard condition at time of inspection.

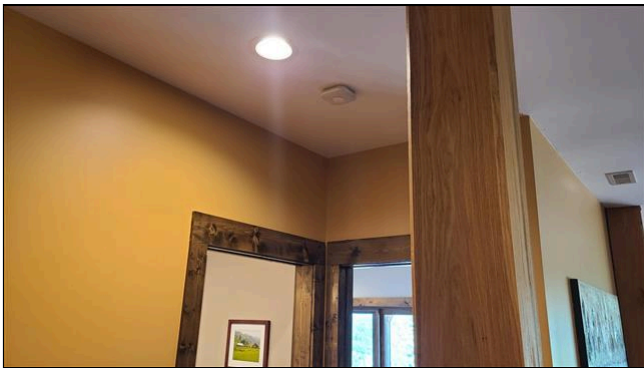
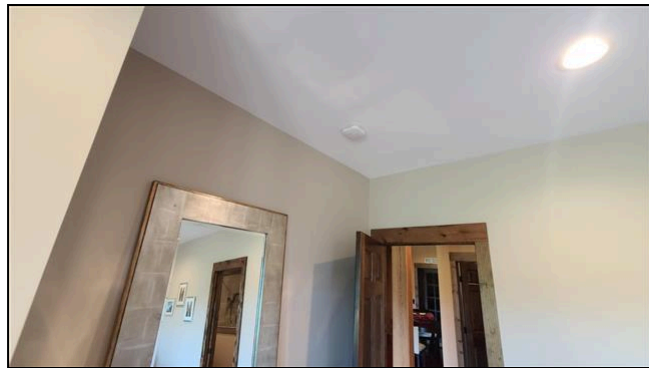
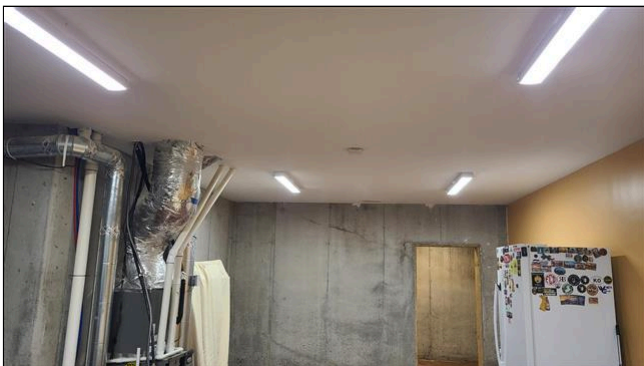
9.6 Item 2(Picture) Nest Sensors present throughout the home at each level and in each bedroom at time of inspection

Recommend verifying operations by the current homeowner for full array of services provided by these sensors.

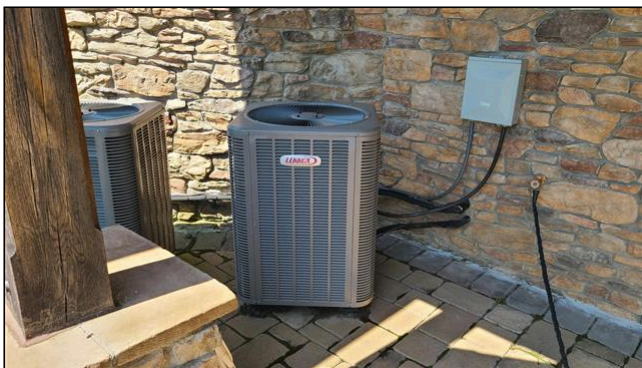
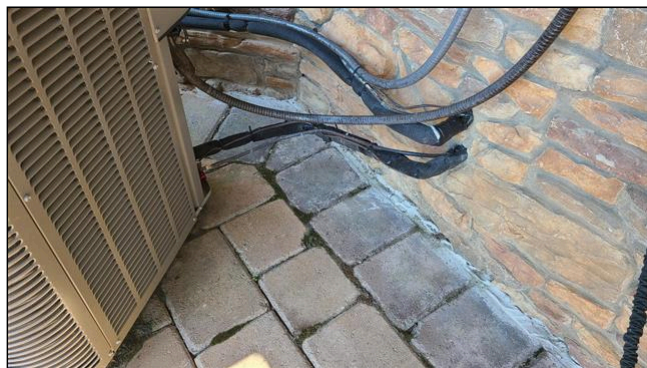
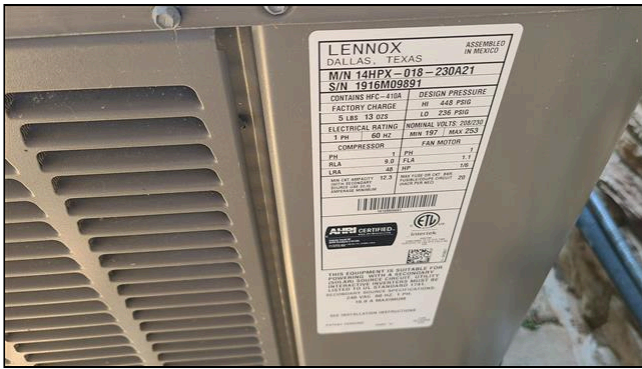
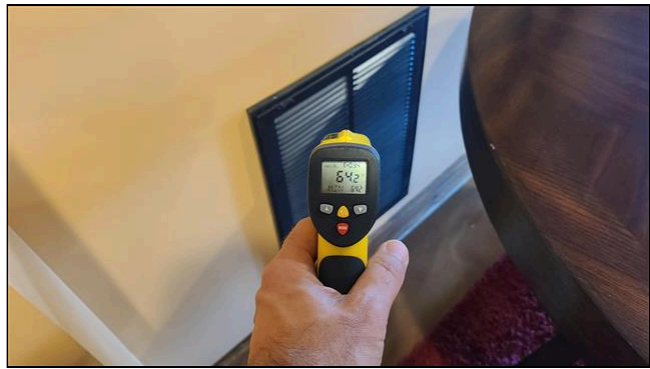
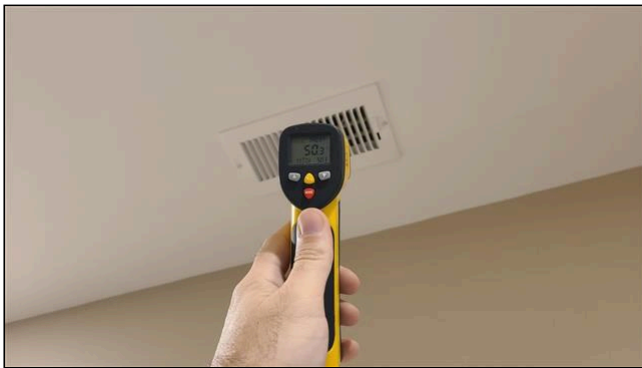
(1) LENNOX heat pump was manufactured in 2016 and supplies air to the basement areas. Average life span of heat pumps is 14 years. Tested the unit in cooling mode as it was over 60 degrees outside. Delta T (Temperature measured at return air and closest supply to air handler) was within the recommended range of 14-22 degrees.

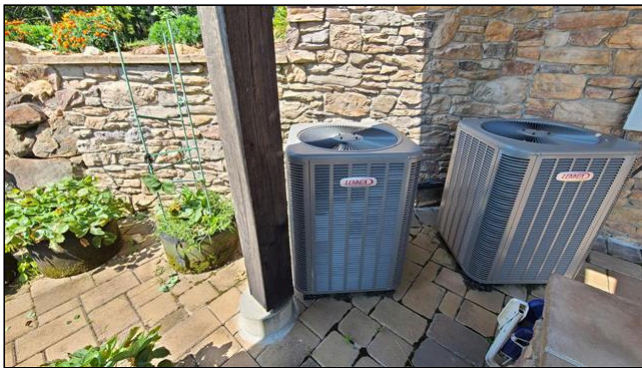
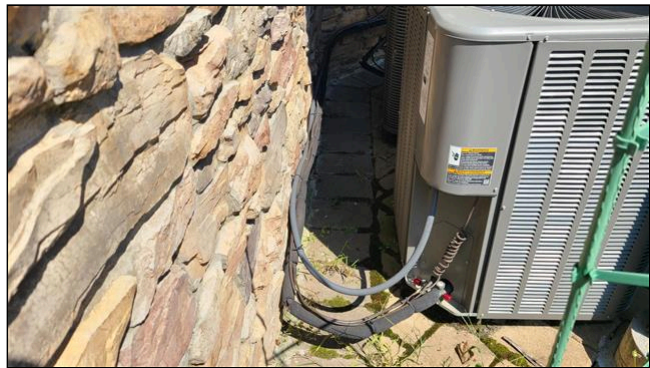
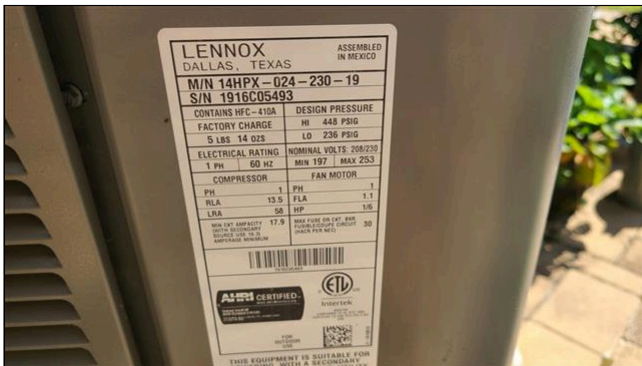
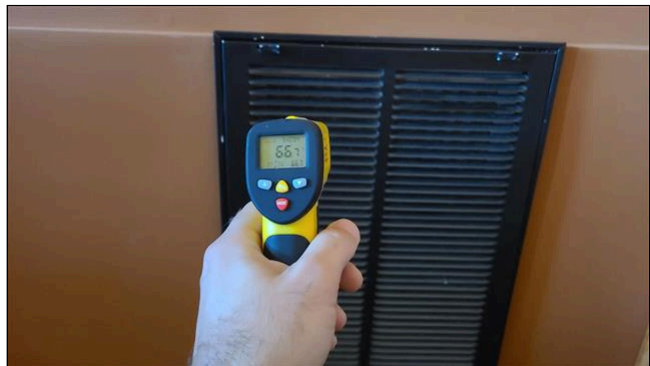
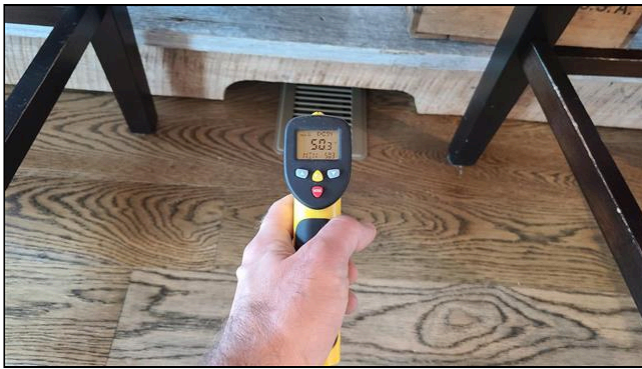
(2) LENNOX heat pump was manufactured in 2016 and supplies air to the main floor areas of the home. Average life span of heat pumps is 14 years. Tested the unit in cooling mode as it was over 60 degrees outside. Delta T (Temperature measured at return air and closest supply to air handler) was within the recommended range of 14-22 degrees.

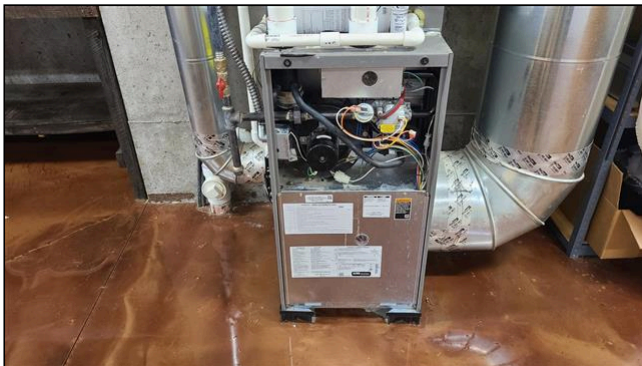
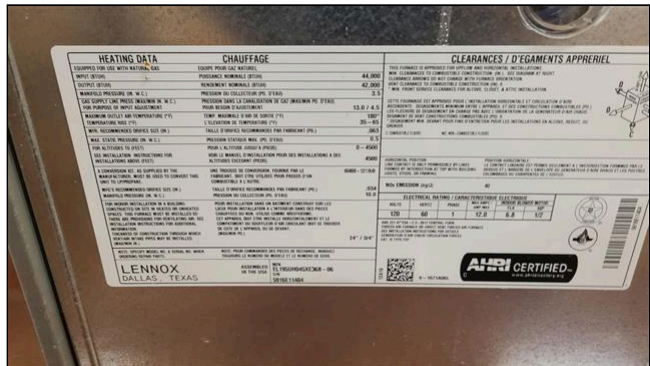
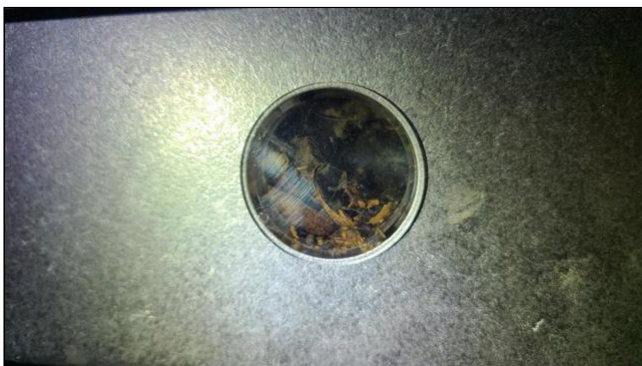
(3) The main floor gas furnace system is a LENNOX brand unit manufactured in 2016. Average life of the furnace is 17 years.

Tested during inspection and CO reading at supply was below the action level of 9 Parts Per Million.

Recommend routine annual maintenance as the main concern is that the heat exchanger stays in good condition to prevent carbon monoxide from entering the supply ducts.

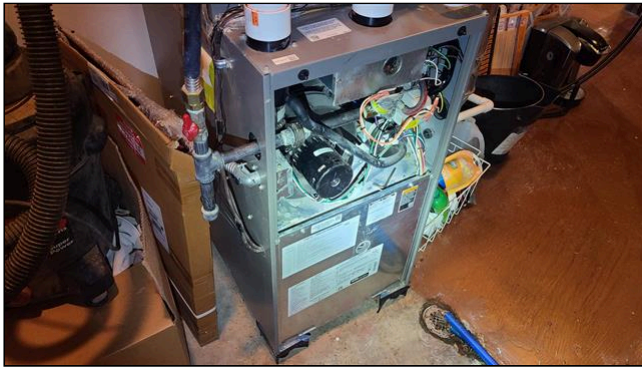
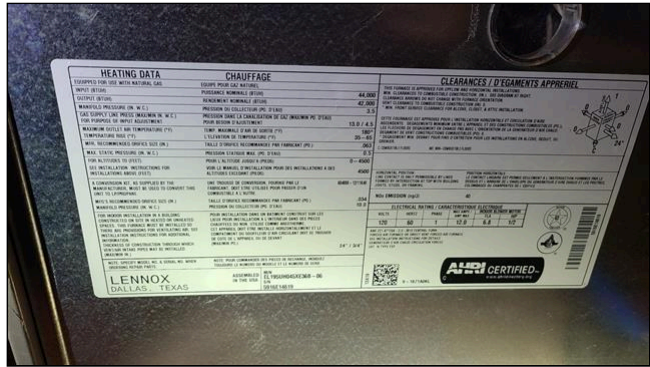
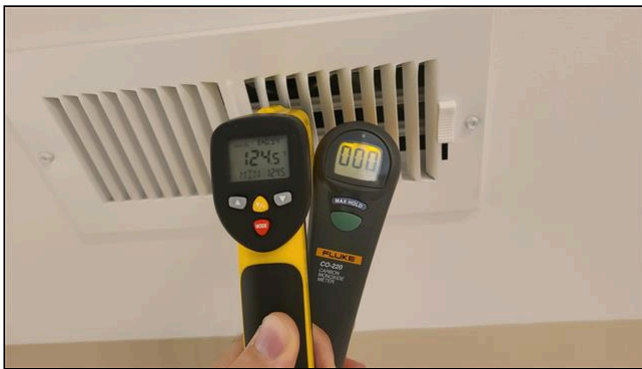
(4) The basement gas furnace system is a LENNOX brand unit manufactured in 2016. Average life of the furnace is 17 years.

Tested during inspection and CO reading at supply was below the action level of 9 Parts Per Million.

Recommend routine annual maintenance as the main concern is that the heat exchanger stays in good condition to prevent carbon monoxide from entering the supply ducts.
