# Inspection Report

**Property Address:**  
420 Borderline Rd NW  
Willis VA 24380

**Straight Point Home Inspections LLC**

| <b>Date:</b> 8/23/2023 | <b>Time:</b> 12:00 PM | <b>Report ID:</b><br>20230823-420-Borderline-Rd-NW |

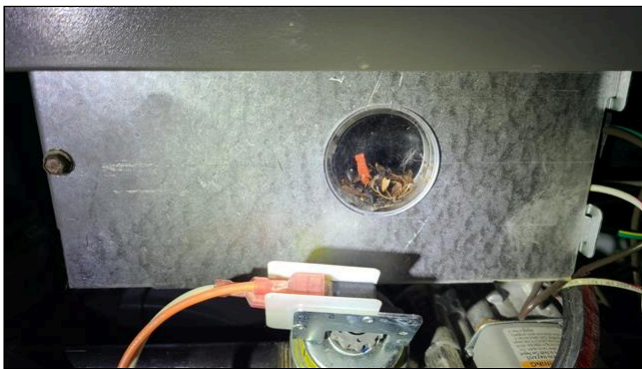
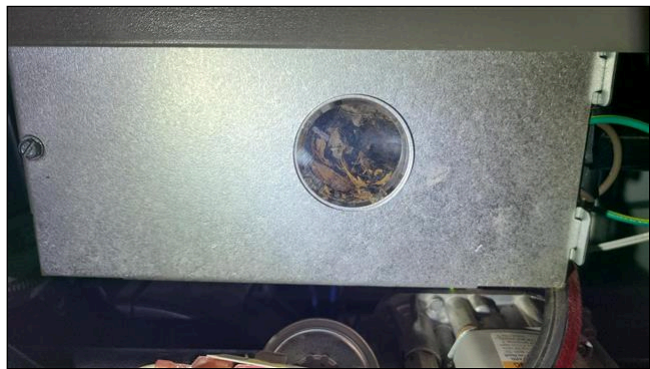
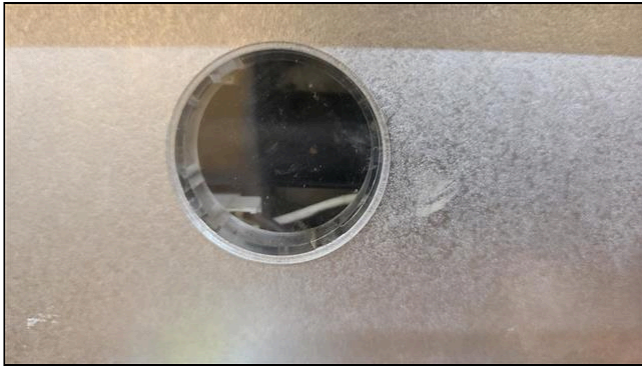
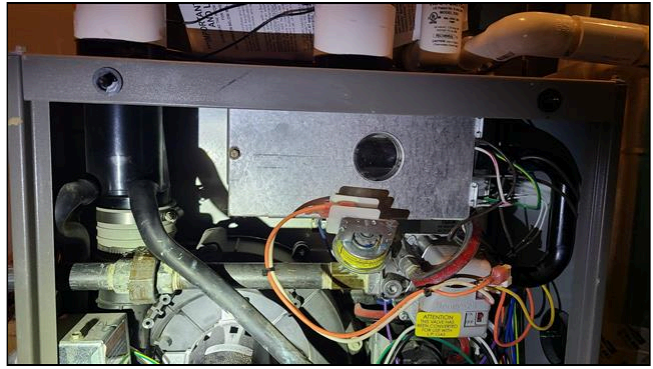
(5) Debris was visible inside the heat exchanger observation glass. This is likely due to mice entering the flue systems. It may be helpful to have a mesh screen installed to help prevent intrusions to the units at the exterior as long as ventilation is still adequate for the units.

Debris was removed during inspection at both units and appear in standard condition at time of inspection.

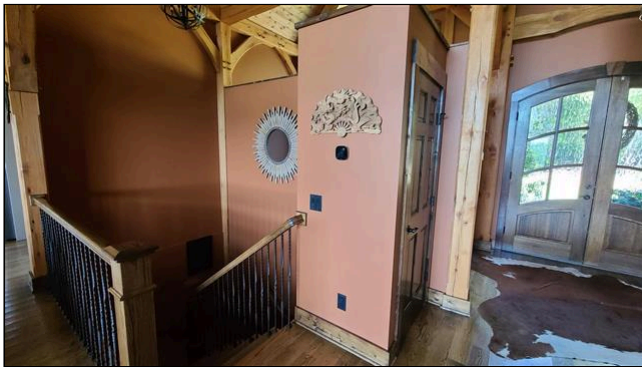
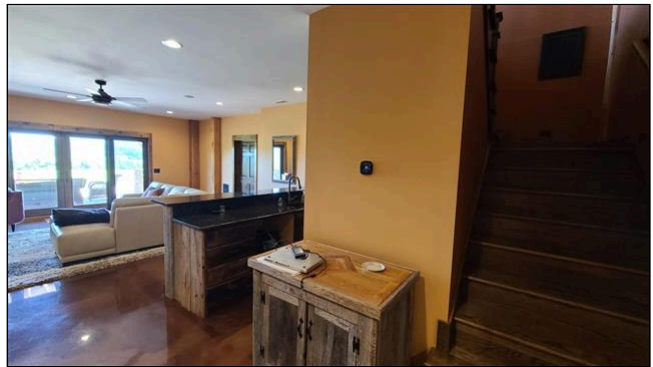
Thermostat for main floor located at middle by stairwell set to 71° beginning at beginning of inspection.

Basement thermostat located at middle of home by stairwell. Set to off at beginning of inspection. Tested in cooling which was set to 72° at beginning of inspection.

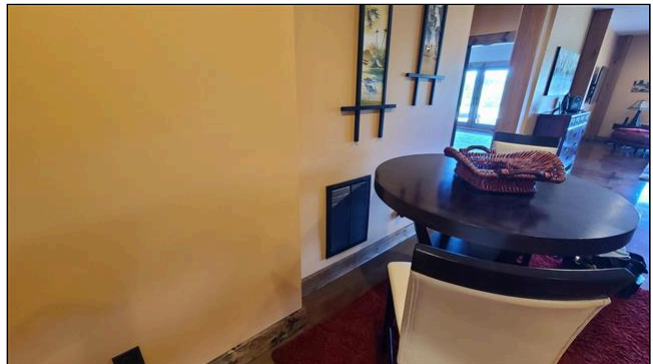
10.3 Item 2(Picture) basement middle front - left side wall - 14x20

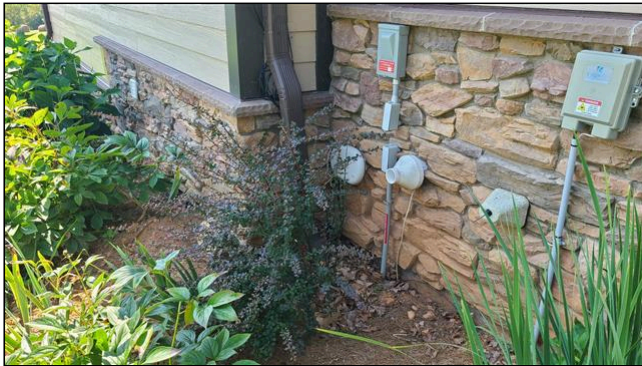
(1) Area around intake and exhaust for gas furnace and water heater systems should be kept clear of vegetation and other items by at least 5 ft.

10.5 Item 1(Picture) front left corner of home

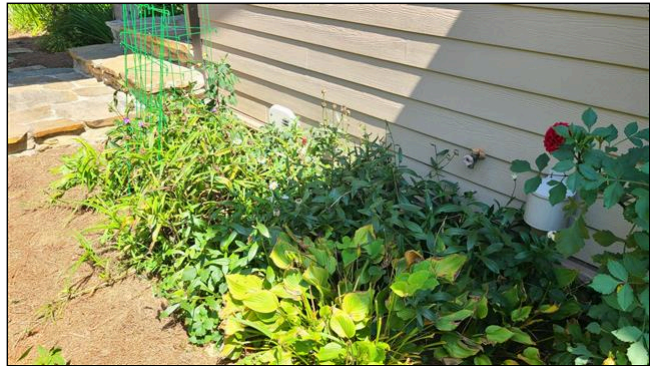
10.5 Item 2(Picture) front right corner

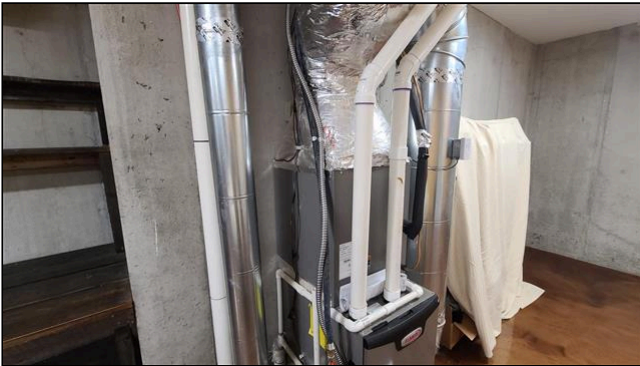
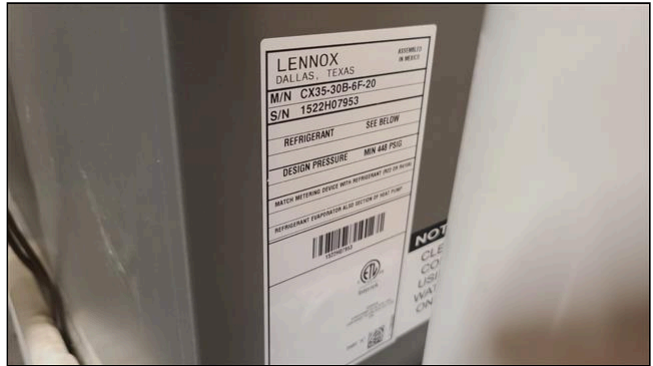
(1) The main floor air handler is a LENNOX brand unit manufactured in 2015. Average life of an air handler is 17 years.

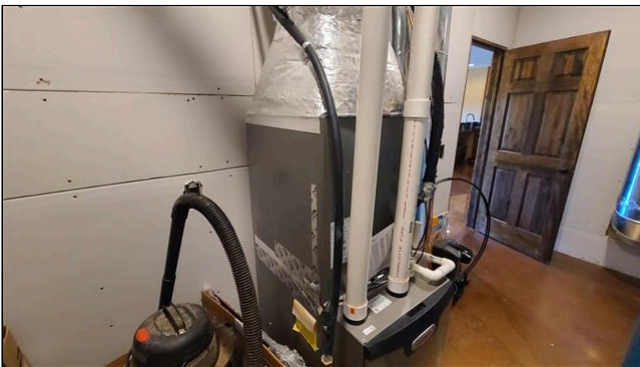
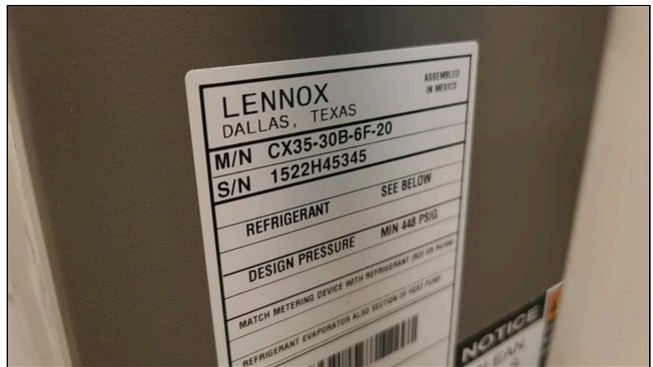
(2) The basement air handler is a LENNOX brand unit manufactured in 2015. Average life of an air handler is 17 years.

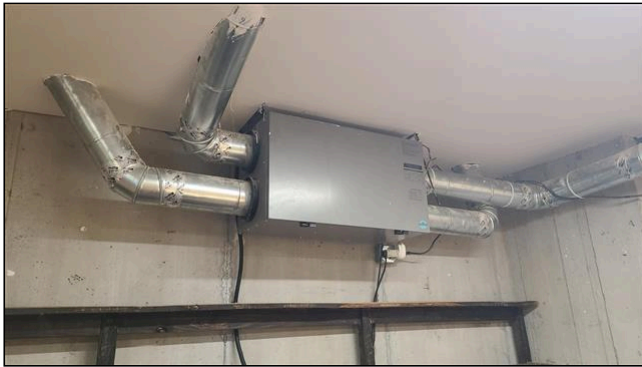
10.7 Item 5(Picture)

(3) Fresh air exchanger is installed in the basement at the right side middle. This unit allows fresh air into the home as the construction has sealed the home so well, that air exchange is necessary to help manage proper moisture and air conditions in the home.

Recommend asking current homeowner for more information regarding smart home systems and operation controls.

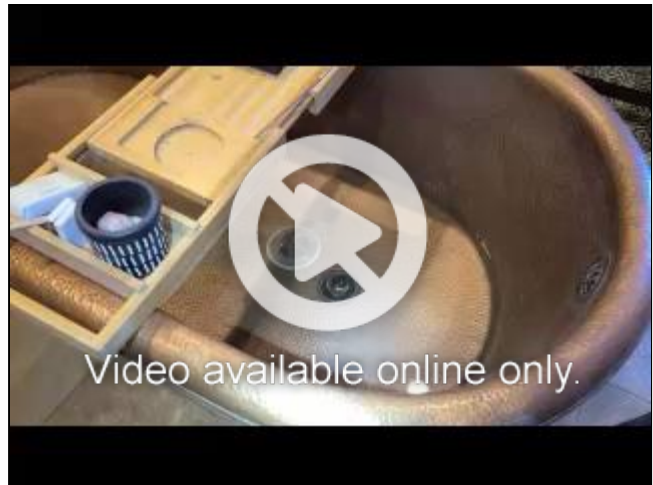
6.10 Item 2(Video)

Slow drain during the inspection. Likely due to build up of debris in the drain at the time of inspection as the plumbing system appeared to be in standard condition at the time of inspection. Recommend drain cleaner be applied and tested before final walk through to confirm cleared condition by a competent handy person.

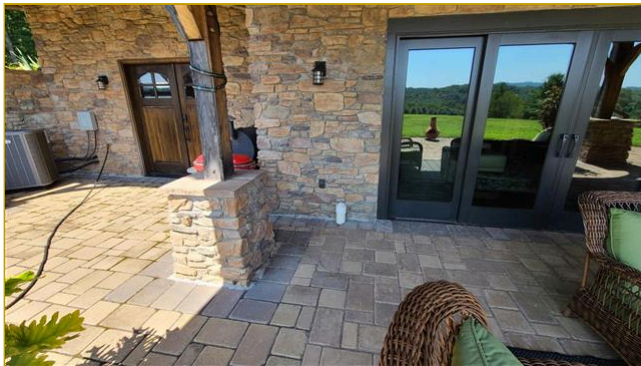
8.0 Item 1(Picture) clean out for drain located at rear middle right side of home

This inspection did not access the tank or determine its location. For a more detailed inspection, I recommend you contact a septic pumping company and have them clean it. At that time the tank could be inspected for proper functioning perhaps by the septic cleaning company.

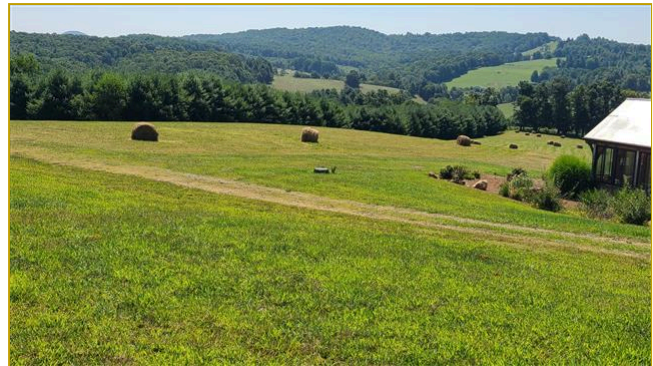
8.0 Item 2(Picture) rear right corner of the property

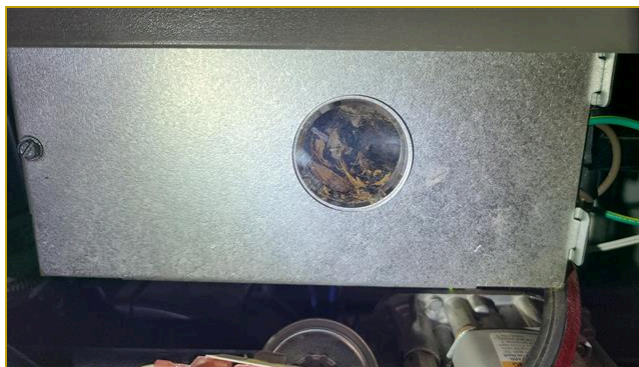
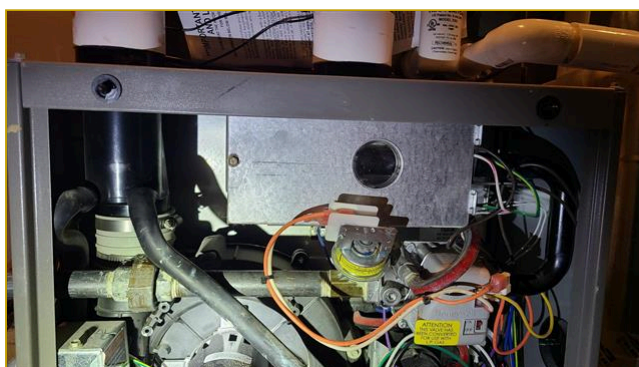
Debris was removed during inspection at both units and appear in standard condition at time of inspection.

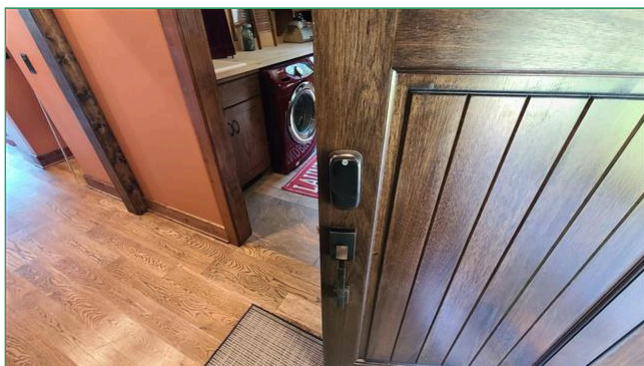
(2) Exterior door(s) has/have an electronic dead bolt lock(s). This should be updated as soon as ownership has transferred. Just a courtesy reminder that a lot of people have had access to the home recently.

2.1 Item 4(Picture) front right side entrance

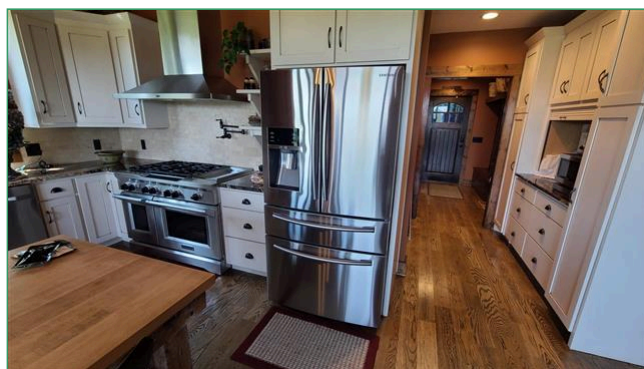
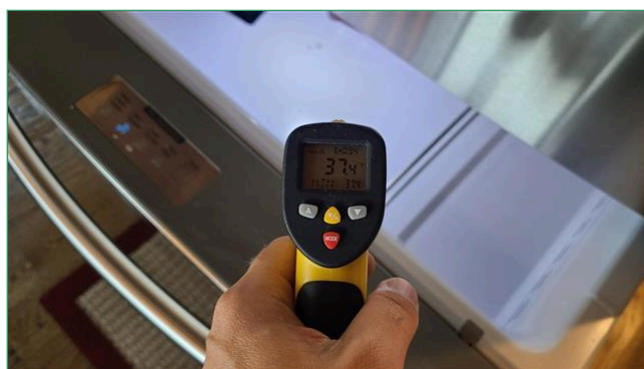
(1) Checked temperatures at time of inspection and found to be cooling adequately.

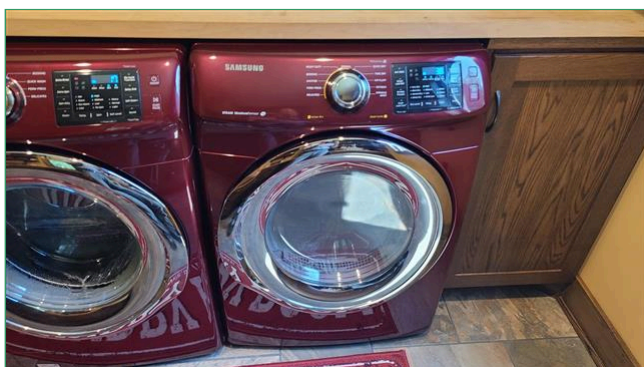
4.15 Item 1(Picture)

Ran a quick cycle and unit heated up during inspection.

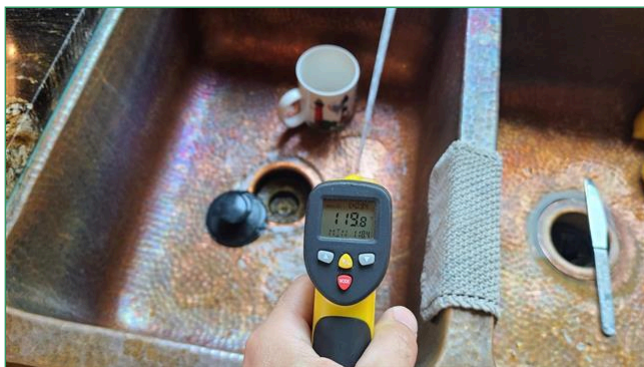
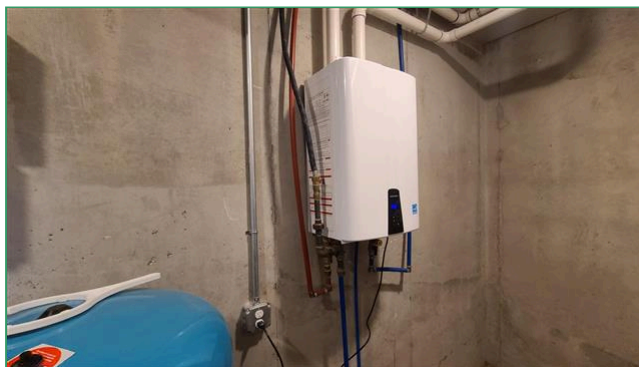
Tankless water heater is a propane gas NAVIEN brand manufactured in 2015. Average life of a tankless water heater is 20 years. Unit heated water to 119 degrees. It is recommended by the EPA that the temperature of your hot water be 120 degrees to kill bacteria but no higher as it can cause burns above 120 degrees in a short period of time.

8.2 Item 1(Picture) Temperature at kitchen sink

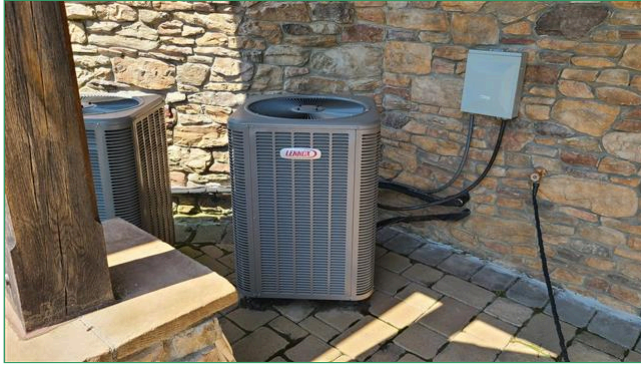
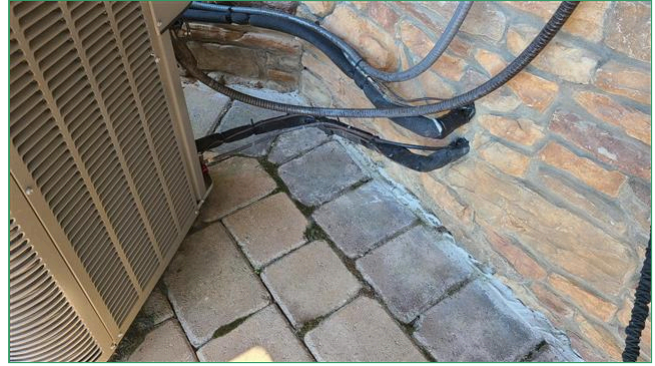
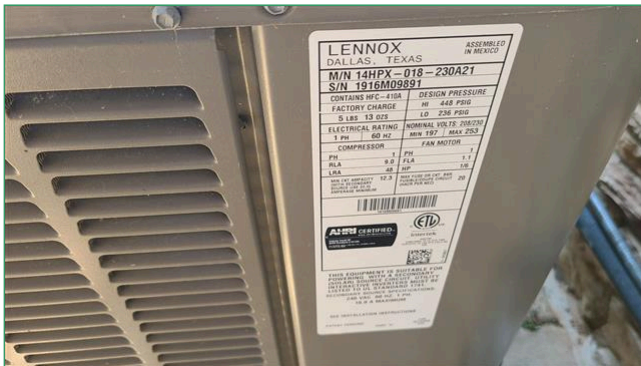
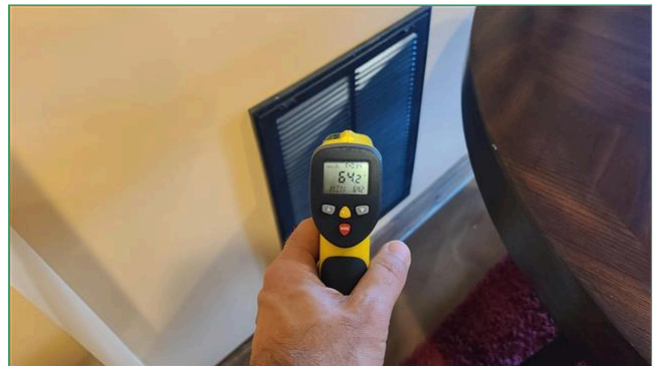
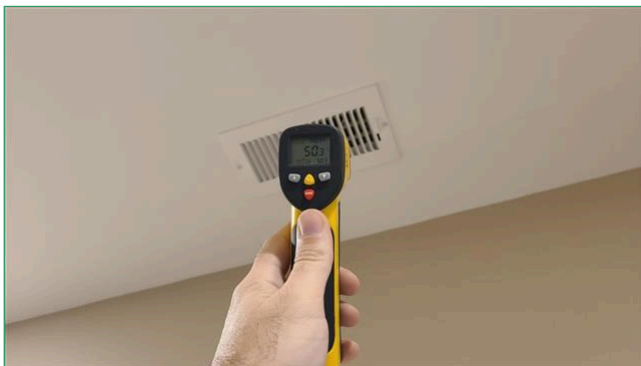
(1) LENNOX heat pump was manufactured in 2016 and supplies air to the basement areas. Average life

span of heat pumps is 14 years. Tested the unit in cooling mode as it was over 60 degrees outside. Delta T (Temperature measured at return air and closest supply to air handler) was within the recommended range of 14-22 degrees.

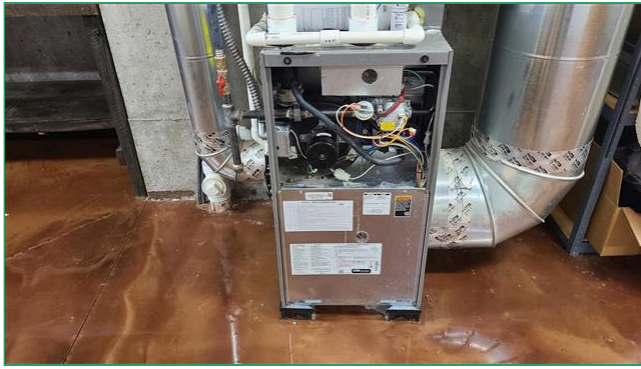
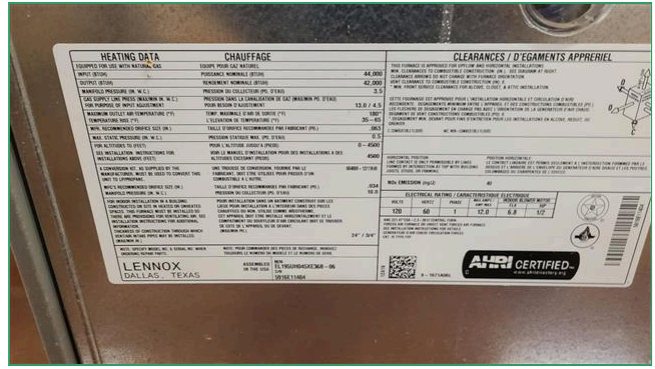
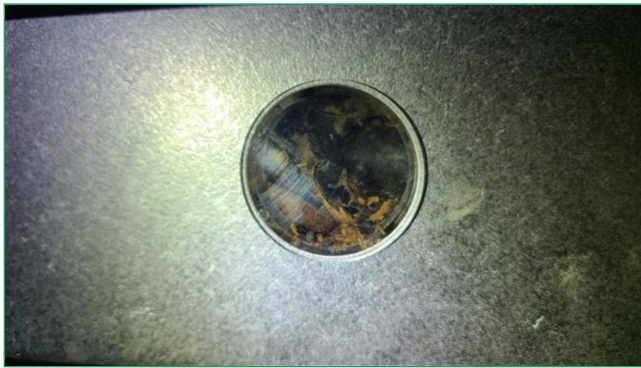
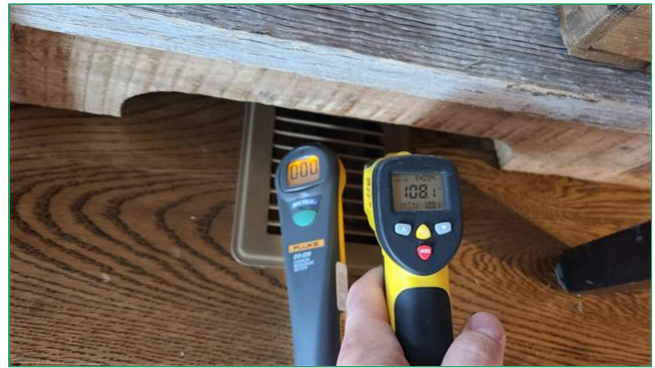
(3) The main floor gas furnace system is a LENNOX brand unit manufactured in 2016. Average life of the furnace is 17 years.

Tested during inspection and CO reading at supply was below the action level of 9 Parts Per Million.

Recommend routine annual maintenance as the main concern is that the heat exchanger stays in good condition to prevent carbon monoxide from entering the supply ducts.

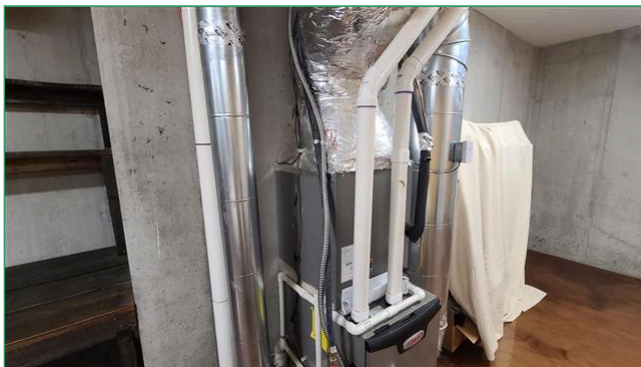
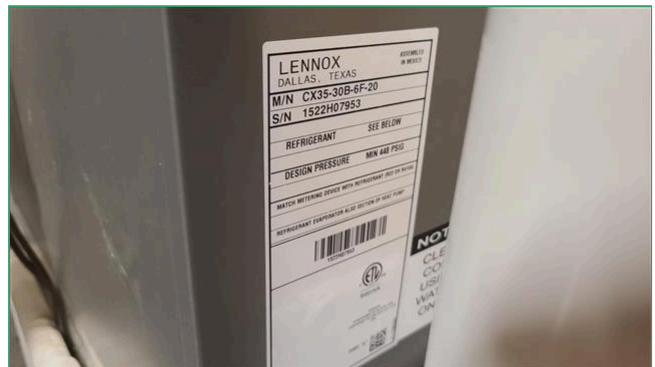
(1) The main floor air handler is a LENNOX brand unit manufactured in 2015. Average life of an air handler is 17 years.

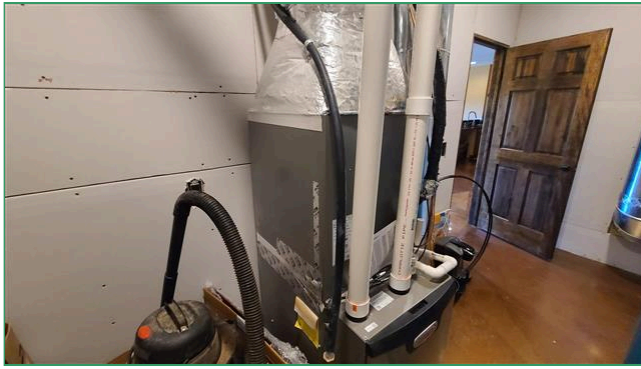
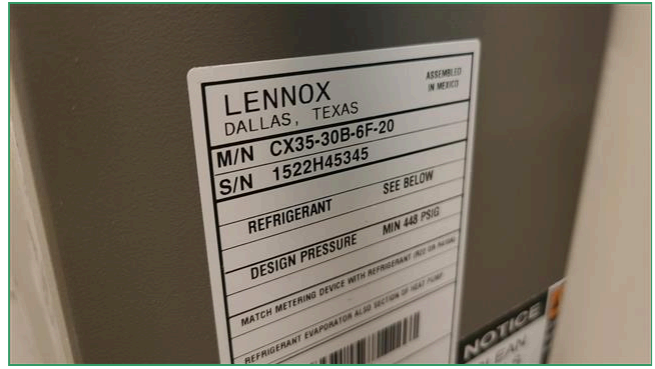
(2) The basement air handler is a LENNOX brand unit manufactured in 2015. Average life of an air handler is 17 years.

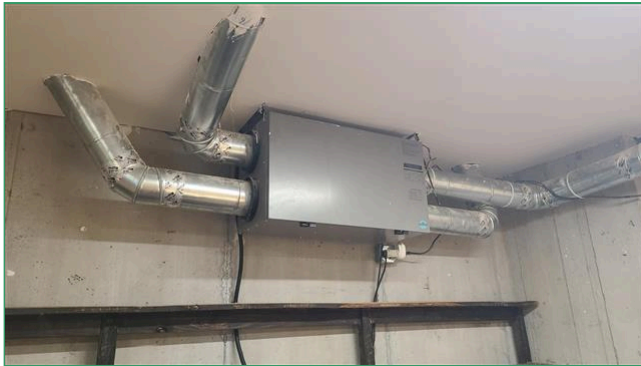
10.7 Item 5(Picture)

(3) Fresh air exchanger is installed in the basement at the right side middle. This unit allows fresh air into the home as the construction has sealed the home so well, that air exchange is necessary to help manage proper moisture and air conditions in the home.

Current air handler has been installed with a smart power plug that can be operated via wireless connection.

Recommend asking current homeowner for more information regarding smart home systems and operation controls.
