Inspection Report

Property Address:
917 Stoneymead Dr
Kings Mountain NC 28086

Date: 8/8/2024	Time: 08:00:00 AM	Report ID: 080824JK5
Property: 917 Stoneymead Dr Kings Mountain NC 28086	Customer: The McLemore Group	Real Estate Professional: Kevin McLemore kevin@themclemoregroup.com

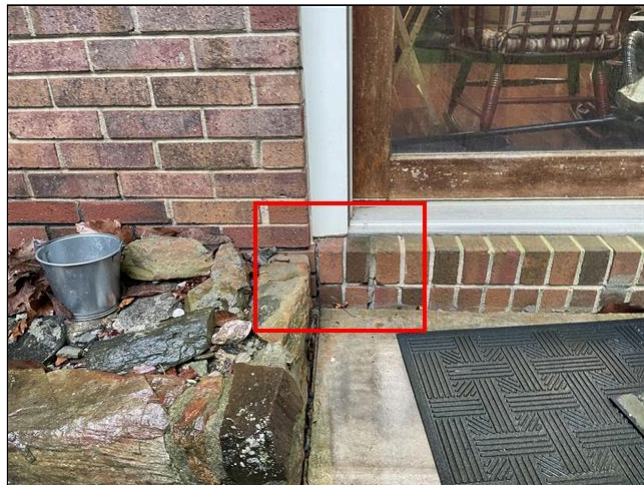
2.

There was/were hairline crack(s) noted in the following locations. Point up and continue to monitor. No corresponding cracks were noted inside the home at these areas and all windows and doors around the area were functioning as intended at the time of inspection. :

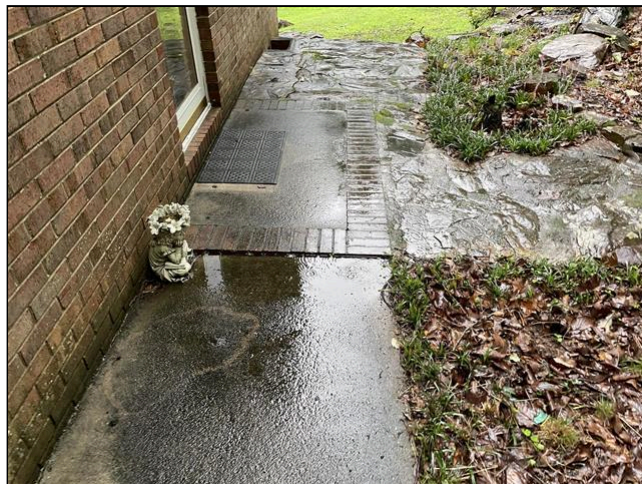
(2) Evidence of poor drainage at the following location(s). This was noted by staining or muddy soil indicating standing water at times or by physically standing water at the time of inspection. This can lead to foundation issues and/or organic growth if standing longer than 48 hours. Contact a qualified professional/landscaper for repairs. :

1. left side of home
2. rear patio
3. right side of home

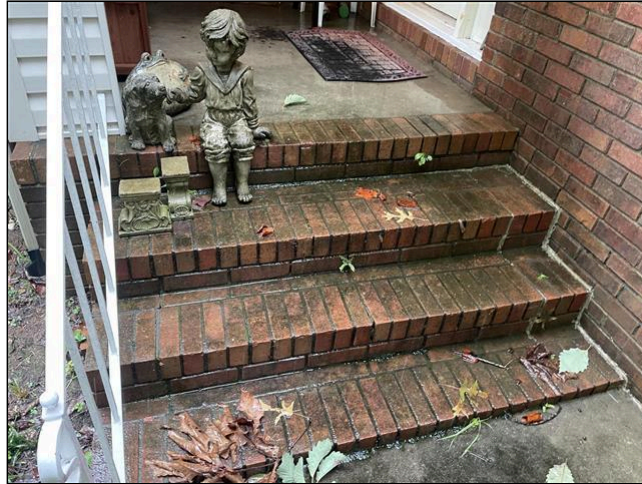
The front porch steps needs to be pointed up (more mortar) in several areas where there are gaps. This is needed prevent water penetration. Contact a qualified professional for repairs.

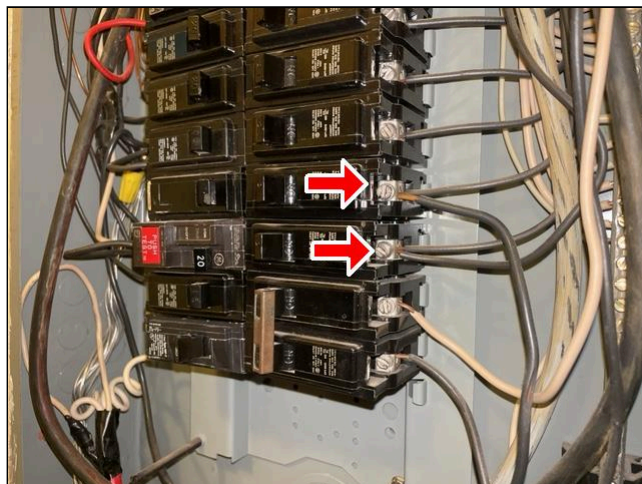
(3) There are multiple wires are connected to a single lug on a circuit breaker in the sub-panel where only one wire should be connected. "Double Tapped". This is an electrical safety hazard. Contact a licensed electrician for repair.

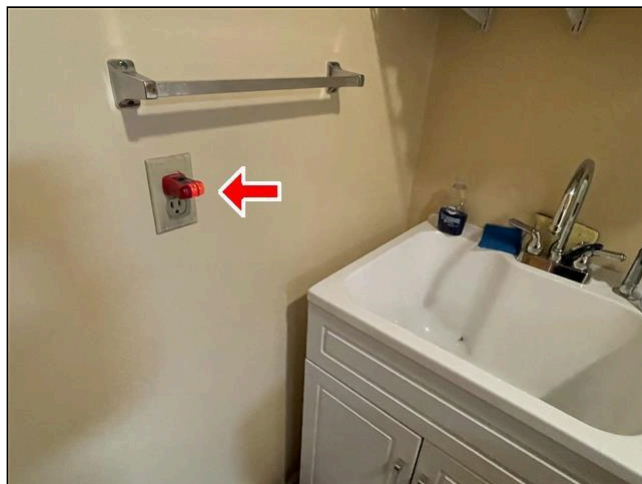
The following outlet(s) are not protected by a GFCI. These are needed in "wet" locations to allow the circuit to turn off in case of an emergency. Contact a licensed electrician for repair. :

1. exterior outlets
2. kitchen outlets
3. bathroom/laundry room outlets

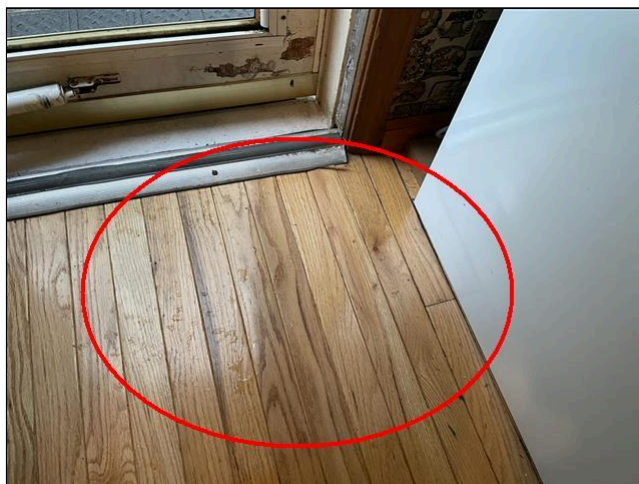
Damage and/or deterioration noted to the floor covering in the following locations. Contact a licensed flooring company for review to determine the repair needed.

1. moisture expansion/deterioration noted at the right side/kitchen exterior door location

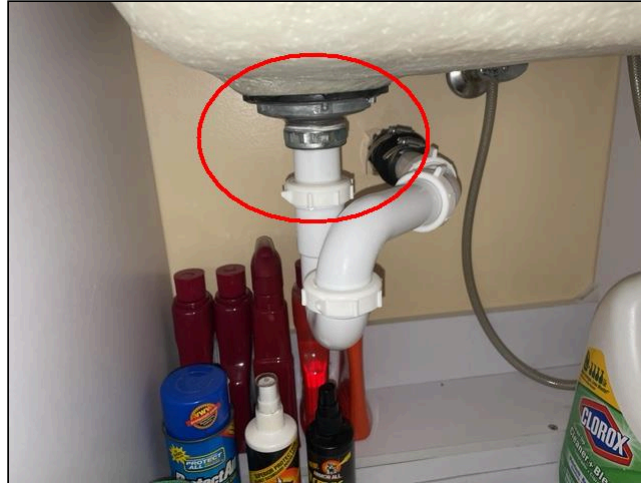
There was an active leak noted under the sink at the waste pipe where it connects to the bottom of the sink at the time of inspection. Corrections are needed to prevent water damage. Contact a licensed plumber for repair.
