Inspection Report

**963 Beaver Creek Road
Bluff City, TN 37618**

1.1 Client Name: Lois Wells.
 1.2 Inspection Number: 042125-02.
 1.3 Inspection Date: April 21, 2025.
 1.4 Inspection Address: 963 Beaver Creek Road, Bluff City, TN 37618.
 1.5 Inspector: Ron Ladd, TNHIL #0000033, VAHIL #3380000585, ASHI #245442.
 1.6 Parties Present: Seller, Sellers Agent.
 1.7 Clients Agent: N/A.
 1.8 Weather: The weather conditions at time of inspection: Sunny, The temperature at time of inspection: 70 - 80 degrees fahrenheit.

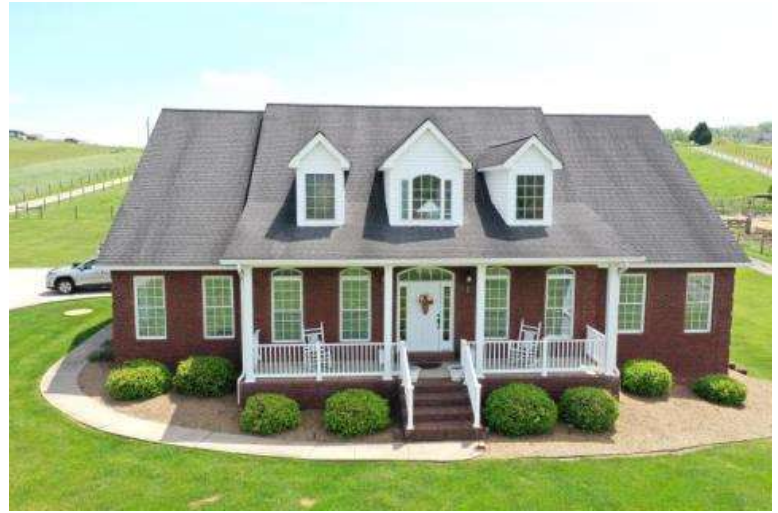
1.13 Structure Views: This is an AERIAL DRONE view of the subject property at time of inspection from the Front.

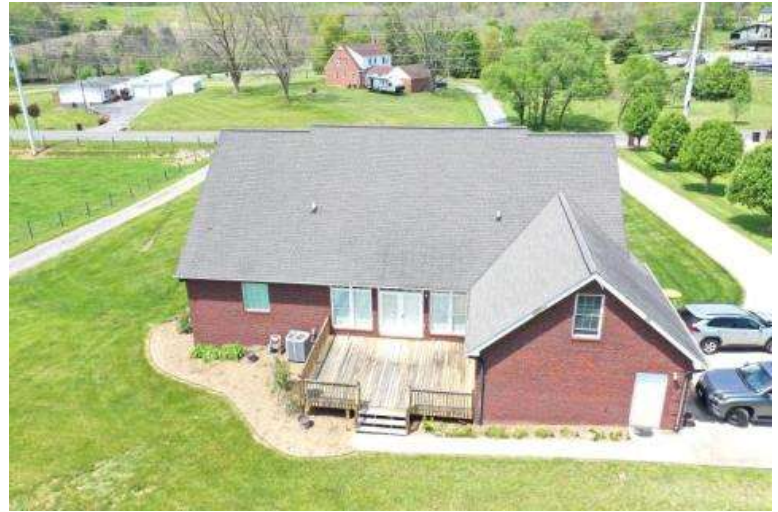
1.14 This is an AERIAL DRONE view of the subject property at time of inspection from the Rear

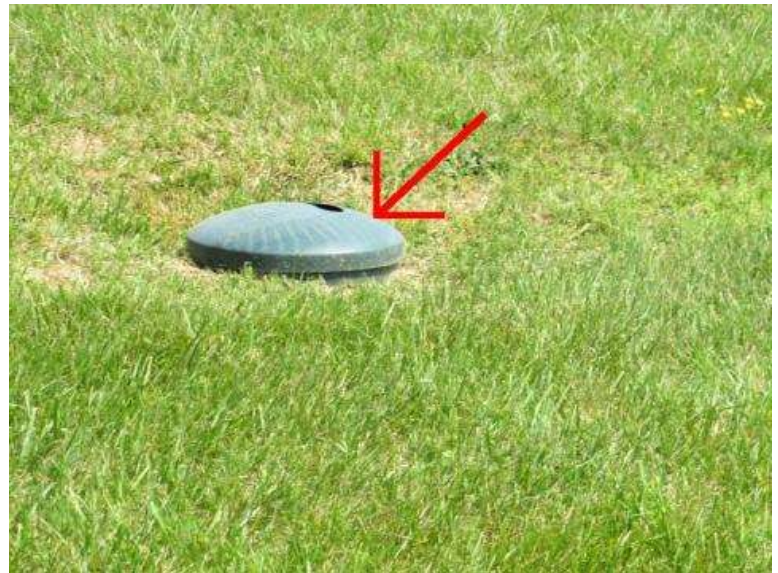
- 2.11 Location: Gas Propane Tank is located at exterior rear of the structure and is buried below grade.

- 2.12 Condition: **Serviceable:** Appears serviceable at time of inspection.

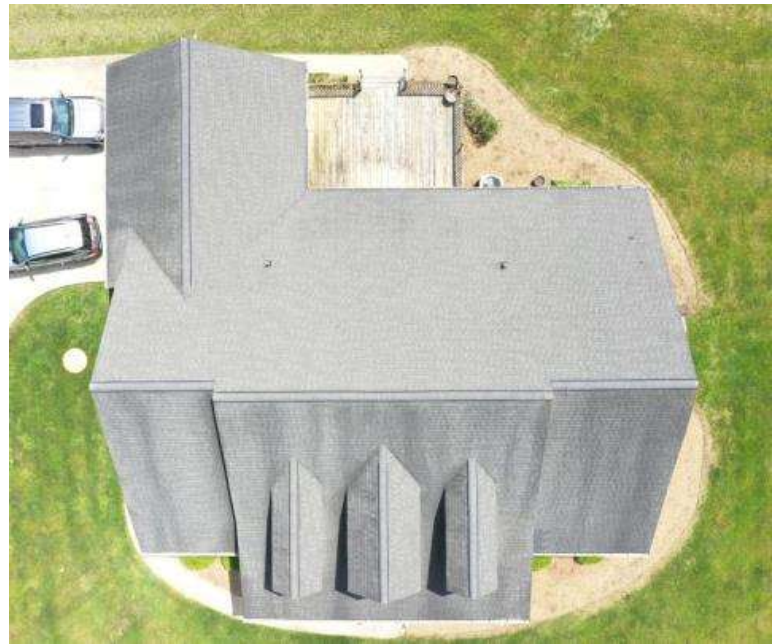
Roof was visually inspected from accessible points on the interior and/or exterior. If a roof is too high, is too steep, is wet or is composed of materials which can be damaged if walked upon, the roof is not mounted. Therefore, client is advised that this is a limited review and a licensed roofer should be consulted for further review if a more detailed report is desired. Roof was not mounted due to: A steep / unsafe pitch prevented access to roof surface. Unable to fully access due to height / pitch / weather or roof type, the roof was: Viewed from roof edge on ladder with binoculars and by AERIAL DRONE. This is a typical view of the roof surface at time of inspection:

Asphalt composition shingles. The roof appears to have: a single layer installed (the roof layers are only checked in spot areas). Determining the remaining life of the roof is beyond the scope of our inspection.

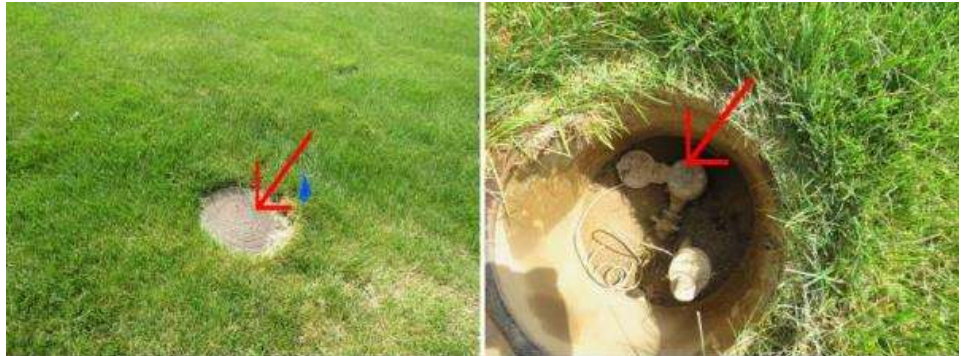
21.1 Water Meter
Location:

Water meter is located:
at the front of the house,
at or near the road.

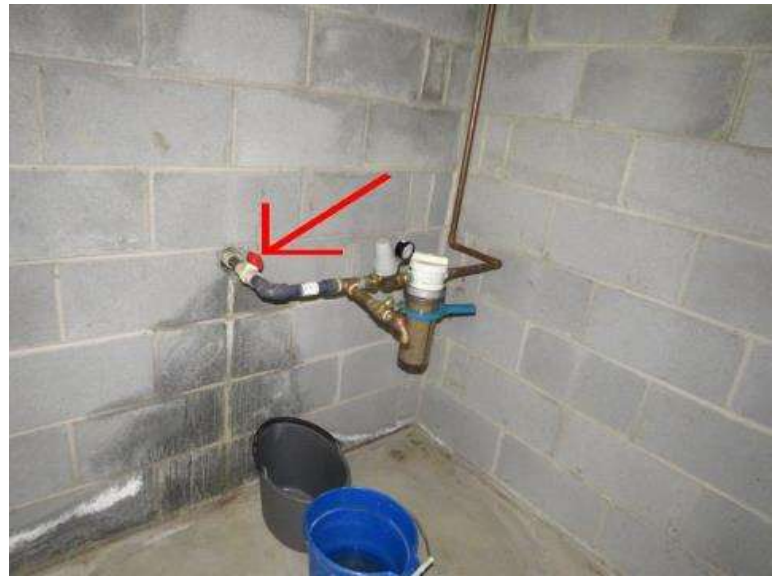
21.4 Water Shutoff
Location:

In the Basement and / or at the Water
Meter.

Serviceable: Appears serviceable at time of inspection where visible.

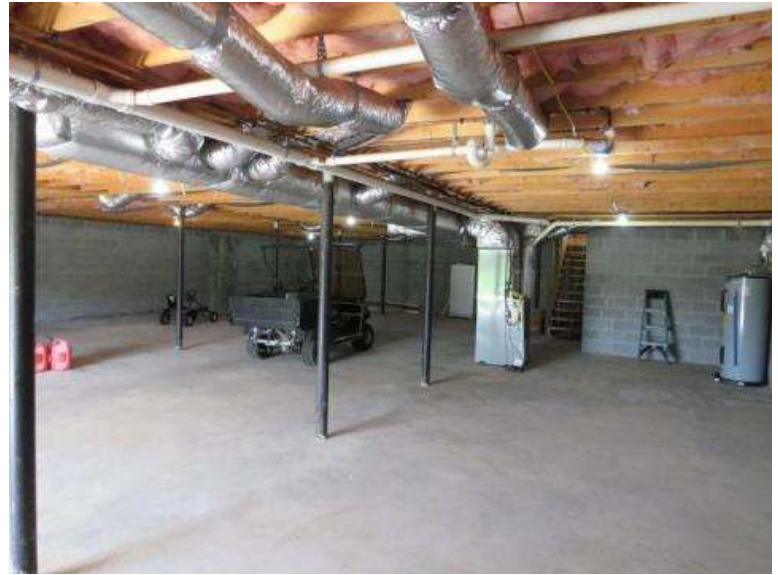
- 24.3 Accessibility: Basement is fully accessible. This is a typical view of the basement area at time of inspection.

- 24.4 Stage of Completion: Basement is unfinished.
- 24.5 Basement Walls Type: Concrete block.
- 24.6 Wall Condition: **Maintenance:** Minor settlement cracks noted, not significant at this time.

- 24.7 **Maintenance:** Staining was observed: Evidence of prior water penetration is noted, inspector probed stains and found them to be dry at time of inspection. Efflorescence seen on walls indicates the past presence of periodic moisture. Suggest checking with seller as to corrective action taken to prevent further moisture entry.

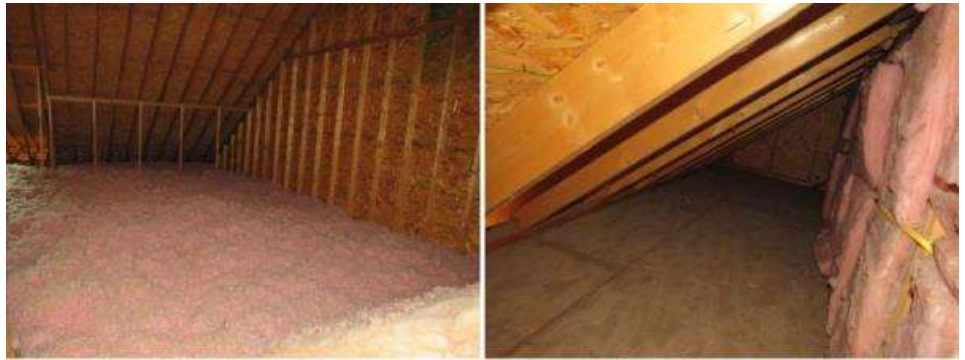
- 25.2 Attic Access: Attic is only partially accessible providing limited access to the entire roof subsystem. The attic has: Conventional framing, This is a typical view of the attic space at time of inspection.

- 25.3 Condition: **Maintenance:** No walk boards are provided. Client may wish to install walk boards to make moving around the attic more readily accessible.

- 25.4 **Maintenance:** Bathroom exhaust vents exiting into attic. This condition allows warm moist air from bathroom to exit into the attic. This condition can lead to condensation forming on roof sheeting and the development of mold growth in the attic.
