Perfection Home Inspections
Mesa, AZ 85203
602-524-2916
perfectionhomeinspections.com

Inspected By:
Greg Oswalt Arizona Lic. 38752

Auction, United Country Excelled
2002 N 25th Street
Phoenix, AZ 85008
480-422-6800

Inspected 5/31/25 8:00 AM
Built 1951
1090sf

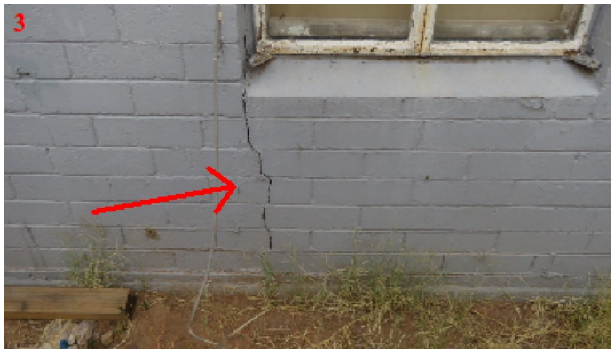
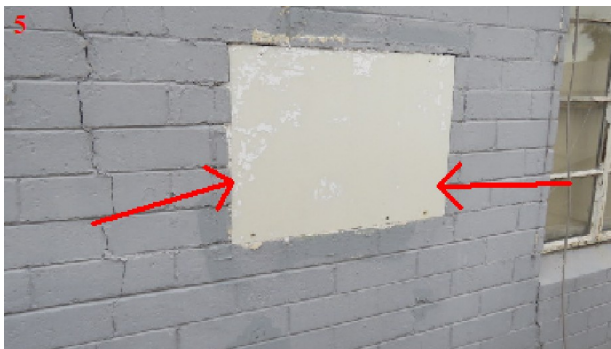
Service/Repair Wall Structure - Racked

Cracks in the exterior wall structure. Racked wall outside of the back bedroom.aka Bedroom 2. There is a sheet of drywall used to patch a hole in an exterior wall outside the master bedroom. Drywall is not water proof.

Cracks in the exterior wall structure. Racked wall outside of the back bedroom. aka Bedroom 2. There is a sheet of drywall used to patch a hole in an exterior wall outside the master bedroom. Drywall is not water proof. Recommend a qualified contractor evaluate and take all necessary steps to solve this problem.

Recommend a qualified contractor evaluate and take all necessary steps to solve this problem.

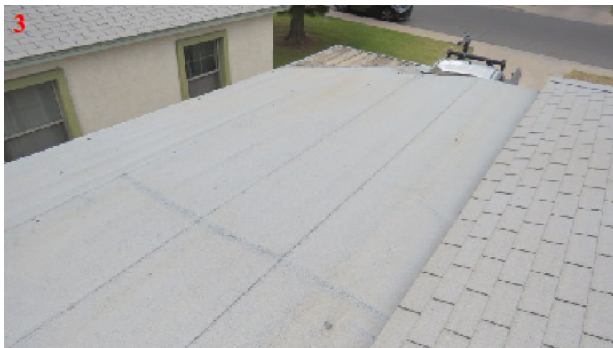
Service/Repair Garage / Carport Roof - Flat

The carport and storage room roof is a rolled material in poor condition lifting in the front and in the back. Recommend a qualified roofing contractor evaluate and make all necessary repairs.

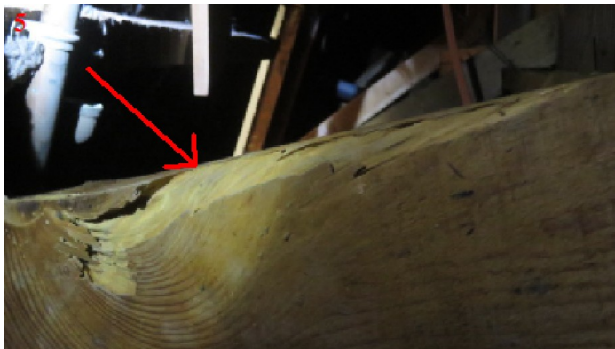
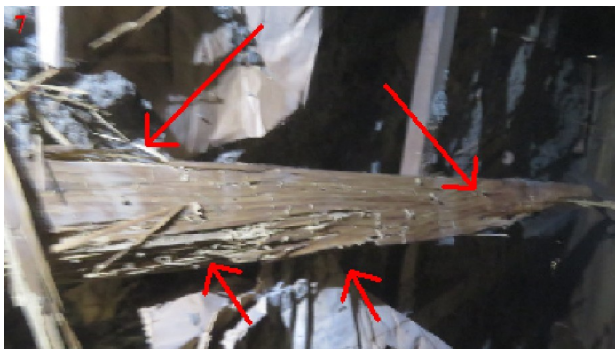
Service/Repair Attic Structural Framing Type - Conventional

Structural damage to attic members from termite damage. Ceiling joist and other structural wood with termite damage. See sample pictures. Recommend a qualified contractor evaluate and make all necessary repairs.

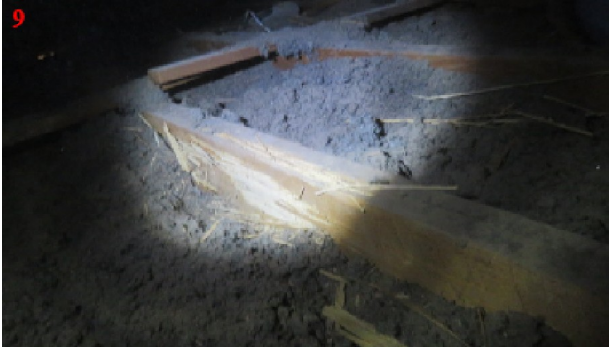
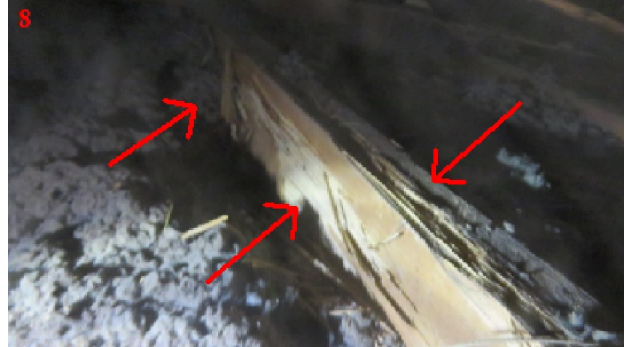
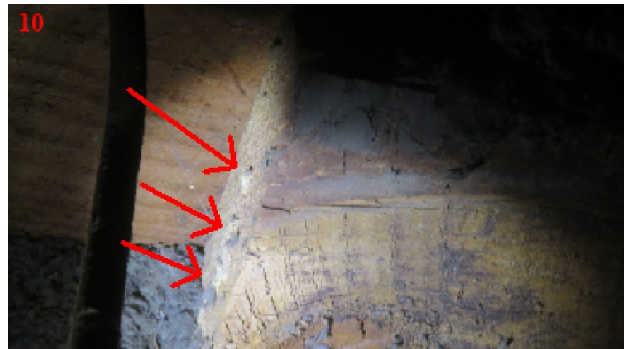
Service/Repair Attic Structural Framing Type - Conventional

Termite damage to ceiling joists in the attic.
Inspected around the area of attic where visible and where accessible only.
Recommend a qualified contractor evaluate and make all necessary repairs.

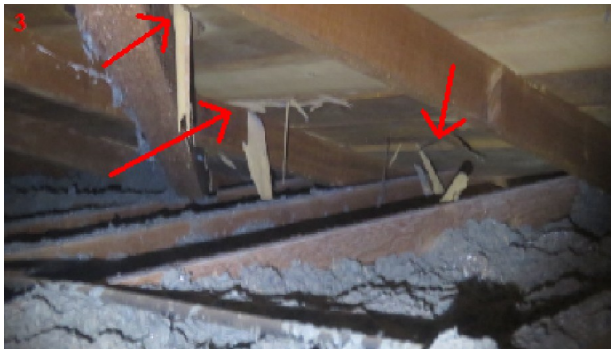
Service/Repair **Roof Sheathing - Board Sheathing**

Water damage and termite damage to roof sheathing. Broken sheathing board at a vent pipe. Recommend a qualified contractor evaluate and make all necessary repairs.

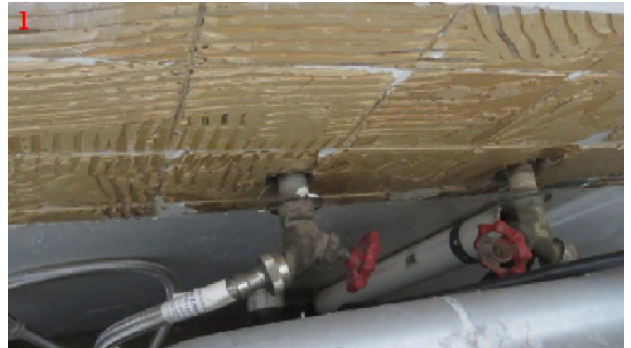
Washer Faucets - Gate Type

No access to test the laundry valves to make sure they turn on and off. Recommend checking after access is provided.

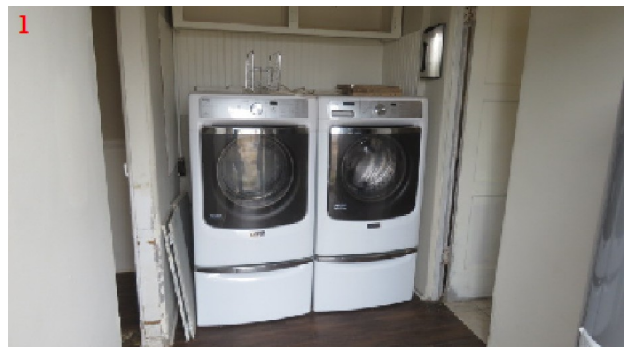
Appliances - Washing Machine & Dryer Tested

The gas valve is not capped off and not attached to a dryer. If something hits the gas valve it could leak gas into the home. Recommend capping all gas valves when not attached to a gas appliance.

The washing machine and dryer were both tested. The only test is to make sure they turn on and turn off with no signs of leaking. The dryer is not plugged in and the gas pipe not attached so it did not work when tested.

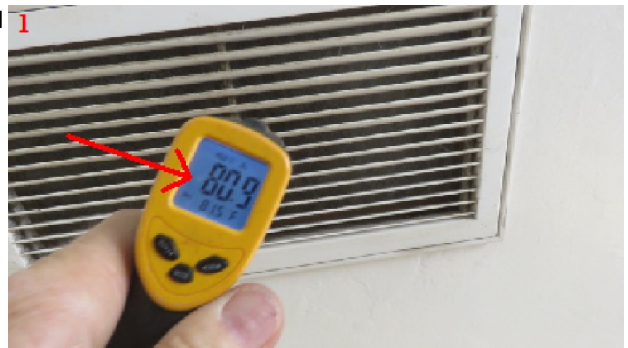
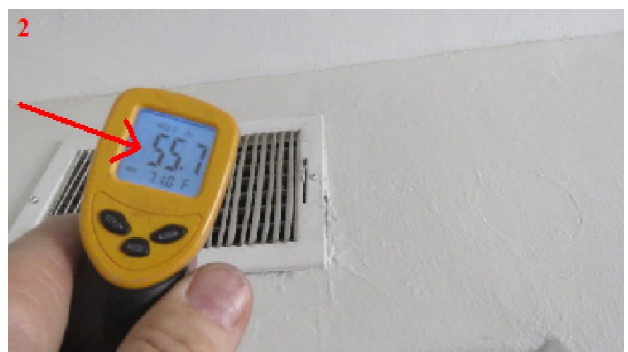
Satisfactory Differential Temperature(s) - Inspected, Details

A differential temperature between 16 and 30 degrees is considered good for a air conditioning system. Over 30 the unit may have a clogged filter or other problem which may cause the unit to ice up. For a split of 16 degrees and lower and for units with a split of 30 degrees and higher I recommend the AC unit be serviced. Unit one has a 25 degree split.

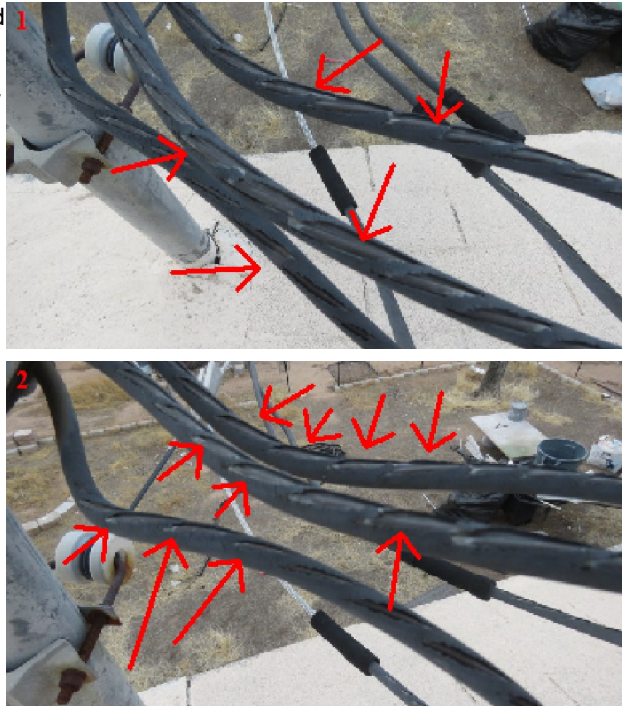
The insulation on the main electric service drop wires is cracked and falling off the lines at the masthead. This is a shock hazard and a fire hazard.

Recommend a qualified contractor evaluate and make all necessary repairs.

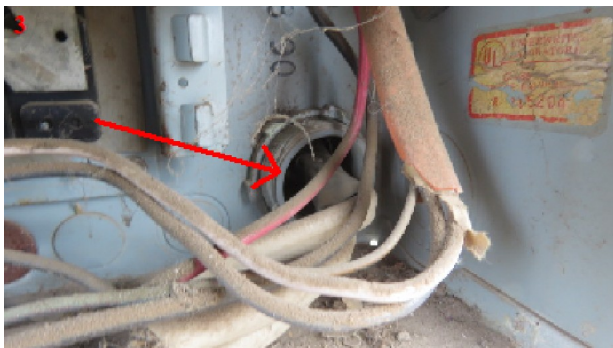
Wires attached to the main electric panel in the back are missing a grommet needed to keep the wires off the sharp metal box and the wires may short out on the sharp metal panel. This is a shock hazard and a fire hazard.

Wires attached to the main electric panel in the back are missing a grommet needed to keep the wires off the sharp metal box and the wires may short out on the sharp metal panel. This is a shock hazard and a fire hazard. Recommend a qualified electrical contractor evaluate and make all necessary repairs. See Picture

Recommend a qualified electrical contractor evaluate and make all necessary repairs. See Picture

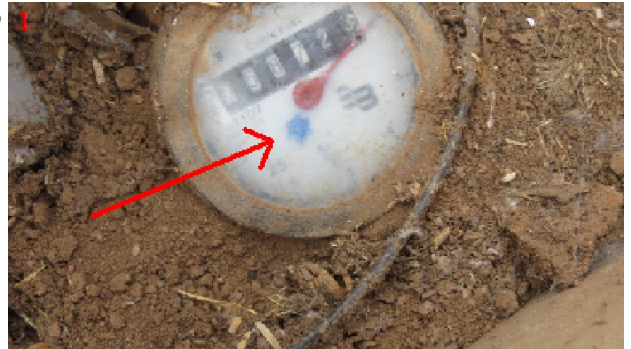
PLUMBING - Meter Inspected

The water meter was inspected and the dial was not moving. So no water was detected as leaking at the start of the home inspection.

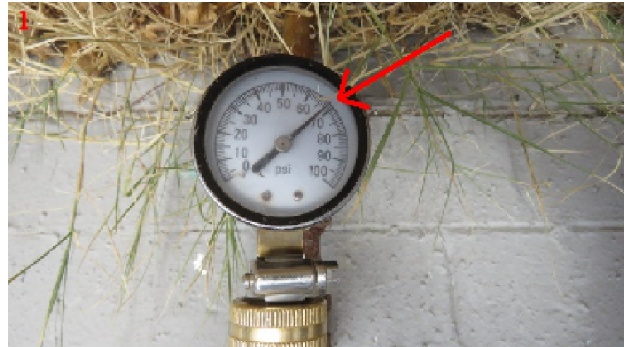
Water Pressure - 40 to 80 PSI

Water pressure recorded today was 78 psi.
Recommended water pressure between 40 to 80 PSI.

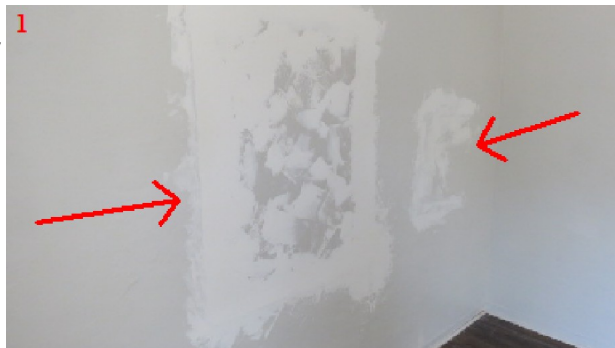
Service/Repair Walls and Ceiling - Inspected

Large unfinished patches on the wall in the master bedroom. Recommend a qualified contractor evaluate and make all necessary repairs.

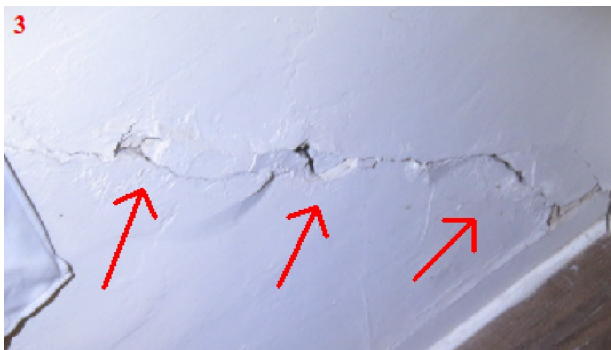
Service/Repair Walls & Ceiling - Inspected

There is a hole in the wall next to the door and the back wall is racked from the moving block wall and the ceiling has a zagged crack. Recommend a qualified contractor evaluate and make all necessary repairs.
