## ***WHAT REALLY MATTERS IN A HOME INSPECTION***

Saturday, May 31, 2025

Inspection Site

2716 Peaks Mountain Road  
Galax VA

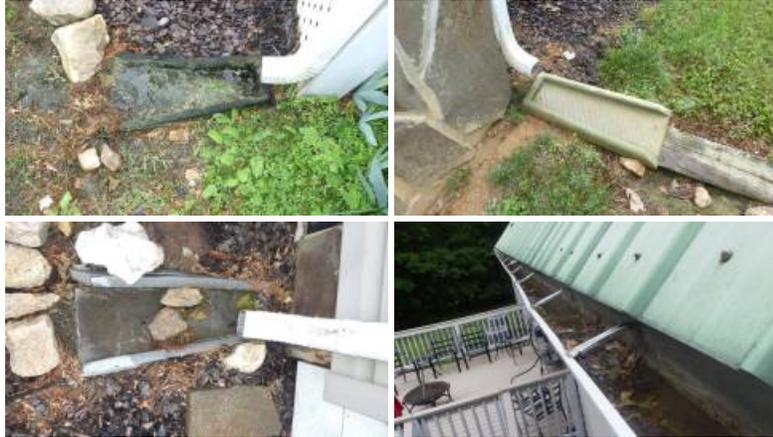
Guttering holding water - recommend removing blockage for proper drainage of the Guttering system

*Concern(s) / Recommendation(s)* Recommended to periodically clean debris from the guttering channels to prevent downspouts from clogging. Clogs in downspouts can allow the gutters to overflow; damaging roof sheathing, fascia boards, and saturating grounds at the foundation.

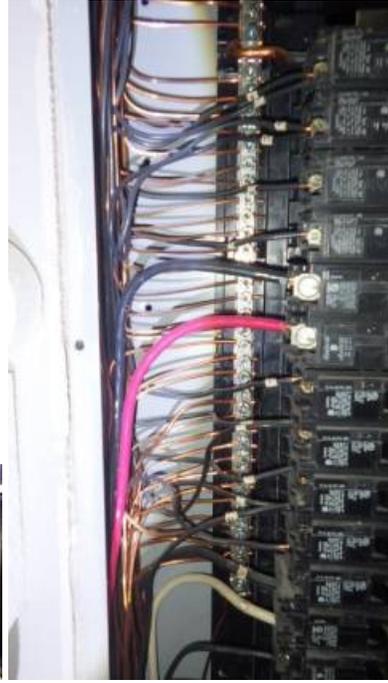
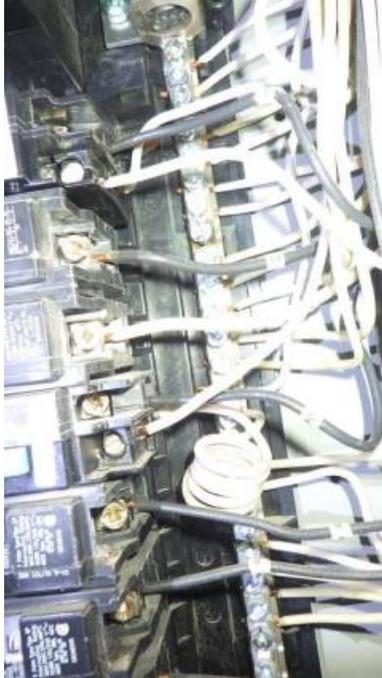
The electrical panel was equipped with breaker(s) manufactured by a company other than the panel manufacturer. Some circuit breaker models from different manufacturers may be substituted for each other, but confirmation of what models are acceptable is beyond the scope of a home inspection. An evaluation of the breaker(s) to determine their acceptability is recommended to be performed by a licensed electrical contractor, with replacement of breakers made as needed, if needed.

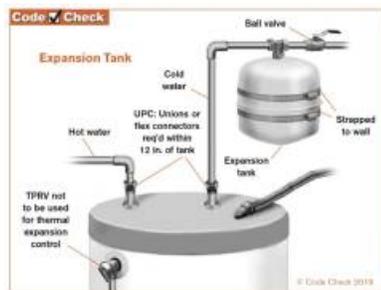
No expansion tank was present. Expansion tanks allow for the thermal expansion of water in the pipes. These have been required in certain areas for new installs or replacement since 2012. Recommend a qualified plumber evaluate and install. Even if not required, these are a good investment to prevent potential problems.

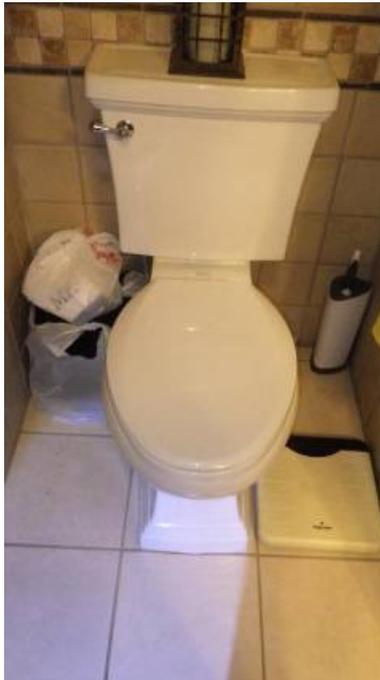
| <input type="checkbox"/> | <input type="checkbox"/> | <input checked="" type="checkbox"/> | <input type="checkbox"/> | Caulk around the base of the toilet was missing, substandard and/or deteriorated. Modern standards require caulk to be installed around the toilet base where it meets the floor for sanitary reasons. Without it, soiled water can soak into flooring and sub-floor materials if the toilet overflows. Condensation from the toilet can also soak into the flooring. Recommend that a qualified person caulk around toilet bases leaving a one inch gap to allow for visual of a leak per standard building practices.<br>- Recommend caulking around toilet base leaving a gap of about an inch to 1 1/2 inches to allow for visual when leakage is occurring |

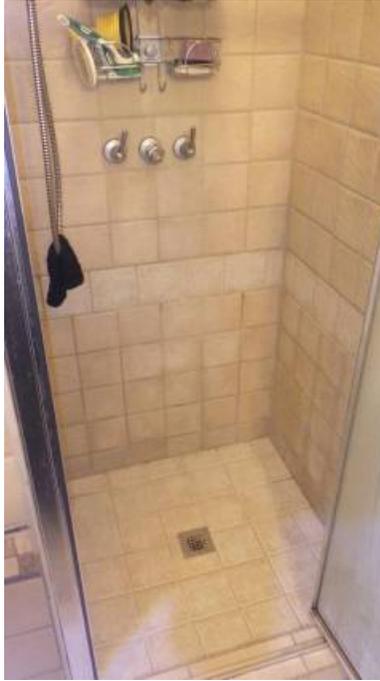
*Tub/Shower And Walls:*

- Sealant maintenance is recommended around tubs, showers and sink fixtures to prevent moisture intrusion

- Keep walls / seams / joints caulked and sealed to prevent moisture damage - Caulk and seal all tub and shower areas as a precaution.

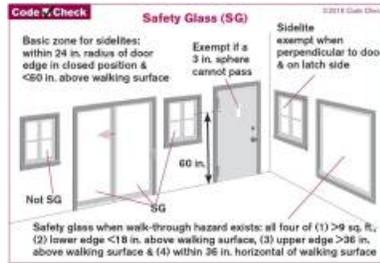
Windows are present that do not have tempered glass or safety glazing. According to current industry standards, tempered / safety glass is required for windows in specific hazardous locations. Most windows that are tempered are etched with identifying markings. If these markings are not present, the window is likely not tempered, which presents a potential safety hazard. We have identified the windows of concern in the photographs and the location descriptions. Consult with a window company to make any desired repairs or upgrades deemed necessary.

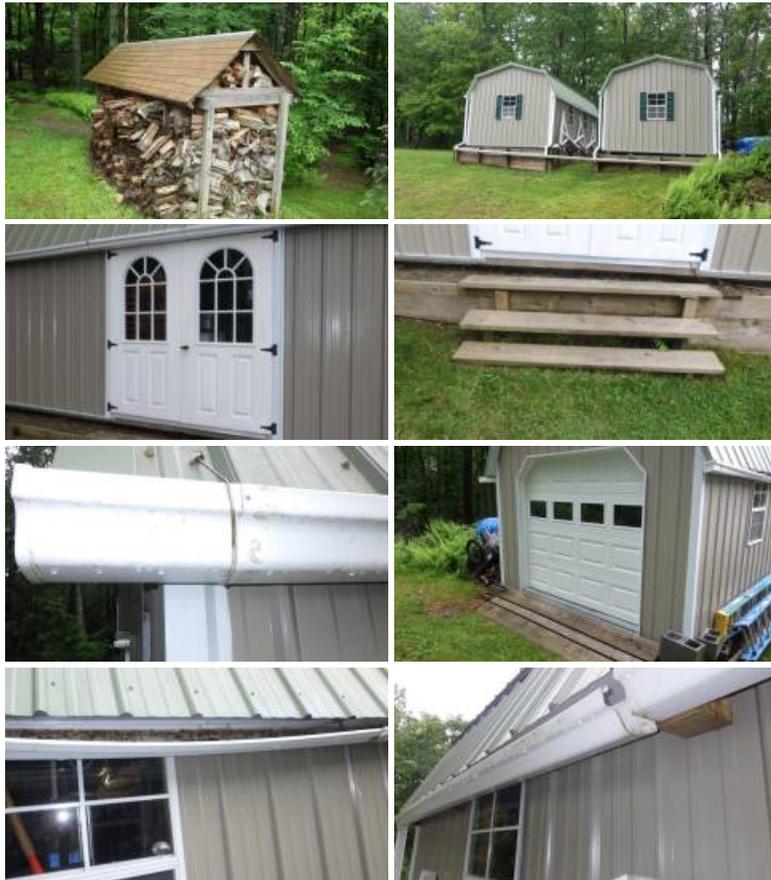
ELECTRICAL OBSERVATIONS- Building is not properly wired and relying on an extension cord for power, if electrical service is needed then properly wiring of the building and supply is recommended

gutter improvements needed.

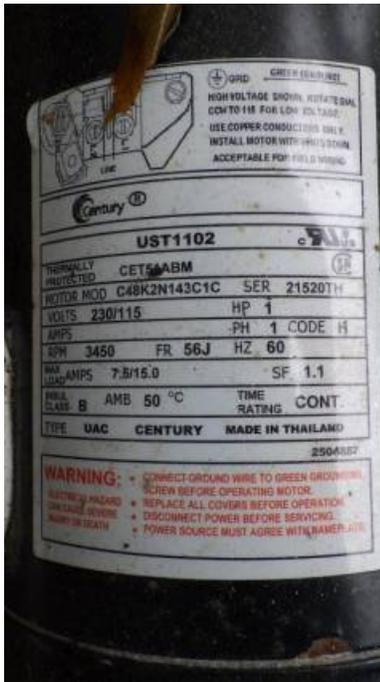
Pump Motor Manufacture Date: Manufacturer label picture.

OK NI MM RR  
    Condition: Fair- motor is aged.

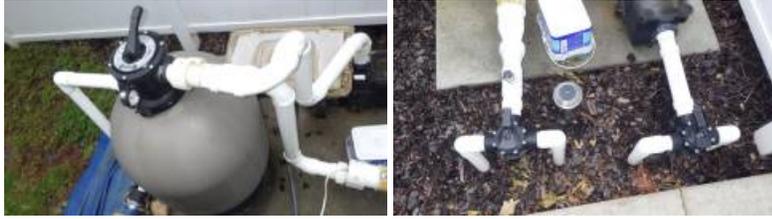
PVC PIPING SHOULD BE PAINTED.

PVC can be damaged by sunlight and should be painted or coated for UV protection.

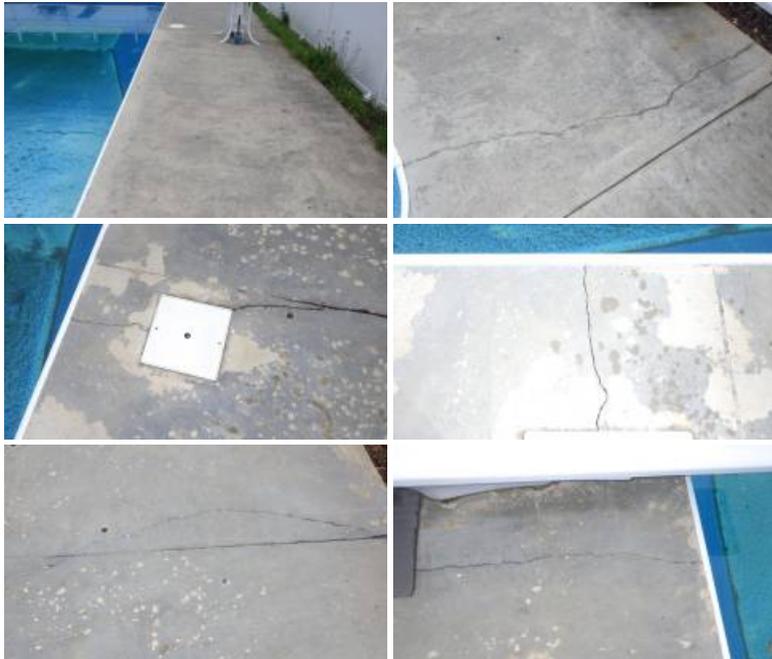
| <input type="checkbox"/> | <input type="checkbox"/> | <input checked="" type="checkbox"/> | <input type="checkbox"/> | Minor settlement cracks are noted at several locations. |
| <input type="checkbox"/> | <input type="checkbox"/> | <input checked="" type="checkbox"/> | <input type="checkbox"/> | -Depth markings not noted at pool edge areas. Recommend clear and proper marking for improved safety. |

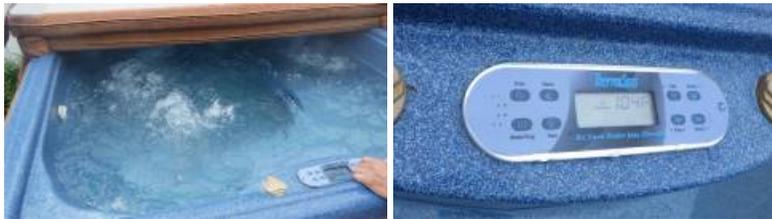
- OK NI MM RR  
    The hot tub was found to be operational and in serviceable condition.  
 Note to buyer - internal tub jets, components and water chemical levels were not inspected at the time of inspection.  
 Recommend a hot tub specialist service the hot tub to find out if any maintenance is needed.

Water temperature: 104 F.
