Perfection Home Inspections
Mesa, AZ 85203
602-524-2916
perfectionhomeinspections.com

Inspected By:
Greg Oswalt Arizona Lic. 38752

Auction, United Country Excelled
18212 N 43rd Place
Phoenix, AZ 85032
480-422-6800

Inspected 6/19/25 8:00 AM
Built 1962
2071 sf

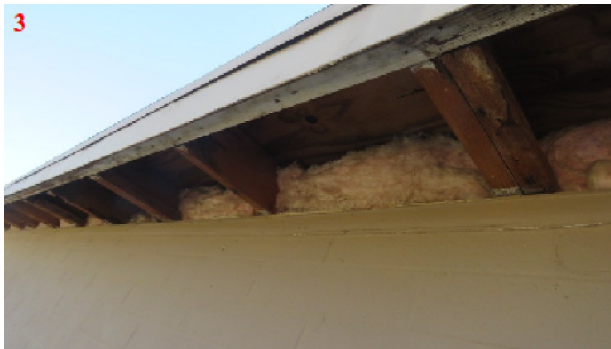
Service/Repair Soffit\Eaves\Fascia - Wood

The house soffit area is covered with wood except the area behind the laundry all the soffit covering wood has been removed. The soffit covering is bowed down in the back. Recommend replacing the soffit covering or installing bird blocking at all the areas between the rafters to keep pests out of the attic. Recommend a qualified contractor evaluate and make all necessary repairs.

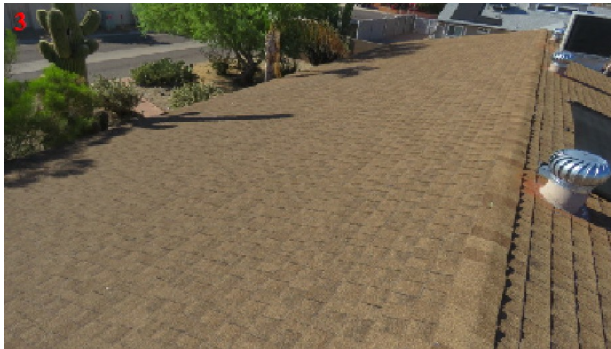
Service/Repair Roof Covering - Asphalt Shingles

The asphalt shingles are a multilayer or multidimensional and are showing sign of wear with loss of rock cover on the edge and bottoms of shingles. Recommend a qualified roofing contractor evaluate and make all necessary repairs.

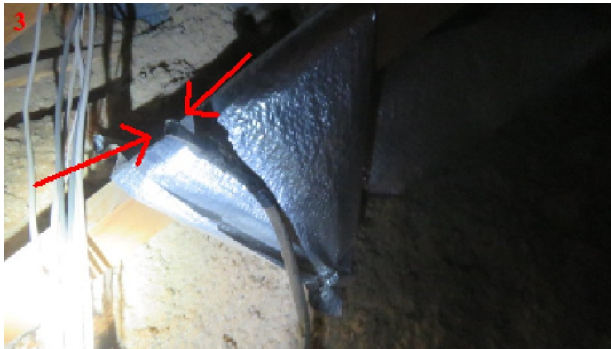
Spliced wires in attic not properly installed in electrical junction box. This is a shock hazard. Recommend placing all spliced wires in an electrical junction box. Recommend a qualified electrical contractor make all necessary repairs. See Picture

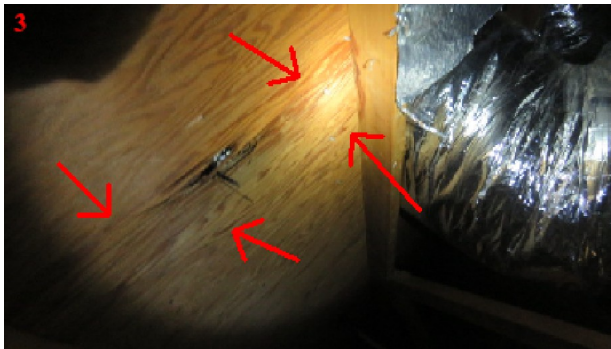
Service/Repair Attic Leaks - Sheathing

Signs of prior roof leaks in attic. Sheathing has water stains in several areas. Recommend asking seller if this problem has been solved and if not recommend a qualified roofing contractor evaluate and make all necessary repairs. See picture

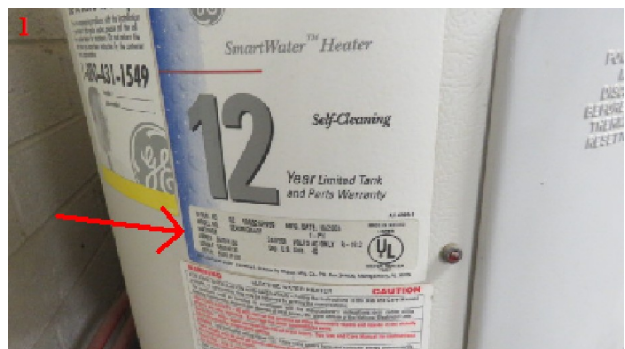
Satisfactory Water Heater 1 Rated BTU/Watts - 5500

5500 watts.

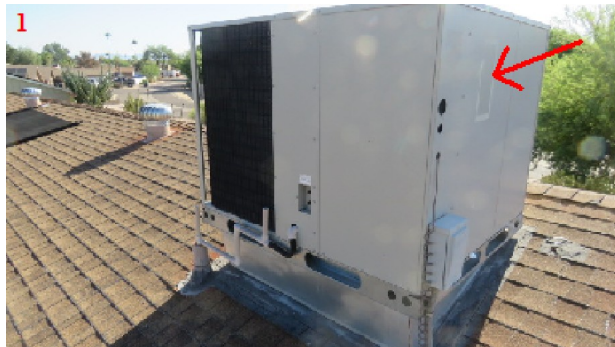
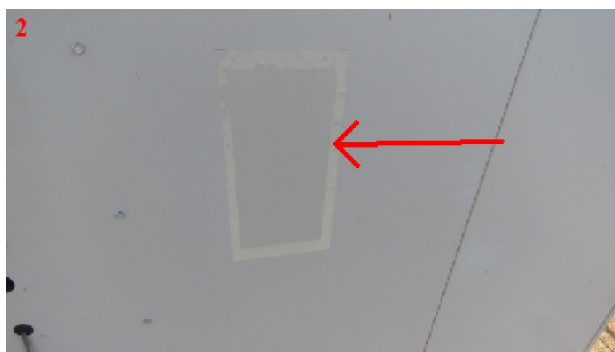
Cooling System(s) - No Service Tag

Tag on unit either non-legible or missing. All or some of the information in this section assumed.

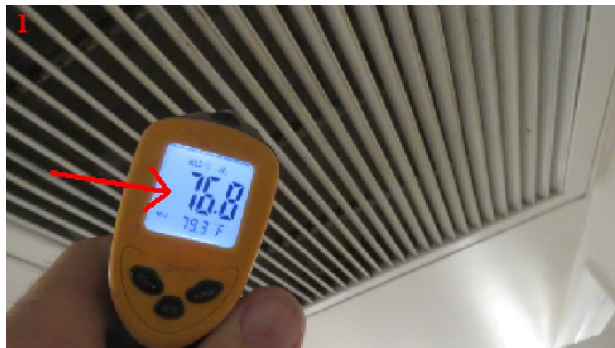
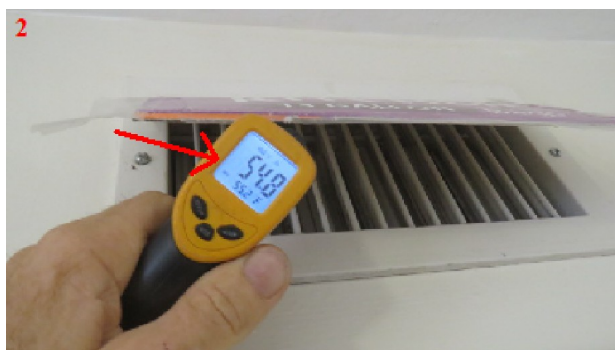
Differential Temperature(s) - Inspected, Details

A differential temperature between 16 and 30 degrees is considered good for a air conditioning system. Over 30 the unit may have a clogged filter or other problem which may cause the unit to ice up. For a split of 16 degrees and lower and for units with a split of 30 degrees and higher I recommend the AC unit be serviced. Unit one has a 22 degree split.

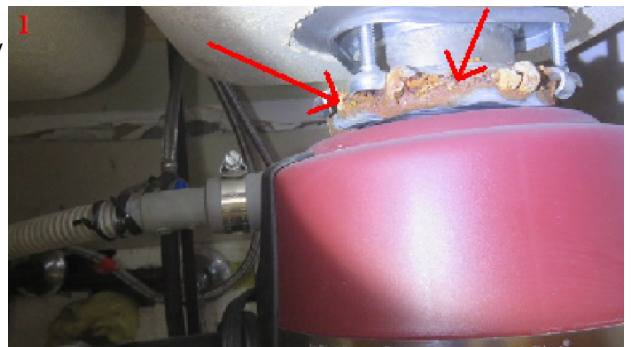
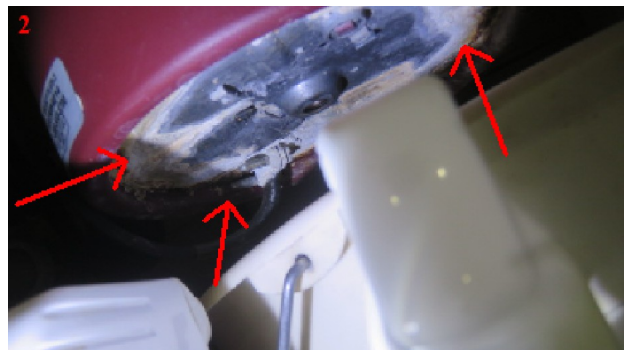
Rust at the top and bottom of the disposal.

Recommend a qualified contractor evaluate and make all necessary repairs.

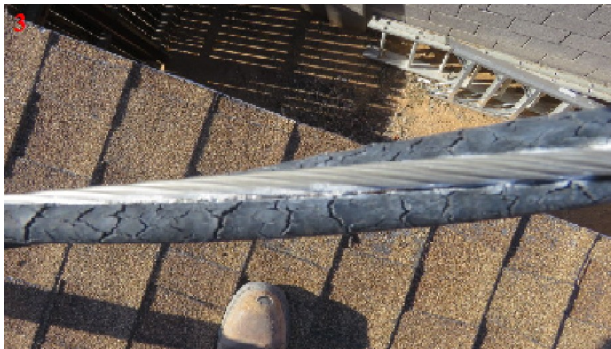
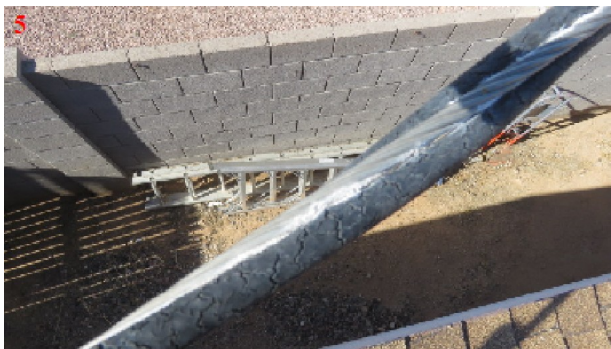
Solar energy cells installed to assist in electric power for this home. Recommend inspection solar panel leased carefully before buying. Solar energy systems are observed for obvious signs of defects but not operated or tested by the home inspector.

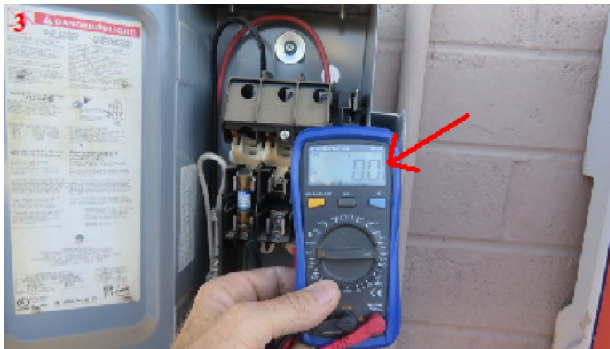
Service/Repair Main Elect. Panel Location - Side of House

The solar panel control panel is blank. No visible data. This is a defect. The solar panels on the roof are not providing any usable electricity. Zero volts recorded. Recommend a qualified contractor evaluate and make all necessary repairs.

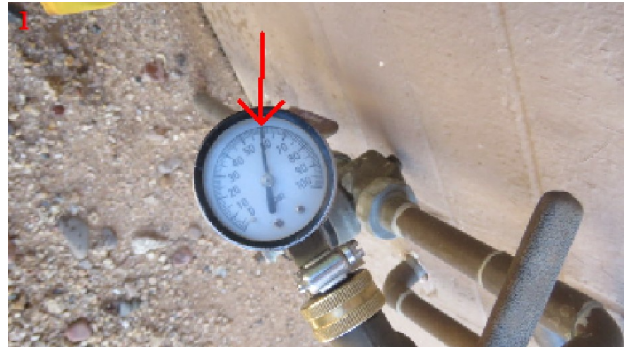
Satisfactory Water Pressure - 40 to 80 PSI

Water pressure recorded today was 60 psi.
Recommended water pressure between 40 to 80 PSI.

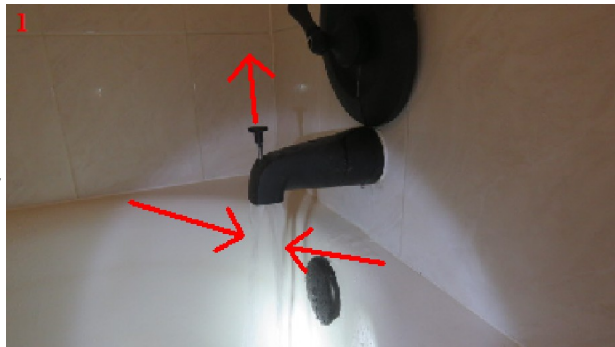
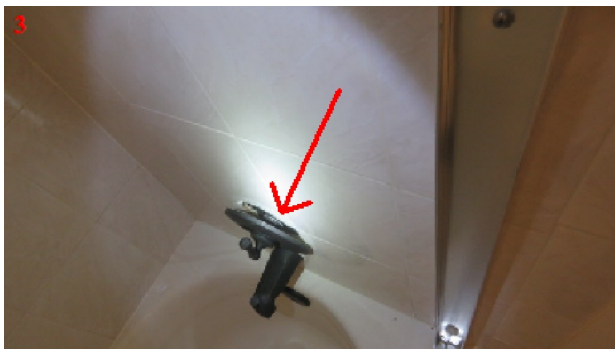
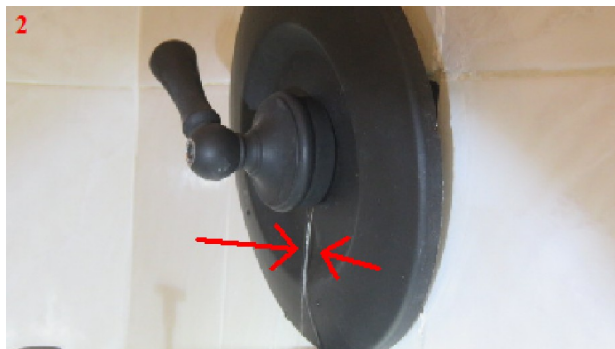
Trim on the front of the shower valve is not properly attached to the wall.

Recommend a qualified contractor evaluate and make all necessary repairs.
