# Home Inspection

**Property Address:**  
11021 McArthur Rd  
Atlanta MI 49709

**Hawkeye Home Inspection Co**

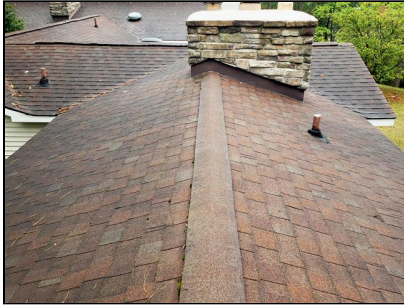
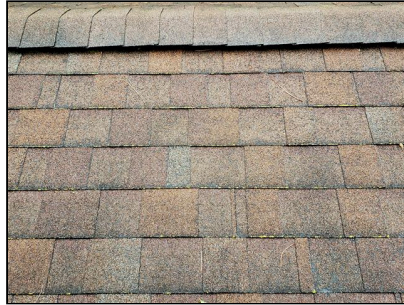
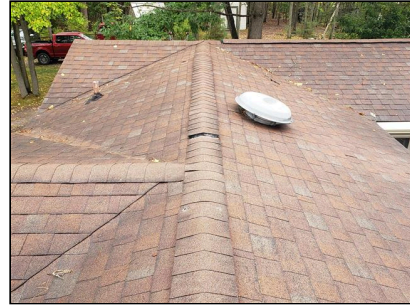
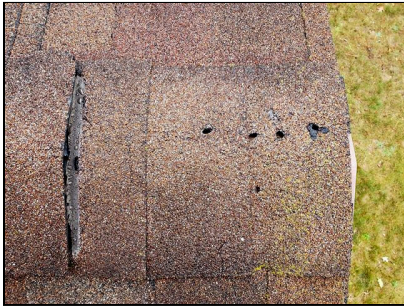
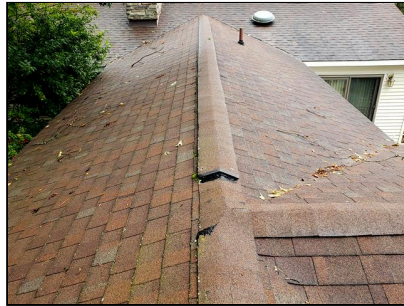
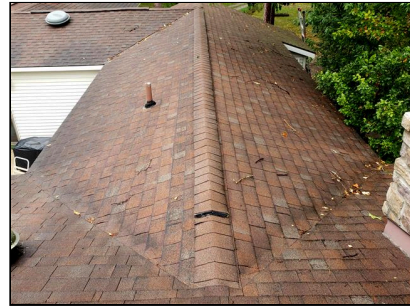
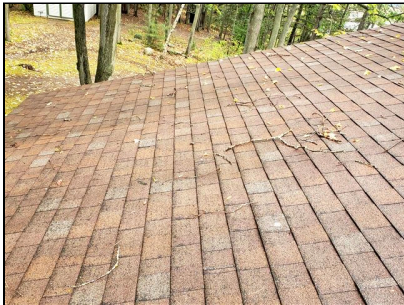
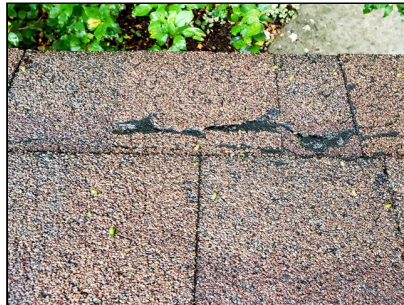
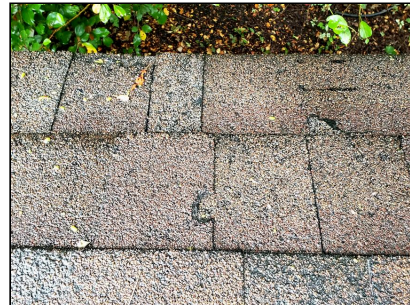
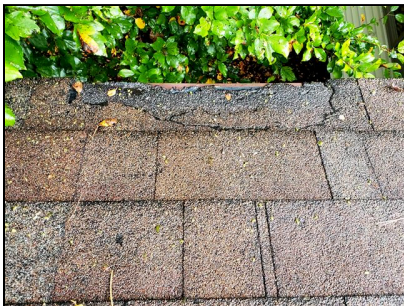
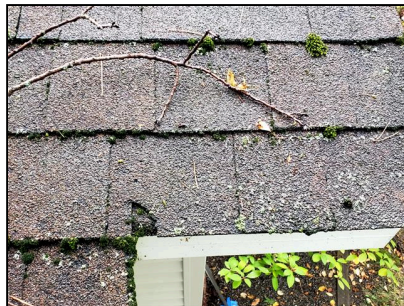
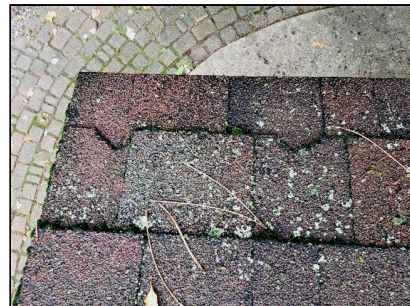
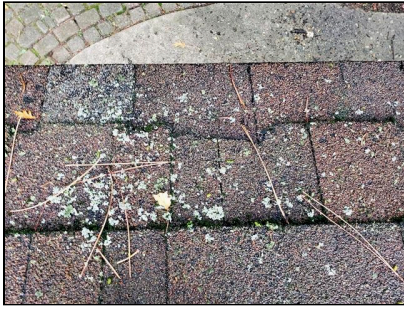
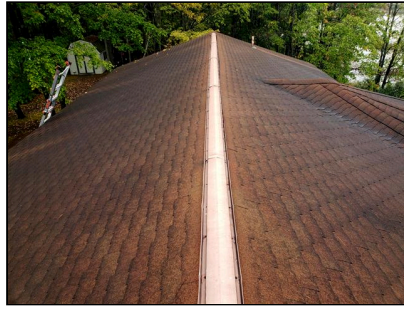
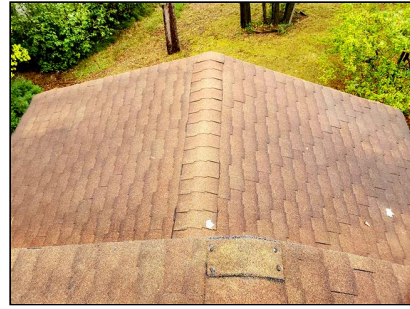
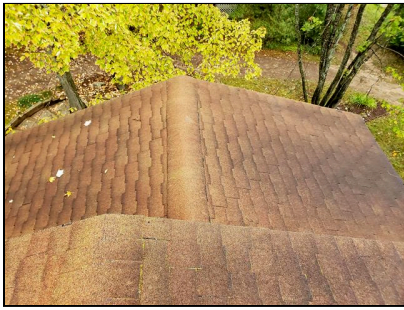
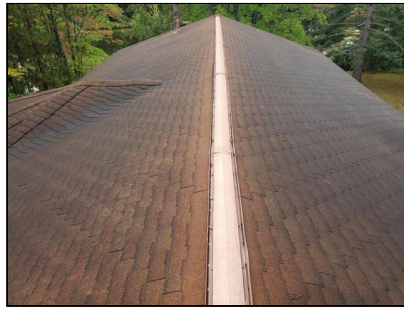
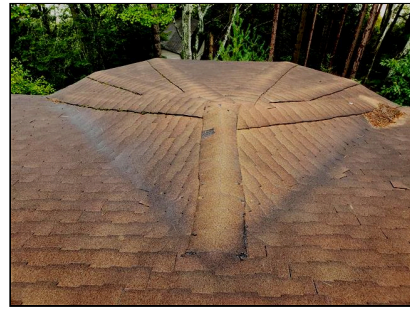
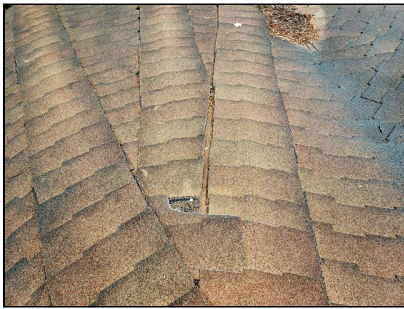
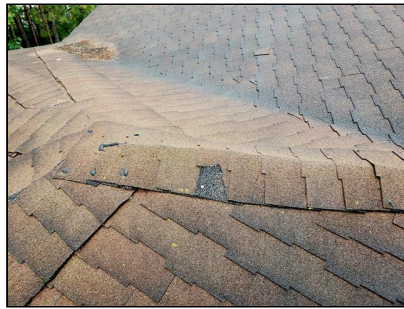
**1.0** The roof covering is old, and the life of covering has almost expired. The covering does need to be replaced within the next 3 years. While it could last a couple years or so, some areas may need patching with tar as leaks develop. NOTE: All areas of shingle tabs missing should be sealed with a roofing tar to help prevent water leaks until new roofing is installed.

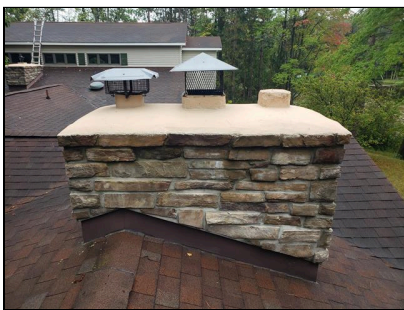
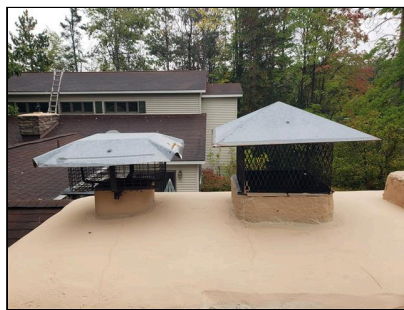
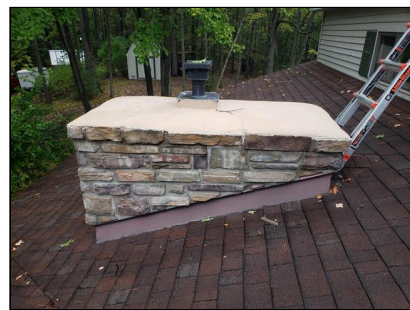
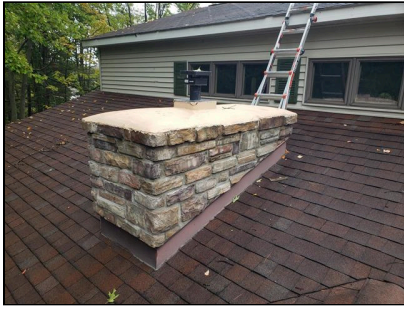
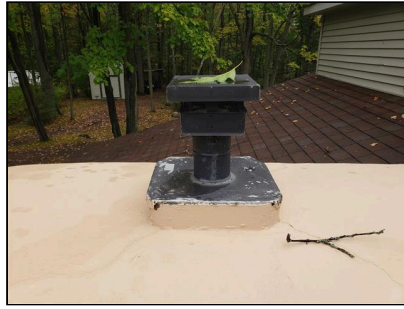
**1.1** The chimney mortar and bricks appeared to be in satisfactory condition and well maintained at both chimneys. There were crown assemblies installed on the flue pipes to prevent water and weathering elements from entering the chimney.

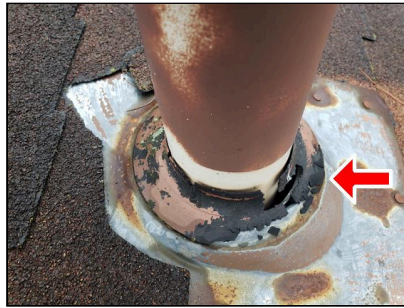
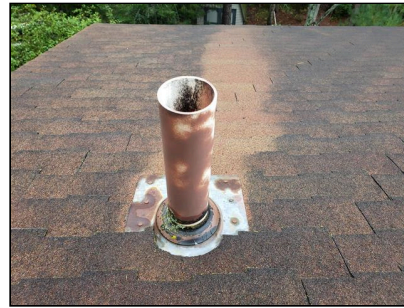
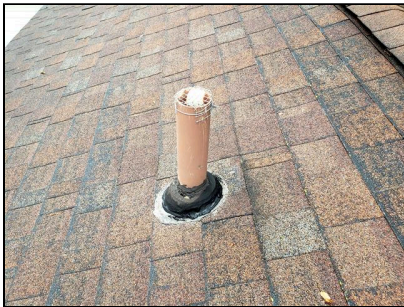
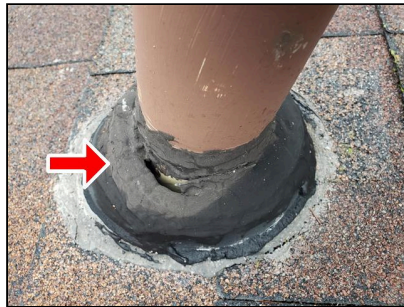
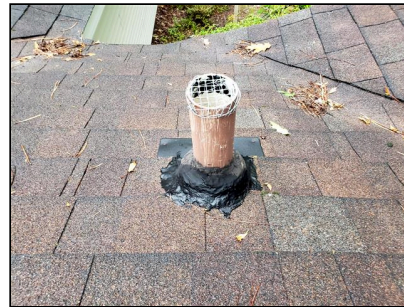
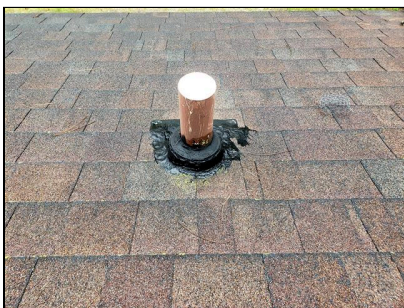
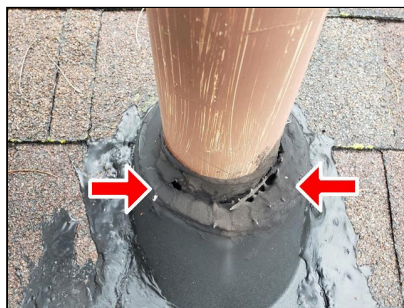
**1.2** (1) PVC vent pipe was in satisfactory condition when inspected. The rubber boot flashing was damaged/ cracked and needs to be repaired. The cracks can allow water to seep into the attic space and deterioration and mildew can accrue. Recommend a contractor to replace the rubber boot flashings as needed.

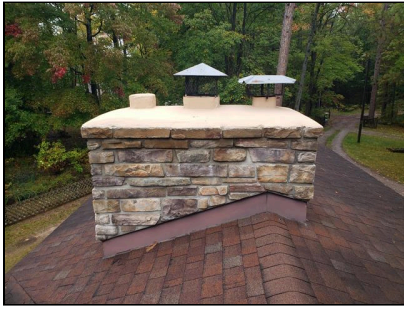
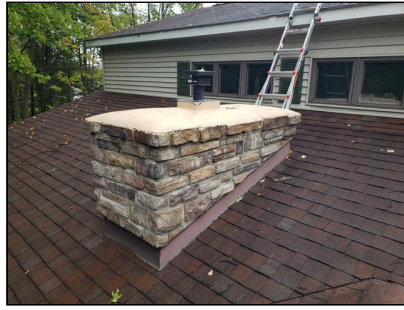
(2) Flashings appeared to be in satisfactory condition (viewed from walking the roof).

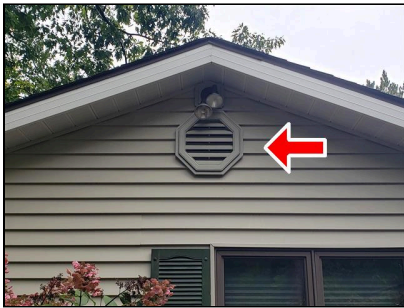
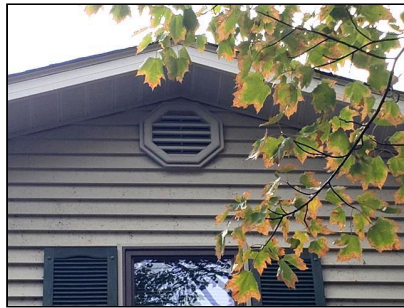
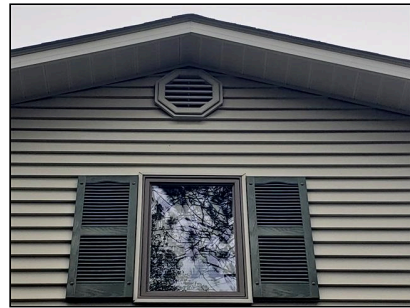
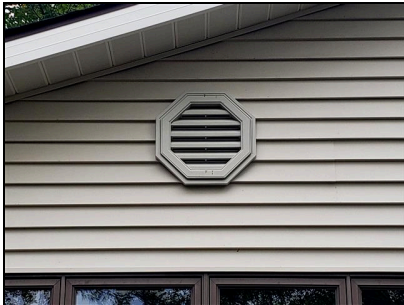
1.4 Ridge vents, gable vents and soffit vents were installed for attic ventilation.

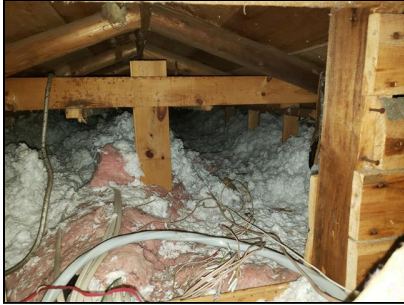
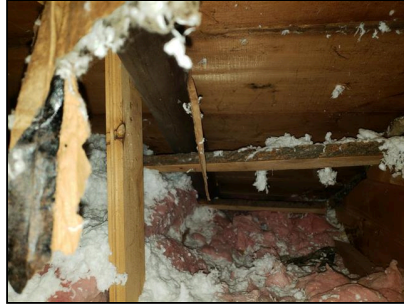
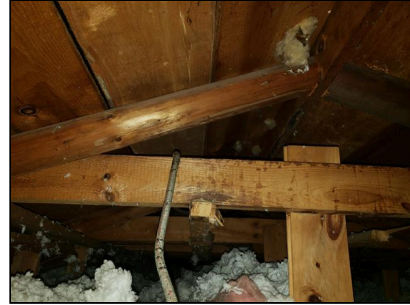
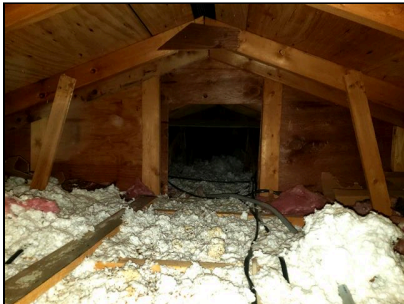
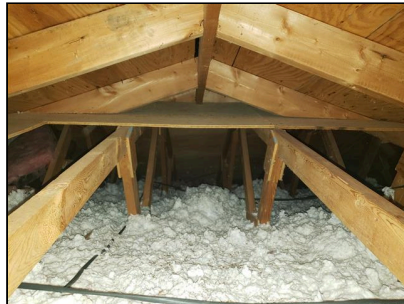
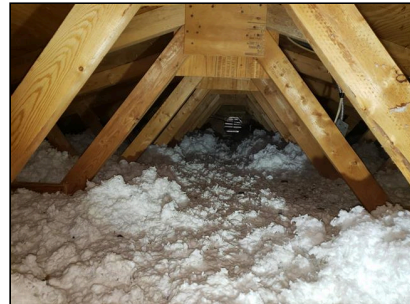
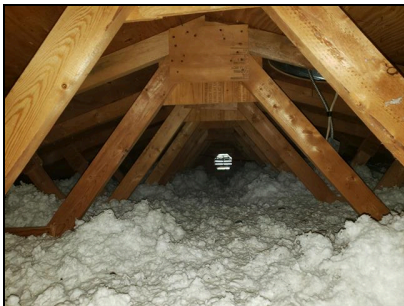
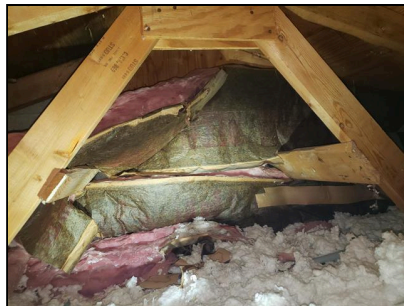
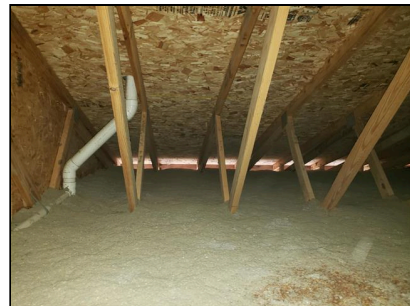
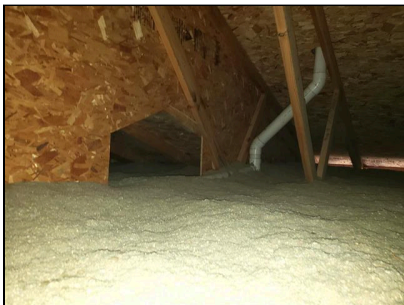
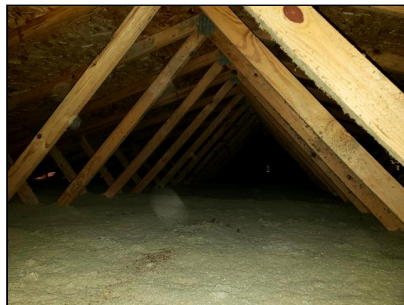
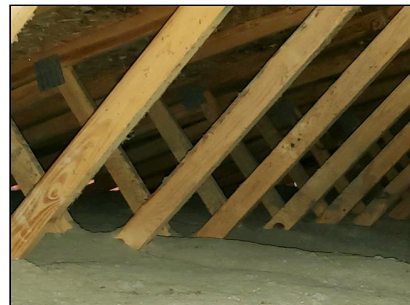
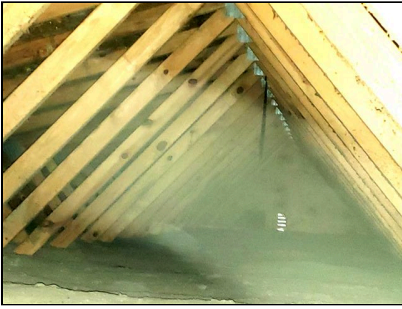
1.5 Attic was in overall satisfactory condition. Trusses showed no major defects or damage at the time of inspection. Rafters appeared to be in overall adequate condition.

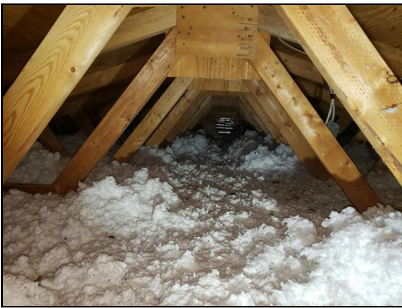
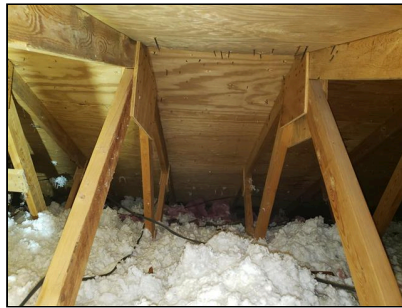
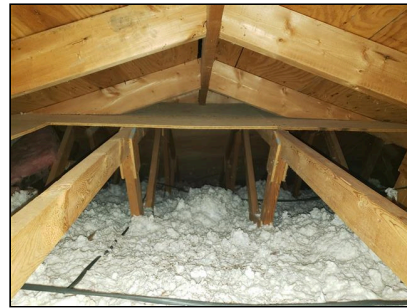
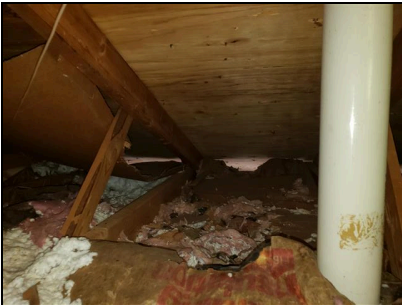
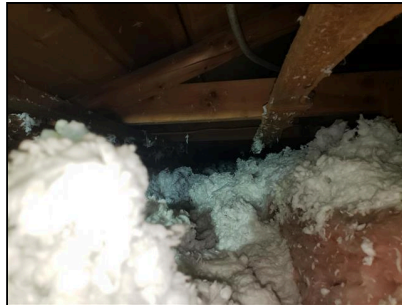
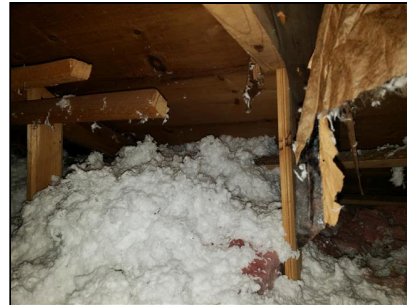
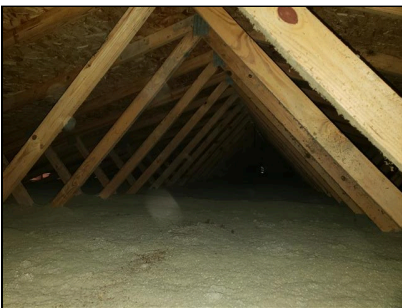
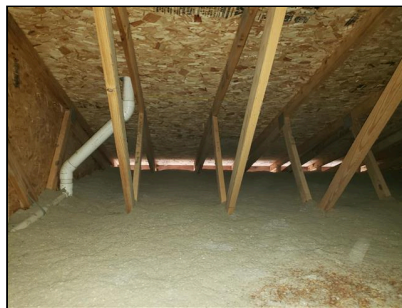
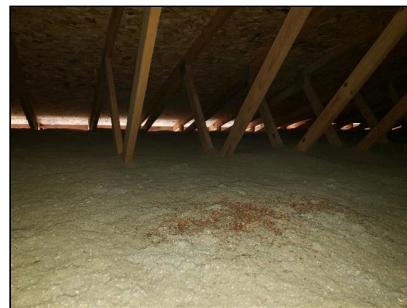
**1.6** The attic was well insulated at the small attic space that could be viewed, insulation was sufficient at 12+ inches, R-38.

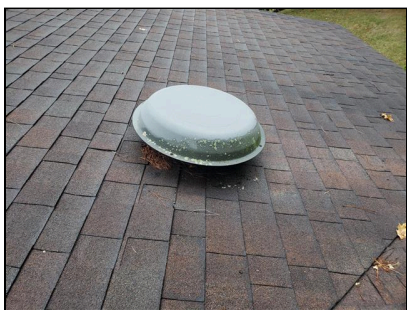
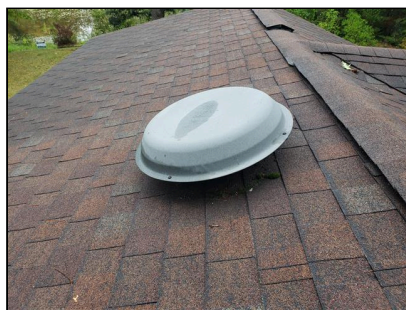
**1.7** The roof vents installed were in satisfactory condition at time of inspection.

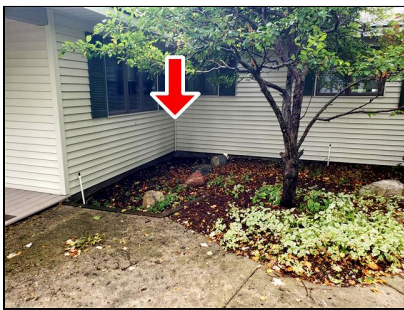
2.0 Item 1(Picture)

**2.0 (1)** There were a few areas around the house where the grading was low. Recommend back filling for proper drainage away from the house. May consider installing gutters and down spouts where grade is low to help move water shed from areas of foundation where water can puddle.

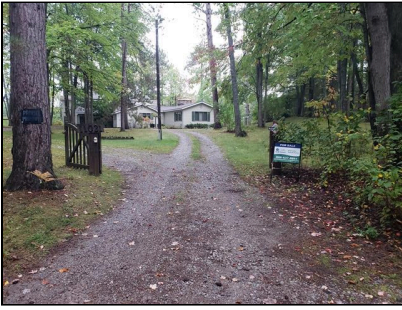
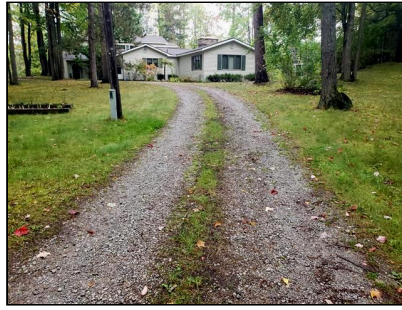
(2) The gravel driveway was in satisfactory condition when inspecting the home.

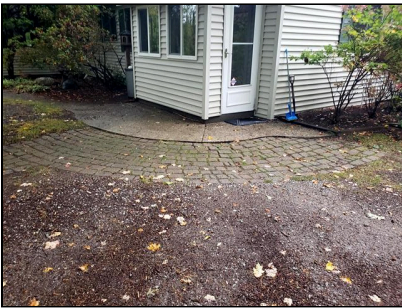
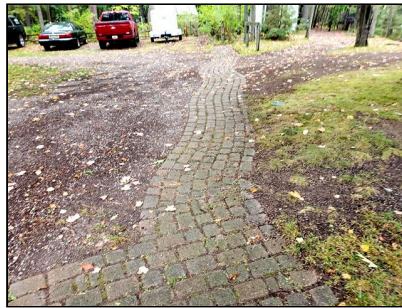
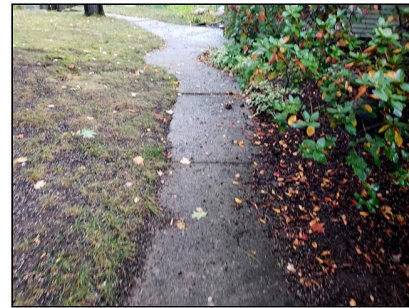
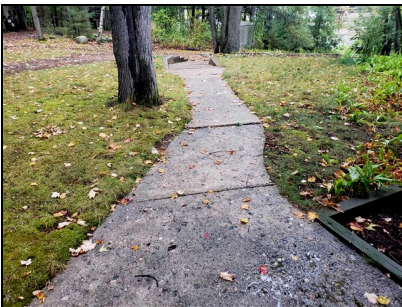
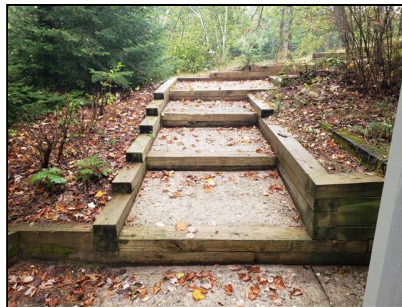
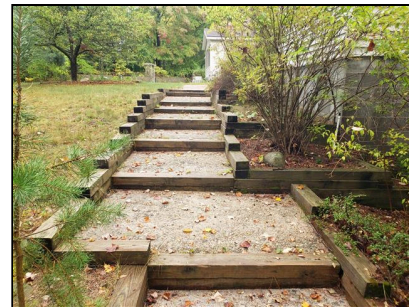
(3) The concrete walkways were in satisfactory condition when inspecting the home.

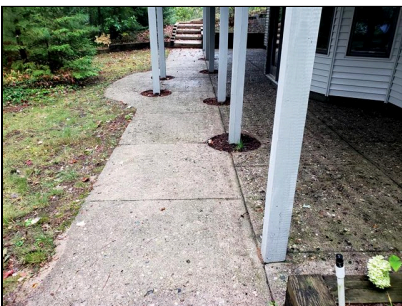
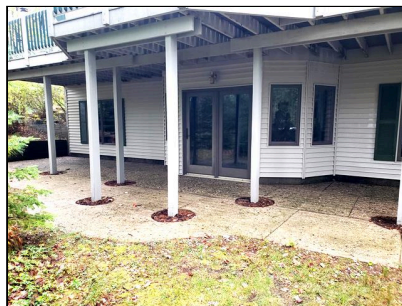
(4) The concrete patio was in satisfactory condition when inspecting the home.

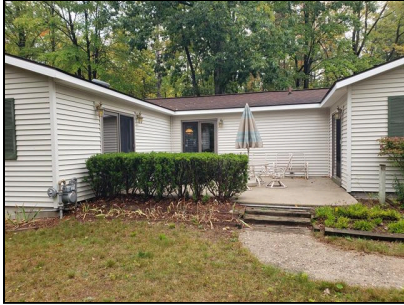
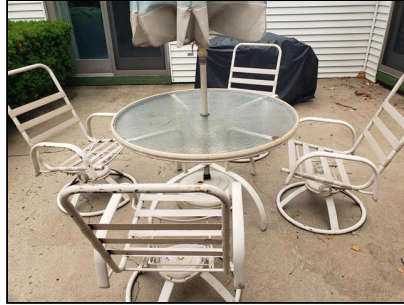
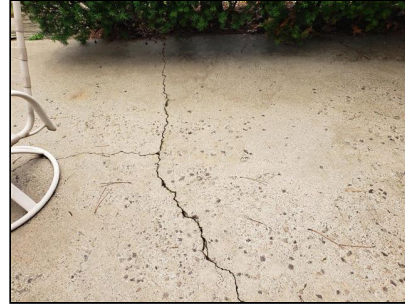
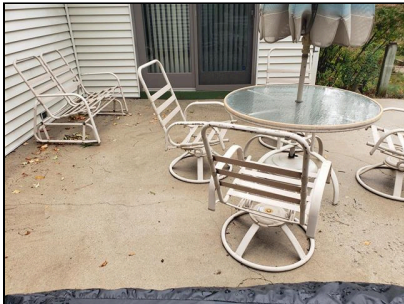
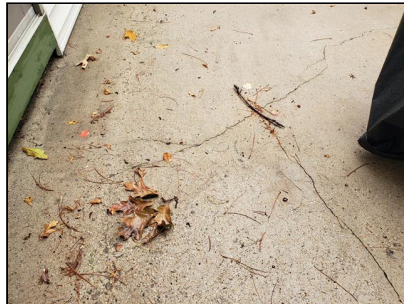
(5) The back patio has cracks and some are slightly gaping. This is for your information and may consider applying a sealer to help prevent further cracking and displacement.

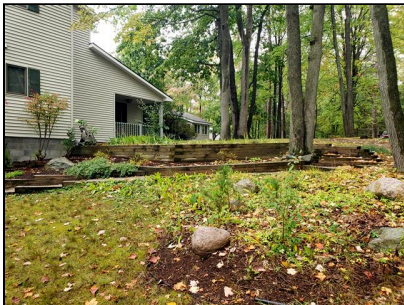
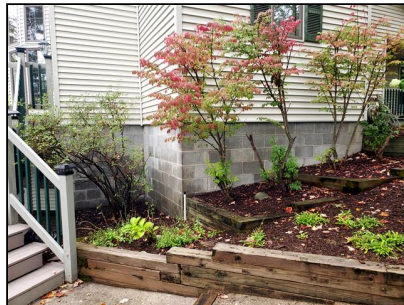
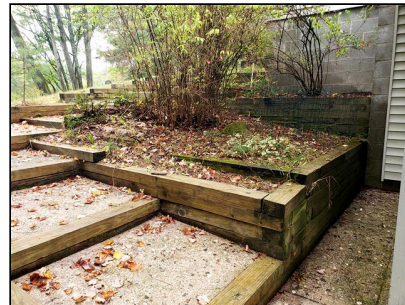
(6) Wood retaining walls were in satisfactory condition at time of inspection.

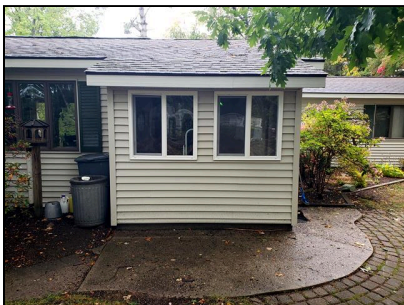
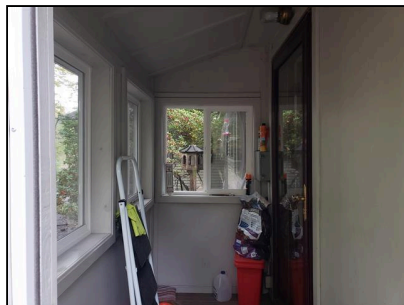
**2.1** (1) Small mud room was in satisfactory condition at time of inspection.

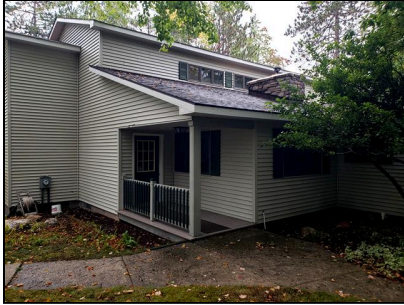
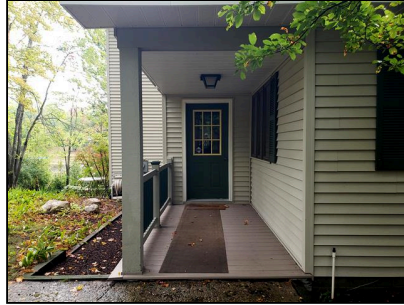
(2) East side porch is in overall satisfactory condition. The decking and handrail was in satisfactory condition when inspected. Recommend keeping the side walk cleaned and salted in the winter season.

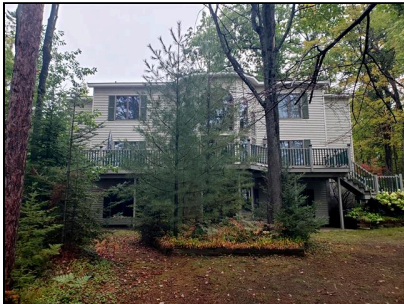
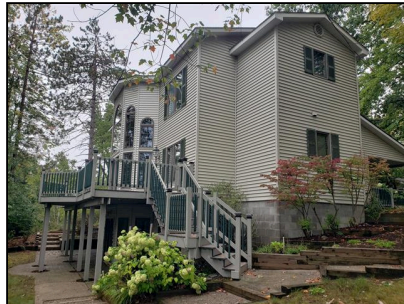
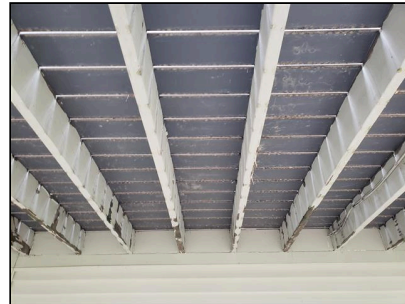
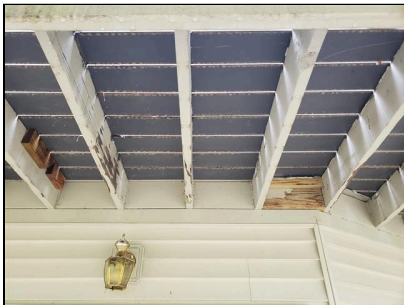
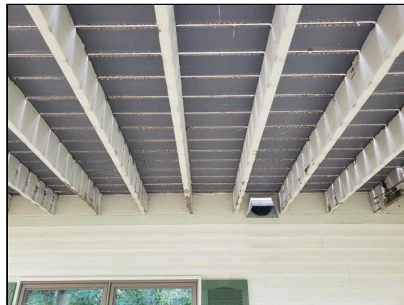
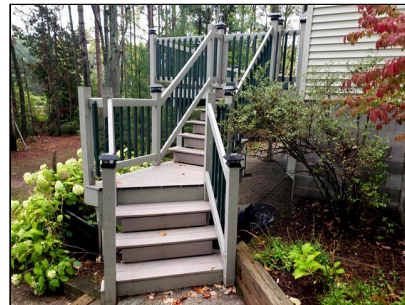
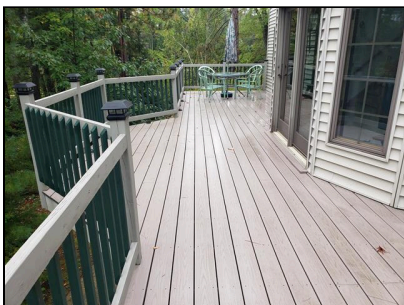
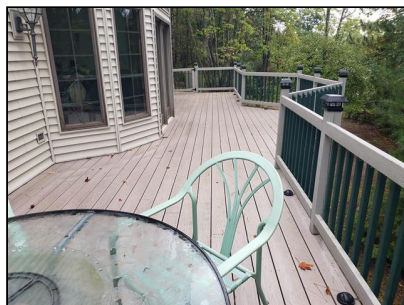
(3) The front deck was in satisfactory condition and well maintained. Decking boards and handrails were well maintained and sealed. NOTE: There were areas of paint/sealer peeling at the under side of the lake side deck. Recommend a qualified person to prep and paint all areas of peeling sealer as needed.

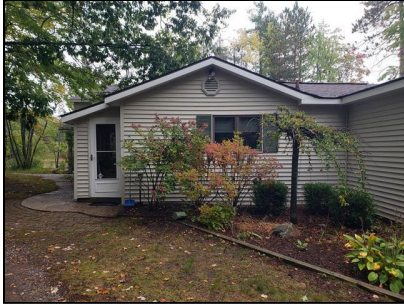
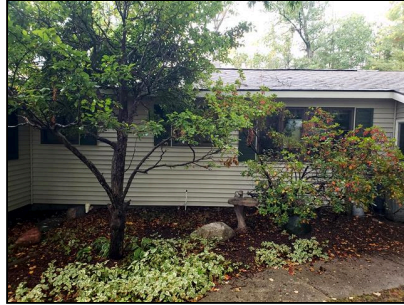
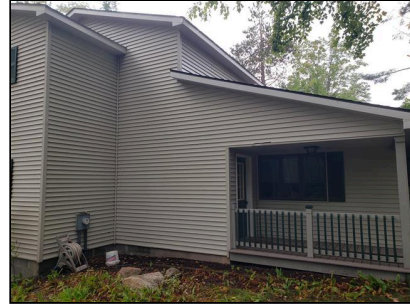
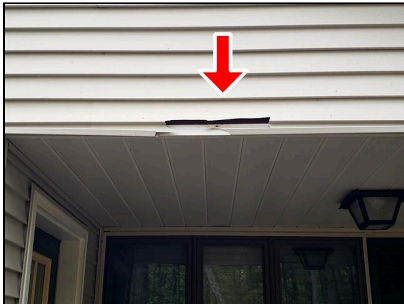
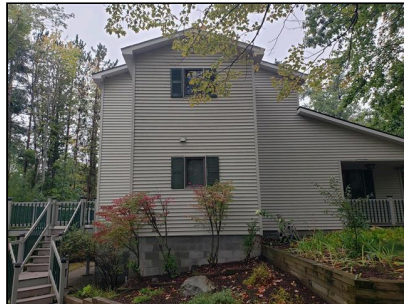
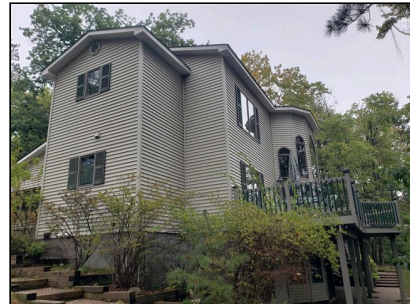
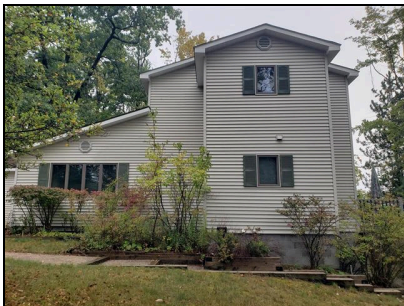
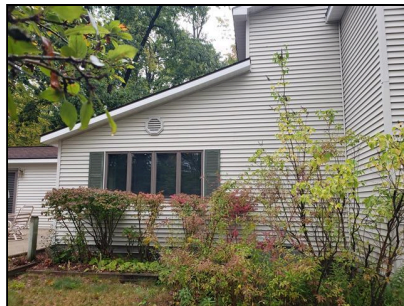
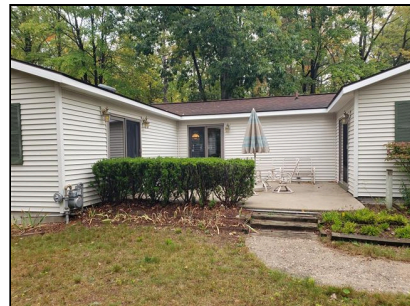
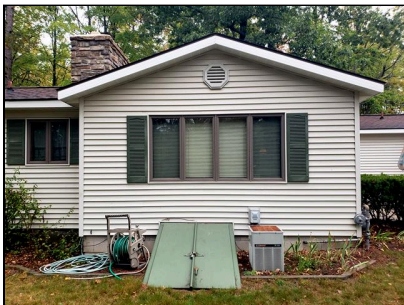
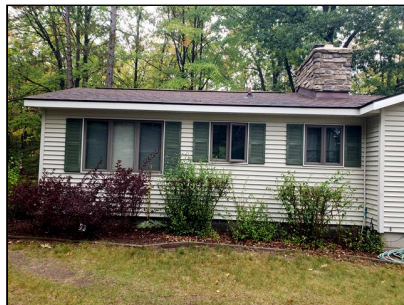
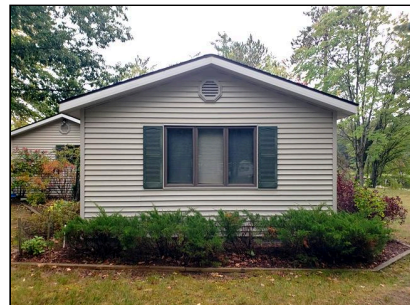
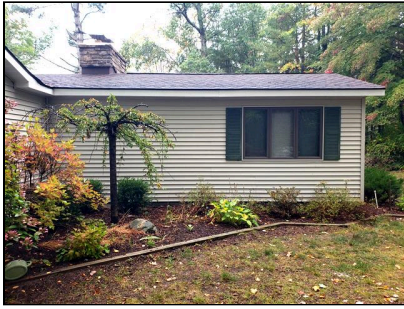
2.2 The vinyl siding was in overall satisfactory condition at time of inspection. There were a couple small cracks and breaks on the siding. Recommend repair as needed.

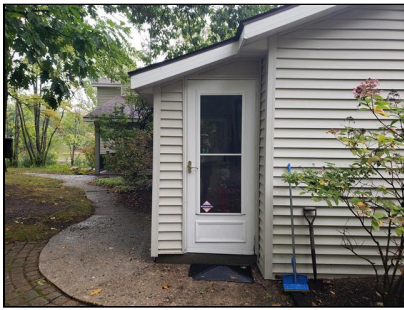
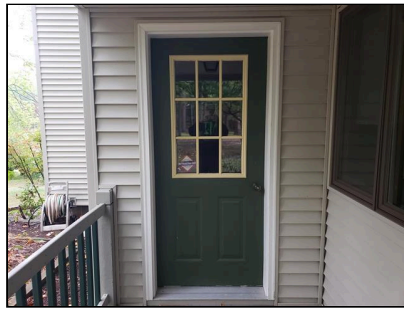
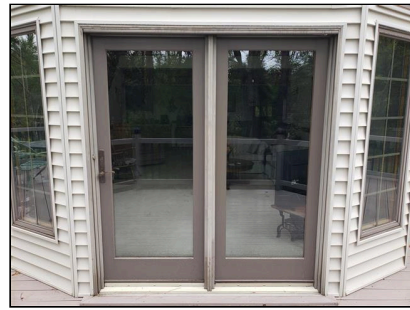
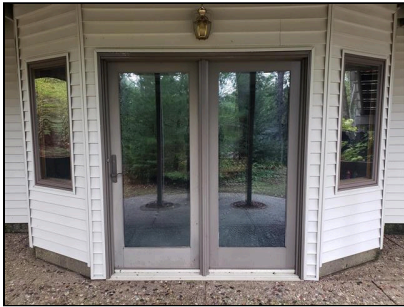
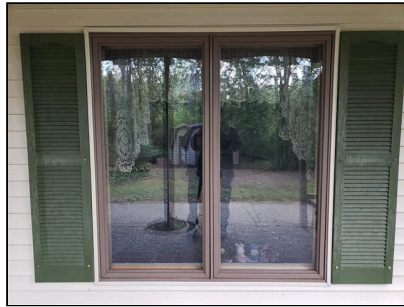
2.4 The entrance doors, storm doors, french doors and patio doors were in satisfactory working condition at time of inspection.

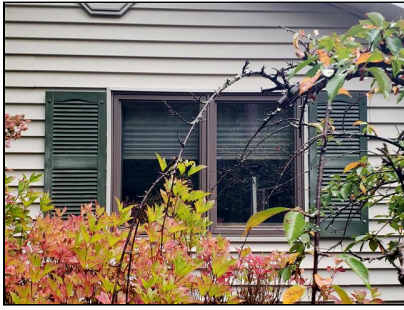
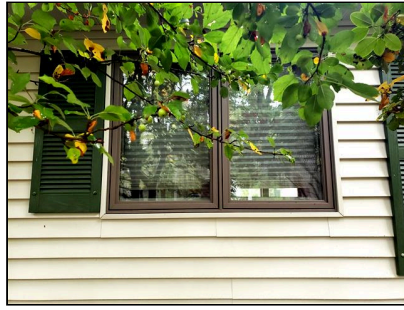
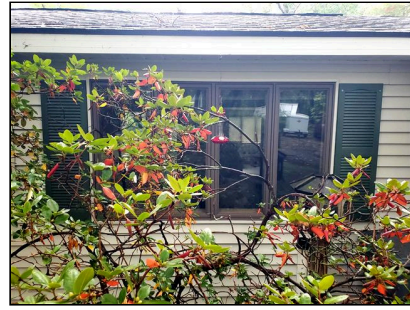
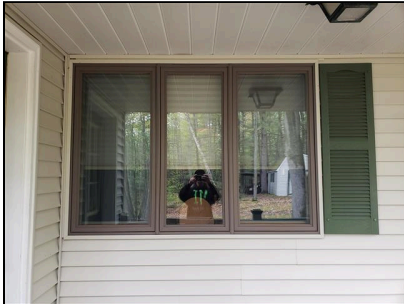
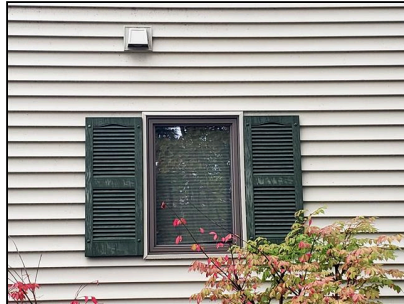
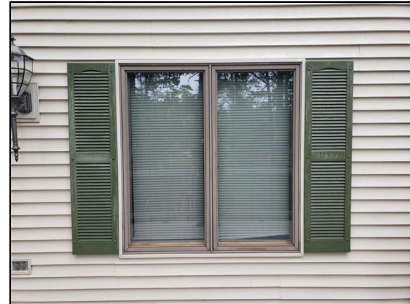
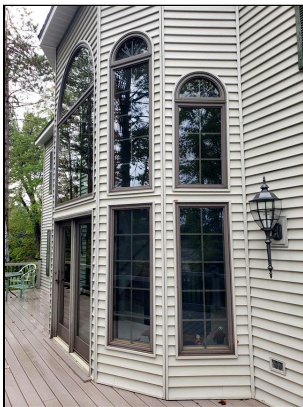
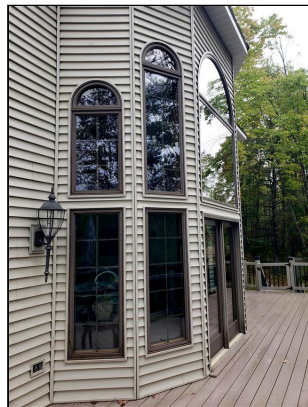
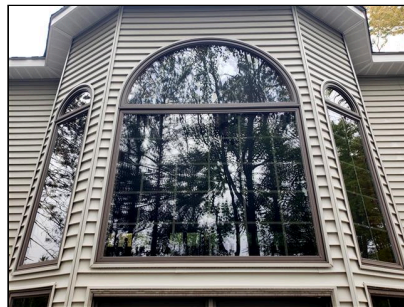
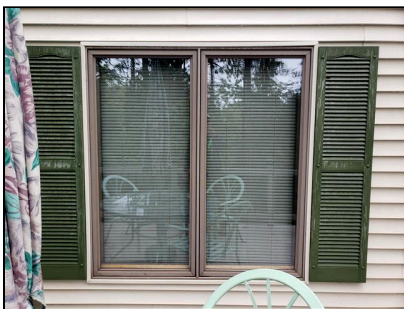
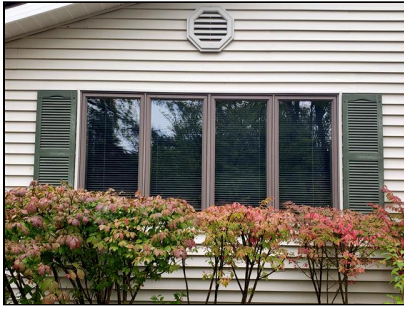
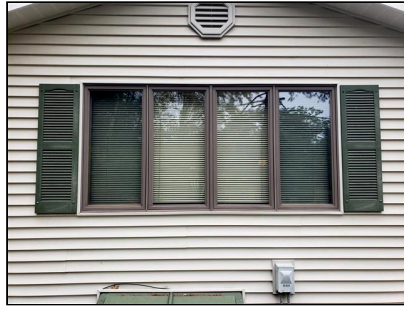
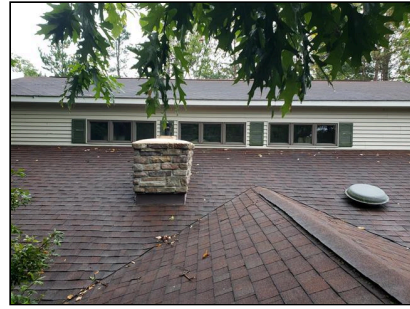
2.5 The exterior window frames were in overall satisfactory condition.

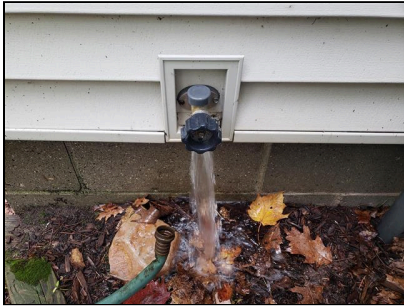
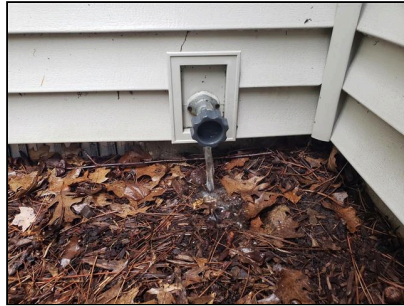
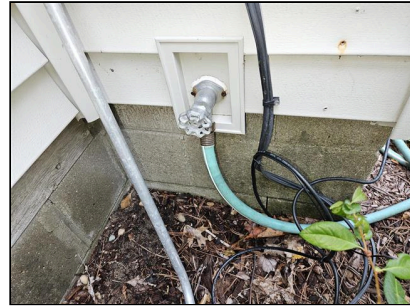
2.6 Exterior hose bibs were frost free and were in working condition when tested.

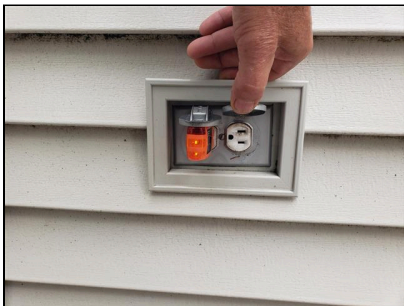
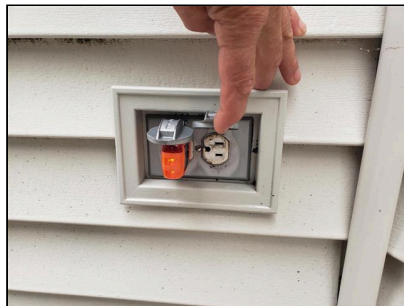
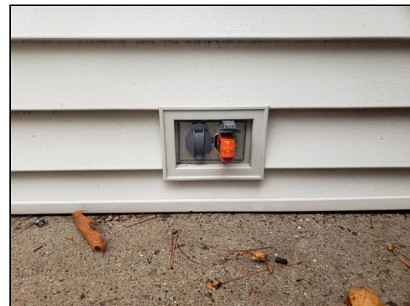
2.7 The exterior outlets were not GFCI outlets (Ground Fault Circuit Breakers), but were grounded when tested. Recommend replacement of outlets. NOTE: All exterior outlets would be required to be on a GFCI system with new construction. This is for your information. Recommend a contractor to repair as needed.

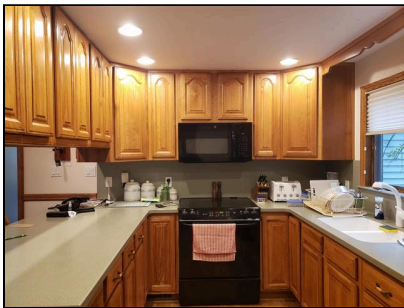
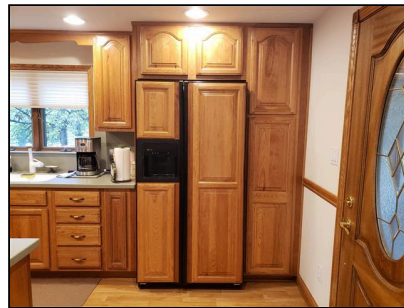
**3.0** Kitchen cabinets and counters were in overall satisfactory condition.

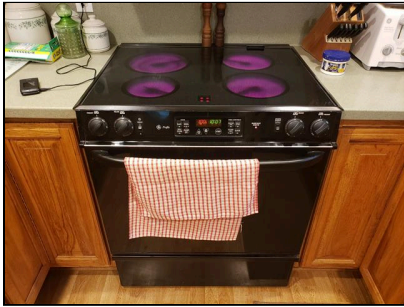
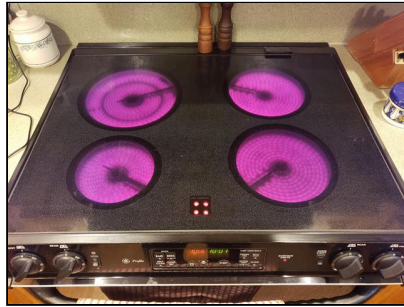
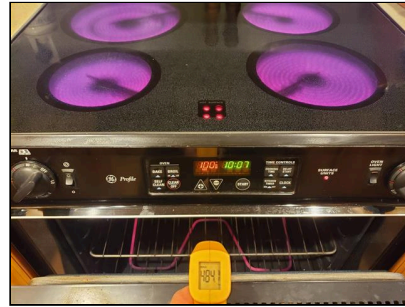
3.6 Stove was in working condition at the time of the inspection. Heating temperature in oven was not tested for accuracy, which is beyond the scope of this inspection.

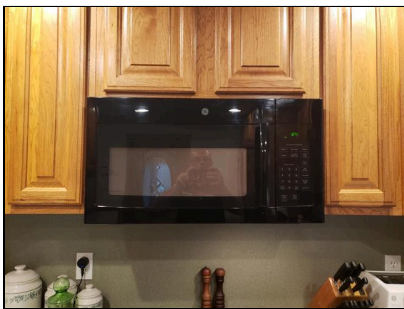
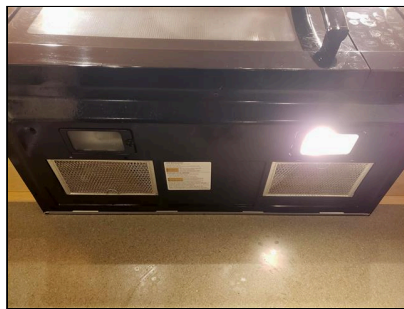
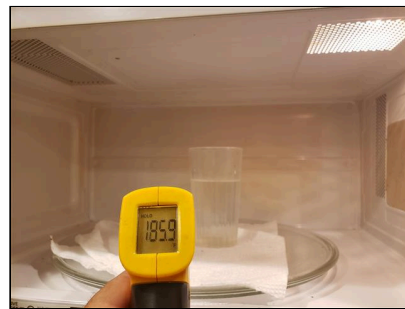
3.7 Range exhaust fan and light on microwave, and microwave are in satisfactory working condition. Microwave was working when tested with a glass of water.

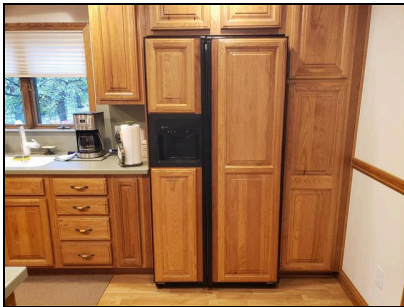
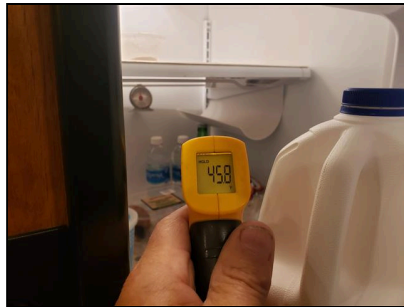
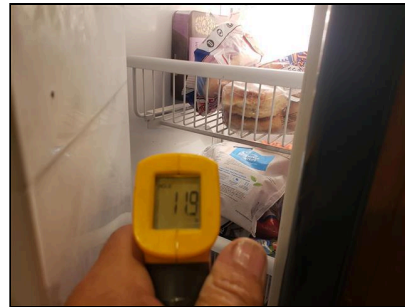
3.8 Refrigerator was in working condition at the time of the inspection. Cooling temperature in refrigerator was not tested for accuracy, which is beyond the scope of this inspection.

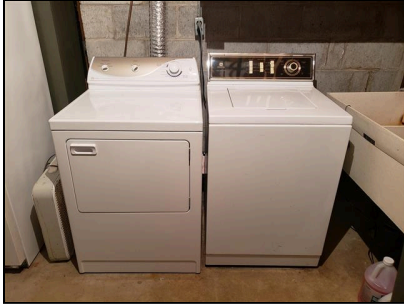
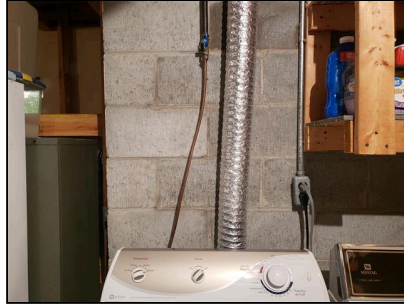
**3.10** Washer and dryer were tested at time of inspection. The dryer was operating from a gas supply and found no electrical supply in area of dryer for a second option.

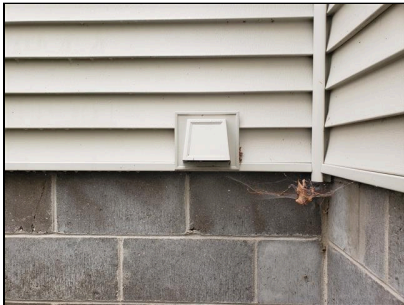
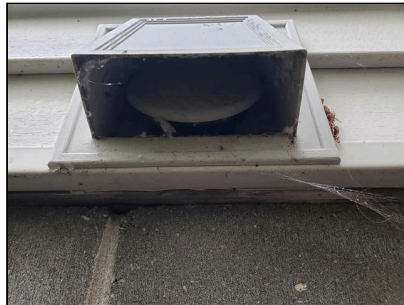
**3.11** The dryer vent is venting outside. The vent should be cleaned occasionally to prevent lint buildup.

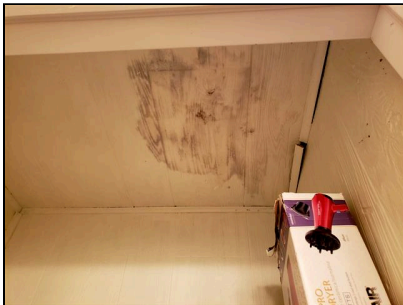
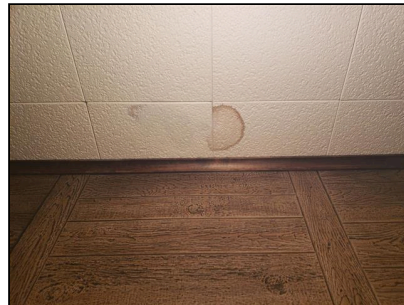
**4.0** Stain marks were present on the ceiling but were dry at the time of the inspection. The stains appear to be from an old leak from bad seals at the vent pipes on the roof.

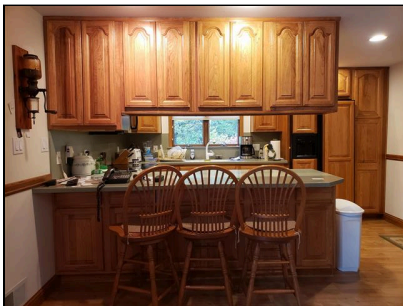
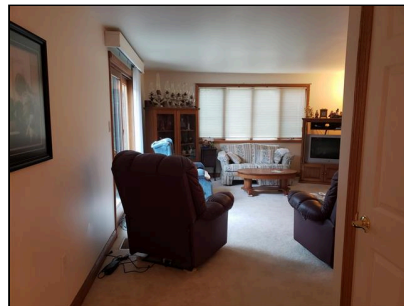
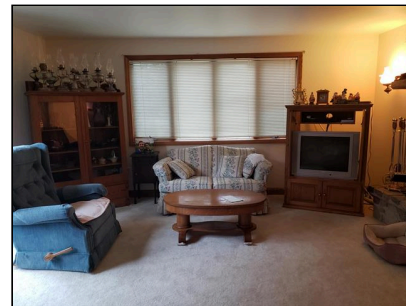
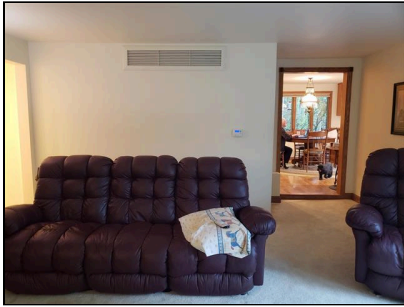
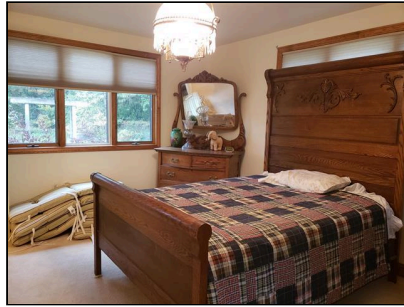
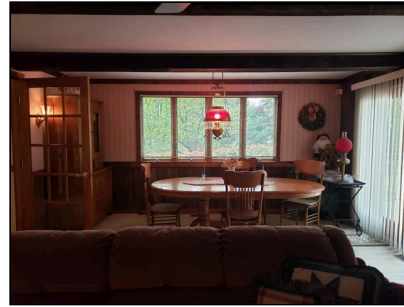
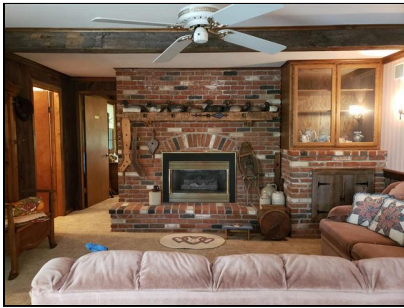
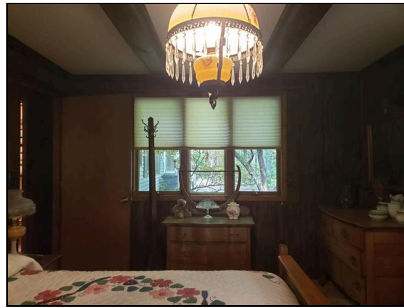
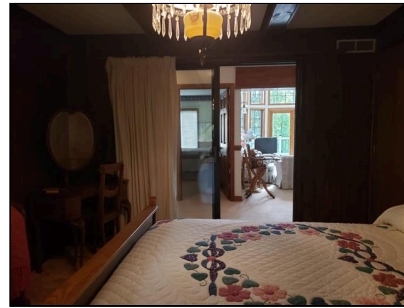
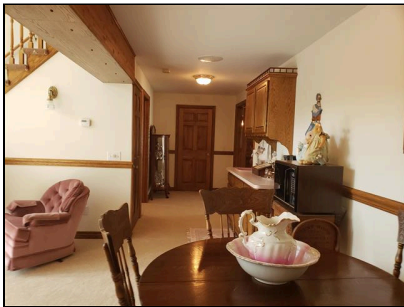
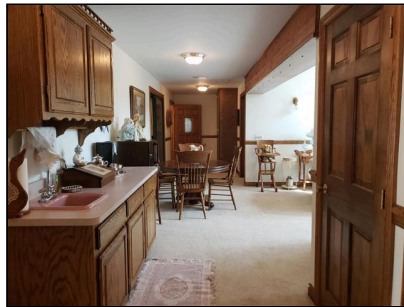
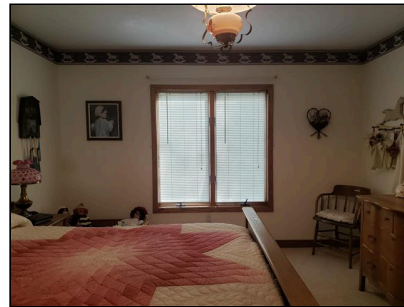
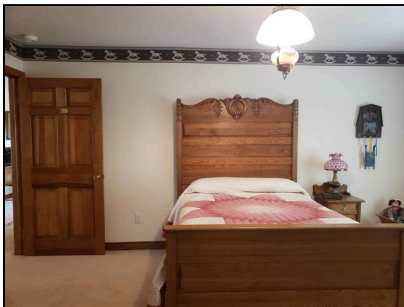
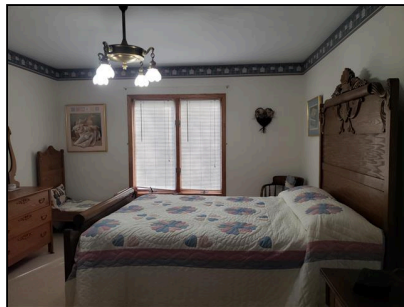
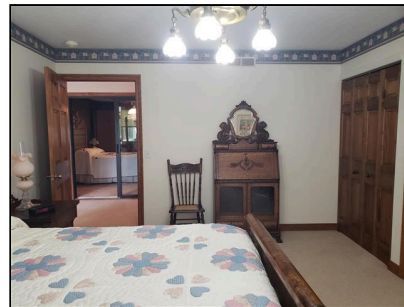
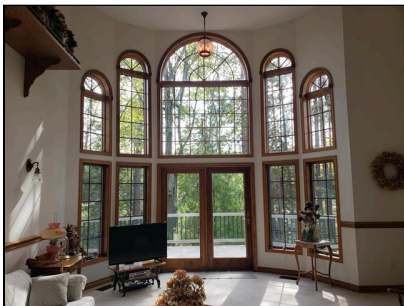
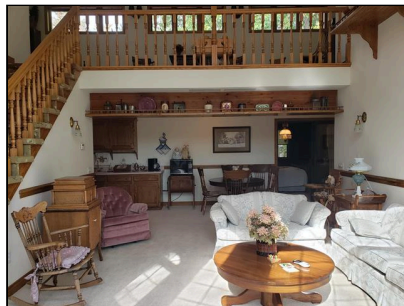
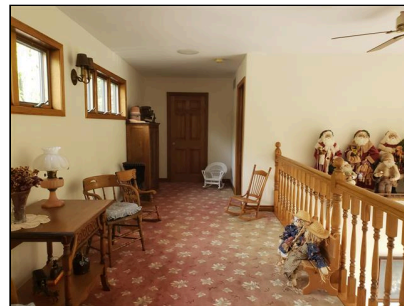
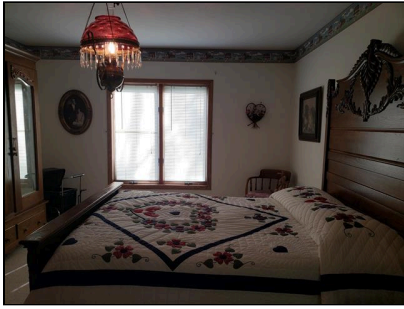
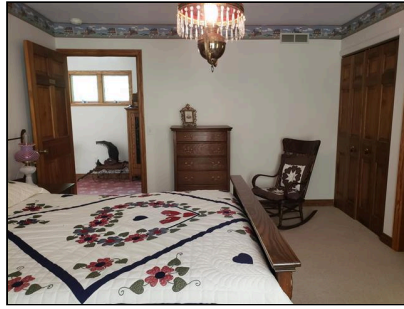
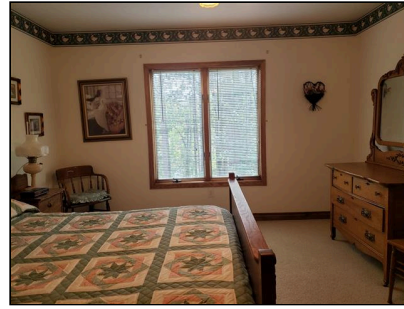
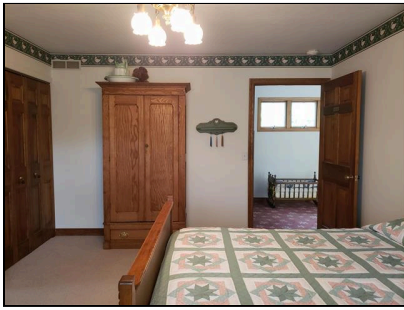
**4.1** Interior walls were in overall satisfactory condition. Drywall had typical hairline cracks in a few areas but no structural deficiencies were visible. Drywall on walls was in overall satisfactory condition with no major defects evident.

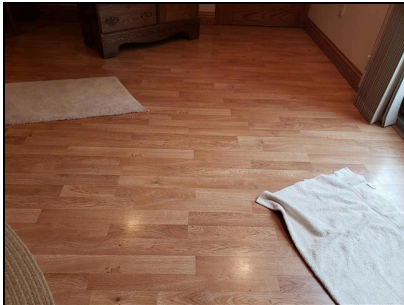
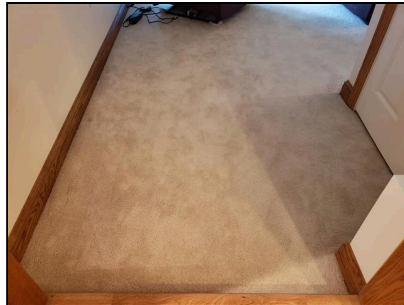
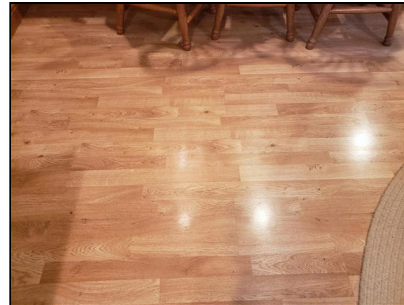
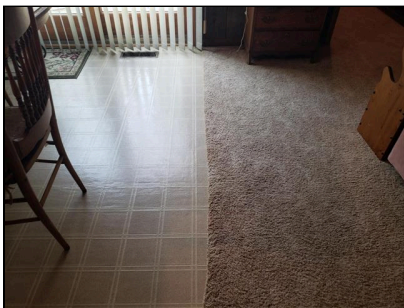
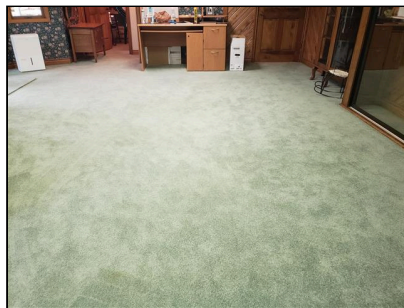
**4.2** Sub floors were solid and appeared in overall satisfactory condition. Floor coverings were in overall satisfactory condition.
