# Home Inspection

**Property Address:**  
11021 McArthur Rd  
Atlanta MI 49709

**Hawkeye Home Inspection Co**

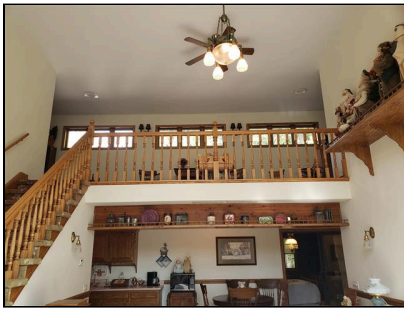
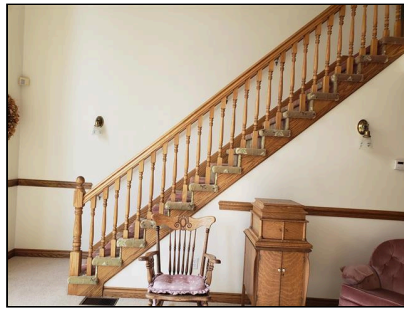
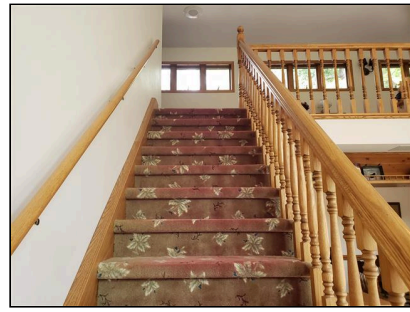
4.3 (1) Stairs and hand railings to second story were in satisfactory condition.

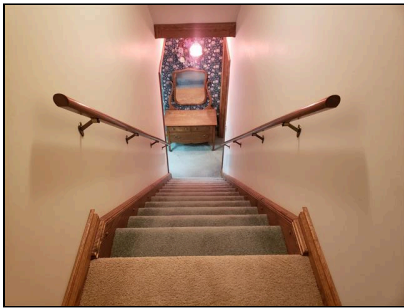
4.3 Item 4(Picture)

(2) Stairs and hand railings to the basement were in satisfactory condition.

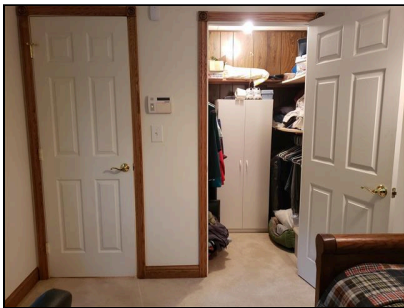
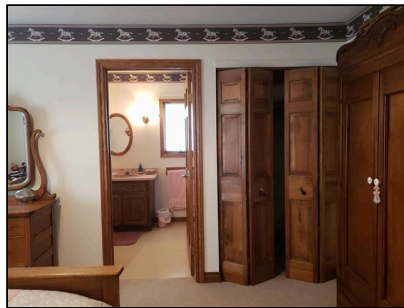
4.4 Interior doors and closet doors were in normal working condition.

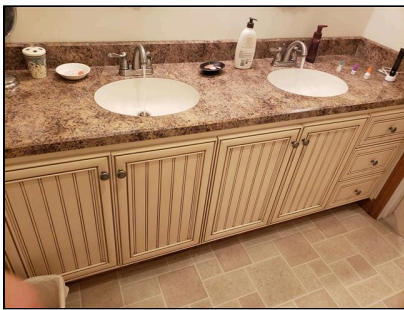
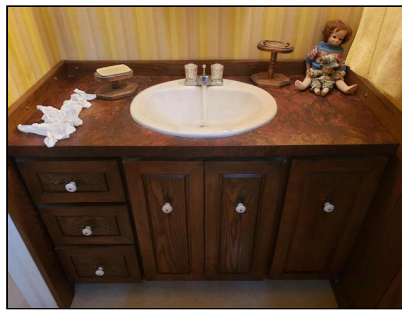
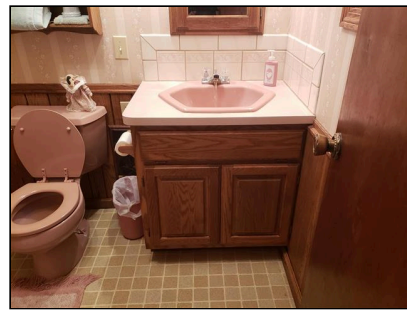
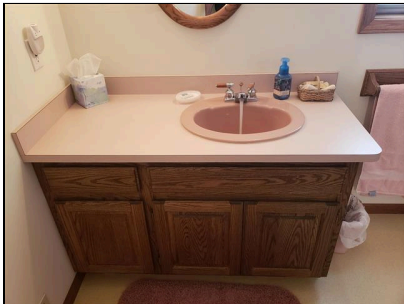
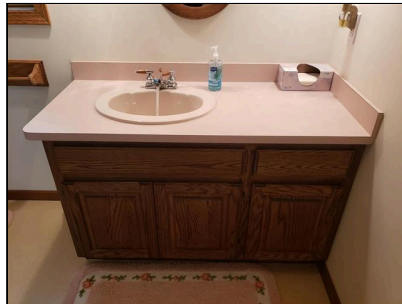
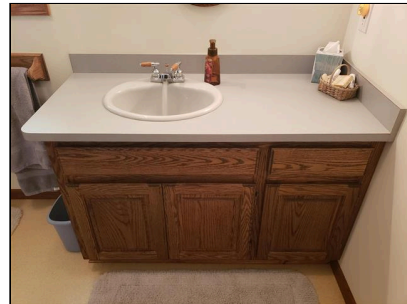
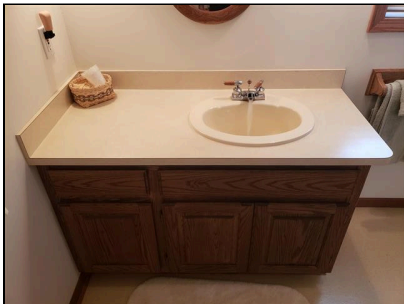
**5.0** Bathroom cabinets and counters were in overall satisfactory condition.

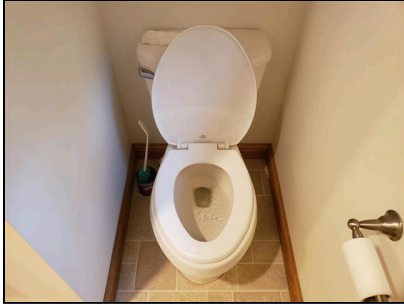
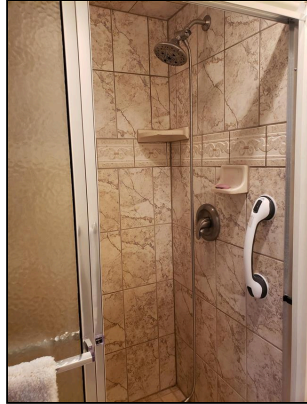
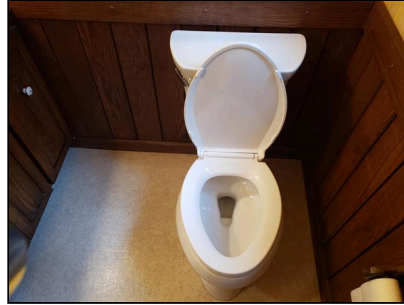
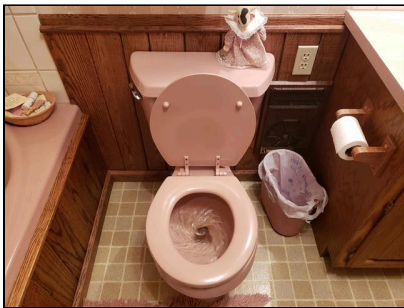
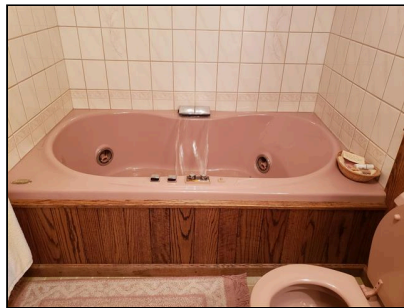
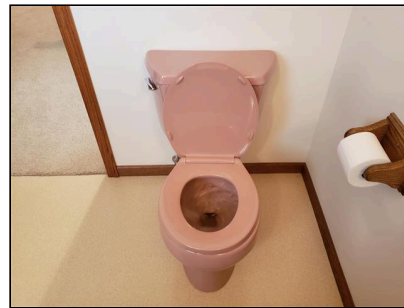
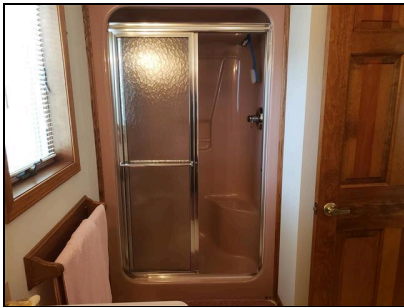
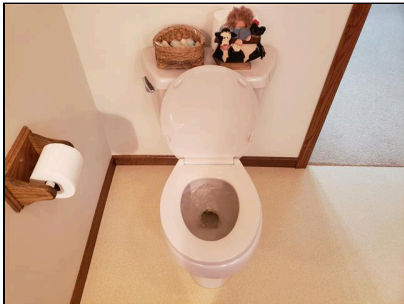
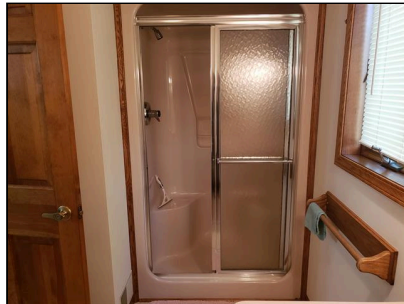
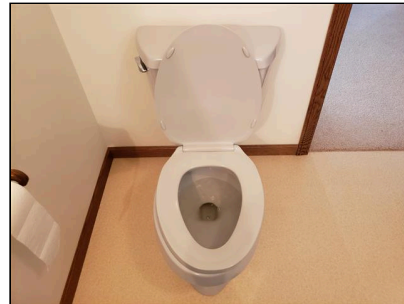
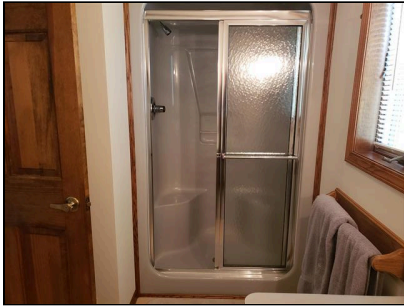
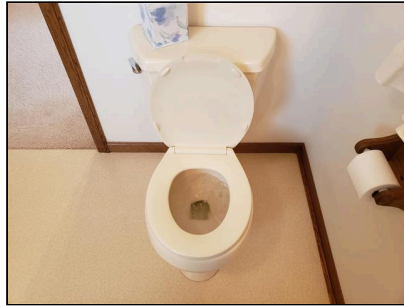
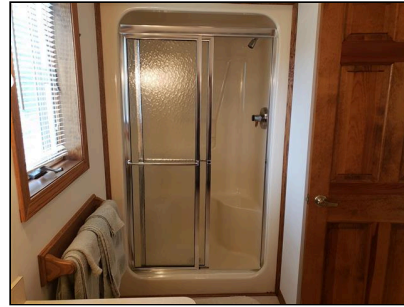
5.1 (1) Waste drain pipes, plumbing vents, and drain pipes were in overall satisfactory condition with no visible leaks or blockage.

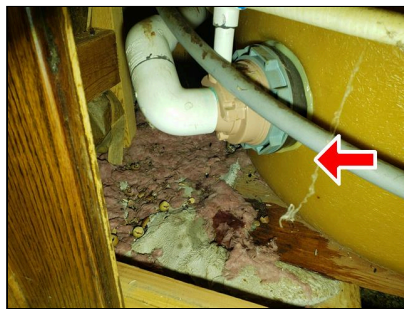
5.1 Item 15(Picture)

(2) The jet powered bath tub worked properly at time of inspection. The power source, GFCI breaker or outlet for a power supply to the bathtub was not found or was not installed. Recommend a contractor to further investigate and to install a GFCI as required when using a jet tub pump. NOTE: There was a small water leak under the bath tub. Recommend a contractor to repair as needed.

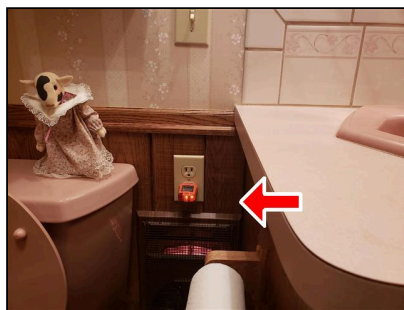
5.3 Item 2(Picture)

**5.3** The bathroom outlets were not on a GFCI system at the older area of the home. New construction would require all outlets within 6' of water to be a GFCI installment. Recommend a contractor to update the outlets as needed.

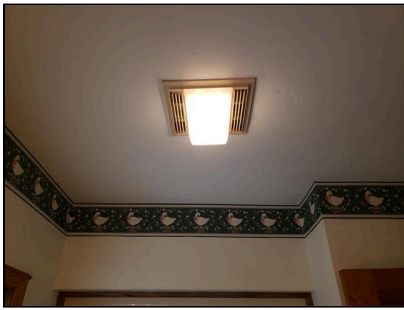
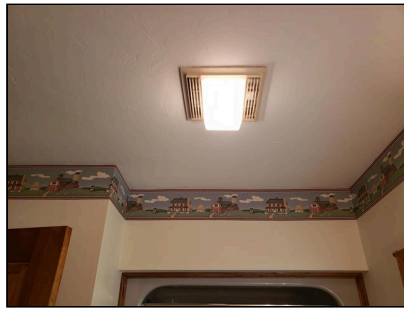
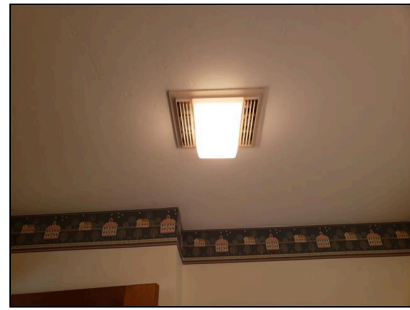
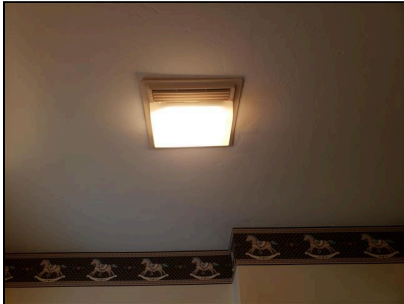
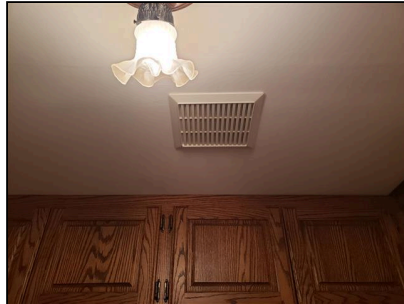
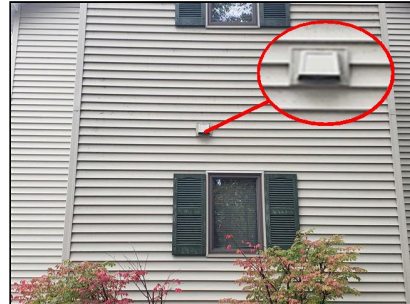
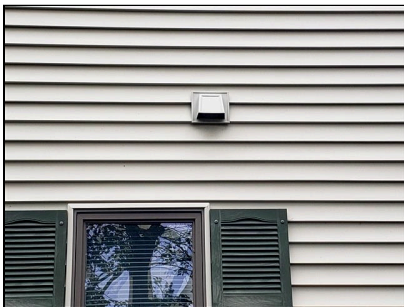
5.4 (1) The bathroom exhaust fans are vented to the exterior side of the home.

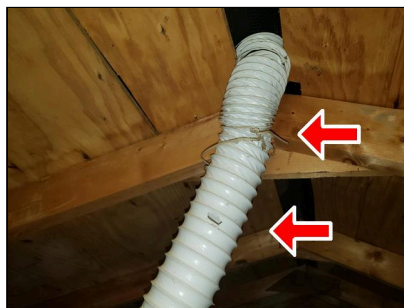
5.4 Item 9(Picture)

(2) There was a flexible vent tube installed to the bathroom vent fan. The flexible vent was damaged and needs to be replaced. Recommend a contractor to replace the vent tube as needed.

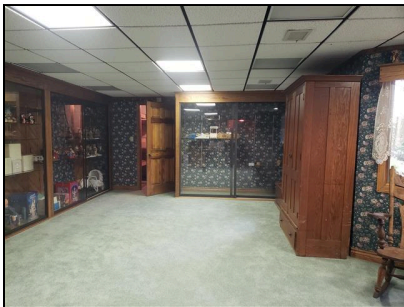
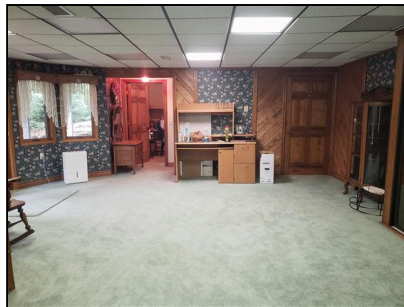
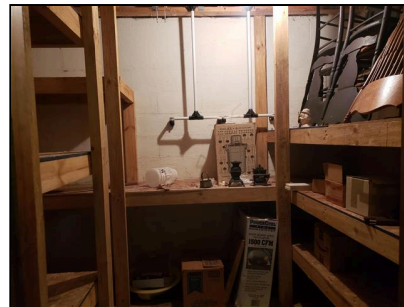
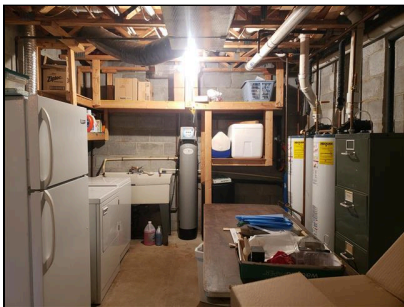
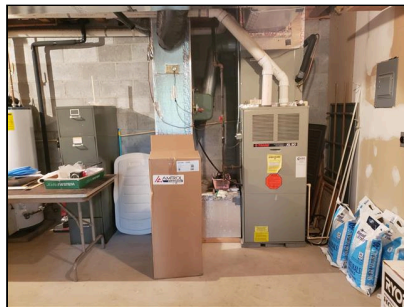
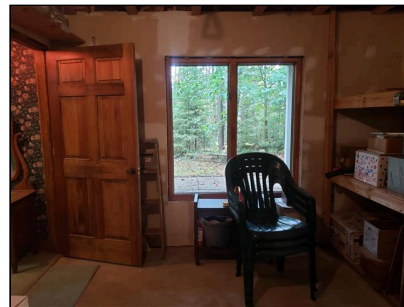
**6.0** (1) Basement walls were in overall satisfactory condition with no major defects or structural damage evident. No active seepage was visible at the time of the inspection. No representation can be made to future leaking of the foundation walls. Due to the lack of heavy rain or heavy melting of snow, I am unable to determine if water intrusion will occur.

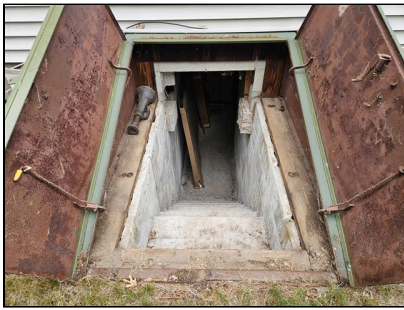
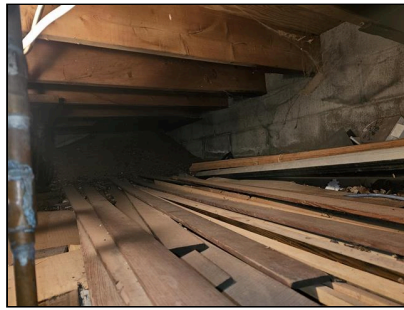
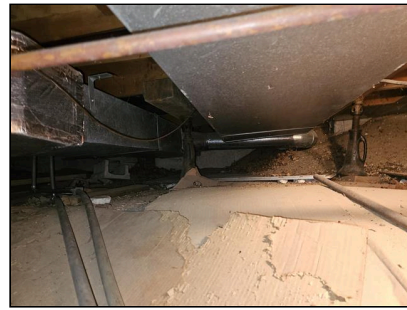
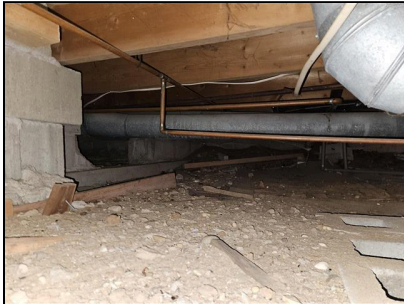
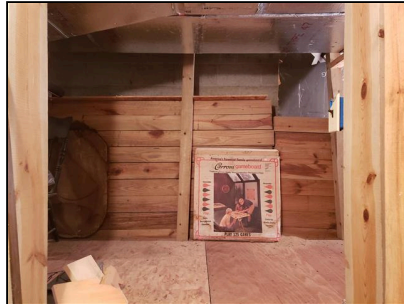
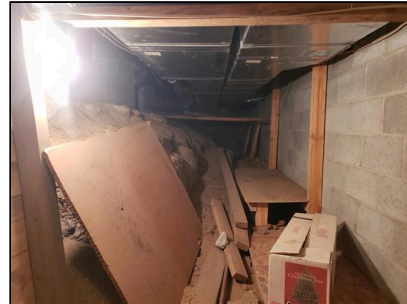
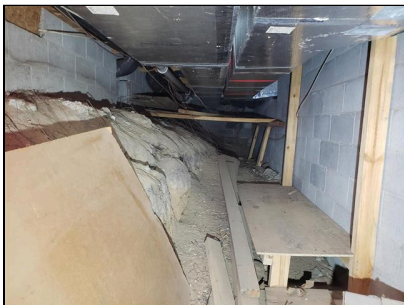
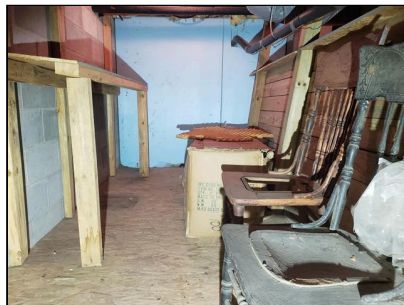
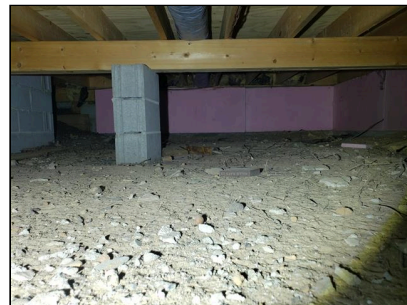
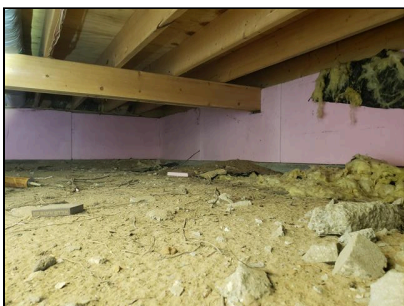
(2) Crawlpace walls were in overall satisfactory condition with no major defects or structural damage evident at all areas of crawlspaces. No active seepage was visible at the time of the inspection. No representation can be made to future leaking of the foundation walls. Due to the lack of heavy rain or heavy

melting of snow, I am unable to determine if water intrusion will occur.

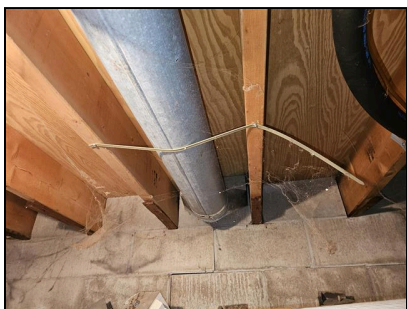
6.1 Item 1(Picture)

**6.1** The floor structure (header boards, joists, sill plates, and sub floors) appeared in overall satisfactory condition from the visible sections viewed. There were no signs of moisture damage in the areas viewed. Due to the insulation in flooring not all of the floor structure was visible.

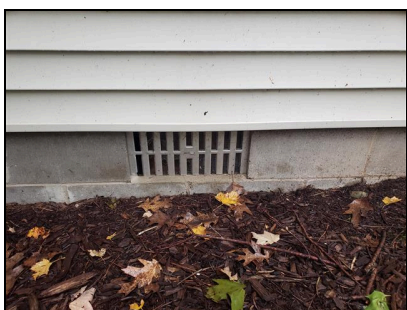
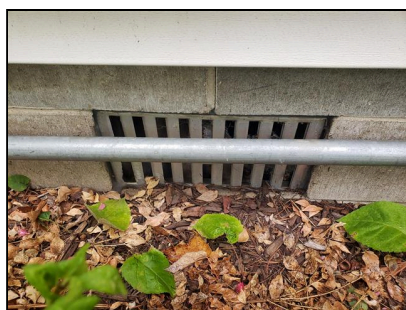
**6.4** Wall vents were in overall satisfactory condition. Wall vents should be open for spring, summer and fall seasons. Wall vents should be closed and sealed from the inside of the crawlspace in the winter seasons. Wall vents were at or near ground level. Water shed and snow melt can seep into the crawlspace where vents are at grade. Crawlspace are to be kept as dry as possible. Half rounded window wells should be installed to help keep water from seeping into the foundation vents. This is for your information and recommend installing half rounded window wells as needed.

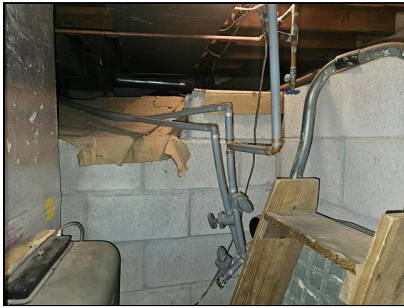
7.1 Item 1(Picture)

7.1 Water flow was normal with several fixtures operated at the same time. There were no visible active piping leaks at the time of the inspection.

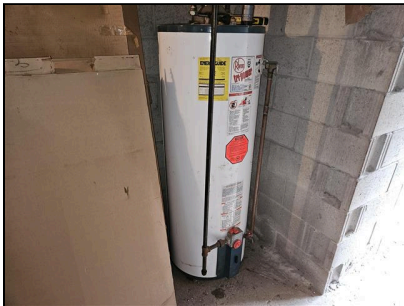
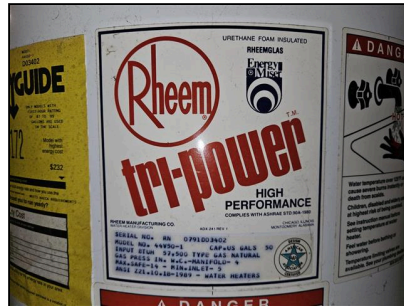
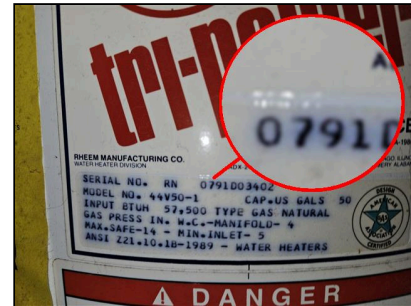
7.2 (1) Water heater was in satisfactory working condition and appeared to be vented properly at the time of the inspection. Water heater was manufactured 07/1991 as stated on the ID tags.

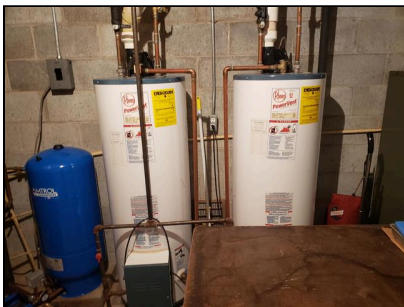
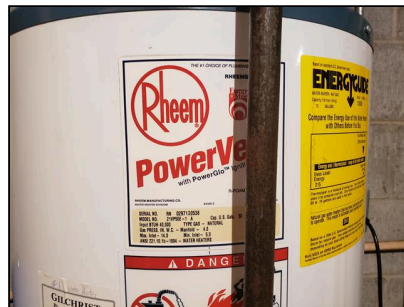
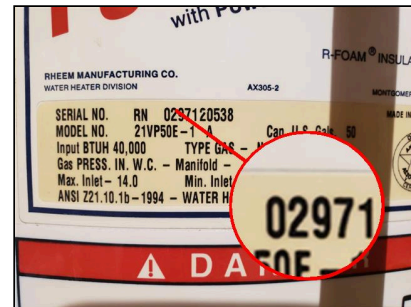
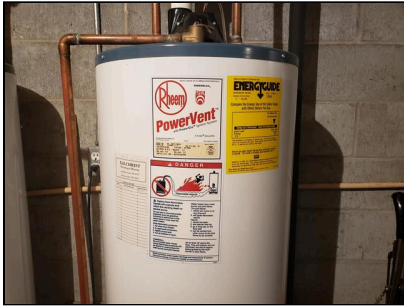
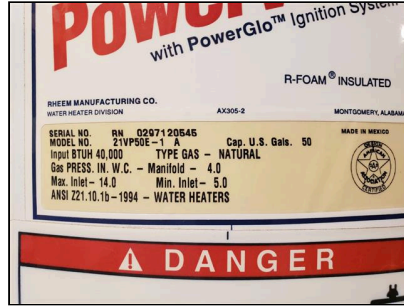
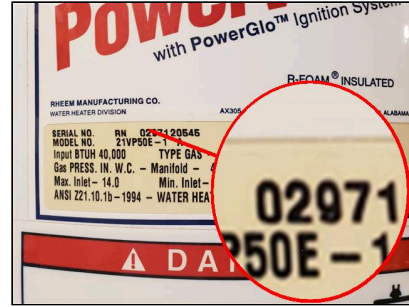
(2) Water heaters were in satisfactory working condition and appeared to be vented properly at the time of the inspection. Water heaters both were manufactured 02/1997 as stated on the ID tags.

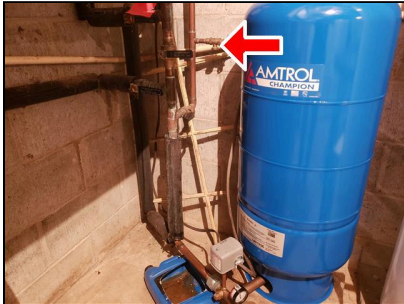
7.3 Item 1(Picture)

7.3 The main shut off for water was located at pressure tank in crawl basement.

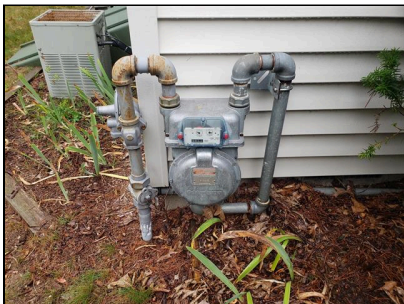
7.4 Item 1(Picture)

7.4 Natural gas is currently being used as the energy source for heat system. There were no odors detected at time of inspection and found no apparent gas leaks. The gas lines were not pressure tested for leaks. Your gas company can pressure test gas lines.

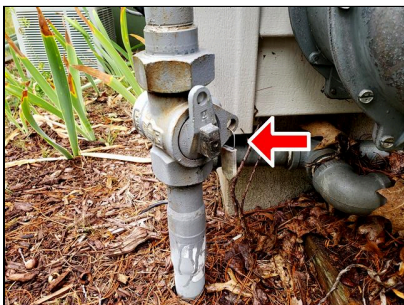
7.5 Item 1(Picture)

7.5 The main fuel shut off is at the gas meter outside. Shut off valve must to be turned until the two holes line up, then the gas will be off. This is for your information and may need a wrench to turn the valve off if needed.

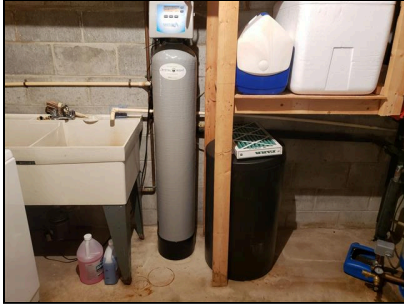
7.7 Item 1(Picture)

**7.7** There was a water softener system installed in the home. Softeners are not inspected by our company and recommend a service contractor to service as needed.

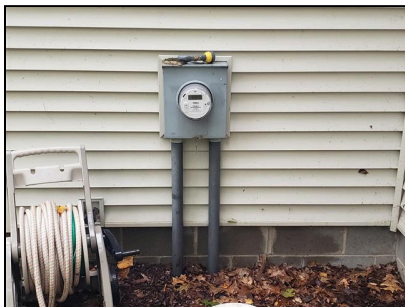
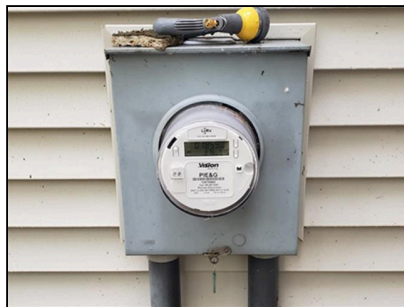
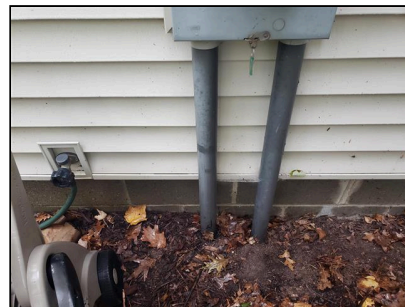
(2) Underground service and meter box appear in satisfactory condition. Ground rod was viewed at time of inspection and secured.

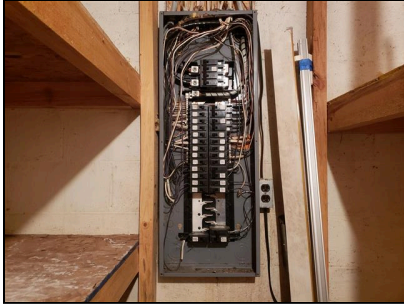
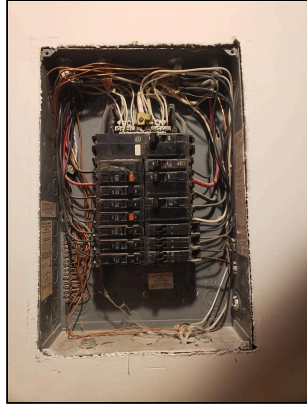
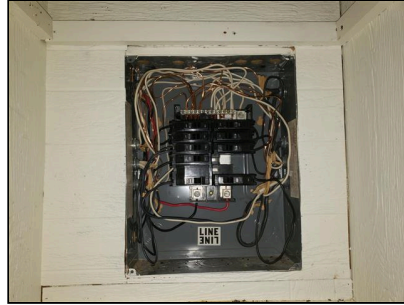
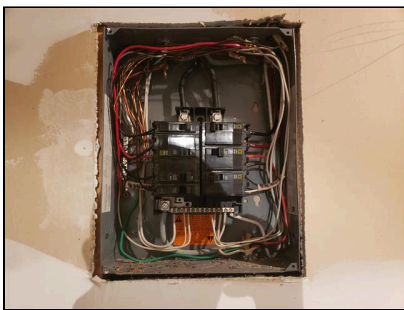
8.1 Main electrical panel and sub panel were sufficient and compatible to service size and wired correctly at time of inspection.

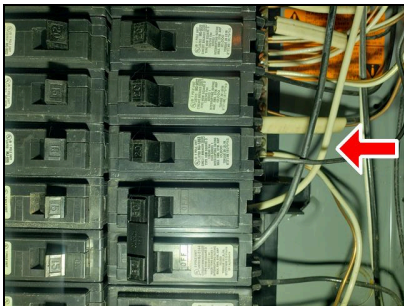
8.2 Item 1(Picture)

(2) At the time of inspection there was one 14 gauge wire in the electric panel that was installed to a 20 amp breaker. 14 gauge wires are not to be installed to any breaker larger than a 15 amp breaker. Recommend a contractor to repair as needed.

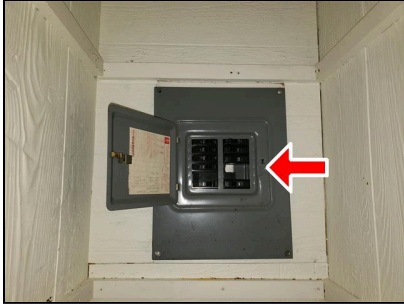
8.2 Item 2(Picture)

(3) There were open knockouts in the sub panel at the hallway closet. Recommend a qualified person to install knockout clips where needed.

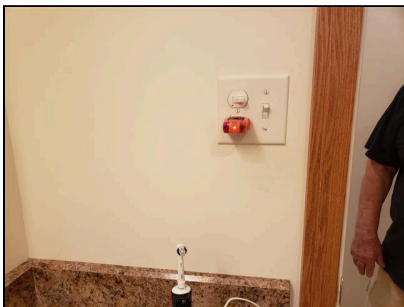
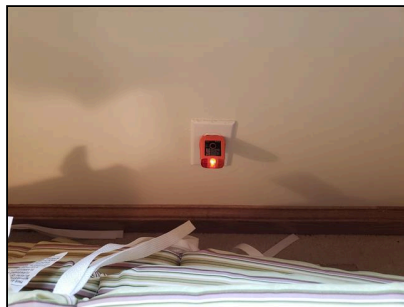
**8.3** There were several ungrounded outlets in the older areas of the home. Contractors have different opinions on ungrounded wiring. This is for your information. May consider a contractor to further evaluate if desired. It is recommended that when using ungrounded outlets that a surge protector be installed.

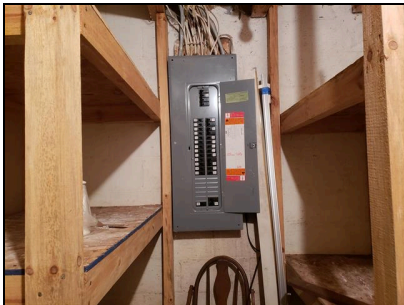
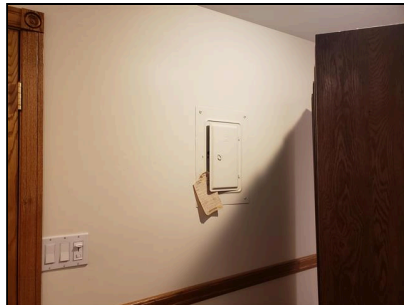
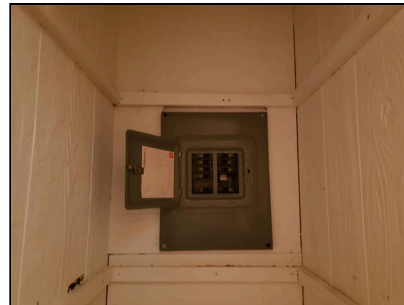
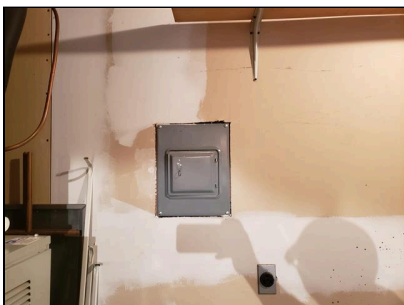
**8.4** The main panel box is located at the main floor and in the basement.

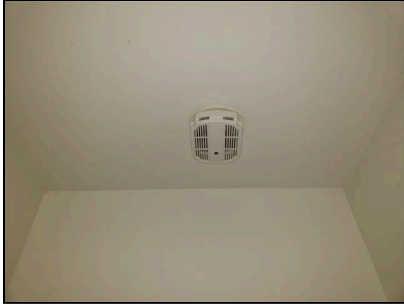
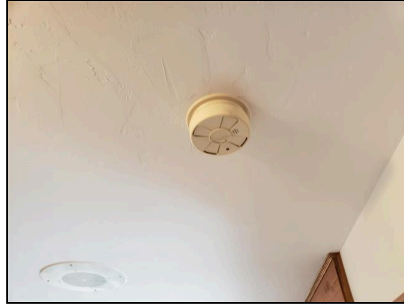
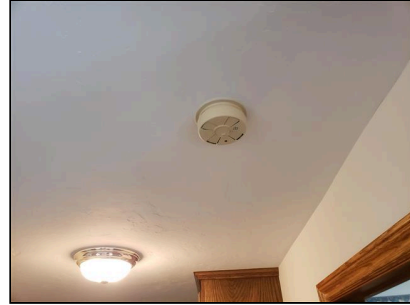
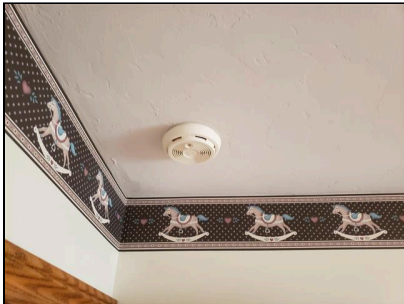
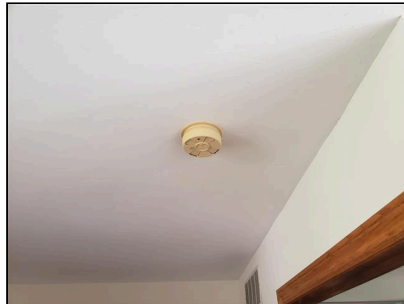
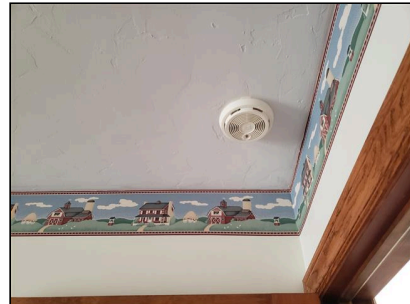
**8.5** The smoke detector should be tested at common hallway to bedrooms upon moving in to home.

Additional smoke detectors should be added at each bedroom in the home. Recommend installing smoke detectors in each bedroom as required with new construction.

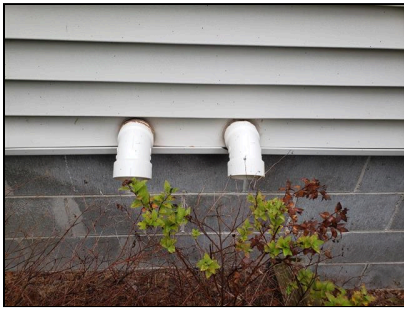
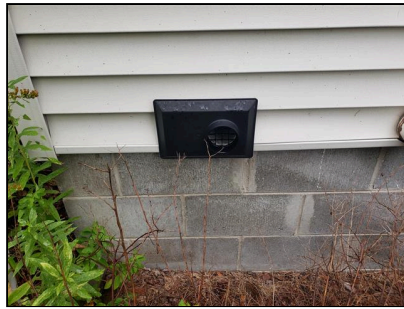
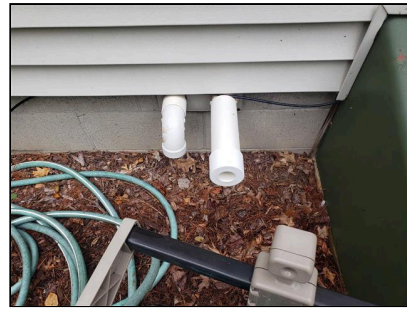
9.0 (1) PVC flue pipes for the water heaters and metal furnace vents were in satisfactory condition. NOTE: Recommend cleaning all snow and ice from area of vent. Furnace/water heaters may stop working if vent is plugged/covered.

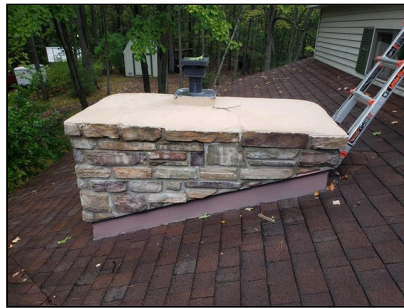
9.0 Item 5(Picture)

(2) The liners were mainly visible and appears good except for creosote dust that may conceal a hairline crack until cleaned and inspected by a licensed chimney sweep. For a detailed inspection of liners, I recommend a qualified chimney sweep inspect for safety. The liners were not inspected by our company. I recommend a qualified chimney sweep inspect for safety.

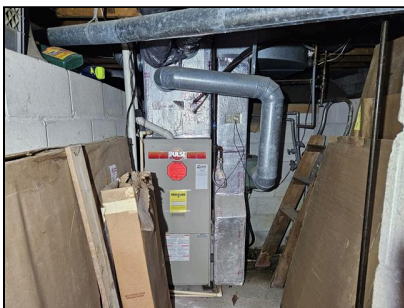
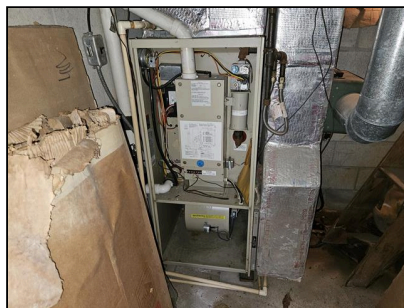
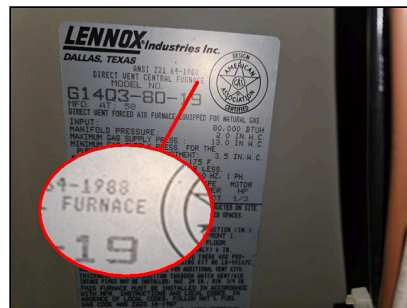
(2) Furnace was in normal working condition at the time of the inspection. No carbon monoxide was detected at the time of the inspection. Heat exchanger had no visibility due to its high efficiency design. Flue and fan were drafting properly at the time of the inspection. Blower motor appeared to be in satisfactory working condition. The furnace was manufactured the year 1988 as stated on the ID tags.

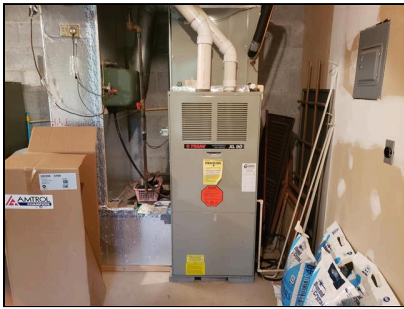
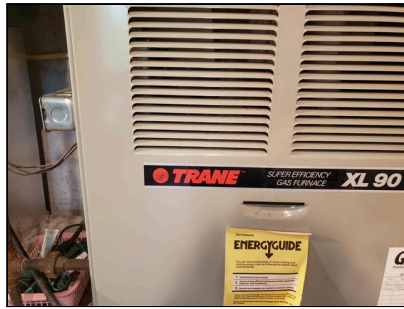
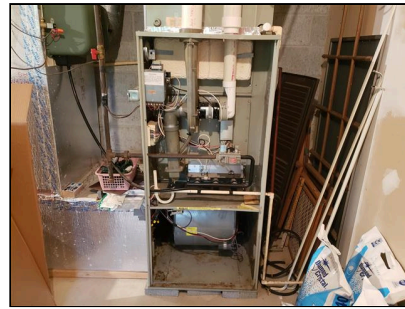
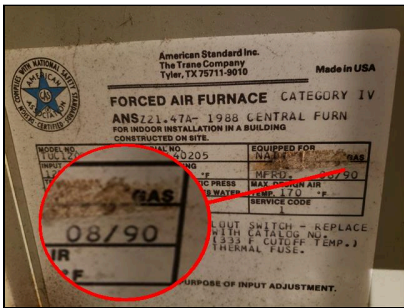
(3) Furnace was in normal working condition at the time of the inspection. No carbon monoxide was detected

at the time of the inspection. Heat exchanger had no visibility due to its high efficiency design. Flue and fan were drafting properly at the time of the inspection. Blower motor appeared to be in satisfactory working condition. The furnace was manufactured the year 08/1990 as stated on the ID tags.

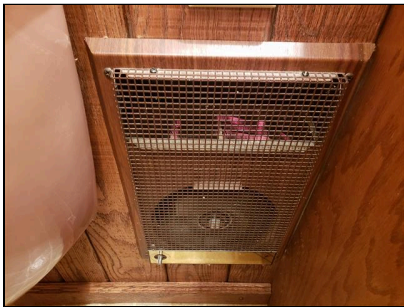
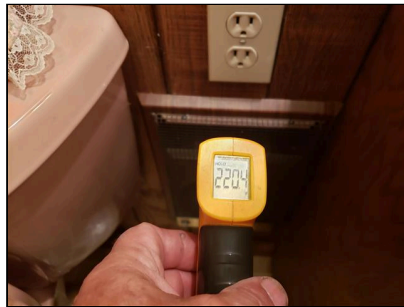
(4) There was an electrical wall heater in one bathroom and the heater was in satisfactory working condition when inspected. This is for your information.

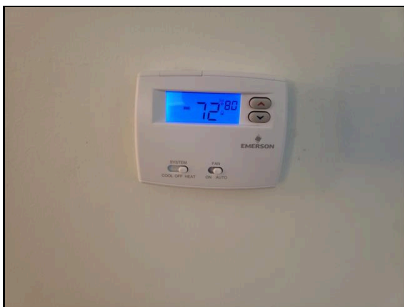
9.2 Item 1(Picture)

9.2 Thermostats were in working condition. Thermostats were not tested for accuracy. Settings when entered the home were set back to original setting of off when inspection was completed.

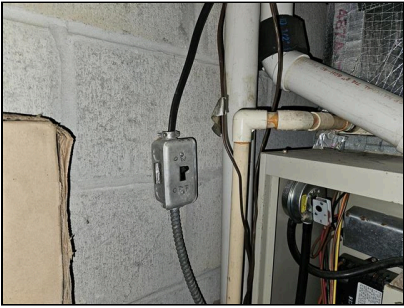
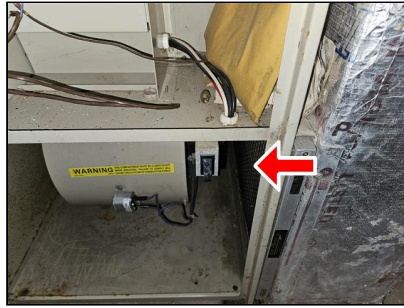
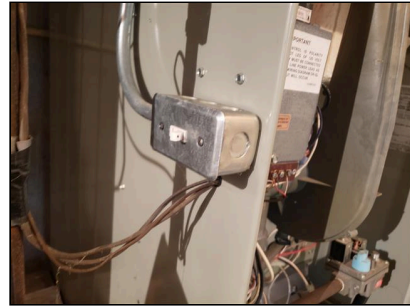
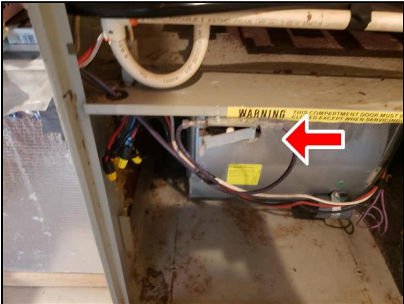
9.3 Service man switch and safety door switch were in working condition.

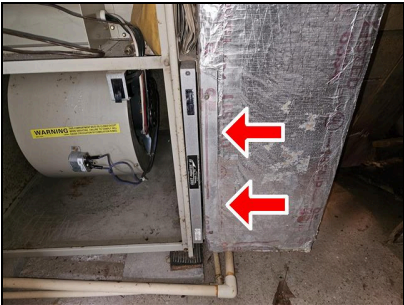
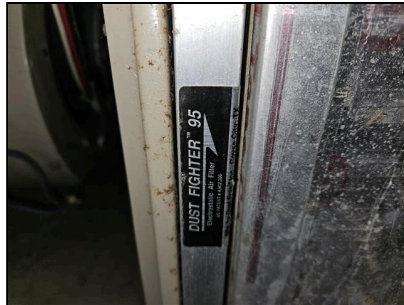
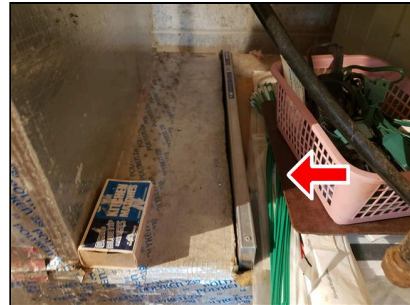
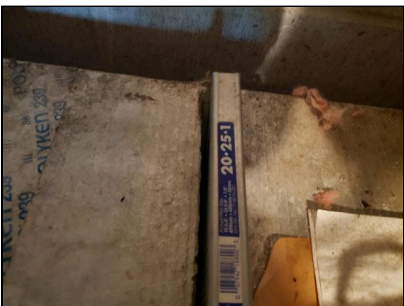
9.4 Filter locations. (see photo)

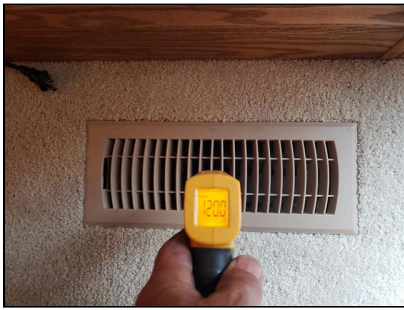
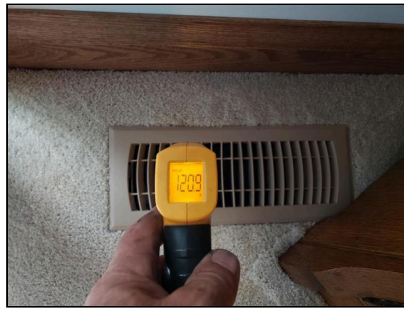
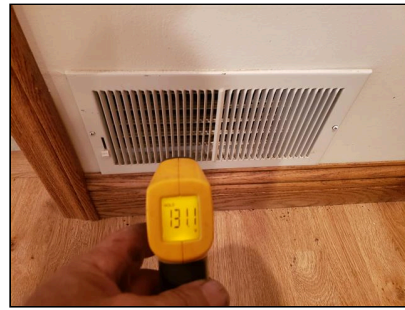
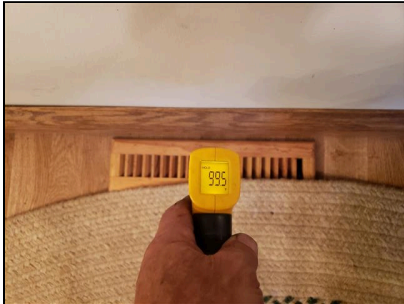
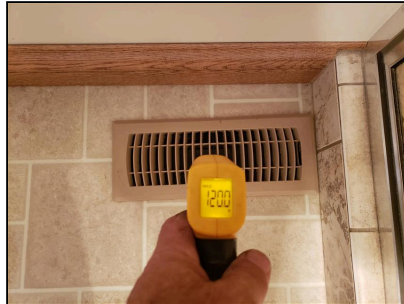
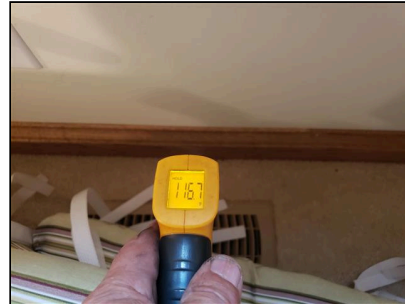
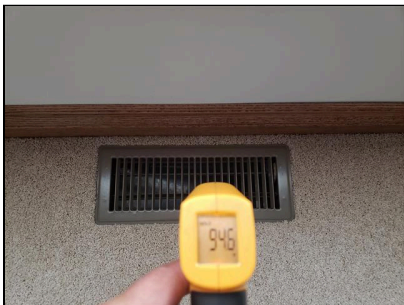
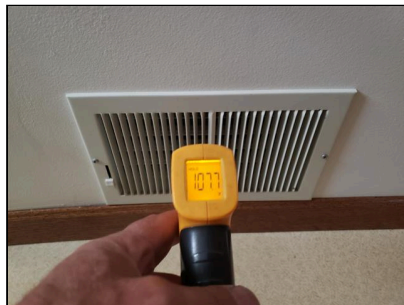
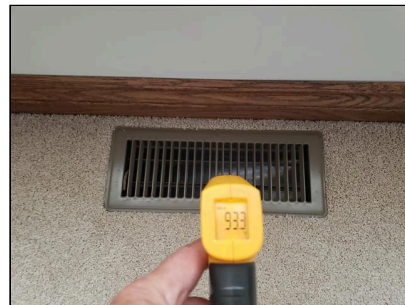
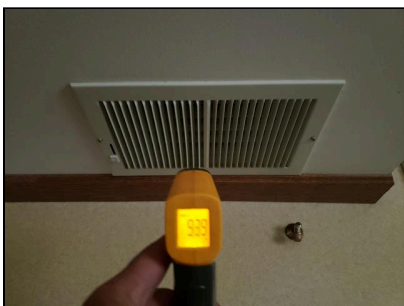
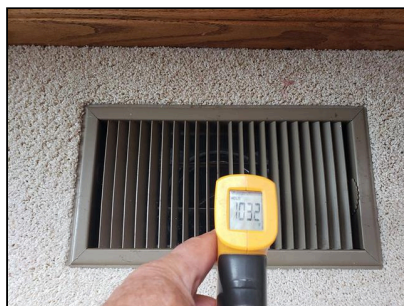
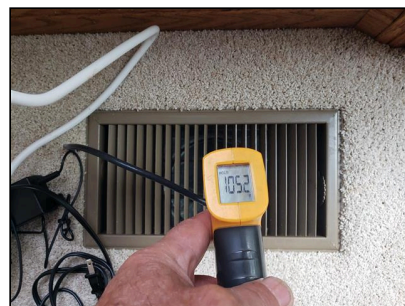
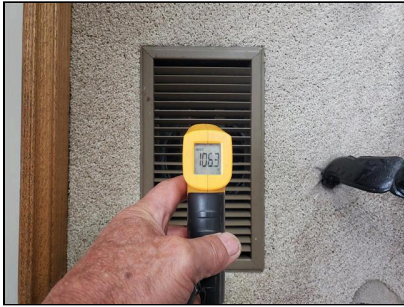
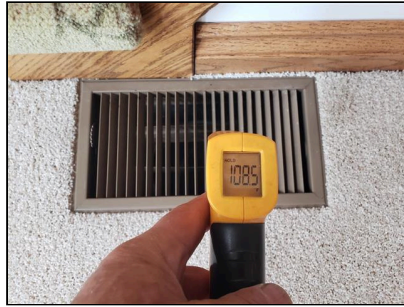
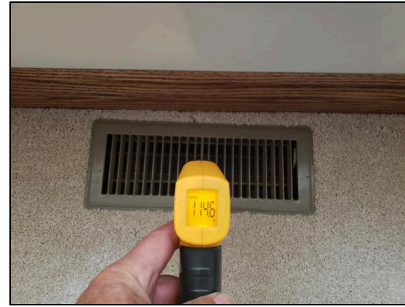
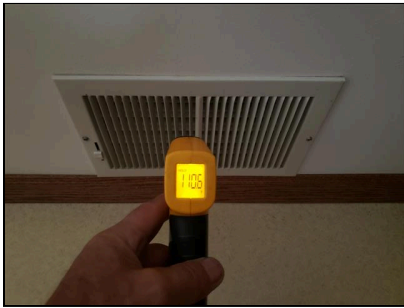
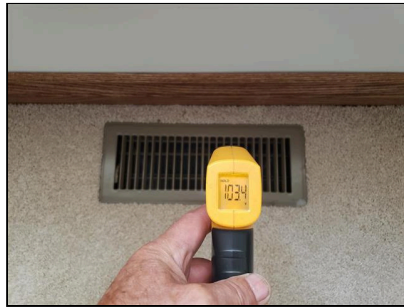
9.5 There was a heat source at each room and each register was working at time of inspection.

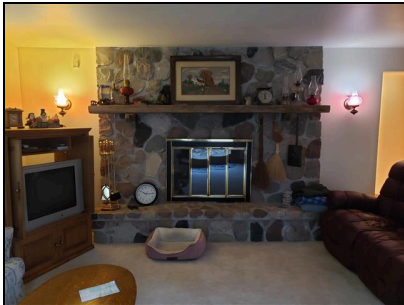
9.6 Item 1(Picture)

**9.6** Wood fireplace was not tested but appeared to be in working condition and vented properly. The flue should be cleaned before using. I recommend a chimney sweep to further evaluate and clean before using.

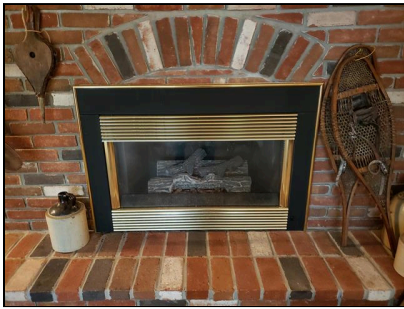
9.7 Item 1(Picture)

9.7 Gas log fireplace appeared to be in satisfactory working condition and vented properly. Control panel for operation of the fireplace was found on the left wall of fireplace. Recommend a contractor to clean and further evaluate the gas log fireplace as needed. It has not been in operation for a few years.

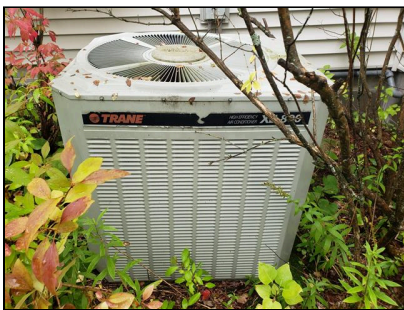
9.8 Item 1(Picture)

9.8 (1) The A/C was short tested at time of inspection and appeared to be in satisfactory working condition. Recommend keeping the A/C unit level as recommended by the manufacturer. The A/C unit was manufactured 10/1990 As stated on the ID tag.

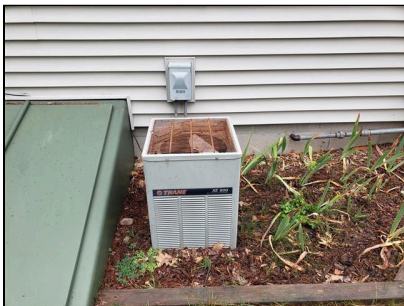
9.8 Item 4(Picture)

(2) The A/C was short tested at time of inspection and appeared to be in satisfactory working condition. Recommend keeping the A/C unit level as recommended by the manufacturer. The A/C unit was manufactured 05/1991 As stated on the ID tag.

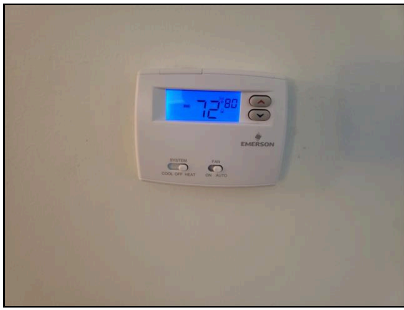
9.9 Item 1(Picture)

9.9 Thermostat were tested at time of inspection and appeared to be in working condition.

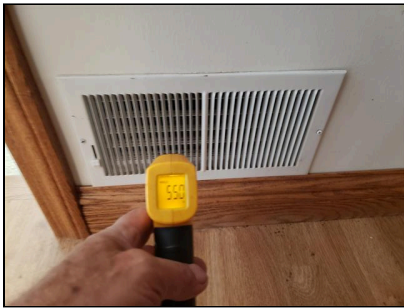
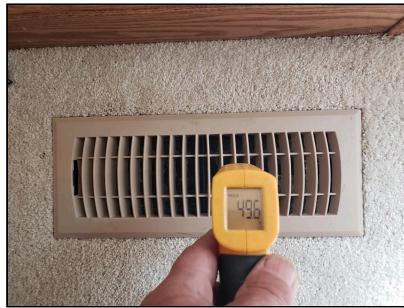
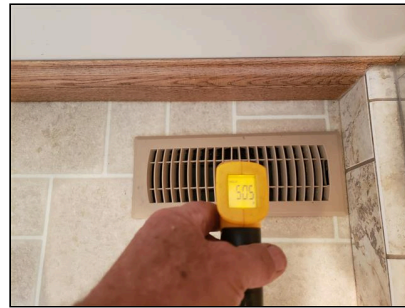
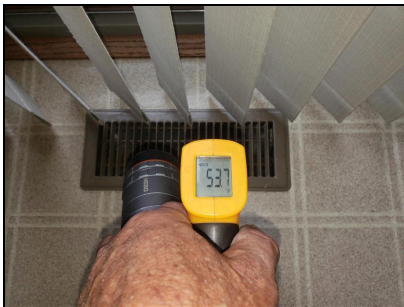
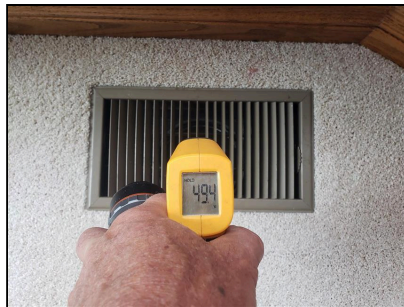
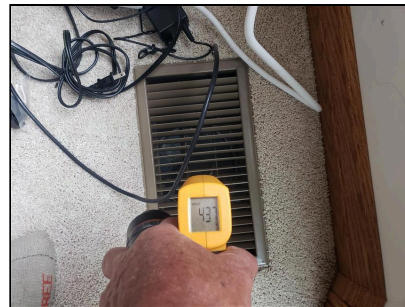
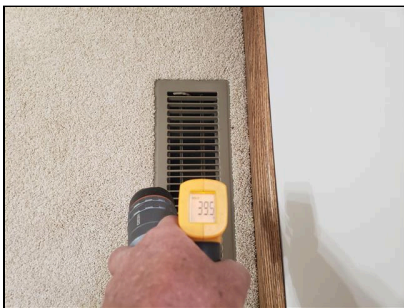
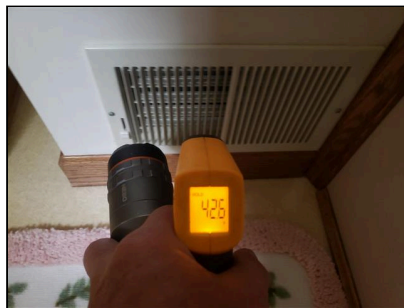
9.10 There was a cooling source at each room and each register was working at time of inspection.

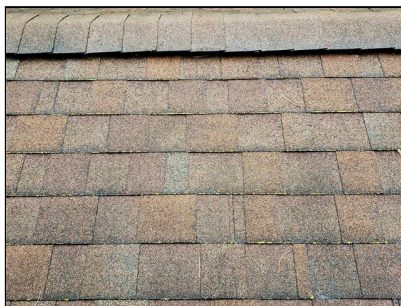
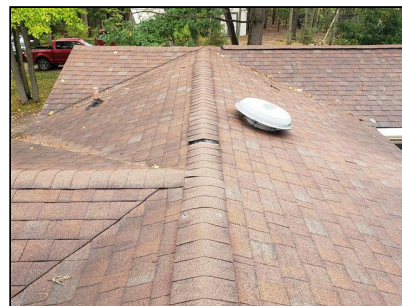
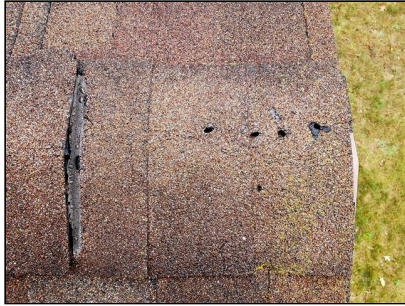
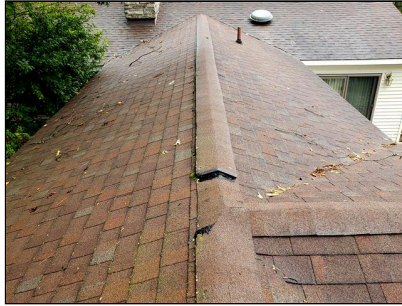
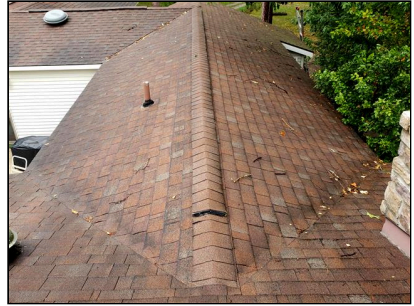
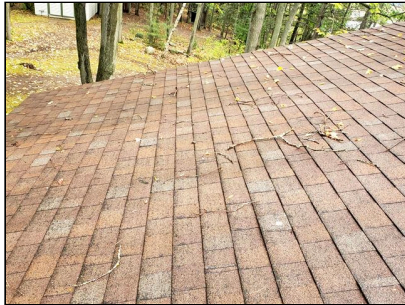
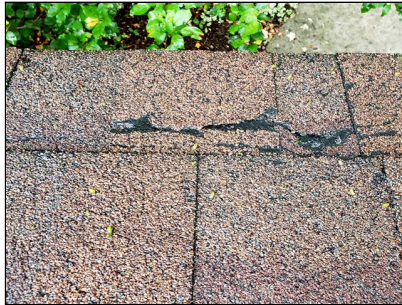
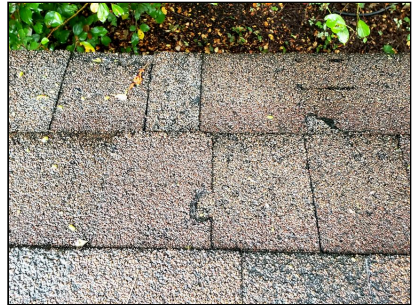
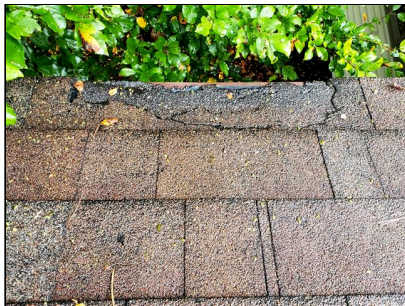
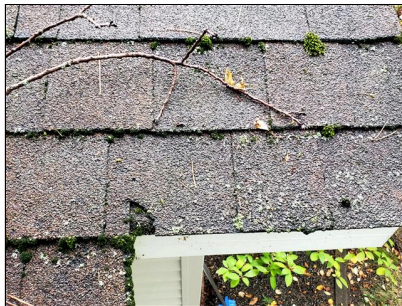
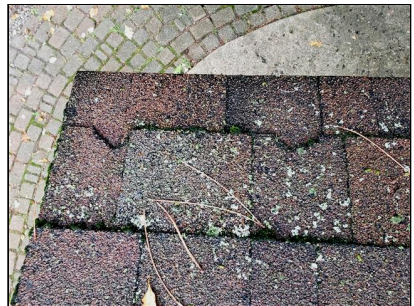
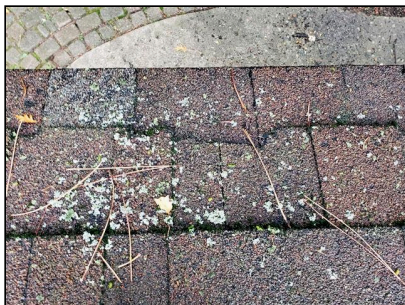
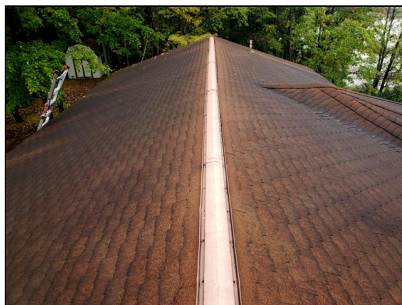
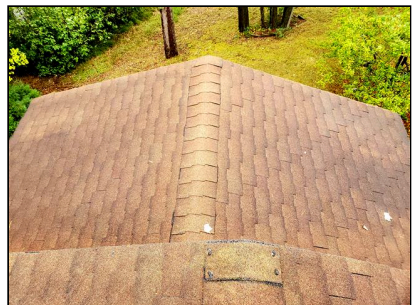
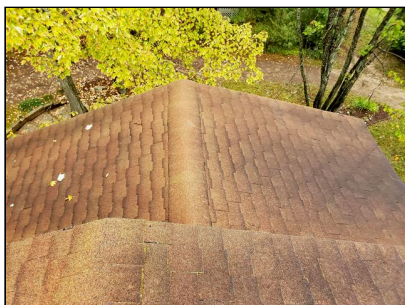
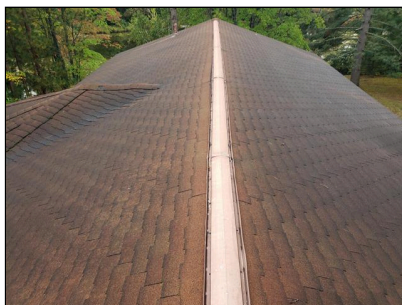
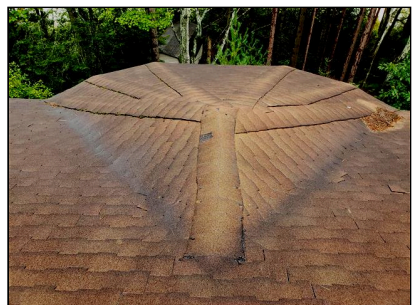
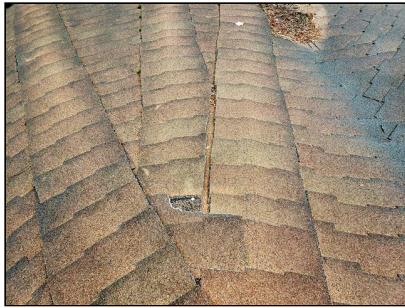
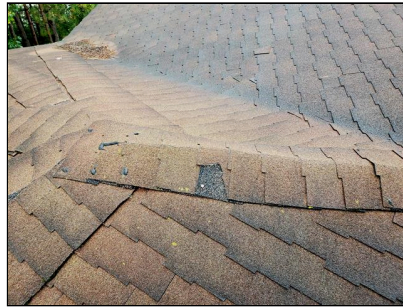
The roof covering is old, and the life of covering has almost expired. The covering does need to be replaced within the next 3 years. While it could last a couple years or so, some areas may need patching with tar as leaks develop. NOTE: All areas of shingle tabs missing should be sealed with a roofing tar to help prevent water leaks until new roofing is installed.
