# Home Inspection

**Property Address:**  
11021 McArthur Rd  
Atlanta MI 49709

**Hawkeye Home Inspection Co**

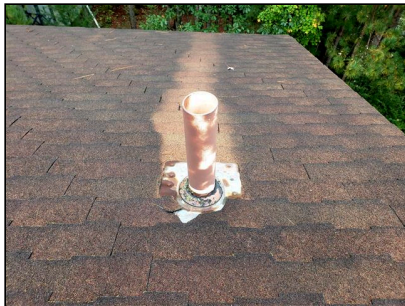
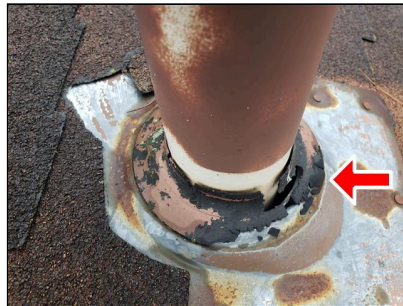
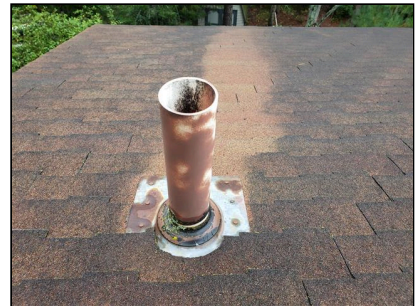
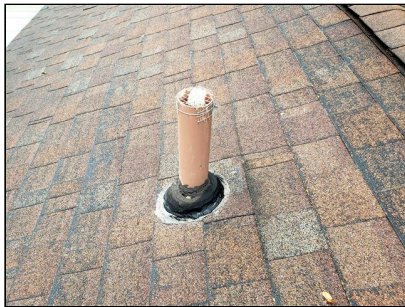
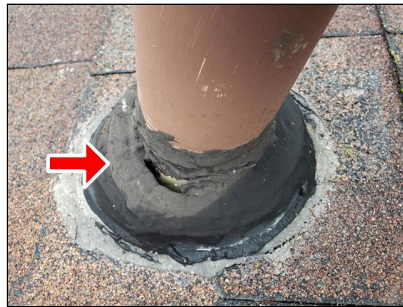
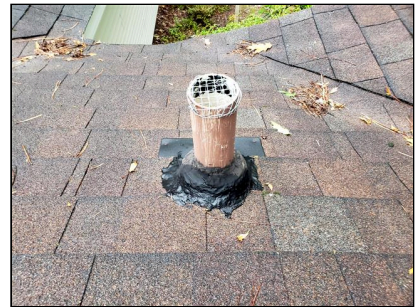
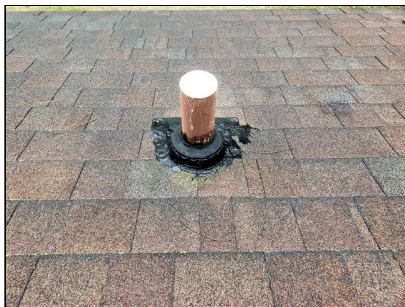
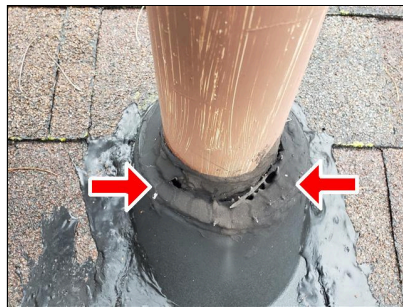
(1) PVC vent pipe was in satisfactory condition when inspected. The rubber boot flashing was damaged/cracked and needs to be repaired. The cracks can allow water to seep into the attic space and deterioration and mildew can accrue. Recommend a contractor to replace the rubber boot flashings as needed.

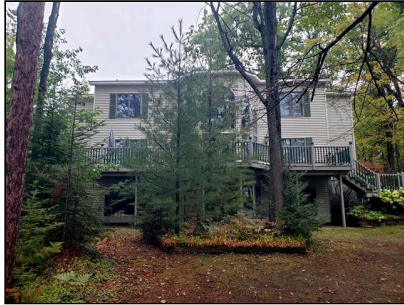
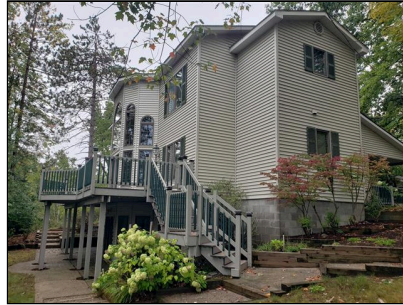
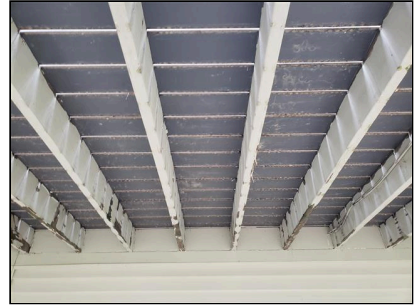
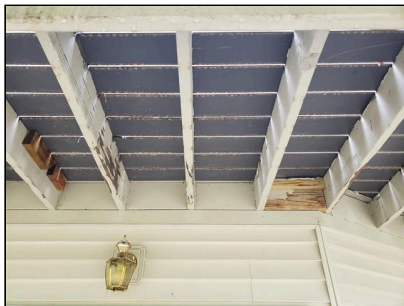
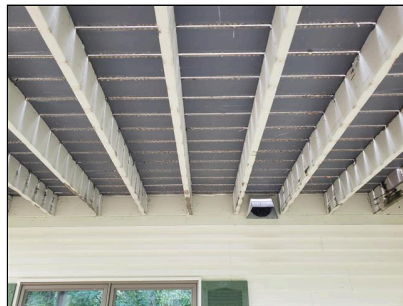
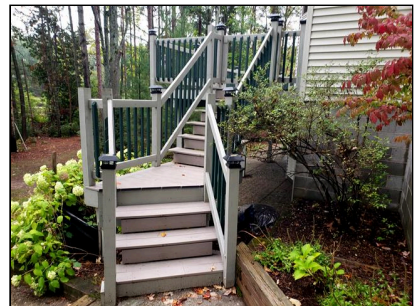
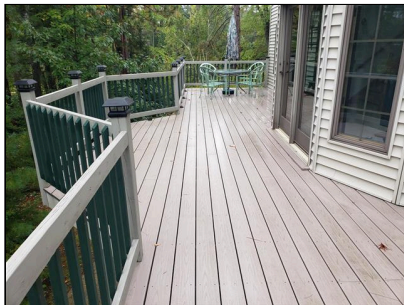
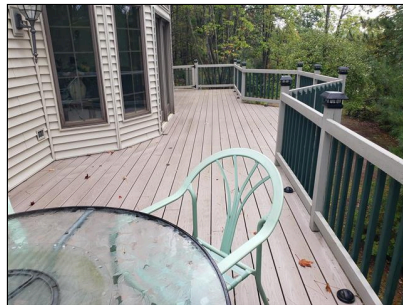
(3) The front deck was in satisfactory condition and well maintained. Decking boards and handrails were well maintained and sealed. NOTE: There were areas of paint/sealer peeling at the under side of the lake side deck. Recommend a qualified person to prep and paint all areas of peeling sealer as needed.

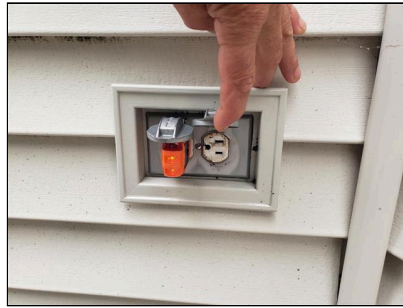
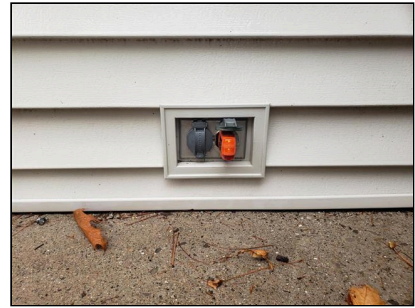
The exterior outlets were not GFCI outlets (Ground Fault Circuit Breakers), but were grounded when tested. Recommend replacement of outlets. NOTE: All exterior outlets would be required to be on a GFCI system with new construction. This is for your information. Recommend a contractor to repair as needed.

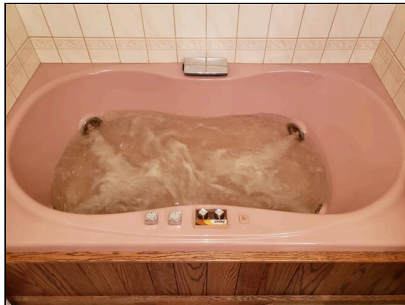
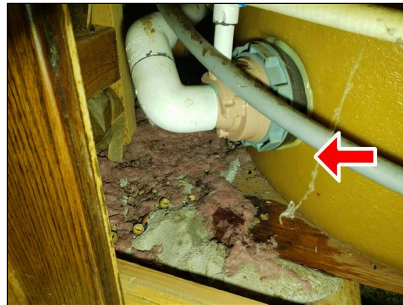
(2) The jet powered bath tub worked properly at time of inspection. The power source, GFCI breaker or outlet for a power supply to the bathtub was not found or was not installed. Recommend a contractor to further investigate and to install a GFCI as required when using a jet tub pump. NOTE: There was a small water leak under the bath tub. Recommend a contractor to repair as needed.

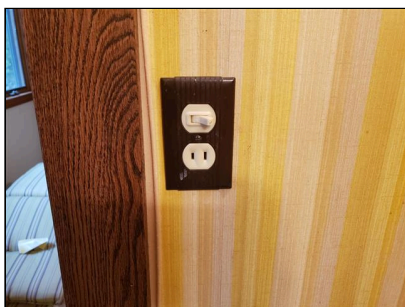
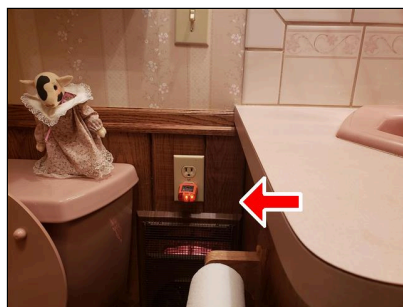
The bathroom outlets were not on a GFCI system at the older area of the home. New construction would require all outlets within 6' of water to be a GFCI installment. Recommend a contractor to update the outlets as needed.

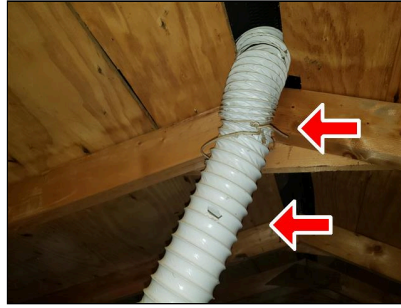
5.4 Item 9(Picture)

(2) There was a flexible vent tube installed to the bathroom vent fan. The flexible vent was damaged and needs to be replaced. Recommend a contractor to replace the vent tube as needed.

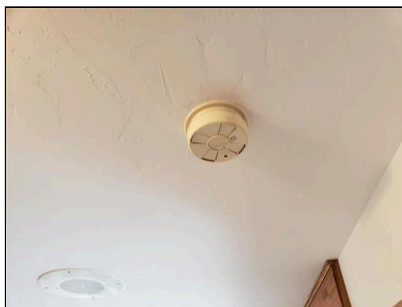
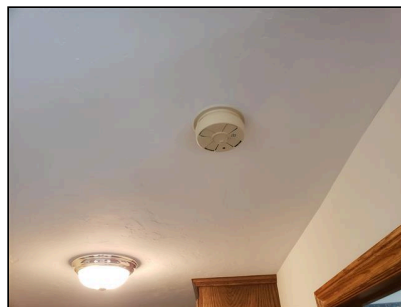
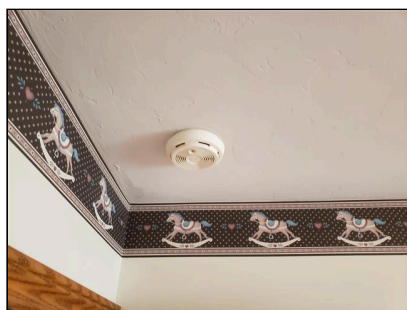
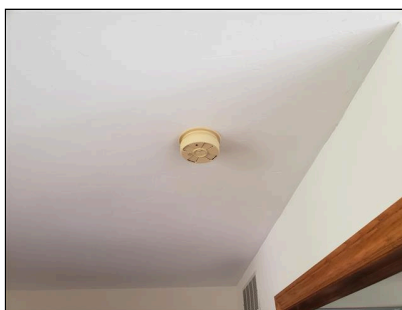
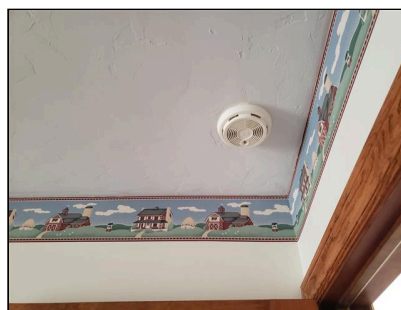
The smoke detector should be tested at common hallway to bedrooms upon moving in to home. Additional smoke detectors should be added at each bedroom in the home. Recommend installing smoke detectors in each bedroom as required with new construction.

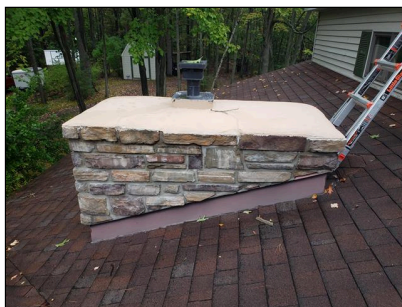
9.0 Item 5(Picture)

(2) The liners were mainly visible and appears good except for creosote dust that may conceal a hairline crack until cleaned and inspected by a licensed chimney sweep. For a detailed inspection of liners, I recommend a qualified chimney sweep inspect for safety. The liners were not inspected by our company. I recommend a qualified chimney sweep inspect for safety.

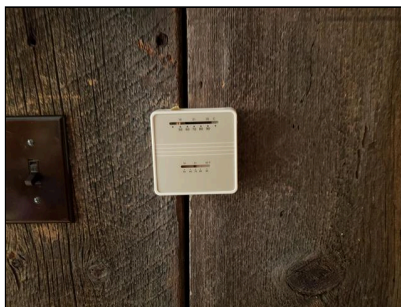
9.7 Item 2(Picture)

9.7 Gas log fireplace appeared to be in satisfactory working condition and vented properly. Control panel for operation of the fireplace was found on the left wall of fireplace. Recommend a contractor to clean and further evaluate the gas log fireplace as needed. It has not been in operation for a few years.

Gas log fireplace appeared to be in satisfactory working condition and vented properly. Control panel for operation of the fireplace was found on the left wall of fireplace. Recommend a contractor to clean and further evaluate the gas log fireplace as needed. It has not been in operation for a few years.
