# GUARDIAN REAL ESTATE INSPECTIONS

## PUNCHLIST INSPECTION

887 Snug Harbor Rd  
Hertford, NC 27944

08/03/2026

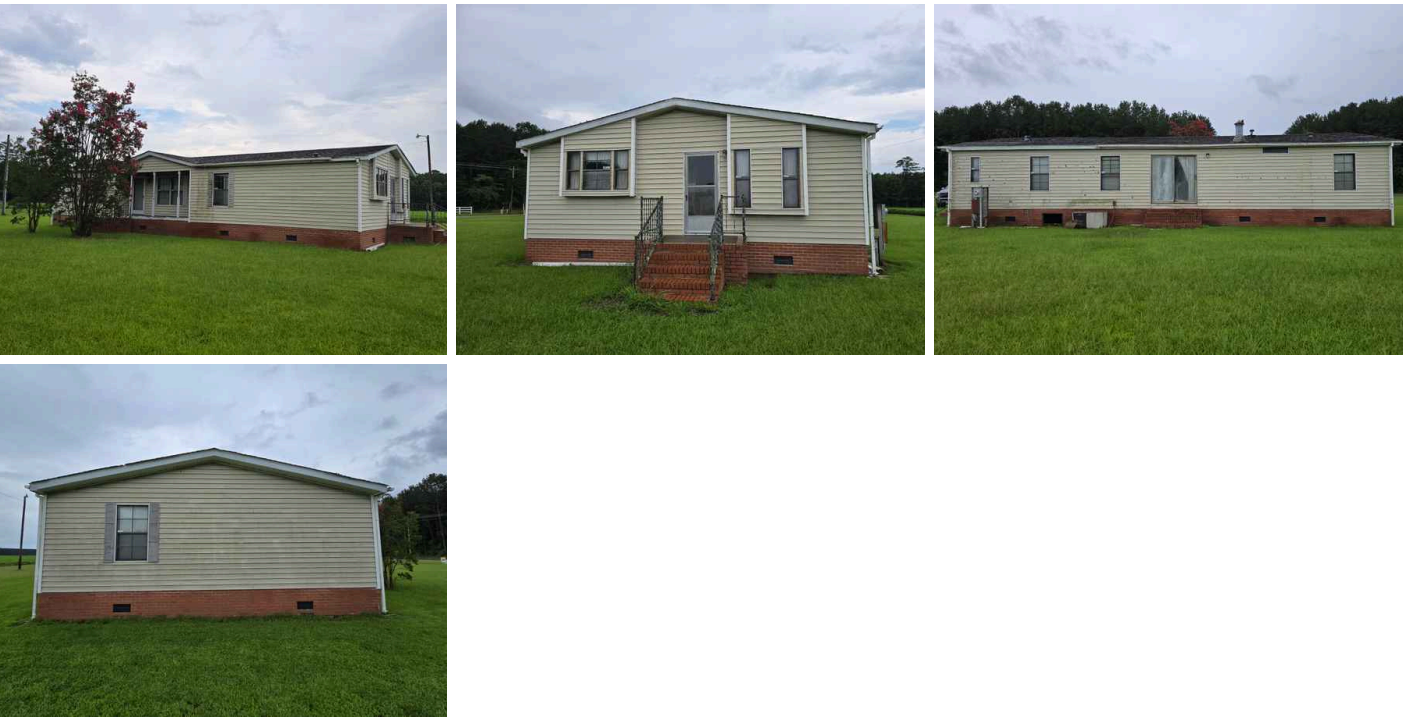
**SLIDING GLASS DOOR - DAMAGED**

At the time of this inspection, the sliding glass door was missing portions of its frame. This condition has allowed water intrusion into the interior of the structure, and organic growth was observed at interior surfaces surrounding the door. Only visible and accessible components were evaluated.

Recommend evaluation and repair by a licensed general contractor, including:
