**Perfection Home Inspections**  
**Mesa, AZ 85203**  
**602-524-2916**  
**perfectionhomeinspections.com**

Client Information: Record Number 8613

**Sturgeon, Melanie**  
**1211 S. Barkley**  
**Mesa, AZ 85204**  
**480-881-6717**

Inspected 7/24/21 8:00 AM  
Built 1980  
1688 sf

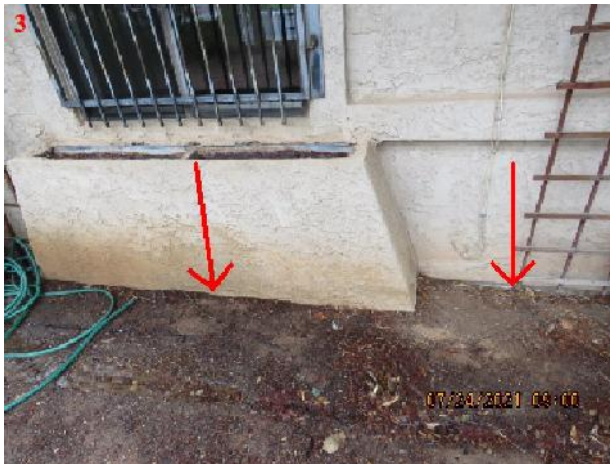
The stucco is too close to the ground in some areas. Recommend a minimum of a 4 inch gap between the bottom of the stucco and the finished grade and a minimum of 2 inches above the cement. Stucco need to be able to drain moisture out of the walls through the bottom of the stucco and termites and other pests may enter the home undetected if this distance is not maintained. Running stucco to the ground is a common practice for masonry homes in this area. Stucco should not go to the ground for framed wall construction.

Crack in the stucco. Recommend repair.

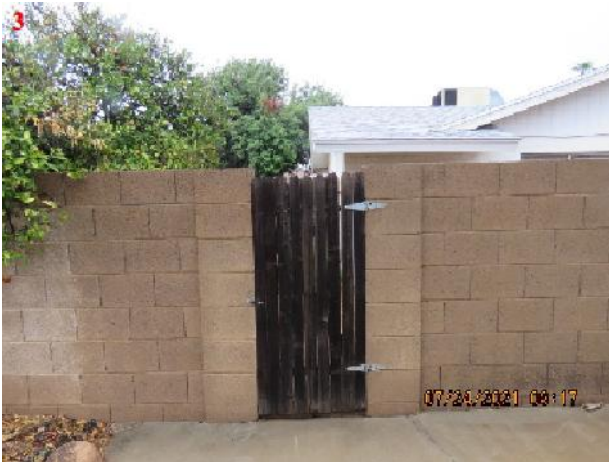
### **Service/Repair** Yard Fences - Masonry, Wood

The fence gate in the front is falling over. There is a fence gate in the side yard to the neighbors back yard. Damage block in the back fence wall. Recommend a qualified contractor evaluate and make all necessary repairs.

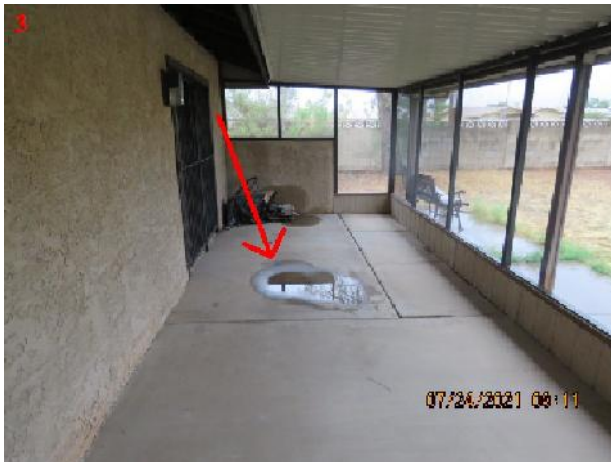
### **Service/Repair** Back Patio Roof - Fascia Attachment, Shed

The back patio roof has been attached to the fascia wood. This is a good indication the patio addition was installed without a permit. Water leaking between the patio roof and the house room in the patio area. Recommend a qualified contractor evaluate and make all necessary repairs. Recommend asking the seller for permits obtained from the city to install the patio roof. Debris on the back patio roof. Recommend removing all debris from the roof.

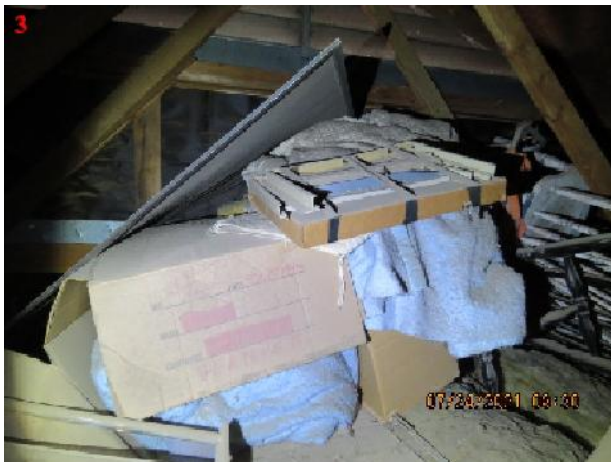
### ATTIC - Sample picture

Sample attic picture. Stuff stored in the attic. Recommend removing the stuff.

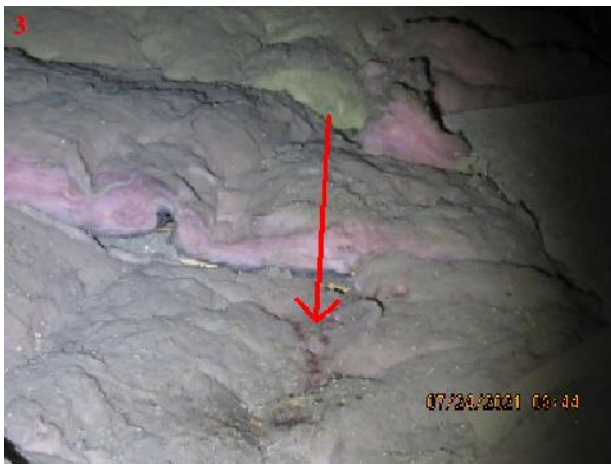
### **Service/Repair** Attic Leaks - Sheathing

Roof leak in the attic at the AC electric line and on the sheathing near the attic hatch above the kitchen area. Sheathing has water stains in several areas. Recommend a qualified contractor evaluate and make all necessary repairs.

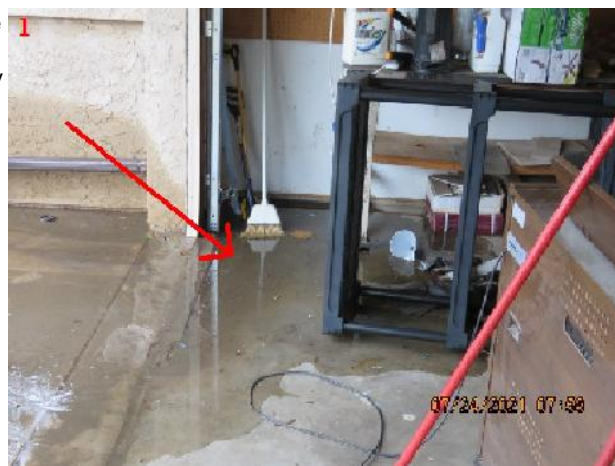
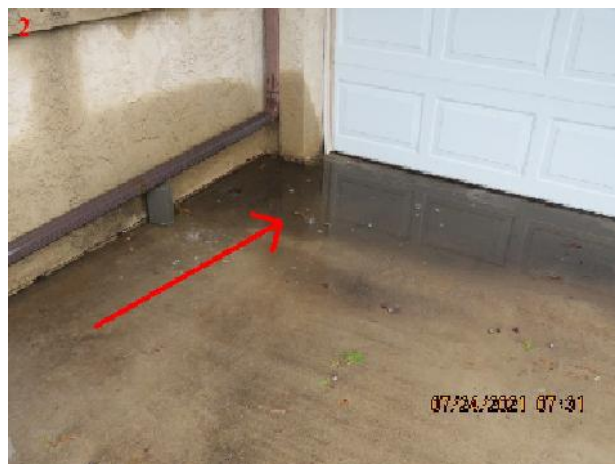
GARAGE - General Comment

The front north corner of the garage gets flooded when it rains. The driveway is sloped toward the garage in this area. Recommend a qualified contractor evaluate and make all necessary repairs.

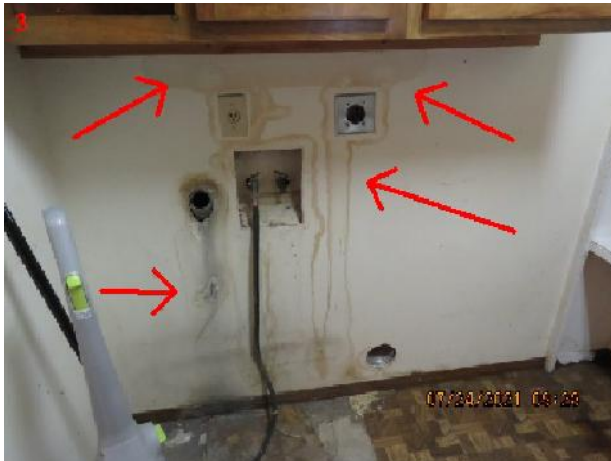
Walls & Ceiling - Inspected

Water stains on the laundry wall at the washer hookup area. Cracks on the ceiling.  
Recommend a qualified contractor evaluate and make all necessary repairs.

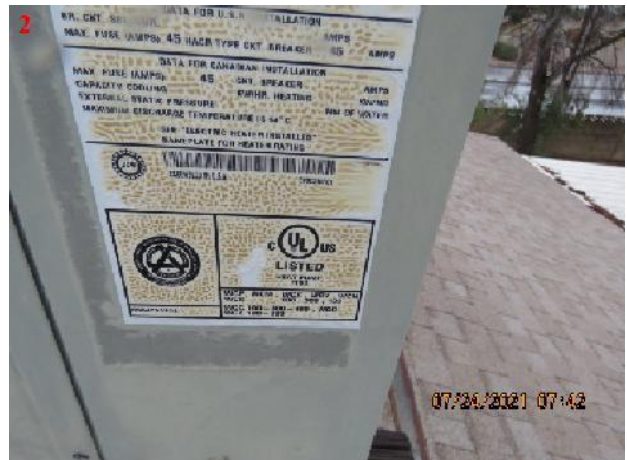
### COOLING SYSTEM - Old Unit

This unit looks like it is over 15 years old. The average life of an AC system in the Phoenix area is 12 to 15 years. This unit may be near the end of its useful life. Typical AC has only 50% of its initial efficiency after 20 years. So a 12 SEER would have a 6 SEER rating.

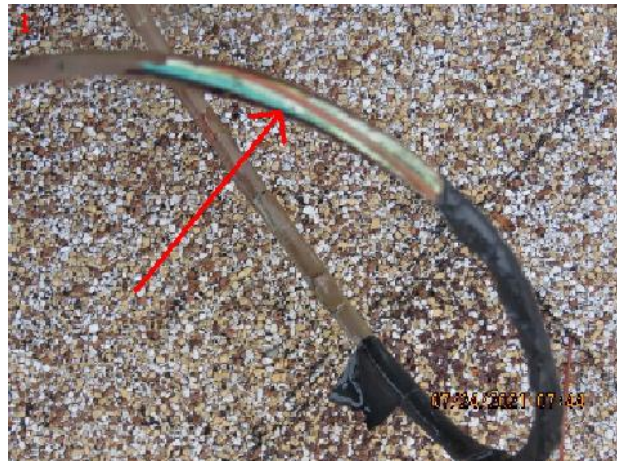
### **Service/Repair** Thermostat wires - Cracked insulation

The low voltage wires from the thermostat to the AC coil on the exterior have damaged insulation. Damage to wire insulation can cause the AC unit to malfunction. Recommend a qualified contractor evaluate and make all necessary repairs.

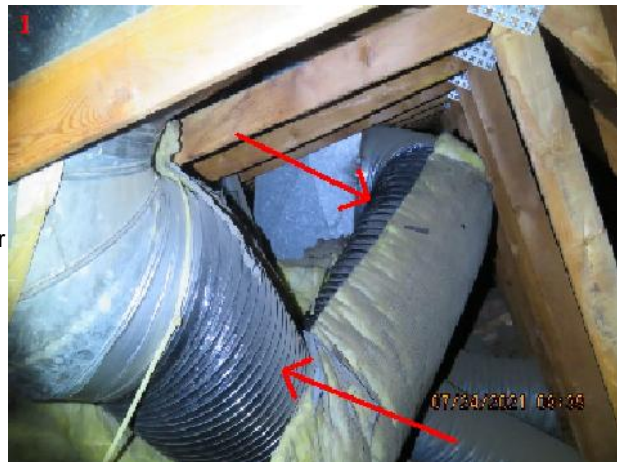
### **Service/Repair** Duct Type - Rigid and Flexible, Vapor Barrier Rip

The outer plaster vapor barrier of one or more of the flexible HVAC ducts in the attic has deteriorated leaving the insulation to the duct loose and falling off the pipe. This allows the hot attic air to warm the cool duct air before it reaches the living space below. When the hot attic air hits the cold AC duct condensation may be formed creating a moisture problem in the attic. Recommend replacing all ducting with a ripped vapor barrier. Recommend a qualified AC contractor evaluate this situation and make all necessary repairs. See picture For all AC repairs and service I recommend Premier Air Solutions Inc. for AC work. 480-940-2351

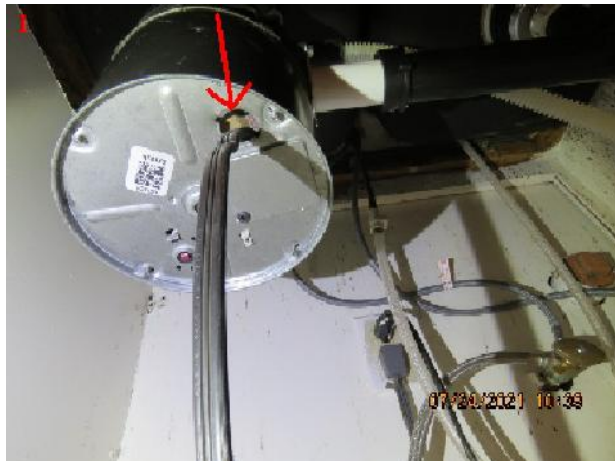
### **Safety Concern** Garbage Disposal - Tested, Power Cord

Electrical cable not properly attached to disposal. Recommend properly attaching cord to disposal. Possible shock hazard. See picture

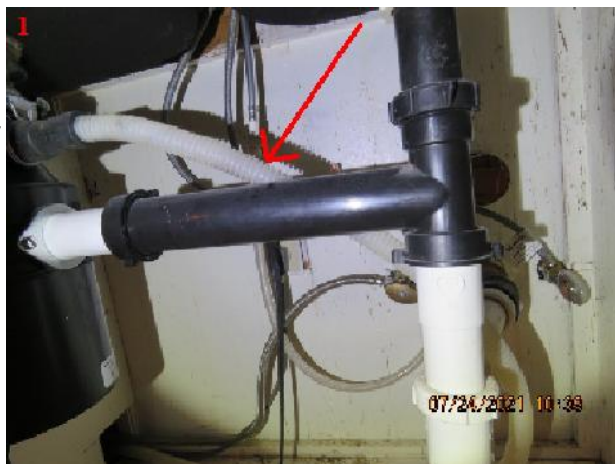
### **Safety Concern** Dishwasher - Drain Hose

The drain hose from the dishwasher to the disposal needs a loop above the disposal drain and most of the sink or a sink air gap to prevent sink drain water from flowing into the dishwasher. See picture  
Recommend a qualified contractor evaluate and make all necessary repairs.

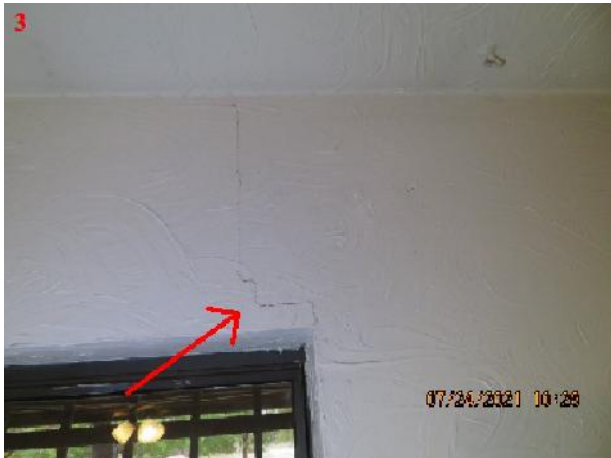
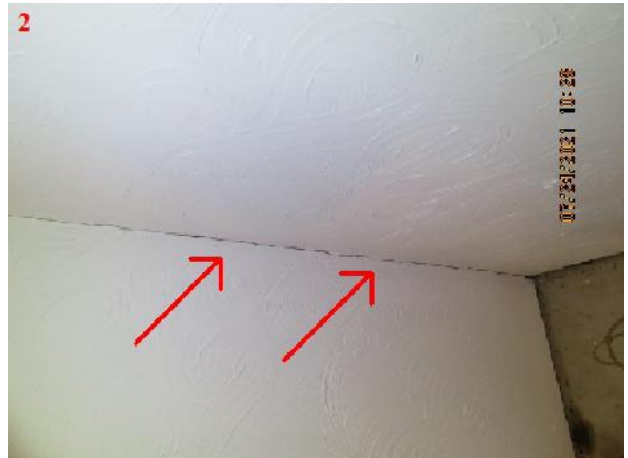
### Interior Walls and Ceiling - Inspected

Cracks in the living room walls and water stain on the family room ceiling in the corner.  
Recommend a qualified contractor evaluate and make all necessary repairs.

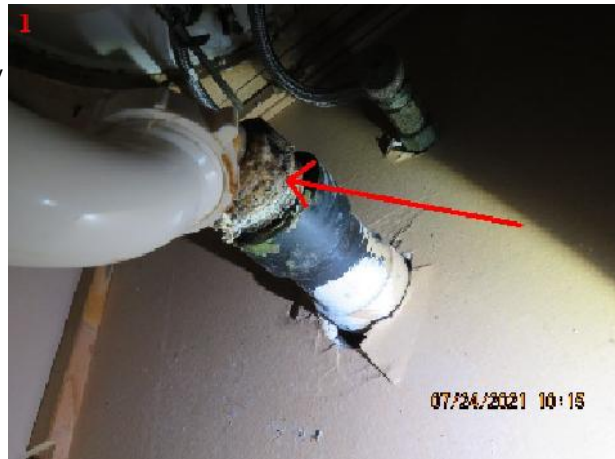
### **Service/Repair** Drain, Trap, Waste and Vent Piping - Tested, Corrosion

Corrosion on the drain pipe for the sink drain in the hall bathroom.  
This is an indication of slow leaking.  
Recommend a qualified contractor evaluate and make all necessary repairs.

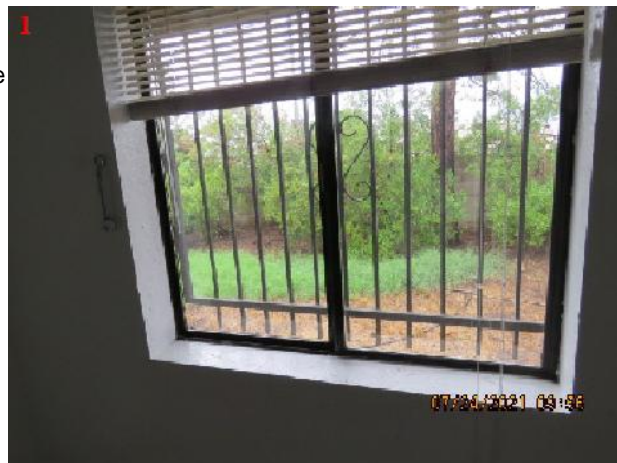
**Safety Concern** **Windows - Approx. 44" or Less to sill, Bars On Windows**

Bars permanently installed on window with or without a quick release are a fire escape hazard. Recommend removing bars from window before sleeping in room. Bars on windows are a fire escape hazard even if they have a quick disconnect. How can a fireman enter if no one opens the bars??

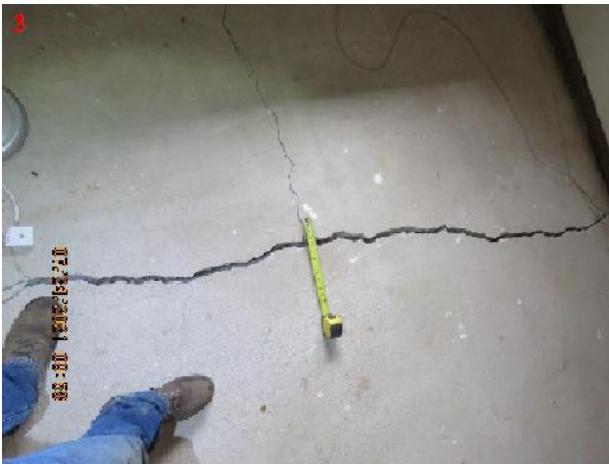
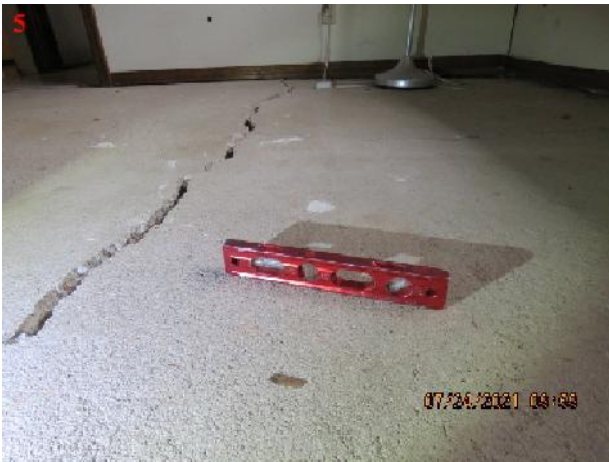
### Floor - Concrete

Large crack running across the center of the floor in this bedroom is up to 1 inch wide and a section of the slab has dropped over 2 inches in 5 feet.

Large crack running across the center of the floor in this bedroom is up to 1 inch wide and a section of the slab has dropped over 2 inches in 5 feet.  
Recommend a qualified contractor evaluate and make all necessary repairs.

Recommend a qualified contractor evaluate and make all necessary repairs.

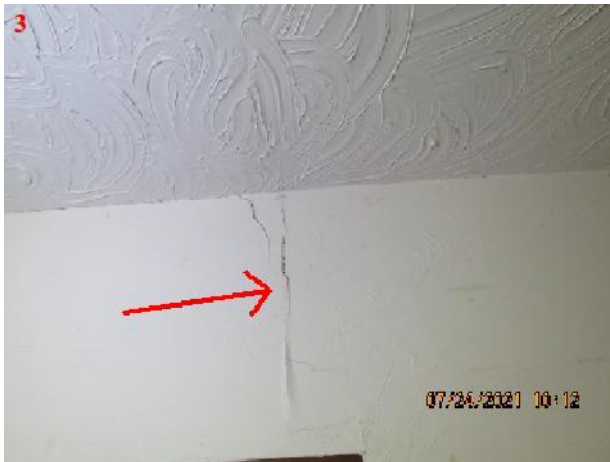
### Service/Repair Walls & Ceiling - Inspected

Cracks on the ceiling and wall in this room and water stains on the ceiling and wall but on wet at this time.  
Recommend a qualified contractor evaluate and make all necessary repairs.
