# Inspection Report

**Property Address:**  
917 Stoneymead Dr  
Kings Mountain NC 28086

| <b>Date:</b> 8/8/2024 | <b>Time:</b> 08:00:00 AM | <b>Report ID:</b> 080824JK5 |

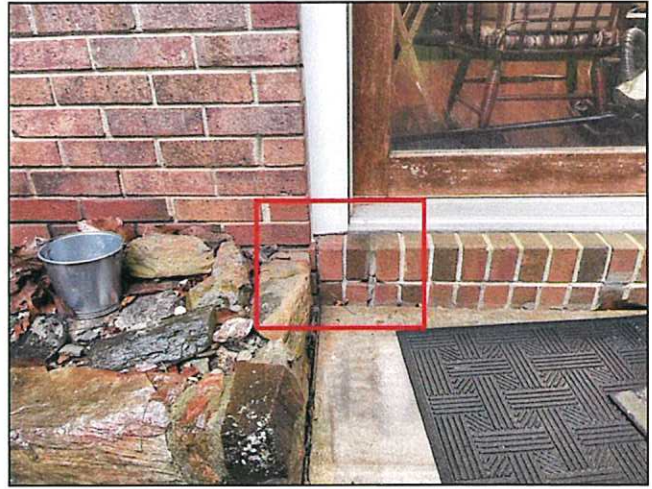
2.

There was/were hairline crack(s) noted in the following locations. Point up and continue to monitor. No corresponding cracks were noted inside the home at these areas and all windows and doors around the area were functioning as intended at the time of inspection. :

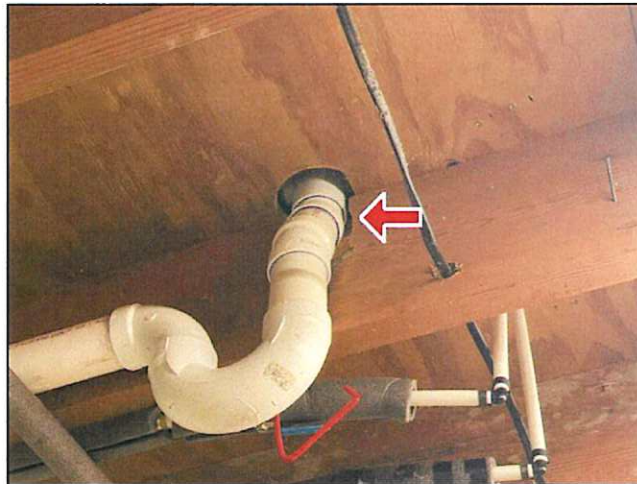
(4) The floor joist has been cut to allow for the plumbing lines under the primary bathroom. This is not typical construction standards. The framing needs to be properly supported. Contact a licensed contractor for review and make repairs as needed.

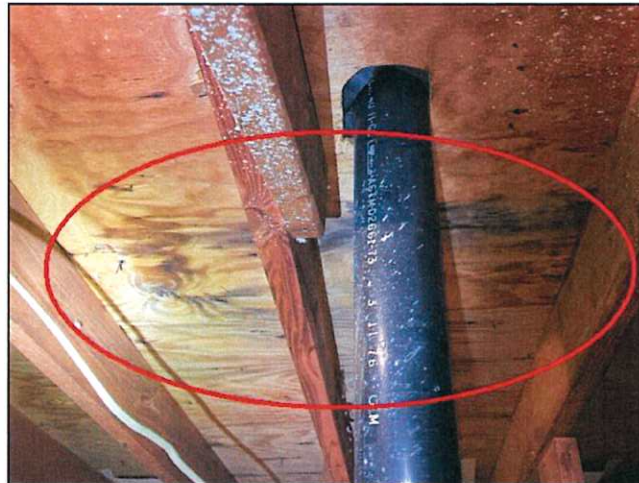
(1) There are stains noted in the attic located at the middle area. Unable to determine if an active leak still existed at the time of inspection. Ask the sellers if a past repair was made. If it is not known then it should be treated as an active issue and further reviewed by a licensed contractor or roofer for evaluation and repair.

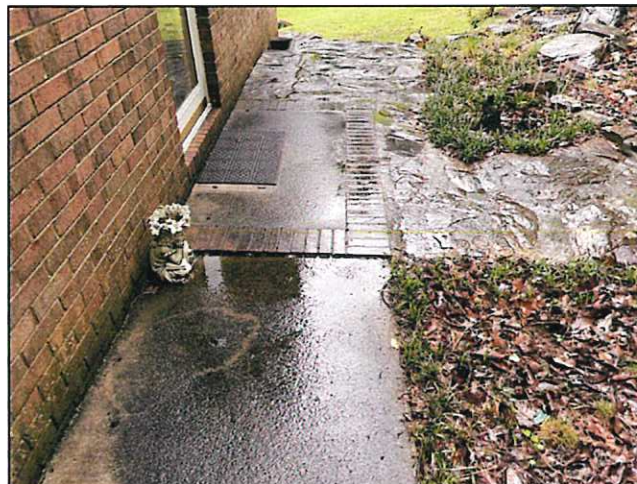
(2) Evidence of poor drainage at the following location(s). This was noted by staining or muddy soil indicating standing water at times or by physically standing water at the time of inspection. This can lead to foundation issues and/or organic growth if standing longer than 48 hours. Contact a qualified professional/landscaper for repairs. :

1. left side of home
2. rear patio
3. right side of home

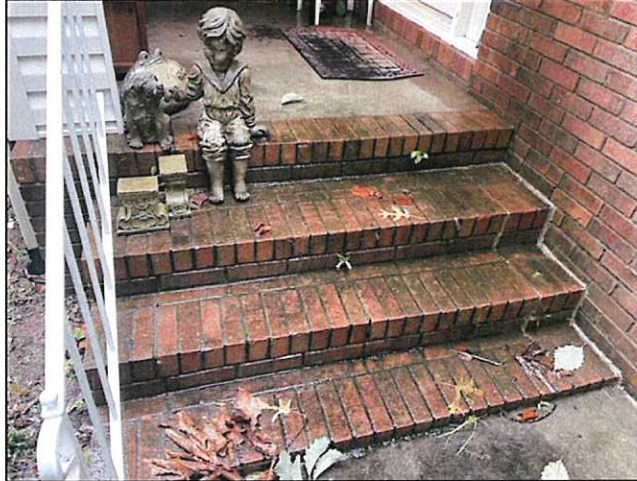
The front porch steps needs to be pointed up (more mortar) in several areas where there are gaps. This is needed prevent water penetration. Contact a qualified professional for repairs.

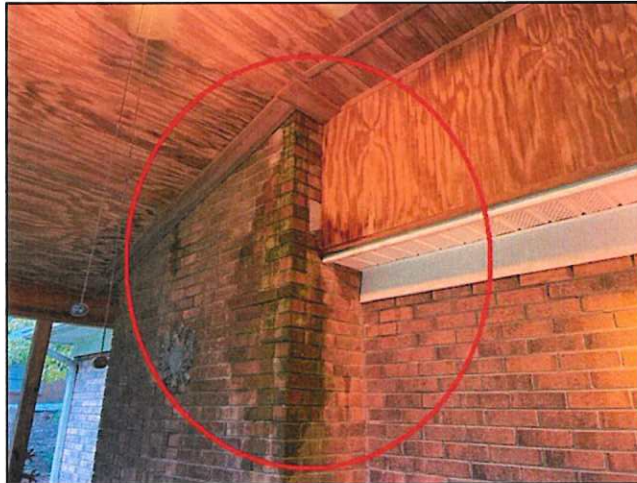
There was an active moisture leaks noted at the rear deck/porch. Contact a licensed contractor for review, determine the source/cause and make any additional repairs as needed.

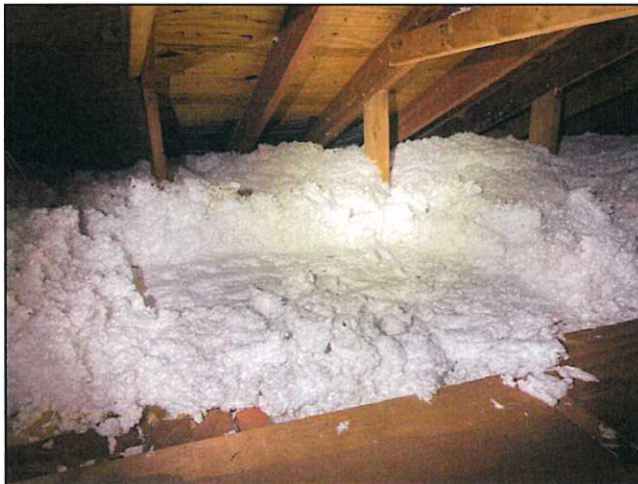
(2) The insulation is compacted in several areas throughout the attic and the true R-factor at this point in time may be substantially less than when originally installed. Installation of additional insulation is needed. Contact a qualified professional for repair.

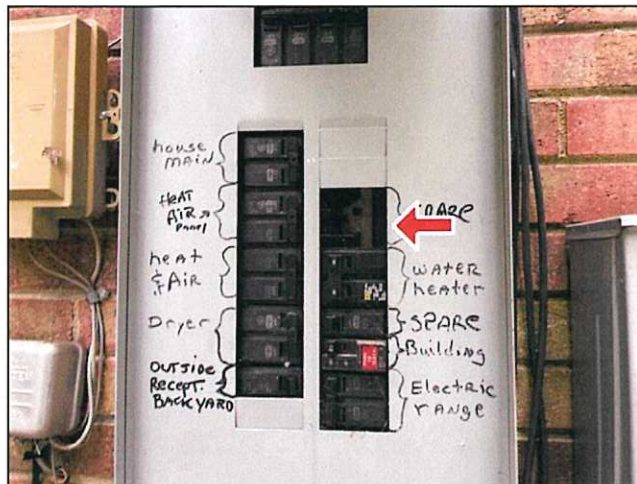
(2) Missing breakers/spacing was noted at the electric panel. This is a safety hazard. Contact a licensed electrician for repair.

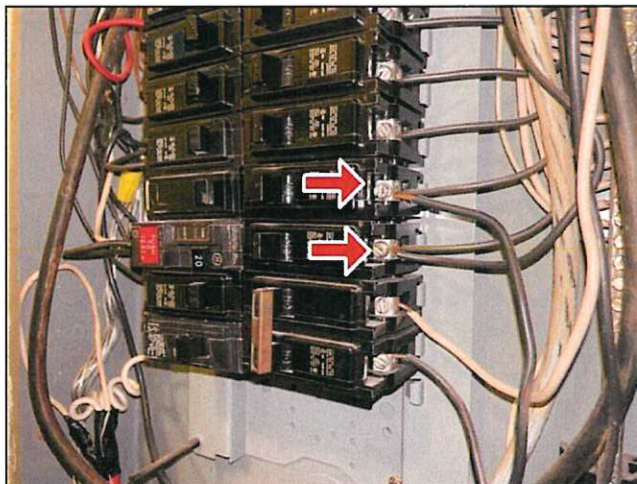
(3) There are multiple wires are connected to a single lug on a circuit breaker in the sub-panel where only one wire should be connected. "Double Tapped". This is an electrical safety hazard. Contact a licensed electrician for repair.

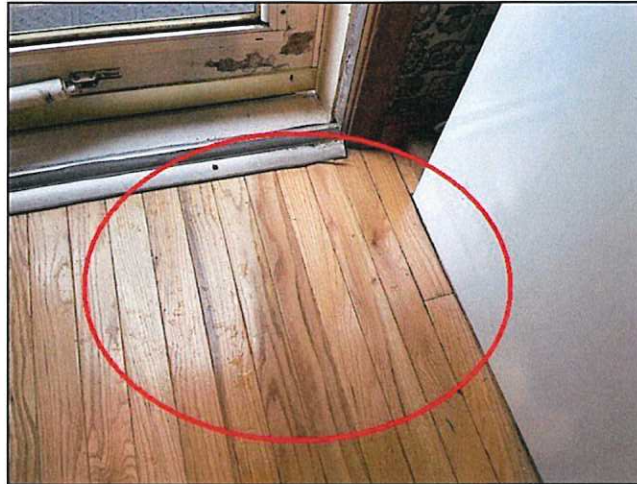
Damage and/or deterioration noted to the floor covering in the following locations. Contact a licensed flooring company for review to determine the repair needed.

1. moisture expansion/deterioration noted at the right side/kitchen exterior door location
