Inspection Report

**963 Beaver Creek Road
Bluff City, TN 37618**

1.1 Client Name: Lois Wells.
 1.2 Inspection Number: 042125-02.
 1.3 Inspection Date: April 21, 2025.
 1.4 Inspection Address: 963 Beaver Creek Road, Bluff City, TN 37618.
 1.5 Inspector: Ron Ladd, TNHIL #0000033, VAHIL #3380000585, ASHI #245442.
 1.6 Parties Present: Seller, Sellers Agent.
 1.7 Clients Agent: N/A.
 1.8 Weather: The weather conditions at time of inspection: Sunny, The temperature at time of inspection: 70 - 80 degrees fahrenheit.

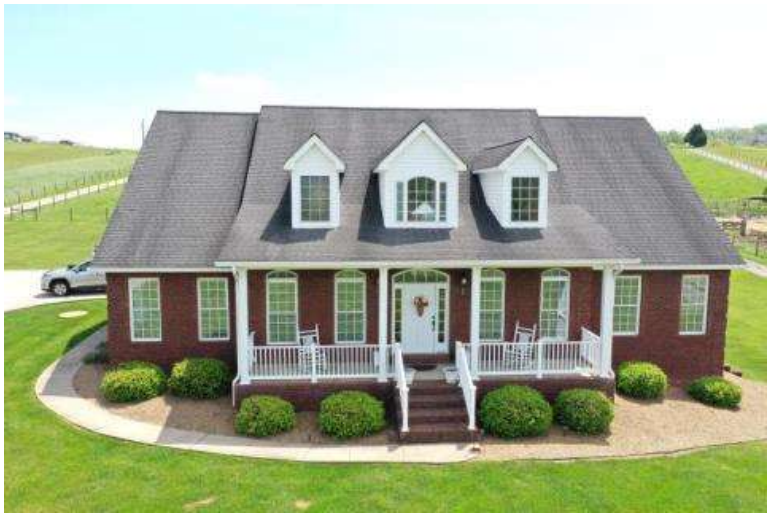
1.13 Structure Views: This is an AERIAL DRONE view of the subject property at time of inspection from the Front.

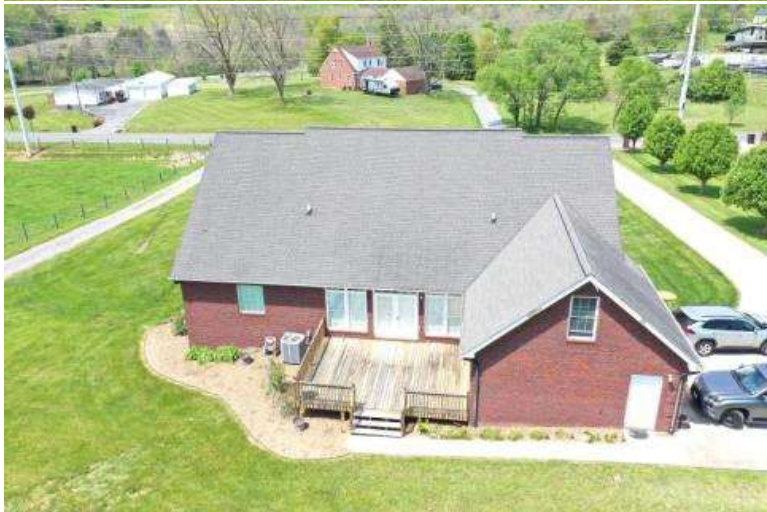
1.14 This is an AERIAL DRONE view of the subject property at time of inspection from the Rear

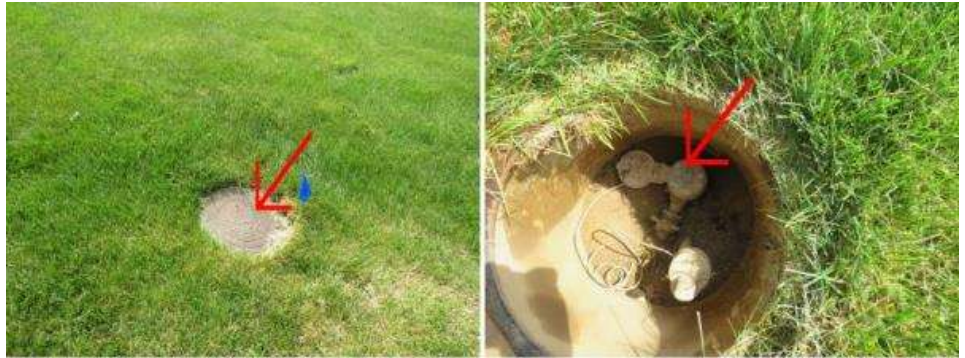
Water meter is located:
at the front of the house,
at or near the road.

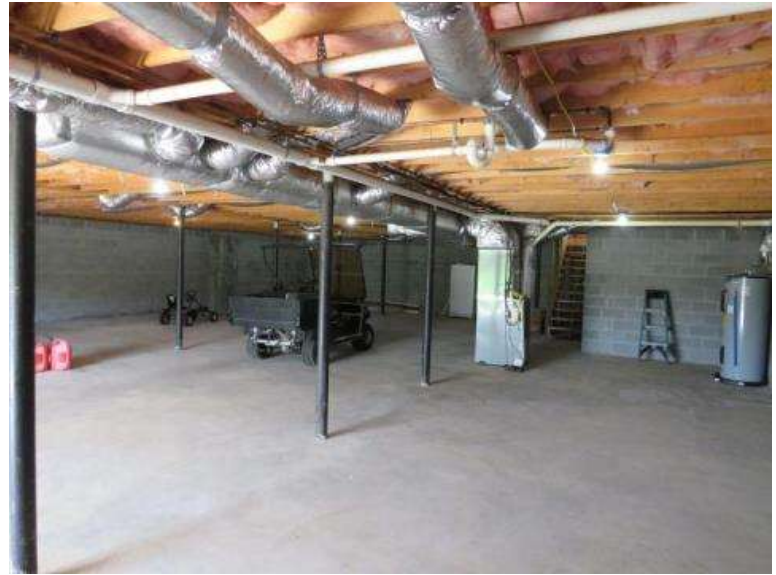
- 24.3 Accessibility: Basement is fully accessible. This is a typical view of the basement area at time of inspection.

- 24.4 Stage of Completion: Basement is unfinished.
- 24.5 Basement Walls Type: Concrete block.
- 24.6 Wall Condition: **Maintenance:** Minor settlement cracks noted, not significant at this time.

- 24.7 **Maintenance:** Staining was observed: Evidence of prior water penetration is noted, inspector probed stains and found them to be dry at time of inspection. Efflorescence seen on walls indicates the past presence of periodic moisture. Suggest checking with seller as to corrective action taken to prevent further moisture entry.
