PROPERTY INSPECTION REPORT

1303 Coggin Ave, Brownwood, TX 76801

Date of Inspection: 11/6/2025 Time: 1:00 PM Size: 1684

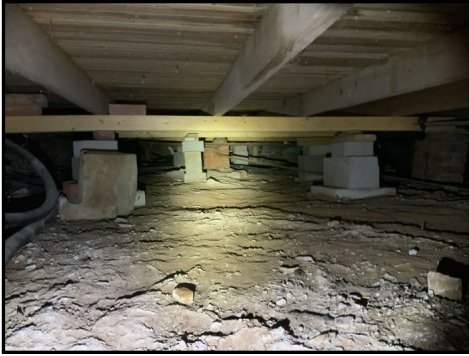
One of the supports are leaning. This is one of the original supports. New supports have been added nearby.

Crawl space

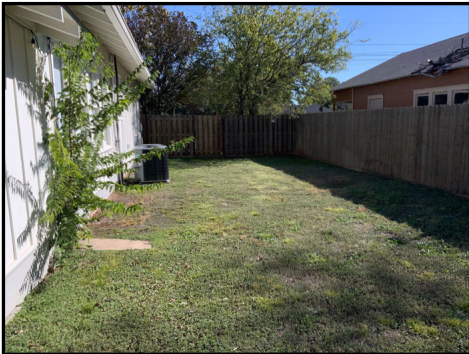
Grading appears to be sufficient around the structure.

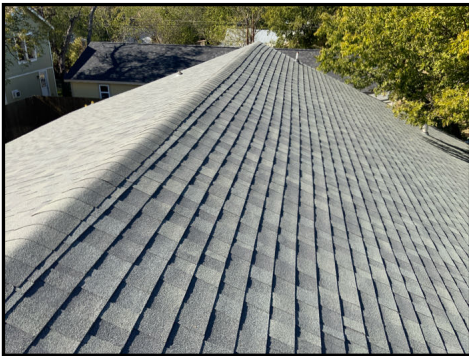
Roof view

Tree limbs are close to touching the roof in several locations. Recommend trimming these back to prevent damage to the roof.

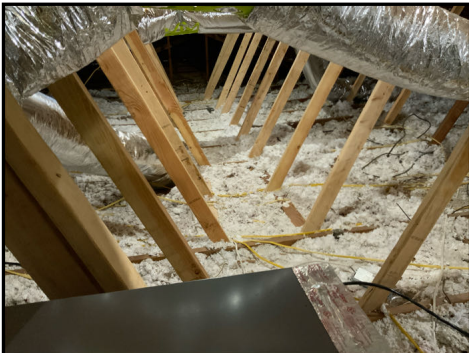
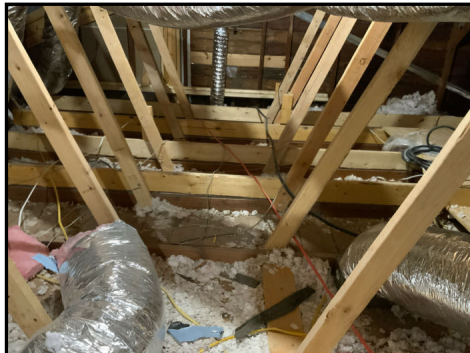
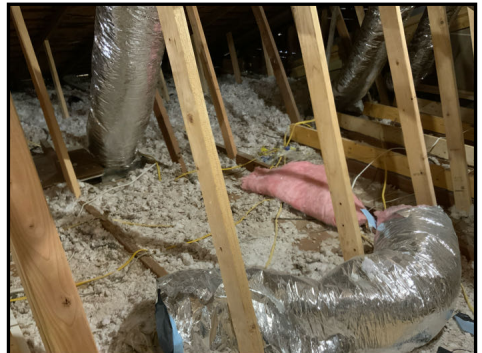
No insulation was installed in parts of the attic. It is recommended that a minimum R-30 value be added to meet current energy standards.

Attic view

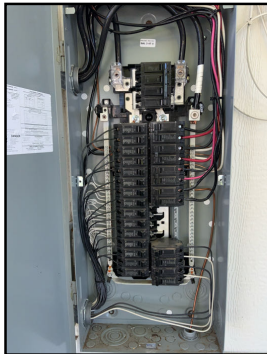
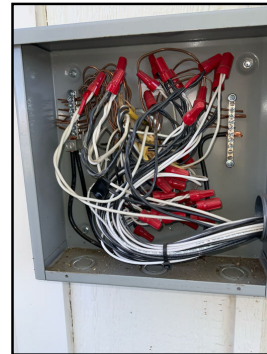
The home does not meet current **AFCI** requirements, which is now required on all new construction. This might not have been a standard when the house was built, but we are required to note this as a deficiency by TREC standards. This does NOT have to be brought up to todays standards, but if electrical upgrades are made to the panel, it is recommended that this be added by a licensed electrician.

Panel interior

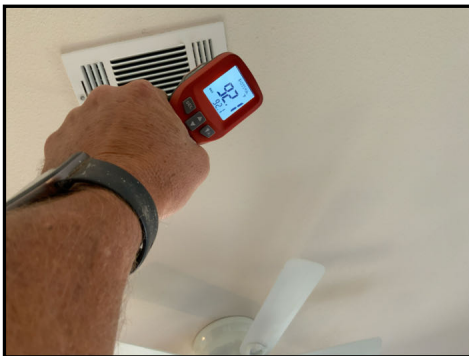
The heat was tested and it functioned at the time of the inspection.

Heat was functional

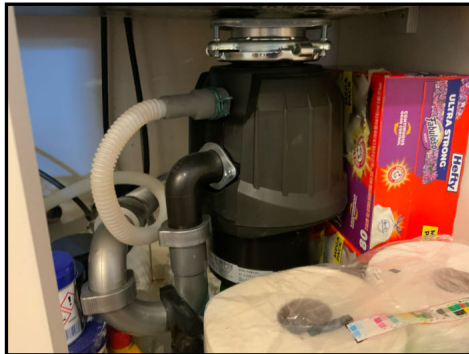
Disposal

Operational and functional at the time of the inspection

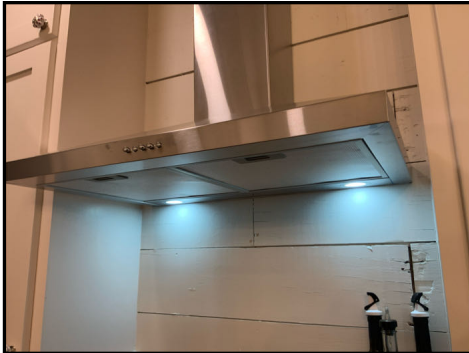
Range hood was functional

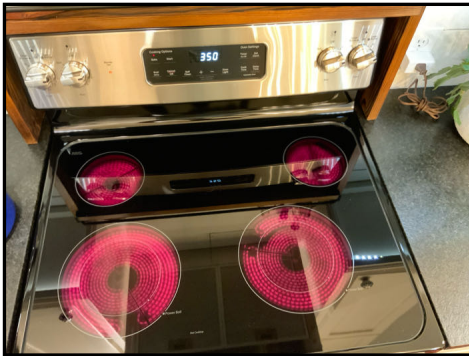
The cook top was functional

Cooktop was functional

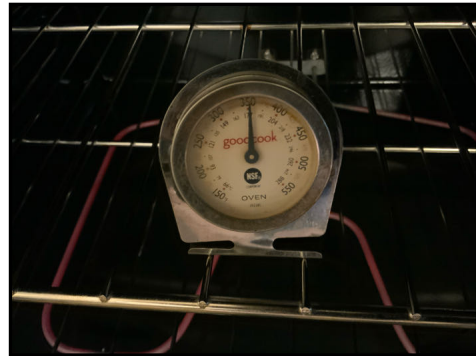
Oven temp

The oven was tested at 350 degrees and reached an internal temperature of approximately 355 degrees using an oven thermometer.

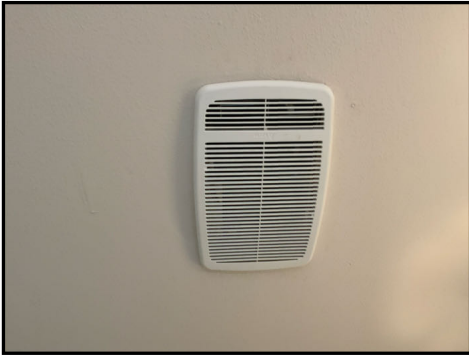
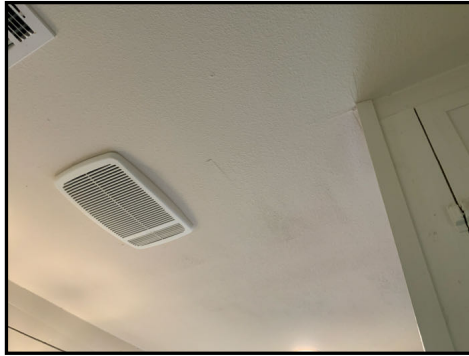
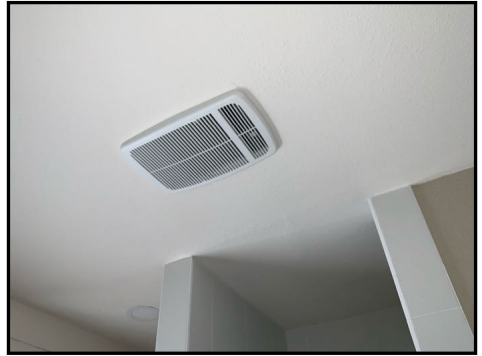
The bath fans functioned at the time of inspection.

The bath fan(s) terminated in the attic space and should be vented to the exterior to prevent moisture build up in the attic.

Bath fan was functional
