**192 Flower House Loop Troutman, NC 28166**

## **Inspection Prepared For Ryan Wright**

Date: 8/5/2026 Time: 9:30 AM

Year Built: 1946 | Size: 1330 sq.ft.

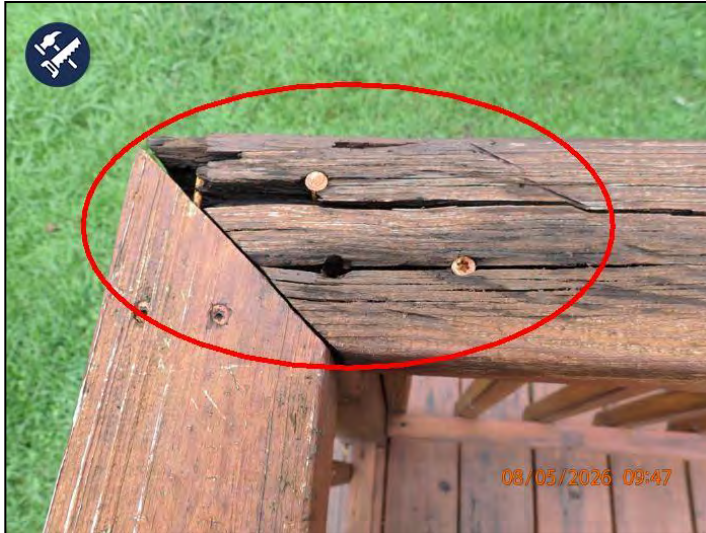
| Page 23 | 2.4 Balcony/Deck | <ul style="list-style-type: none"><li>• <b>SAFETY CONCERN:</b> Multiple deficiencies were observed on and around the balcony and/or deck at the time of inspection. Deficiencies included damage/deterioration to the rails, exposed nails, loose guardrails, inadequate hardware used in the ledger board, missing joist hangers, etc. These combined deficiencies create significant safety risks. Recommend a qualified decking contractor repair or replace the entire balcony and/or deck to restore structural stability and reduce the risk of injury.</li></ul> |

Significant Deterioration/Exposed Nails (Left Of Structure)

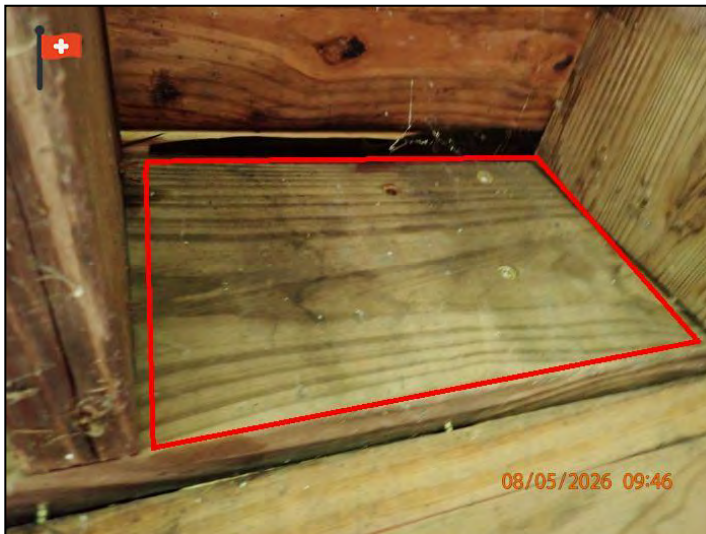
Inadequate Hardware Used In Ledger Board (Left Of Structure)

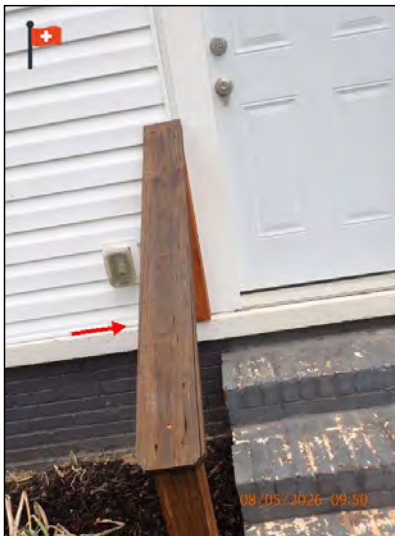
| Page 25 | 2.6 Stairs | <ul style="list-style-type: none"><li>• <b>SAFETY CONCERN:</b> Although handrail(s) were present on the stair assembly at the time of inspection, they were not graspable. Non-graspable handrails cannot provide adequate stability or support to prevent falls, which is a safety hazard. Recommend a qualified contractor replace and/or install proper graspable handrail(s) to reduce the risk of injury.</li></ul> |

Missing Graspable Handrail(s)

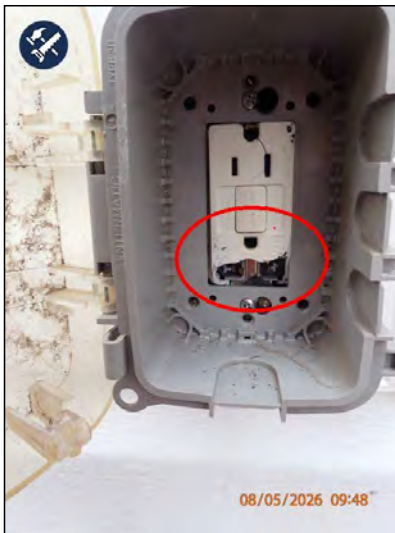
• **REPAIR:** A receptacle was damaged/broken at the time of inspection. This condition can result in poor grounding and present a shock hazard. Recommend a qualified electrical contractor replace the receptacle to restore proper and safe function.

Damaged Receptacle (Left Of Structure)

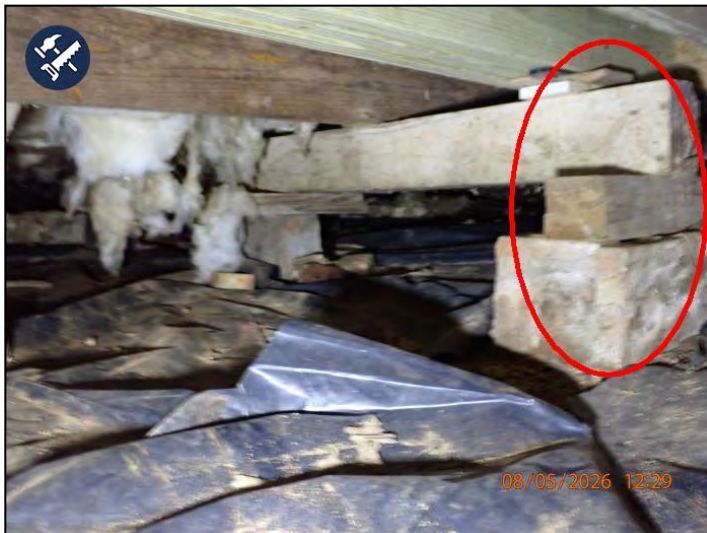
- **REPAIR:** Free-floating support(s) were observed in multiple locations at the time of inspection. Supports not properly anchored or bearing load can fail to provide adequate stability. Recommend a qualified contractor or structural engineer further evaluate and repair or replace as necessary to restore proper structural support.

Free Floating Support(s) (Multiple Locations)

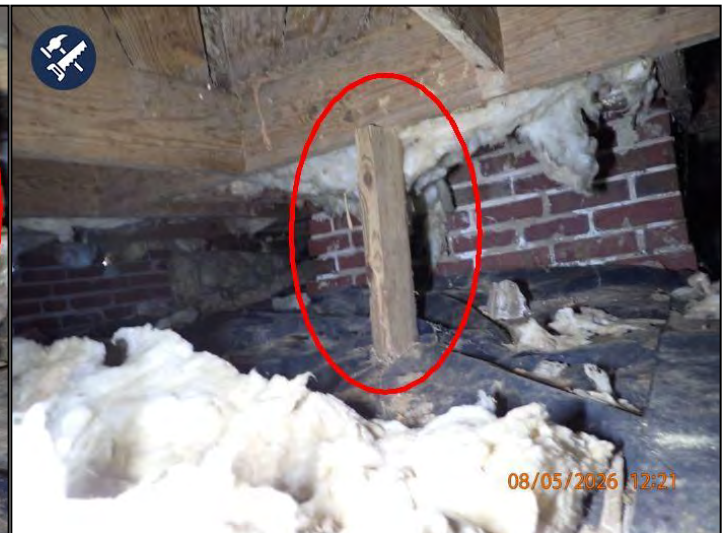
- **REPAIR:** Improperly installed wood pier(s) were observed in multiple locations at the time of inspection. Improper installation can weaken load distribution and allow shifting or settlement. Recommend a qualified contractor or structural engineer further evaluate and repair or replace as necessary to restore proper structural support.

Unprofessional Install

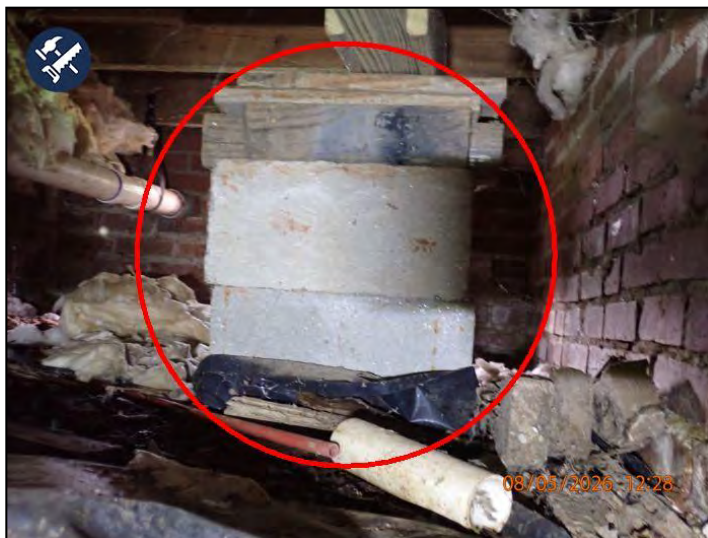
- **REPAIR:** Dry-stacked posts and/or piers were observed at the time of inspection, indicating improper installation. Improper stacking can compromise stability and reduce support performance. Recommend a qualified contractor further evaluate and repair or replace as necessary to restore proper structural support.

Dry-Stacked/Unprofessional Install (Multiple Locations)

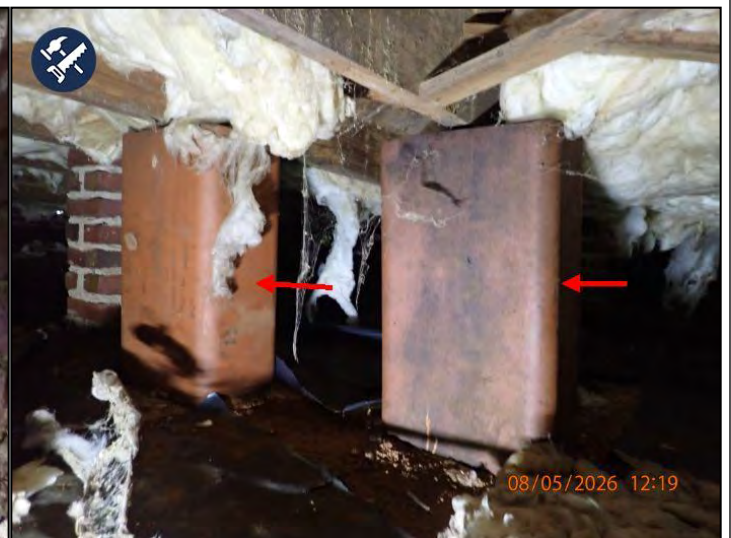
- **REPAIR:** Posts and/or piers were installed with improper material (terracotta pipes) at the time of inspection. These deficiencies can weaken stability and shorten service life. Recommend a qualified contractor or structural engineer further evaluate and repair or replace the supports as necessary to restore proper structural performance.

Unprofessional Install (Terracotta Pipes)

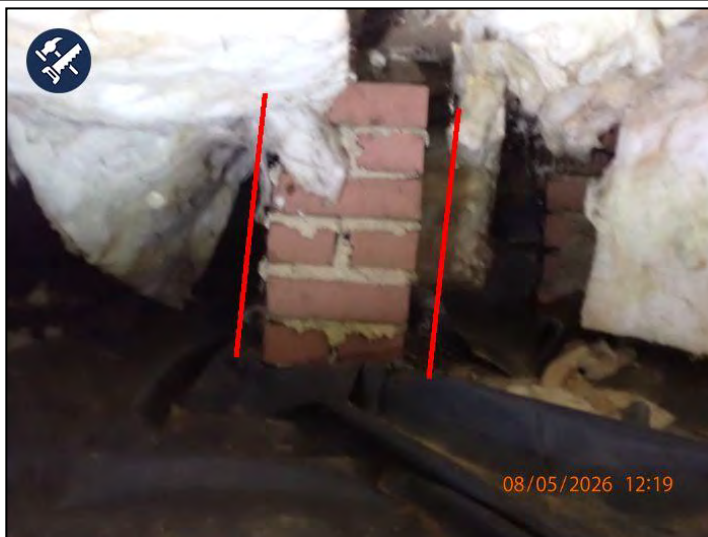
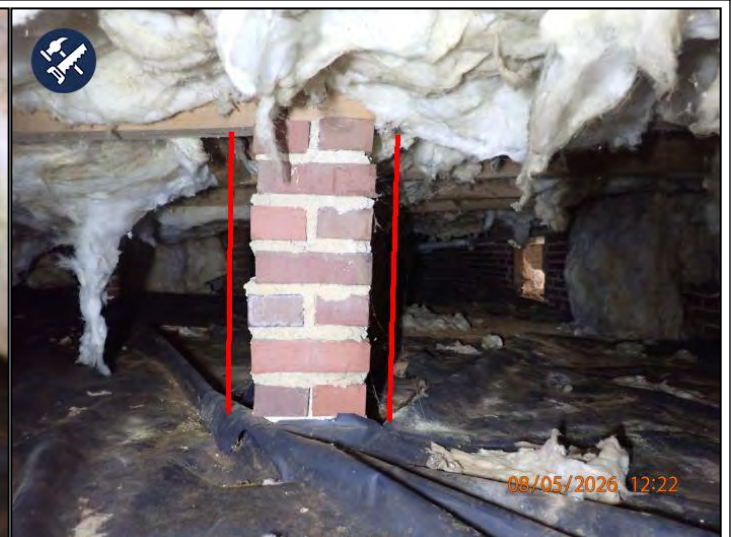
- **REPAIR:** Leaning pier(s) were observed in multiple locations at the time of inspection. Leaning supports can shift under load and reduce structural stability. Recommend a qualified general contractor further evaluate and repair or replace the pier(s) as necessary to restore proper structural support.

Leaning Pier(s) (Multiple Locations)

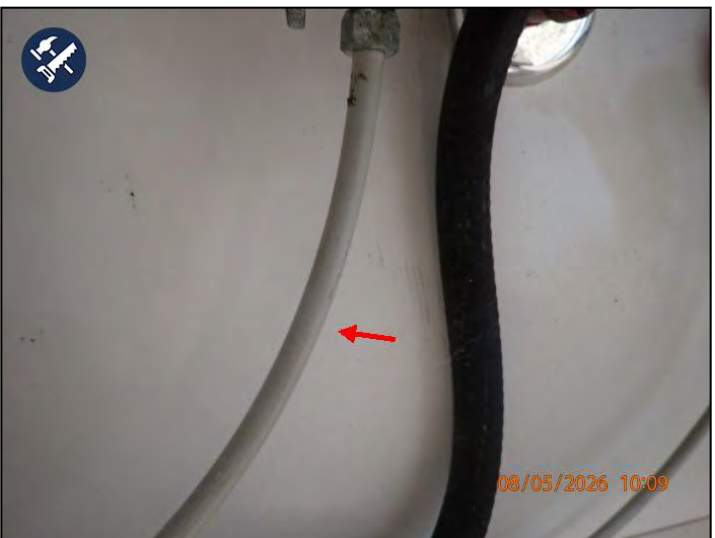
As per NC Licensure Board approved language: 'This home has a plumbing supply system that uses polybutylene plastic distribution lines and compression band fittings. Even though this plumbing system was installed in many homes from 1978 until the mid-1990's, it is no longer an approved plumbing system due to a history of material failures. The failures were related to improper installation, improper handling, improper storage, and plastic deterioration due to chemical reactions with the water supply. Due to the nature of this latent defect, it was not possible to adequately assess the condition of the plumbing system during the home inspection. A licensed plumbing contractor should be consulted for a complete evaluation of the plumbing system to determine the significance of this concern.'

Polybutylene

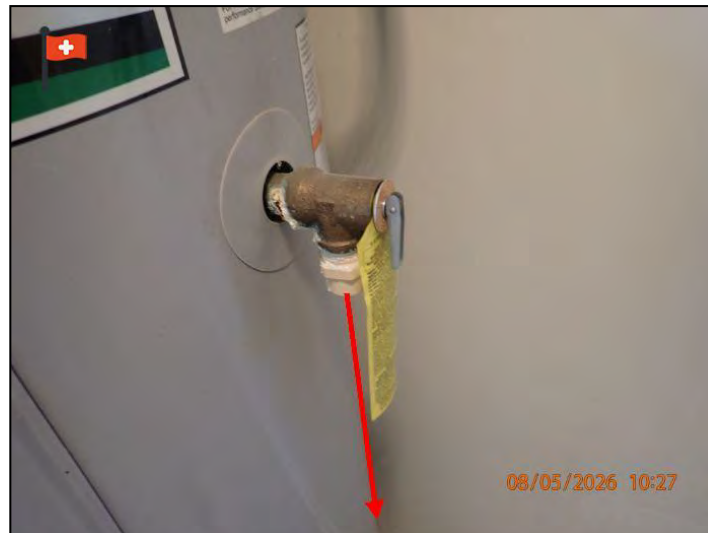
• **SAFETY CONCERN:** Although a Temperature Pressure Relief Valve (TPRV) was present, the discharge pipe was missing. A missing discharge pipe allows extremely hot water to discharge freely into the occupied space during an emergency, posing a severe scalding hazard. Recommend a qualified plumbing contractor install a proper discharge pipe for proper function and reduce the risk of injury.

Missing Discharge Pipe

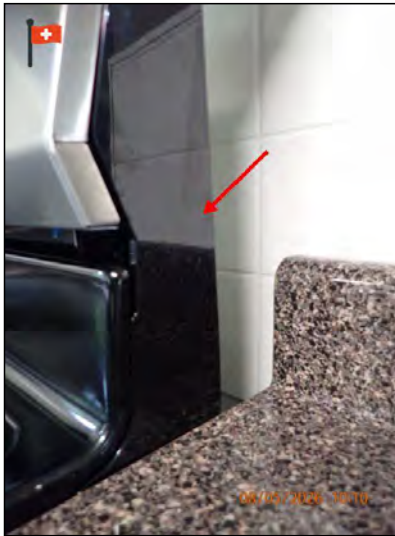
- **SAFETY CONCERN:** An anti-tip bracket was missing from the range installation at the time of inspection. Missing anti-tip devices can allow the range to tip over when excess force is applied to an open oven door, creating a scalding and/or burn hazard. Recommend a qualified appliance contractor install the bracket to reduce the risk of injury.

Missing Anti-Tip Bracket

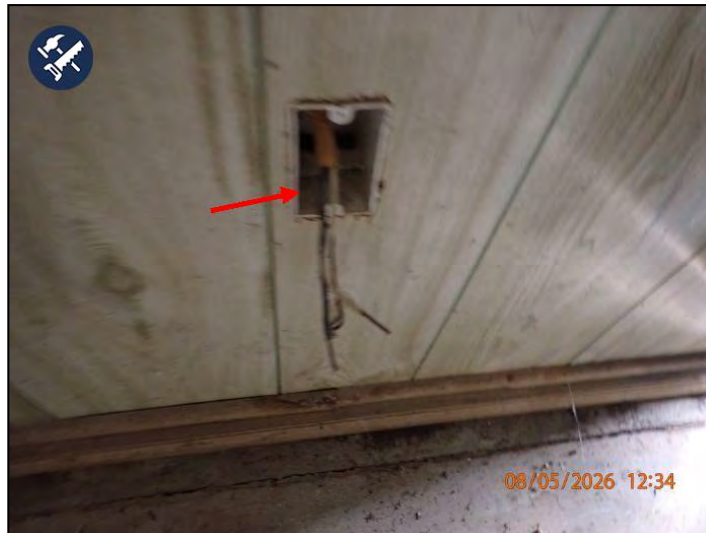
• **REPAIR:** Open junction box(es) were observed at the time of inspection. Open boxes leave splices exposed to separation, arcing, or shock. Recommend a qualified electrical contractor install proper covers to restore safe conditions and reduce the risk of fire.

Open Junction Boxes (Multiple Locations)

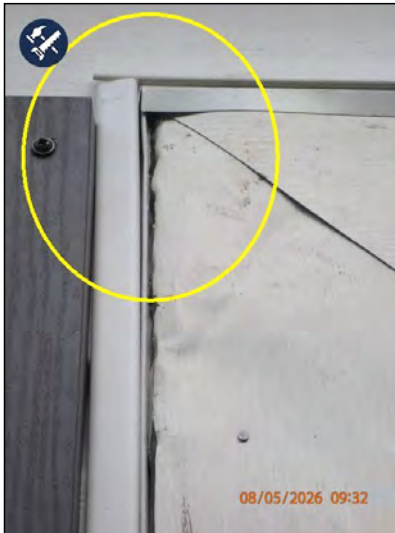
- **IMPROVE:** Damage to the trim was observed at the time of inspection. Damaged trim can allow moisture to contact wall materials and lead to deterioration. Recommend a qualified contractor replace the trim to protect the building materials.

Damaged Trim (Multiple Locations)

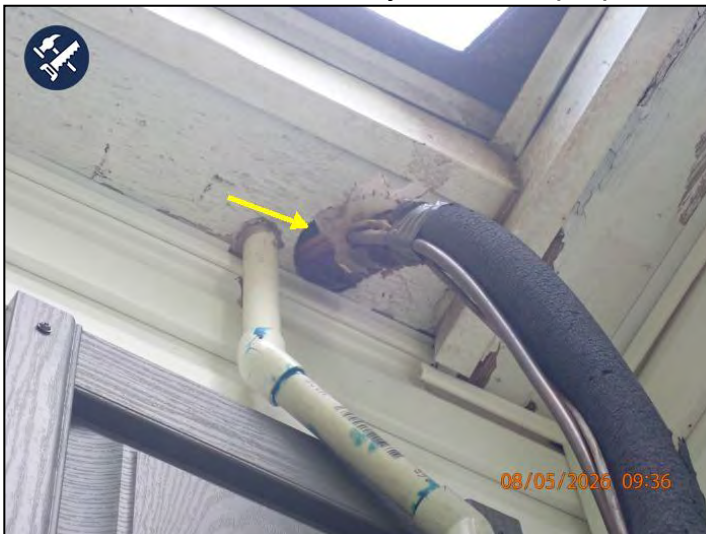
- **IMPROVE:** Unsealed penetration(s) were observed in the eaves and/or fascia at the time of inspection. Unsealed openings can allow moisture intrusion, which may damage building materials. Recommend a qualified contractor seal all penetrations to prevent moisture intrusion and protect the surrounding building materials.
- **IMPROVE:** The fascia boards showed evidence of damage and/or deterioration in multiple locations at the time of inspection. Damaged or deteriorated fascia can compromise the protection of roof edges and allow moisture intrusion. Recommend a qualified contractor repair or replace the fascia boards as necessary to restore proper function and protect the building materials.

Unsealed Penetration(s) (Rear Of Structure At Line Set)

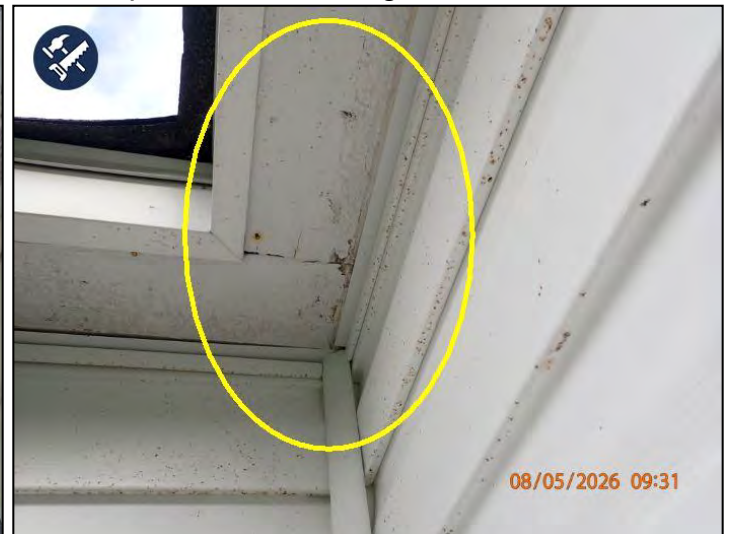
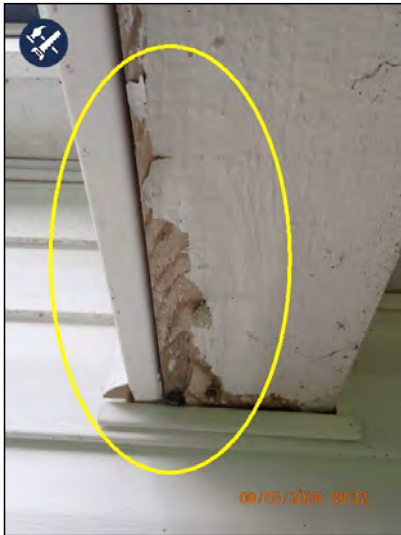
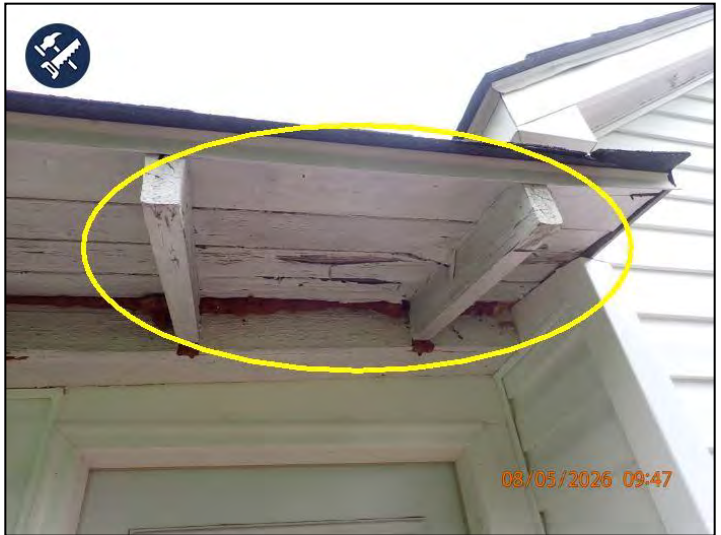
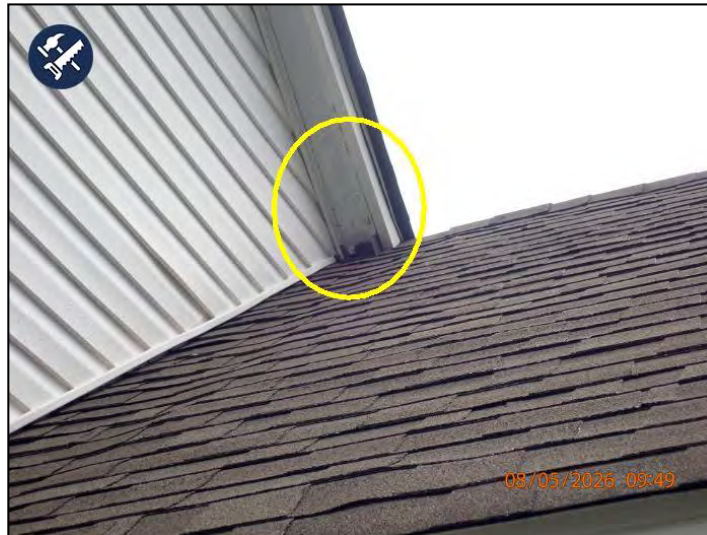
Damage/Deterioration (Multiple Locations)

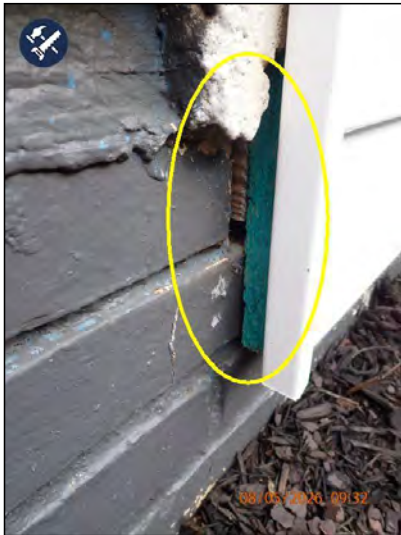
- **IMPROVE:** Exposed wooden sheathing was observed in multiple locations at the time of inspection. Exposed wood can absorb moisture and deteriorate more quickly. Recommend a qualified painting contractor prep, prime, and paint the affected area(s) to protect the building materials and prevent further deterioration.

Exposed Wooden Sheathing (Multiple Locations)    Exposed Wooden Sheathing (Multiple Locations)

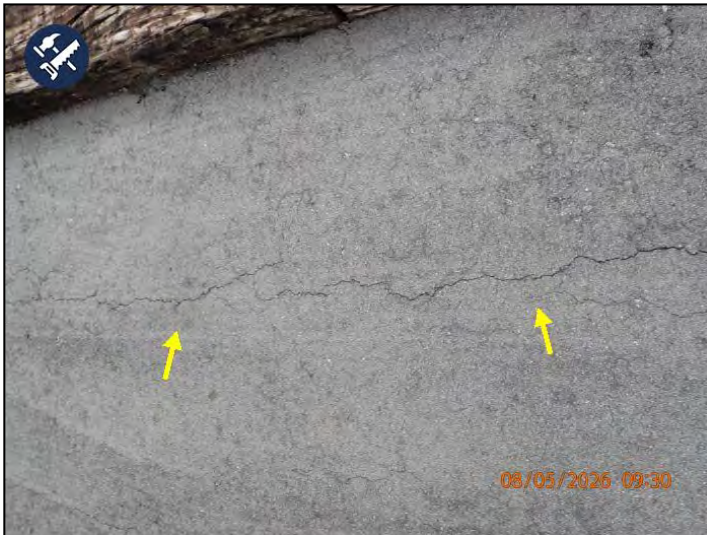
- **IMPROVE:** Typical cracking was observed in the asphalt surface(s) at the time of inspection. Cracks can worsen with freeze-thaw cycles, accelerating deterioration. Recommend a qualified asphalt contractor seal the crack(s) to prevent further deterioration and prolong the service life of the asphalt.

Typical Cracking (Walkway) (Multiple Locations)

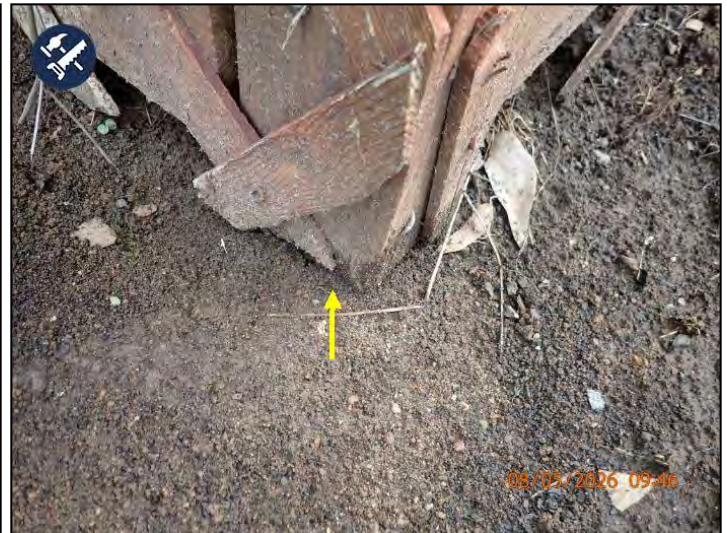
Wood-To-Ground Contact (Left Of Structure)

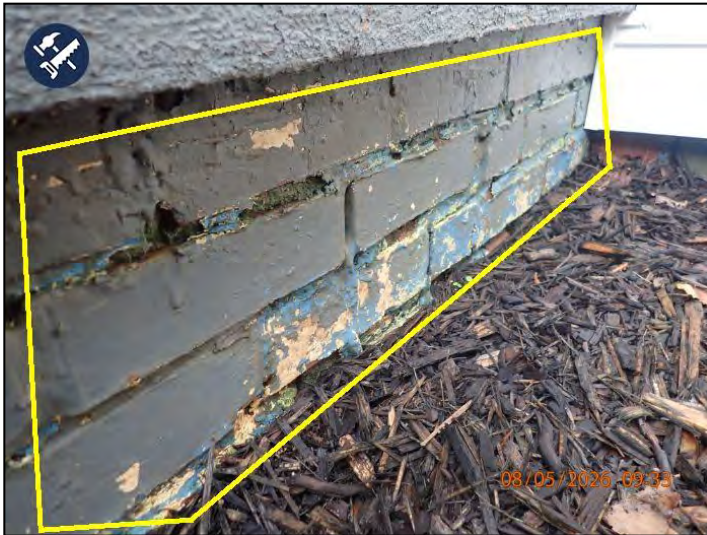
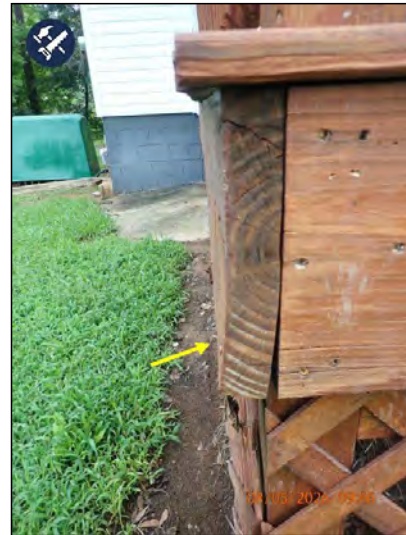
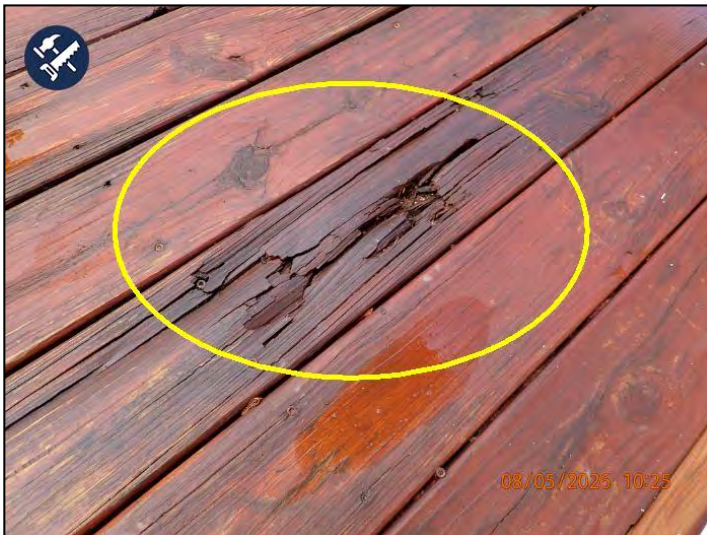
- **IMPROVE:** Wood deterioration was noted in multiple locations on the deck surface at the time of inspection. Deteriorated wood can spread and compromise the surface if not corrected. Recommend a qualified decking contractor repair or replace any compromised area(s) to prevent further deterioration.

Deterioration (Multiple Locations)

Deterioration/Warping (Multiple Locations) (Left Of Structure)

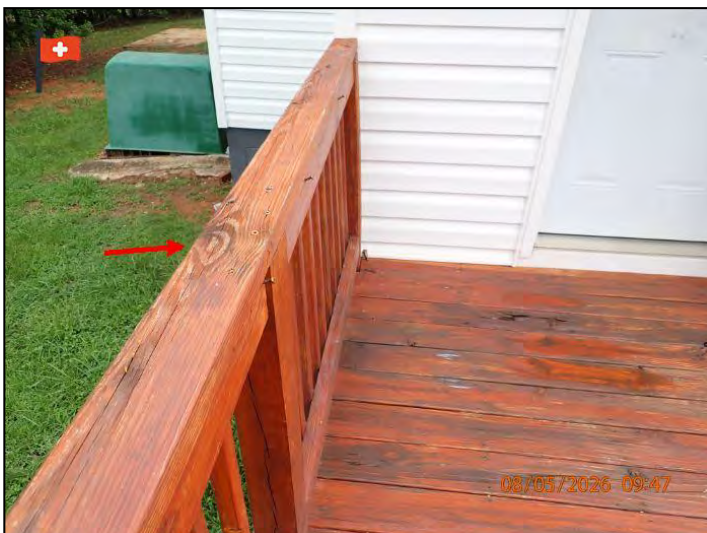
- **SAFETY CONCERN:** Multiple deficiencies were observed on and around the balcony and/or deck at the time of inspection. Deficiencies included damage/deterioration to the rails, exposed nails, loose guardrails, inadequate hardware used in the ledger board, missing joist hangers, etc. These combined deficiencies create significant safety risks. Recommend a qualified decking contractor repair or replace the entire balcony and/or deck to restore structural stability and reduce the risk of injury.

Loose Guardrail(s) (Left Of Structure)

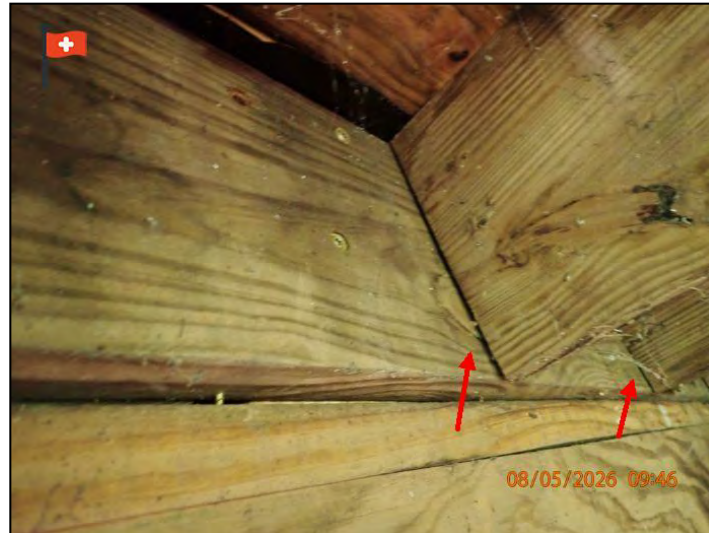
Missing Joist Hangers (Left Of Structure)

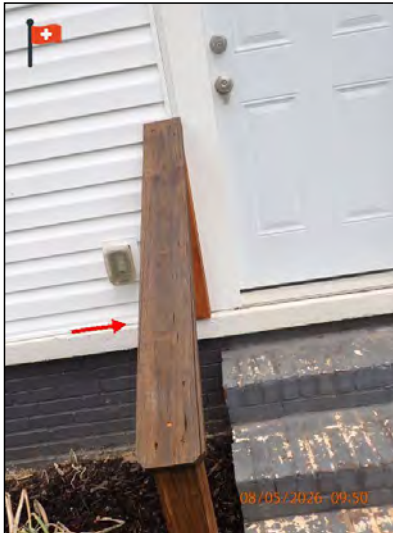
- **SAFETY CONCERN:** Although handrail(s) were present on the stair assembly at the time of inspection, they were not graspable. Non-graspable handrails cannot provide adequate stability or support to prevent falls, which is a safety hazard. Recommend a qualified contractor replace and/or install proper graspable handrail(s) to reduce the risk of injury.

Missing Graspable Handrail(s)

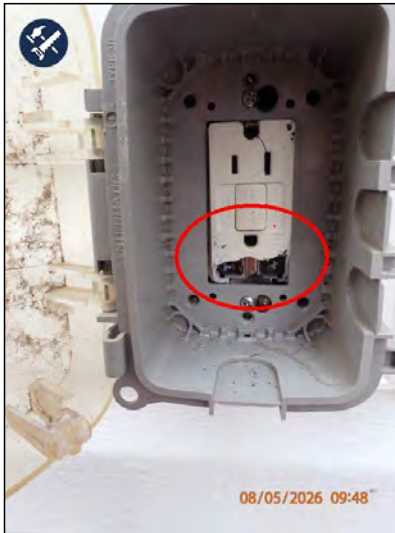
- **REPAIR:** A receptacle was damaged/broken at the time of inspection. This condition can result in poor grounding and present a shock hazard. Recommend a qualified electrical contractor replace the receptacle to restore proper and safe function.

Damaged Receptacle (Left Of Structure)

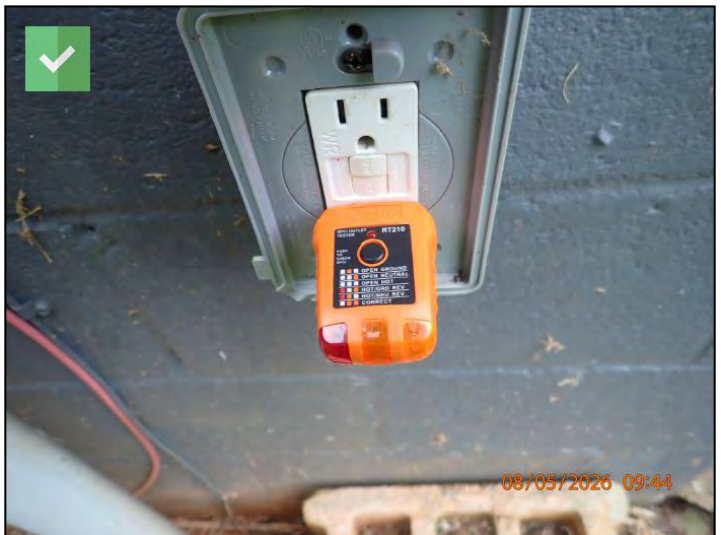
GFCI Reset Location For Exterior Receptacles:  
Within Each Receptacle

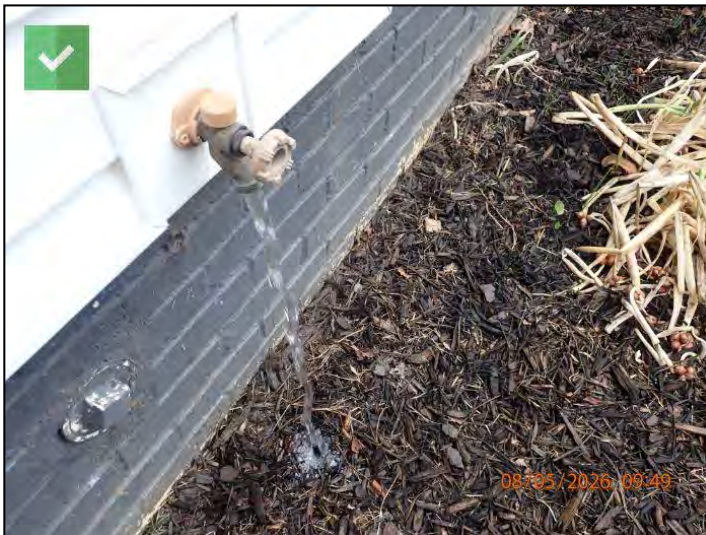
Functional

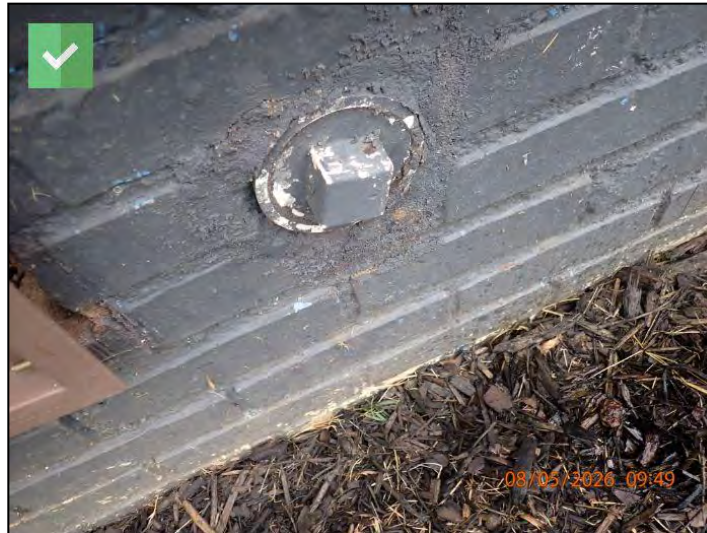
- **NOTE:** A plumbing clean out was observed in the foundation perimeter. No deficiencies observed.
- **IMPROVE:** Due to the age of the home, concealed defects in the buried sewer line and/or septic system may exist even though they were not visible at the time of inspection. Potential defects may include tree root intrusion, broken drain pipes, or other obstructions. Recommend a qualified plumbing contractor perform a sewer line and/or septic inspection to determine the condition and help prevent unexpected failure.

Plumbing Clean Out (Left Of Structure On Foundation Wall)

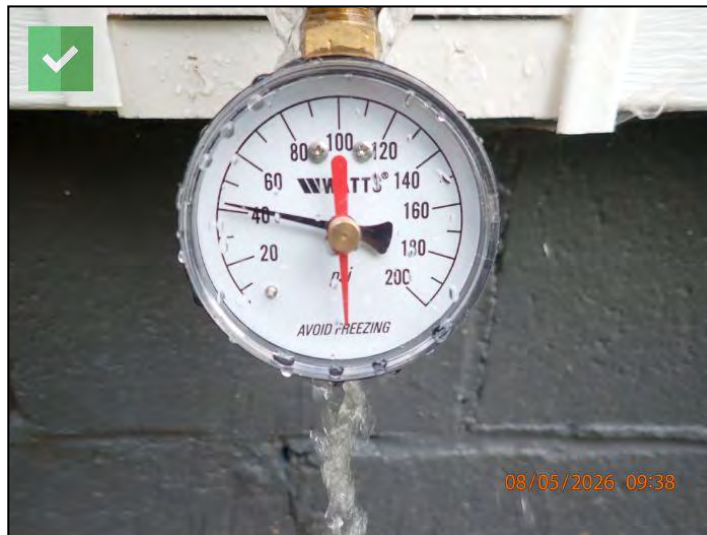
- **NOTE:** Water pressure noted as 42 PSI. Function tests were normal at the time of inspection.

42 PSI

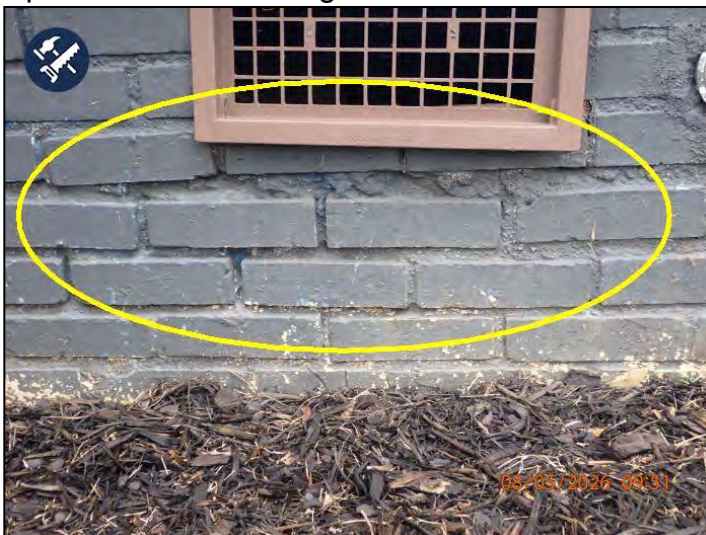
- **IMPROVE:** Past repairs to the perimeter walls were observed at the time of inspection, and their quality or origin could not be confirmed. Unknown repair quality can lead to insufficient long-term performance and possible deterioration of building materials. Recommend a qualified masonry or general contractor further evaluate the repaired areas and professionally repair or replace materials as necessary to prolong the service life of the building materials.

Past Repairs (Unable To Determine If Professional)

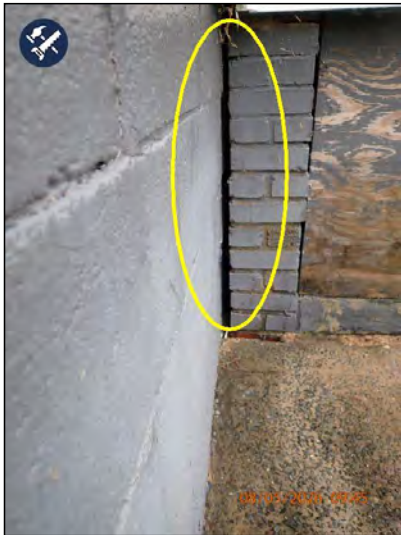
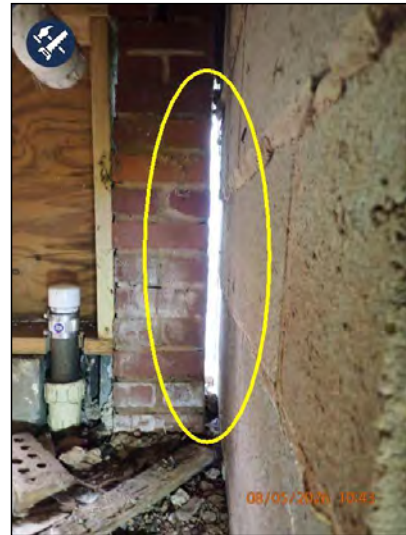
- **IMPROVE:** Unsealed penetration(s) were observed in the perimeter walls at the time of inspection. Unsealed openings can allow moisture intrusion and/or insect and pest entry, which may damage building materials. Recommend a qualified contractor seal the penetration(s) as necessary to prevent moisture intrusion and protect the building materials, as well as to prevent insect and/or pest intrusion.

Unsealed Penetration(s) (Multiple Locations)

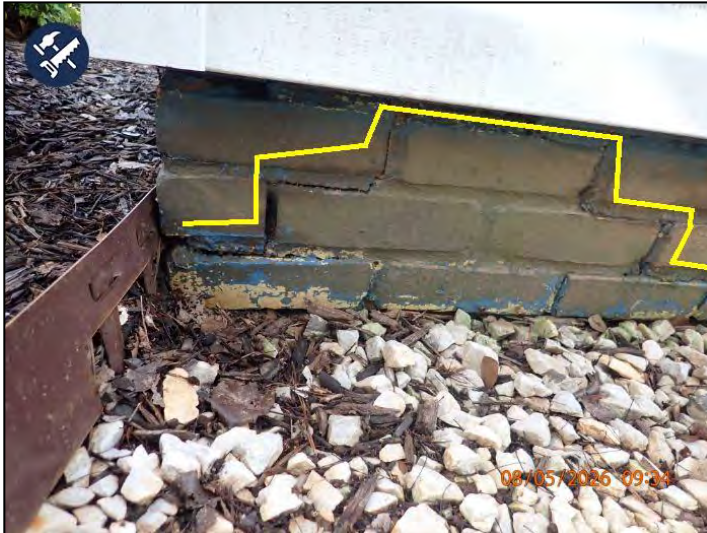
- **IMPROVE:** Step cracking was observed in multiple locations of the foundation perimeter at the time of inspection. This pattern can signify movement or settlement that may progress and affect surrounding building materials. Recommend a qualified masonry contractor point up the affected mortar joints and for the owner to monitor the area(s) periodically. If the condition worsens, contact a qualified structural engineer for further evaluation to prevent further deterioration.

Step Crack(s) (Multiple Locations)

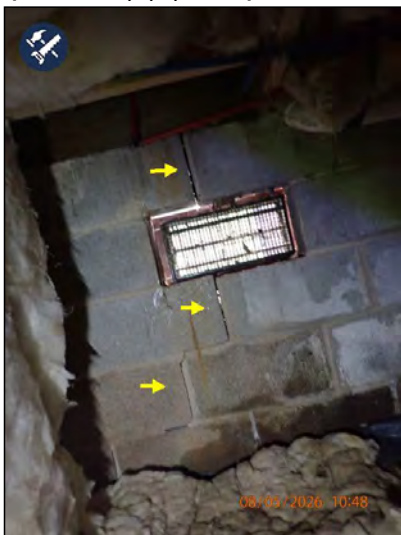
- **IMPROVE:** Typical settlement-related cracking was observed in multiple locations of the foundation perimeter at the time of inspection. Settlement cracking may allow moisture intrusion and can enlarge with continued movement. Recommend a qualified masonry contractor point up the crack(s) and for the owner to monitor the area periodically. If the condition worsens, contact a qualified structural engineer for further evaluation to prevent further deterioration.

Settlement Crack(s) (Right Of Structure)

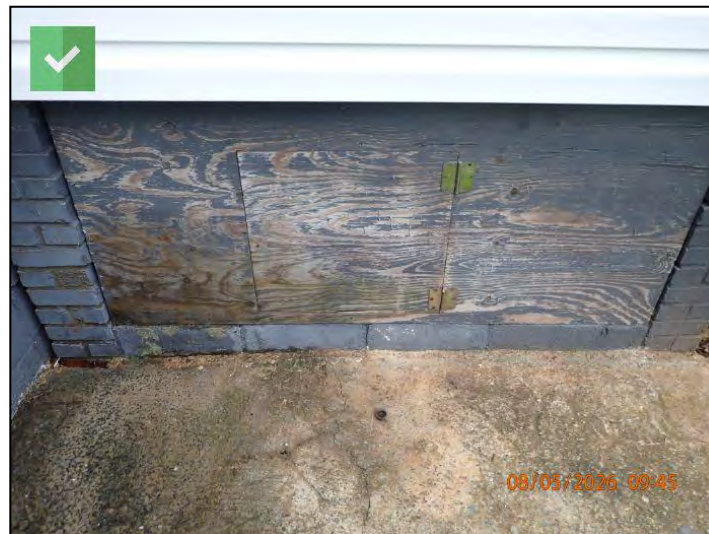
- **NOTE:** The foundation access panel was installed at the time of inspection. No deficiencies were observed.

Foundation Access: Rear Of Structure

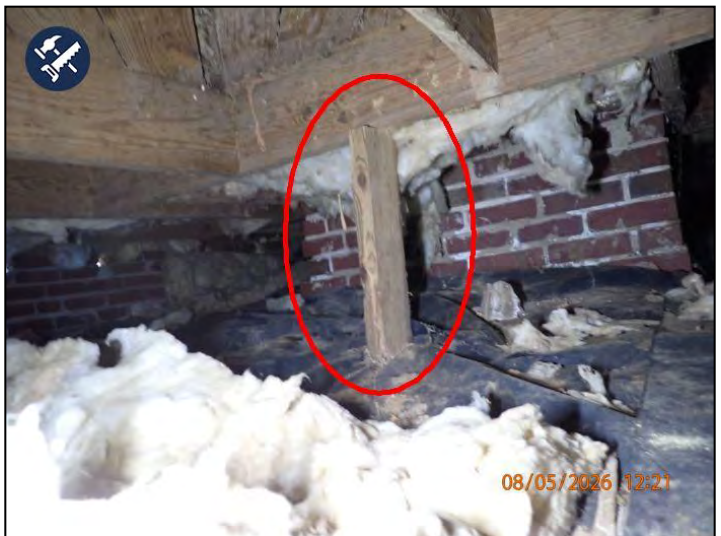
- REPAIR: Improperly installed wood pier(s) were observed in multiple locations at the time of inspection. Improper installation can weaken load distribution and allow shifting or settlement. Recommend a qualified contractor or structural engineer further evaluate and repair or replace as necessary to restore proper structural support.

Unprofessional Install

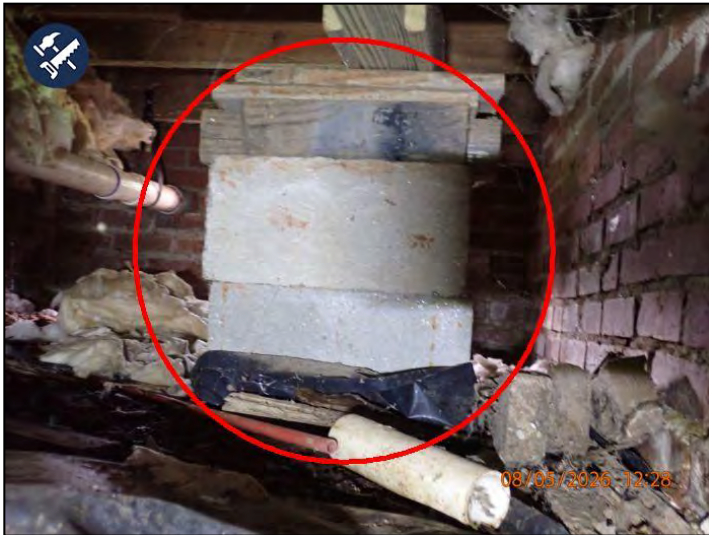
- REPAIR: Dry-stacked posts and/or piers were observed at the time of inspection, indicating improper installation. Improper stacking can compromise stability and reduce support performance. Recommend a qualified contractor further evaluate and repair or replace as necessary to restore proper structural support.

Dry-Stacked/Unprofessional Install (Multiple Locations)

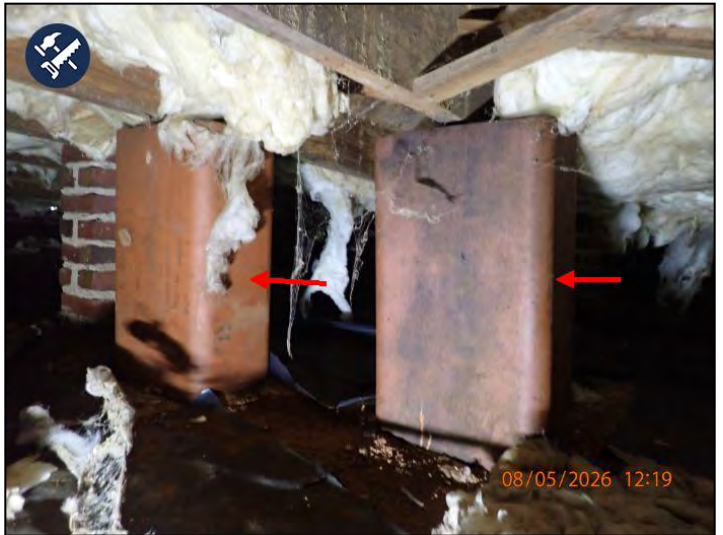
- REPAIR: Posts and/or piers were installed with improper material (terracotta pipes) at the time of inspection. These deficiencies can weaken stability and shorten service life. Recommend a qualified contractor or structural engineer further evaluate and repair or replace the supports as necessary to restore proper structural performance.

Unprofessional Install (Terracotta Pipes)

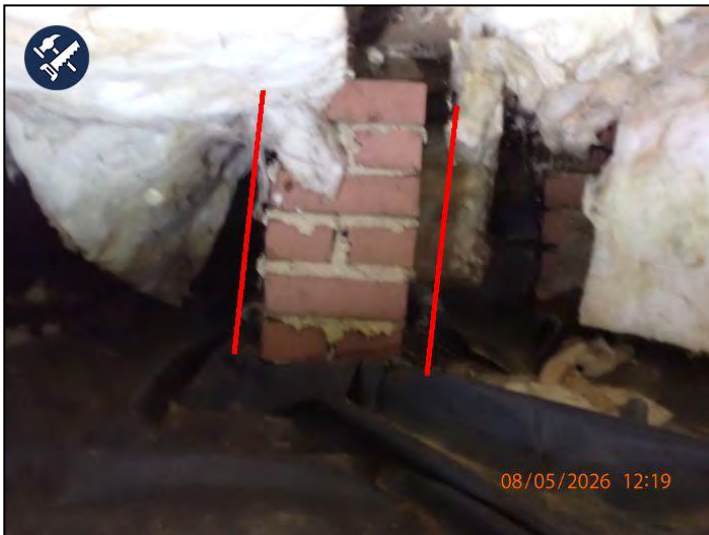
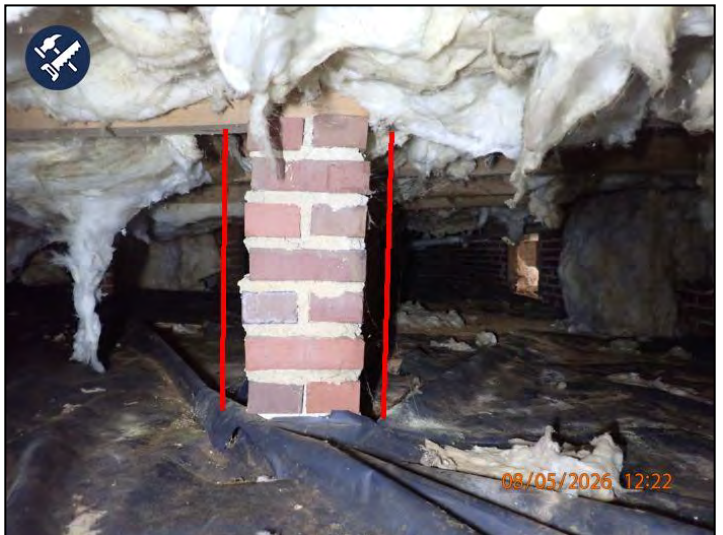
- REPAIR: Leaning pier(s) were observed in multiple locations at the time of inspection. Leaning supports can shift under load and reduce structural stability. Recommend a qualified general contractor further evaluate and repair or replace the pier(s) as necessary to restore proper structural support.

Leaning Pier(s) (Multiple Locations)

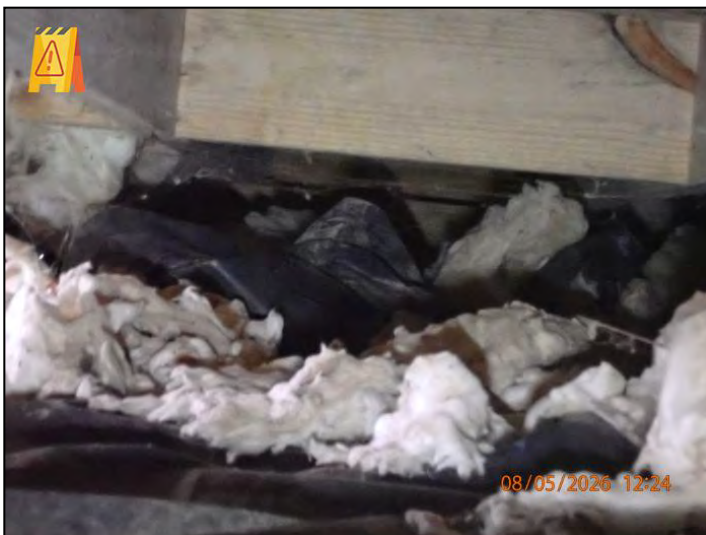
Limited Visual (Entire Front/Right Of Structure)

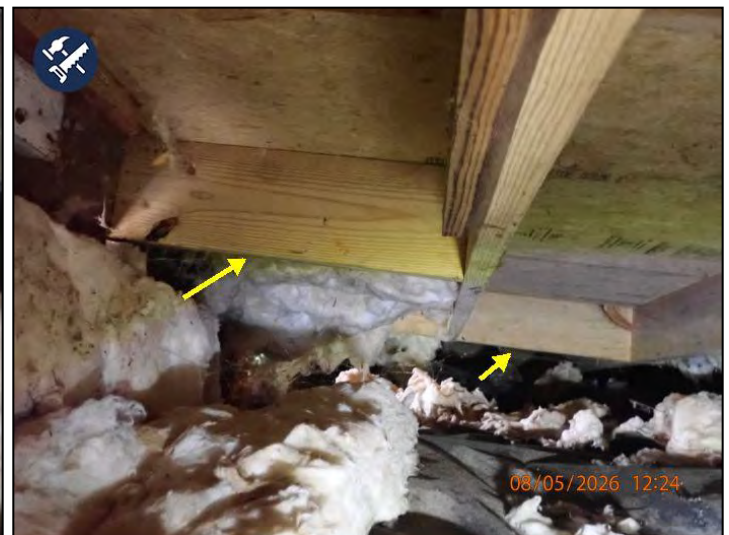
- **NOTE:** Visibility of the front/right of the sub flooring was limited at the time of inspection. These area(s) are excluded from this report.
- **IMPROVE:** Past repairs to the sub flooring were observed at the time of inspection. The quality and effectiveness of these repairs could not be confirmed. Recommend a qualified contractor further evaluate and repair or replace the previously repaired area(s) as necessary to ensure proper performance.

Past Repairs (Unable To Determine If Professional)

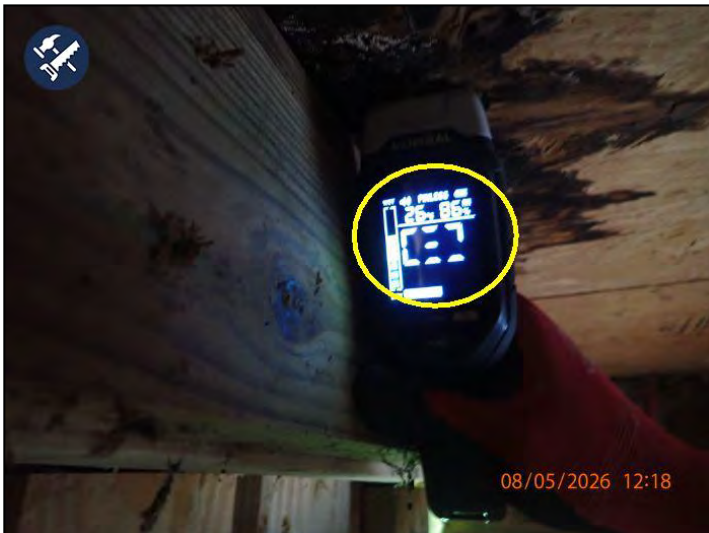
- **IMPROVE:** Evidence of past and/or present moisture intrusion and damage was observed in the sub flooring and joists at the time of inspection. Moisture intrusion can weaken wood components and promote microbial growth. Recommend a qualified contractor further evaluate and repair or replace any compromised materials to prevent further deterioration of the building materials.

Moisture Intrusion/Damage (Beneath Water Heater)

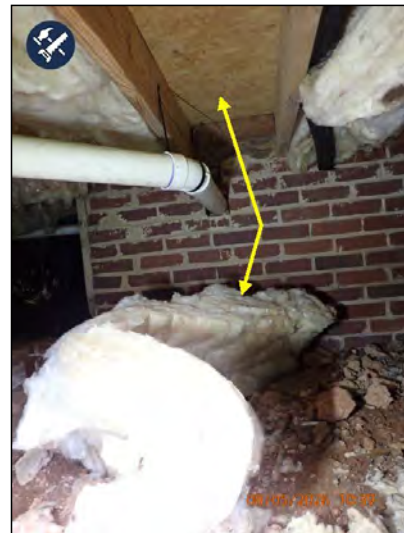
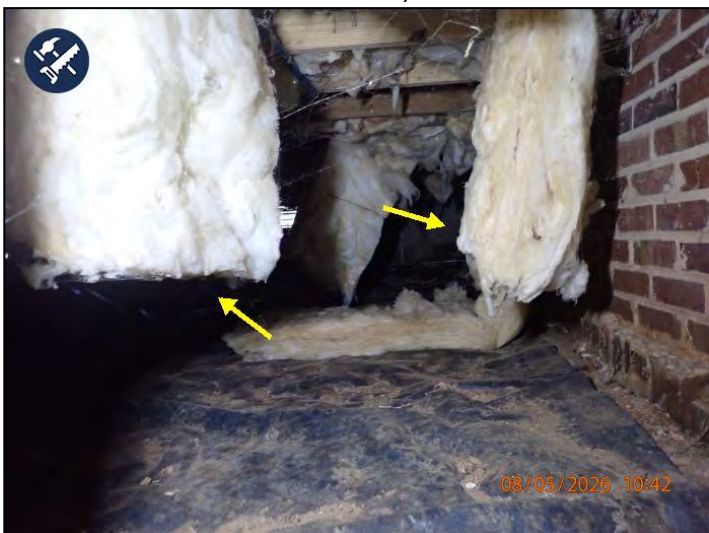
- **IMPROVE:** Failing insulation was observed throughout the crawl space at the time of inspection. Compromised insulation can reduce energy efficiency and contribute to temperature fluctuations. Recommend a qualified insulation specialist repair or replace the insulation as necessary to improve energy efficiency and protect the building materials.

Failing Insulation (Multiple Locations)

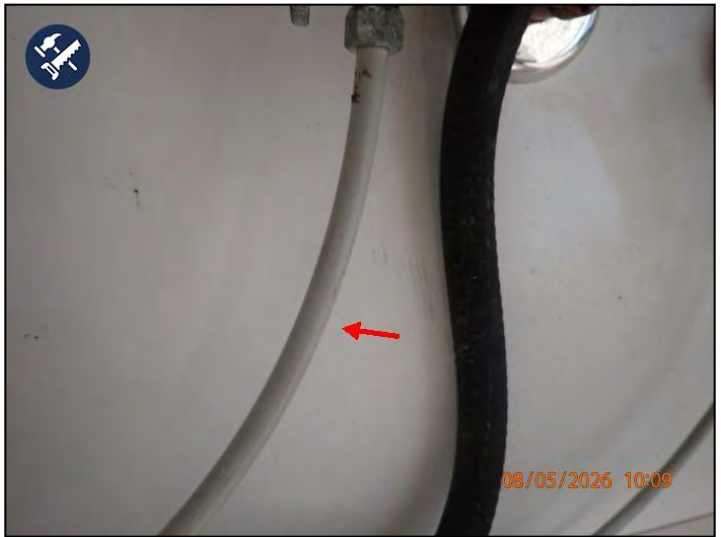
As per NC Licensure Board approved language: 'This home has a plumbing supply system that uses polybutylene plastic distribution lines and compression band fittings. Even though this plumbing system was installed in many homes from 1978 until the mid-1990's, it is no longer an approved plumbing system due to a history of material failures. The failures were related to improper installation, improper handling, improper storage, and plastic deterioration due to chemical reactions with the water supply. Due to the nature of this latent defect, it was not possible to adequately assess the condition of the plumbing system during the home inspection. A licensed plumbing contractor should be consulted for a complete evaluation of the plumbing system to determine the significance of this concern.'

Polybutylene

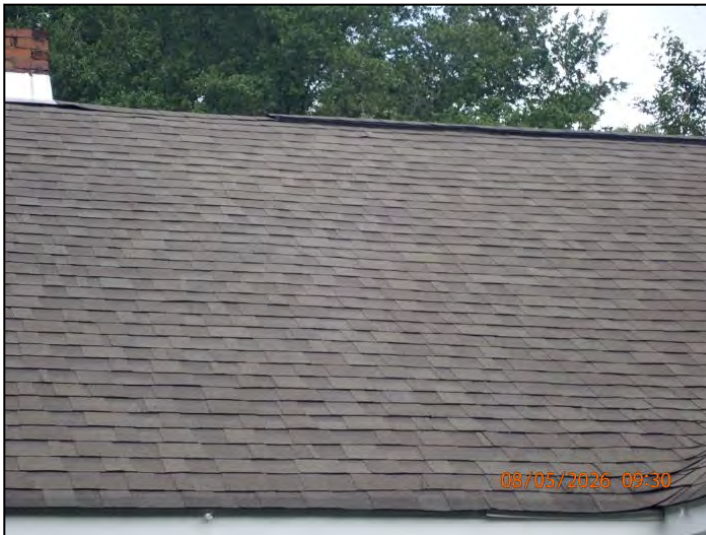
- **NOTE:** Asphalt shingles were noted. This roof is approximately 6-10 years of age and appropriate for the pitch of the roof. The roof was inspected from the ground as well as from a ladder at the eaves using binoculars/digital camera with zoom.
- **NOTE:** The average lifespan of asphalt roofs can range from 15-25 years depending on a number of factors (climate, adequate attic ventilation, extreme temperatures, etc.).
- **IMPROVE:** Section(s) of the roof were sagging and/or buckling at the time of inspection. Sagging or deflection can indicate underlying structural or moisture-related issues that may worsen over time. Recommend further evaluation by a qualified roofing contractor and repair or replace components as necessary to prevent further deterioration and restore proper function.

6-10 Years

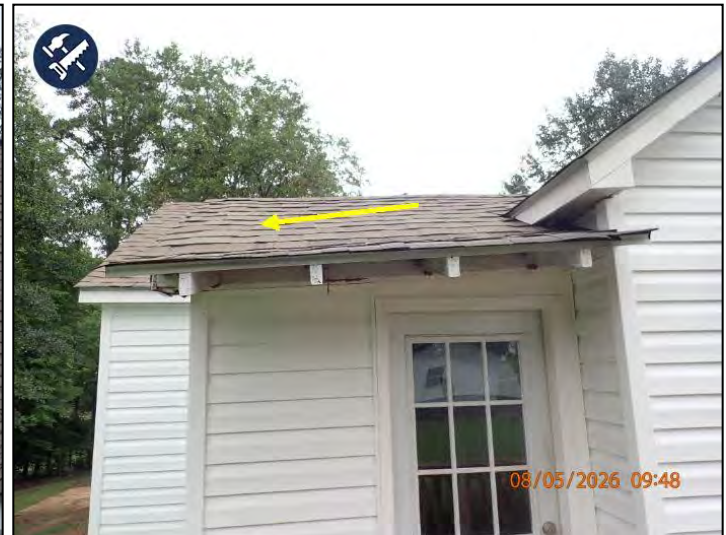
Sagging/Buckling (At Eave)
