**192 Flower House Loop Troutman, NC 28166**

## **Inspection Prepared For Ryan Wright**

Date: 8/5/2026 Time: 9:30 AM

Year Built: 1946 | Size: 1330 sq.ft.

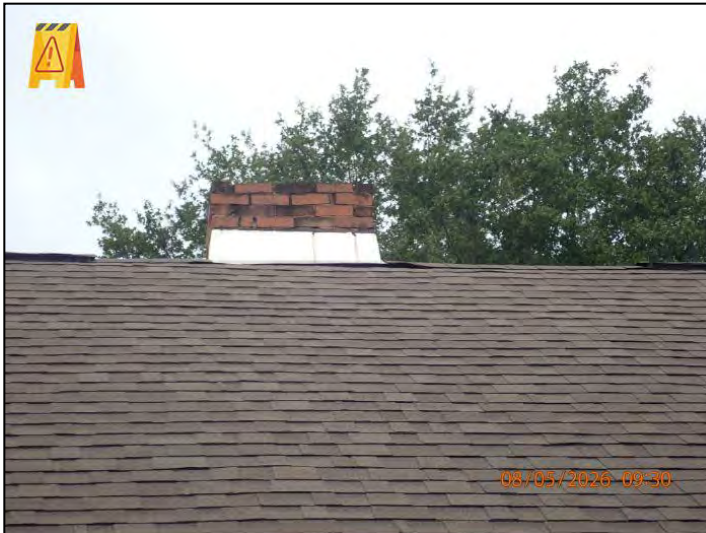
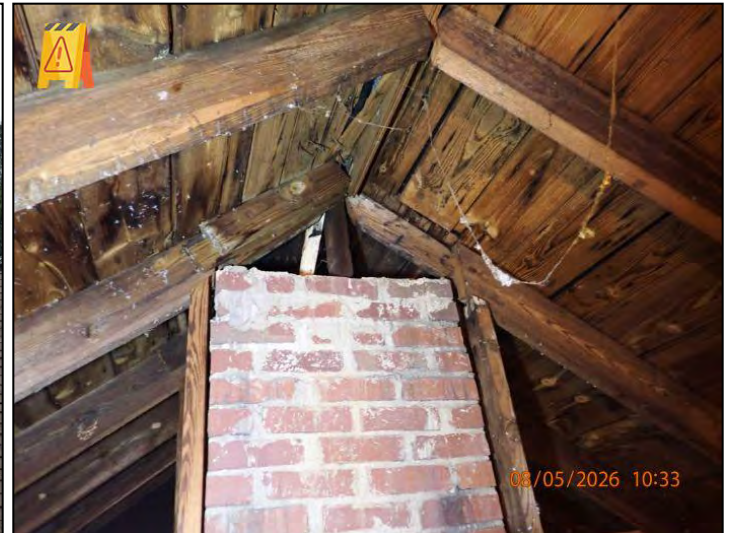
- **NOTE:** Abandoned chimney observed. The inspector could not determine if it was properly capped or sealed due to height restrictions at the time of inspection.
- **IMPROVE:** Evidence of significant mortar deterioration was noted on the chimney at the time of inspection. Mortar deterioration can allow moisture intrusion and may weaken the chimney structure over time. Recommend further evaluation by a qualified masonry contractor and repair or replace the deteriorated mortar as necessary to prevent further deterioration.

Abandoned Chimney (Could Not Determine If Properly Capped/Sealed)

Abandoned Chimney (Unable To Determine If Properly Capped/Sealed Due To Height Restrictions)

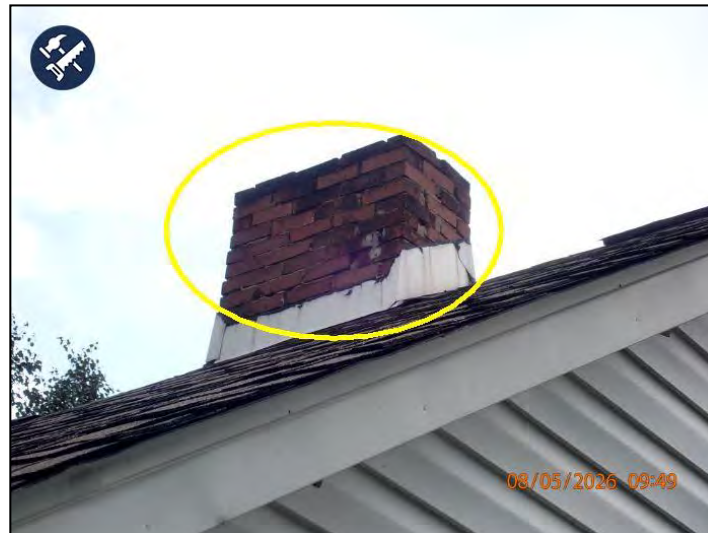
Significant Mortar Deterioration

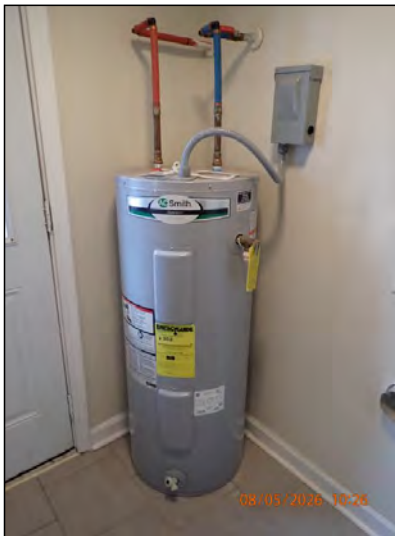
Location: Laundry Room

- **IMPROVE:** Multiple deficiencies were noted in line with the water heater unit and/or system at the time of inspection. System defects can lead to reduced performance and premature unit failure. Recommend a qualified plumbing contractor further evaluate the unit and repair or replace as necessary to restore proper function.
- **IMPROVE:** The water heater could not be tested because the breaker was 'OFF' in the sub electrical panel at the time of inspection. Recommend a qualified plumbing contractor test the water heater for proper function once the breaker is back on.

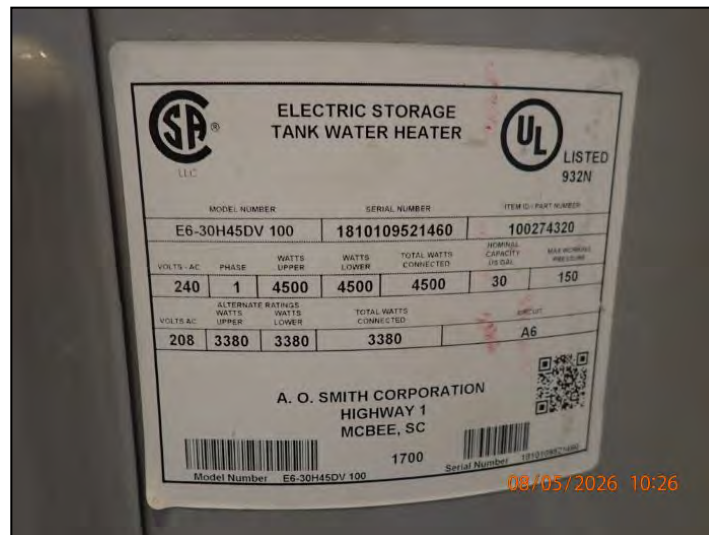
- **NOTE:** The A.O. Smith electric water heater is approximately 8 years old. Water heater lifespans typically average 10–15 years depending on usage and/or various factors.

2018 A.O. Smith Water Heater

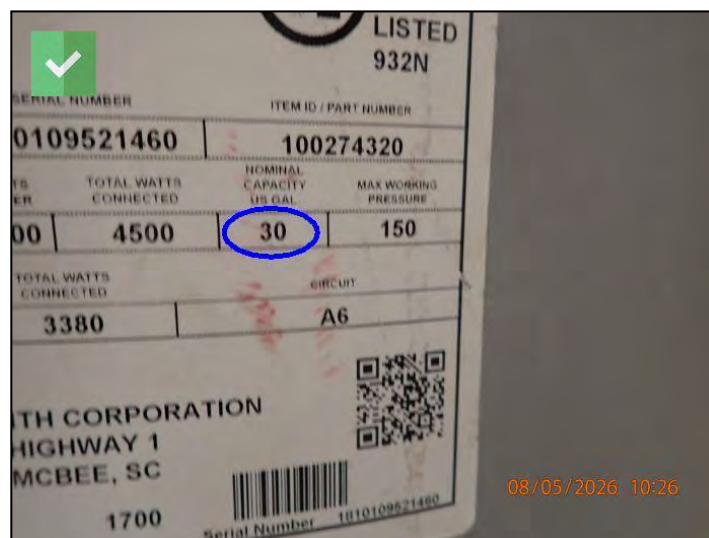
30 Gallons

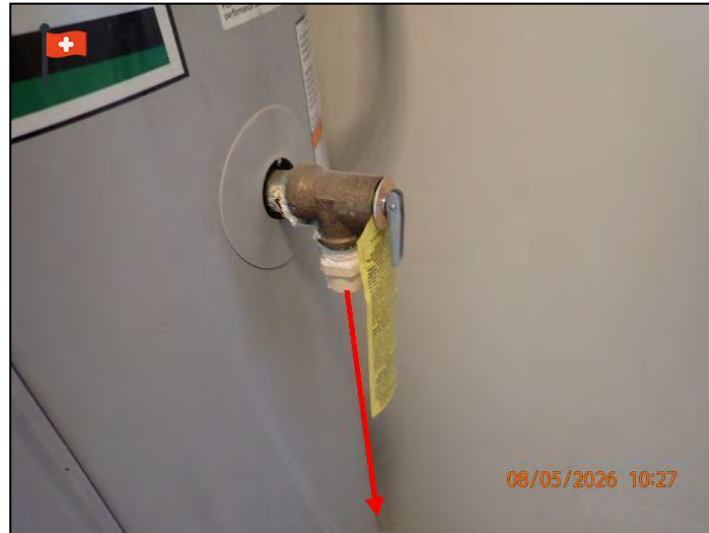
- **SAFETY CONCERN:** Although a Temperature Pressure Relief Valve (TPRV) was present, the discharge pipe was missing. A missing discharge pipe allows extremely hot water to discharge freely into the occupied space during an emergency, posing a severe scalding hazard. Recommend a qualified plumbing contractor install a proper discharge pipe for proper function and reduce the risk of injury.

Missing Discharge Pipe

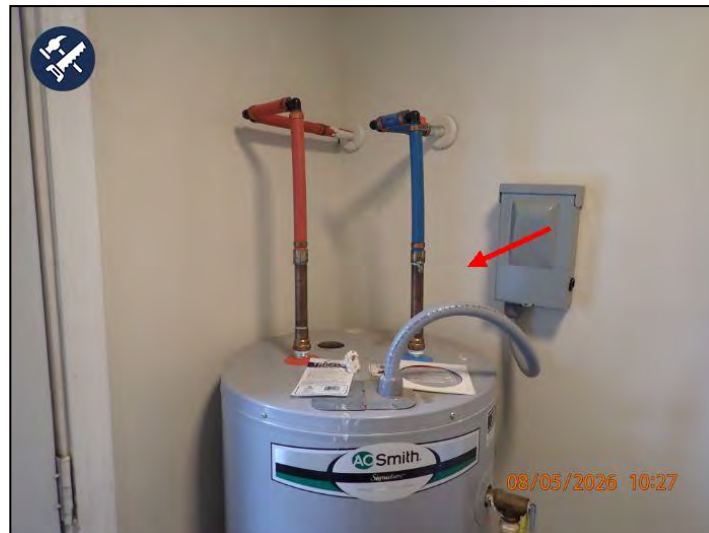
- **REPAIR:** An **expansion tank** was not installed at the time of inspection. Lack of an expansion tank can create trapped, high-pressure spikes every time the water heater runs. This, in turn, strains pipe joints, wears out internal tank linings, and can ruin heating elements. Recommend a qualified plumbing contractor install the expansion tank to ensure optimal function and prolong the service life of the water heater.

Expansion Tank Missing

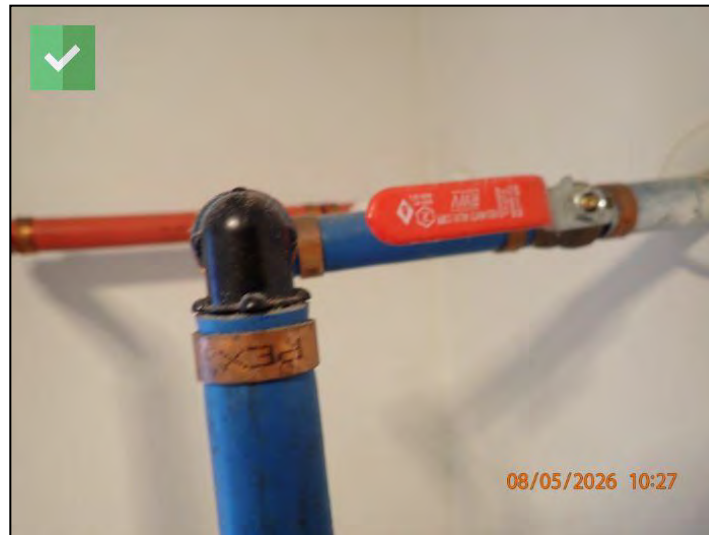
- **NOTE:** A cold water shut off valve was present at the time of inspection.

Cold Water Shut Off Valve Present

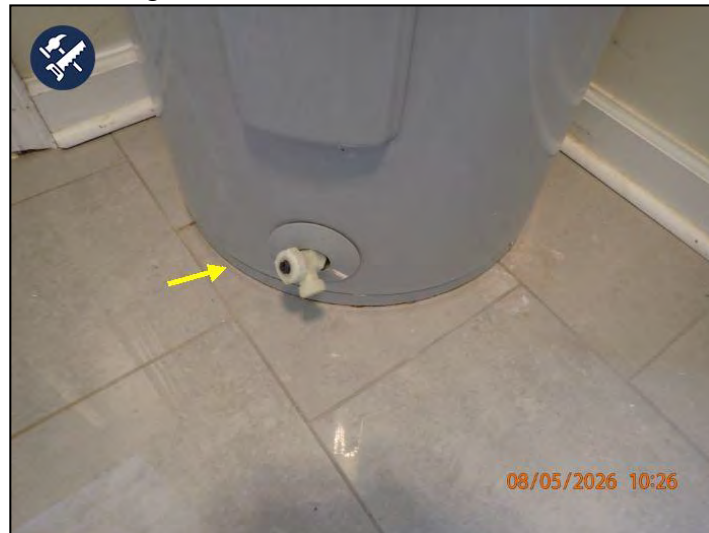
- IMPROVE: A water heater base and/or drain pan was missing and/or not installed at the time of inspection. Missing pans cannot contain leaks or water overflow, which may cause deterioration to the building materials. Recommend a qualified plumbing contractor install a base and/or drip pan to prevent deterioration to the building materials.

Missing/Not Installed

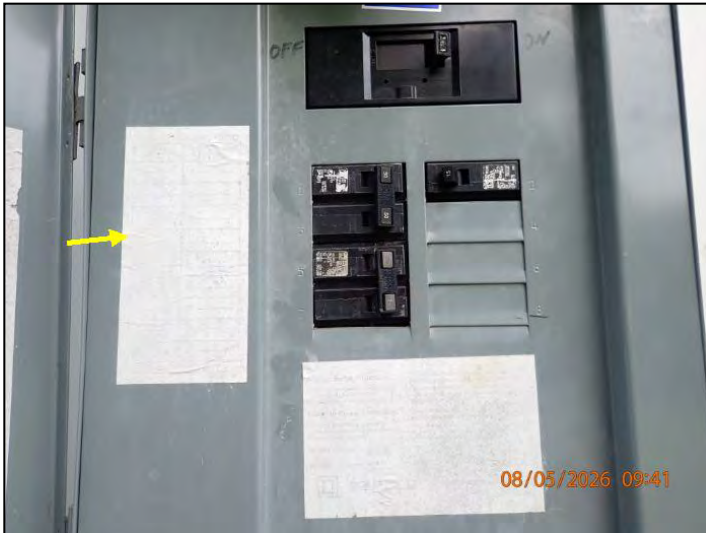
Labels Missing/Illegible (Main Panel)

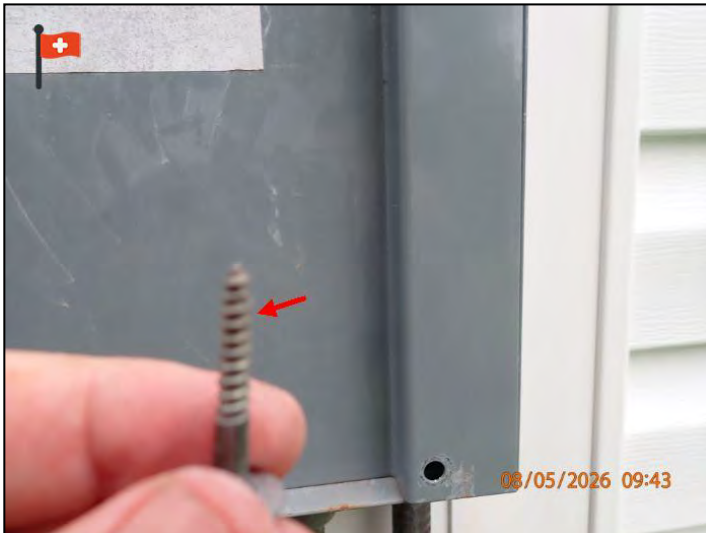
- **SAFETY CONCERN:** Wrong fastener(s) were used in the electrical panel at the time of inspection. Improper fasteners can compromise the panel integrity and safety. Recommend a qualified electrical contractor install correct fastener(s) to restore safe conditions and reduce the risk of injury.

Wrong Fastener(s) (Main Panel)

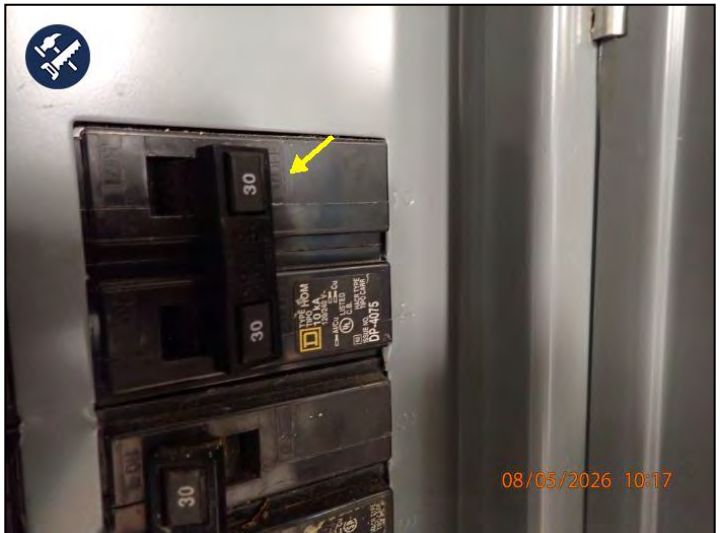
- **NOTE:** All breakers were in the 'ON' position in the main panel at the time of inspection.
- **IMPROVE:** There was 1 breaker (water heater) observed in the 'OFF' position in the sub electrical panel at the time of inspection. An 'OFF' breaker may indicate a tripped circuit due to an underlying electrical issue. Recommend a qualified electrical contractor further evaluate the underlying reason for the breaker being in the 'OFF' position to restore proper function.

1 - Water Heater (Sub Panel)

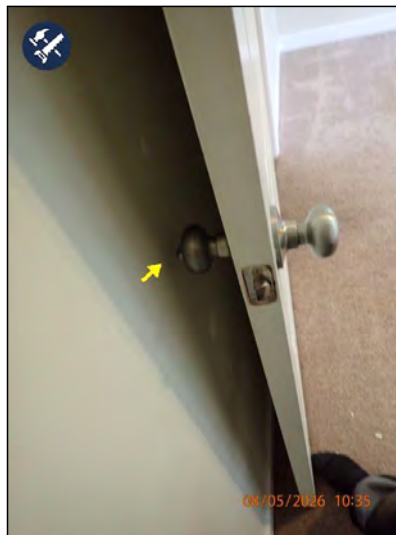
- **IMPROVE:** Door stop(s) were missing at the time of inspection. Missing stops allow doors to strike walls, which can damage walls or hardware. Recommend a qualified contractor install door stop(s) to protect the walls and hardware.

Missing Door Stop(s) (Multiple Locations)

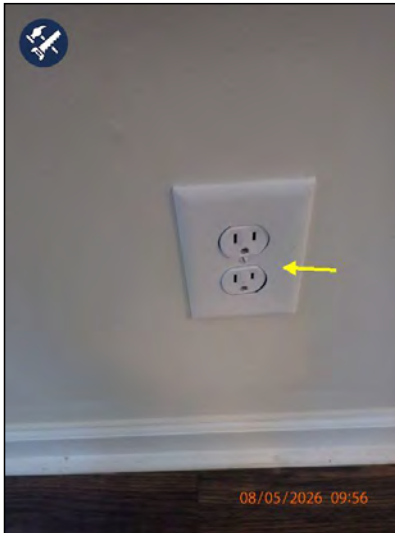
- **IMPROVE:** Loose or improperly installed outlet(s) were observed at the time of inspection. Loose or incorrectly mounted outlets can create poor connections, which may cause arcing, heat buildup, or electrical hazards. Recommend a qualified electrical contractor repair or replace the outlet(s) to restore proper and safe function.

Loose/Improperly Installed Outlet(s) (Living Room)

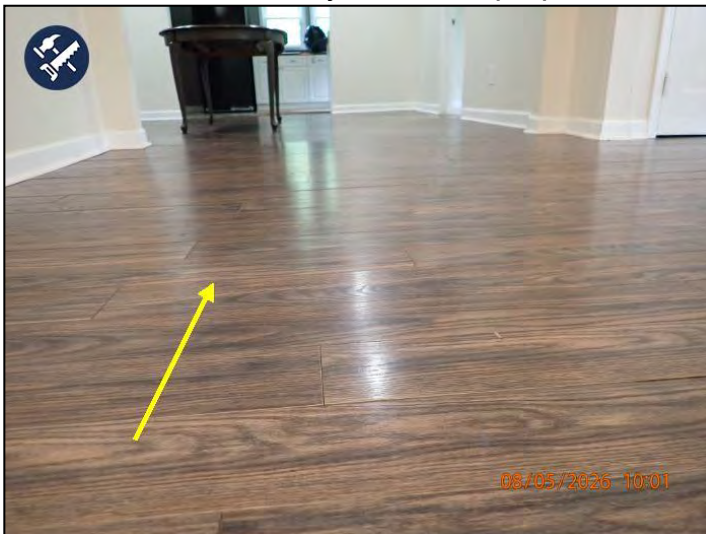
- **IMPROVE:** The interior floor was not level and/or soft sub flooring was observed at the time of inspection. Uneven or soft flooring can indicate underlying structural deterioration or damage. Recommend a qualified flooring contractor further evaluate and repair or replace all compromised materials as necessary to restore proper function.
- **IMPROVE:** The interior floor was not level and/or buckling was observed at the time of inspection. Uneven or buckling flooring can indicate underlying structural deterioration or damage. Recommend a qualified flooring contractor further evaluate and repair or replace all compromised materials as necessary to restore proper function.

Not Level/Soft Sub Flooring (Multiple Locations)

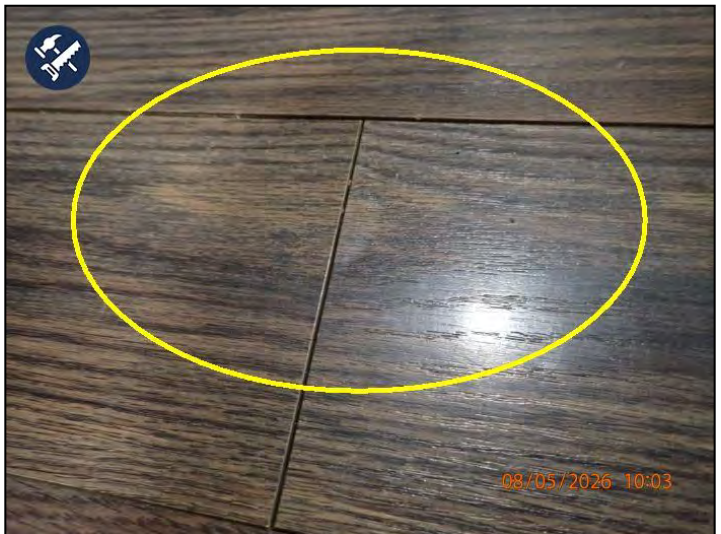
Not Level/Buckling Flooring (Multiple Locations)

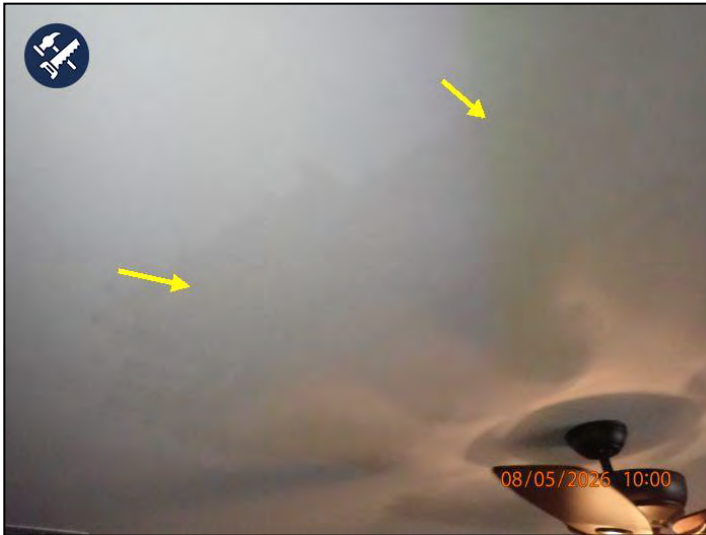
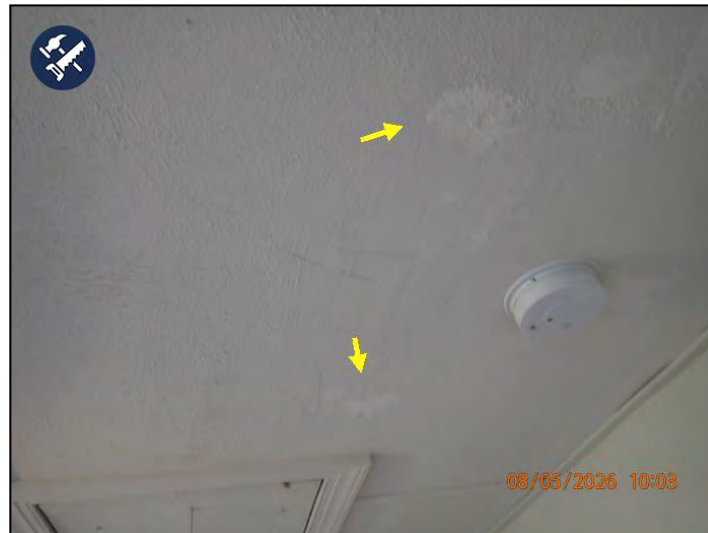
- **IMPROVE:** Past repairs to the ceiling(s) were observed at the time of inspection. The quality and effectiveness of these repairs could not be confirmed. Recommend a qualified contractor further evaluate and repair or replace the previously repaired areas as necessary to ensure proper performance.

Past Repairs (Unable To Determine If Professional) (Multiple Locations)

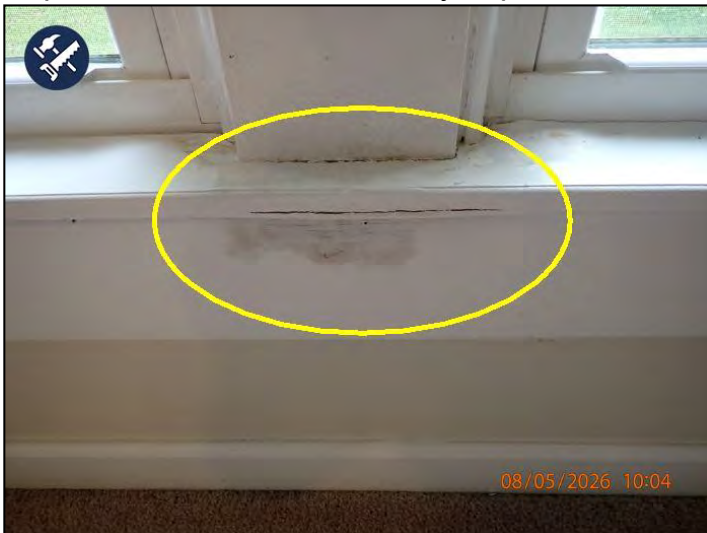
- **IMPROVE:** Evidence of past and/or present moisture intrusion was observed in multiple locations at the time of inspection. Moisture intrusion can weaken building materials and lead to further deterioration if not corrected. Recommend a qualified contractor further evaluate and repair or replace materials as necessary to prevent further deterioration and protect the building materials.

Past/Present Moisture Intrusion (Multiple Locations)

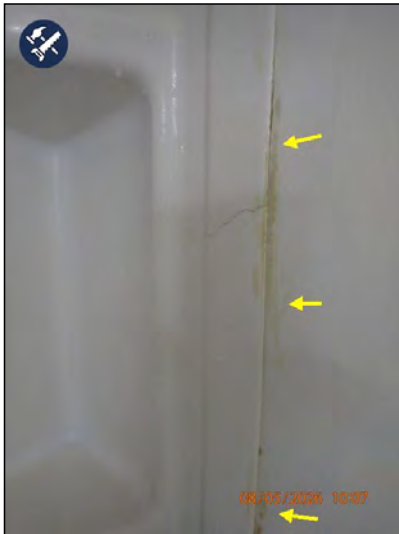
- **IMPROVE:** Failing sealant or caulk was noted at the time of inspection. Compromised sealant can allow moisture intrusion, which may damage surrounding building materials. Recommend a qualified contractor further evaluate and seal or caulk as necessary to prevent moisture intrusion and protect the building materials.
- **IMPROVE:** Unsealed penetration(s) were noted at the time of inspection. Unsealed areas allow water intrusion behind the wall surface. Recommend a qualified contractor repair or seal the penetration(s) to prevent water intrusion and deterioration of the building materials.

Failing Sealant/Caulk (Guest Bathroom)

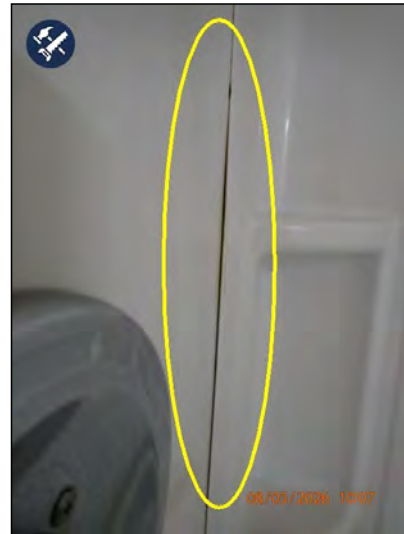
Unsealed Penetration(s) (Guest Bathroom)

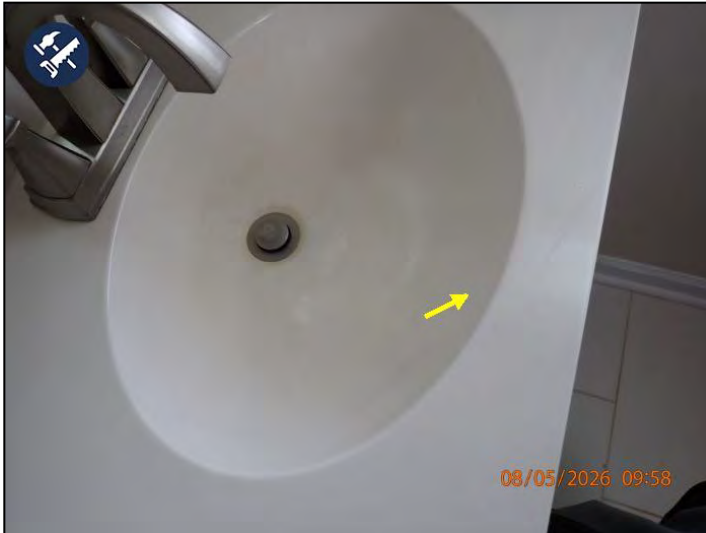
- **IMPROVE:** No overflow holes and/or lines were present in multiple bathroom sinks at the time of inspection. Without an overflow feature, a clogged drain could lead to water overflow. Recommend a qualified plumbing contractor repair or replace the sinks to avoid water overflow and damage to cabinets and/or building materials.

Missing Overflow Drain (Primary Bathroom)

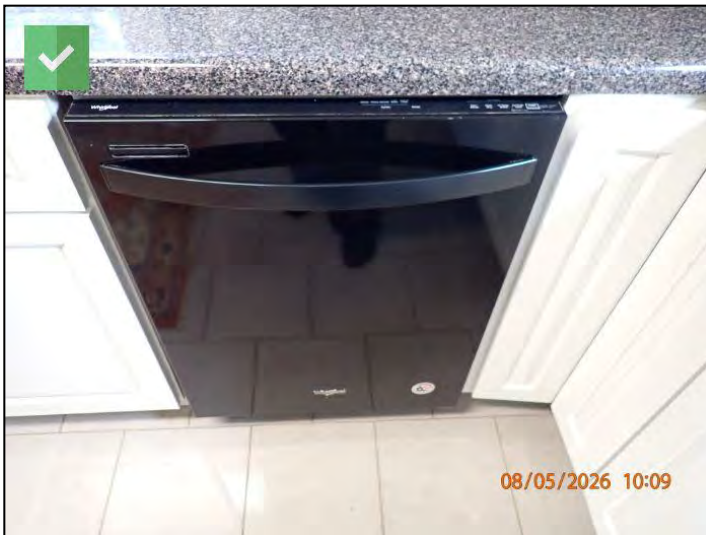
Functional

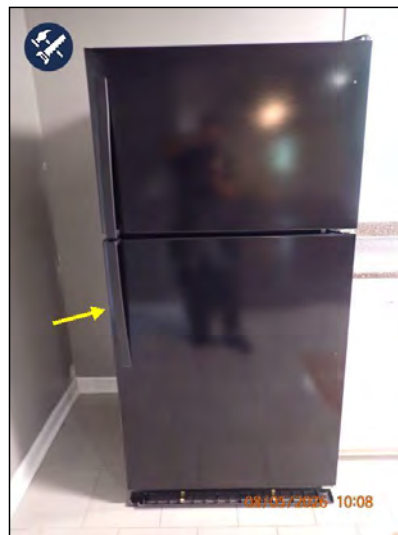
- **IMPROVE:** The condition of the refrigerator could not be determined because the power was 'OFF' to the unit at the time of inspection. Lack of power prevents testing of the unit's function. Recommend a qualified electrical contractor evaluate the refrigerator for proper function once the power is restored.

Power 'OFF' To Unit

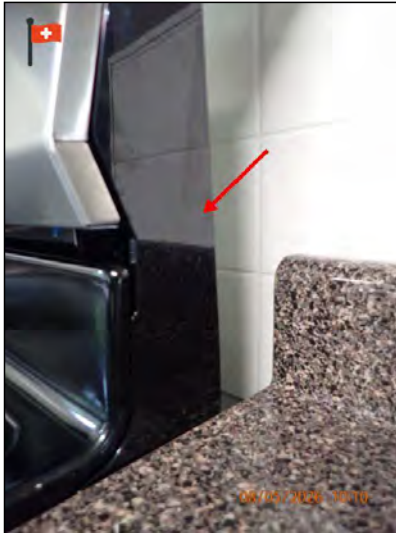
- **NOTE:** Oven - Electric radiant heating coils or infrared halogen.
- **NOTE:** All heating elements operated when tested.
- **SAFETY CONCERN:** An anti-tip bracket was missing from the range installation at the time of inspection. Missing anti-tip devices can allow the range to tip over when excess force is applied to an open oven door, creating a scalding and/or burn hazard. Recommend a qualified appliance contractor install the bracket to reduce the risk of injury.

Missing Anti-Tip Bracket

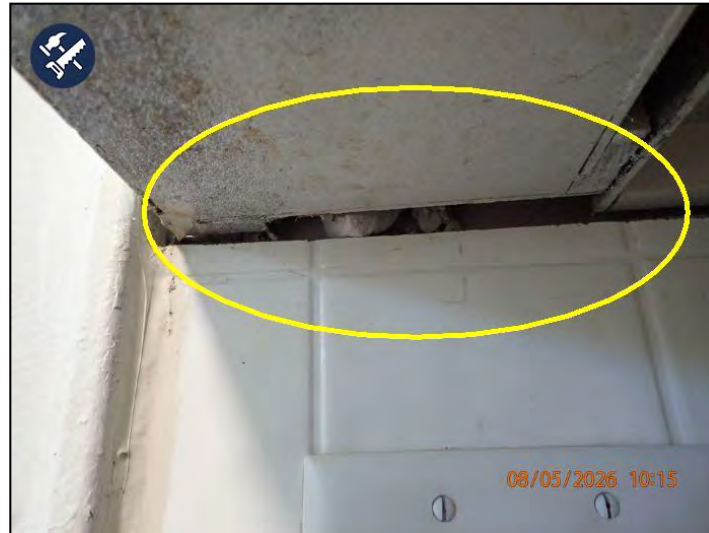
- **IMPROVE:** Trim was missing and/or not installed at the time of inspection. Missing trim can leave gaps allowing moisture intrusion and damage to building materials. Recommend a qualified contractor install the trim to prevent moisture intrusion and protect the building materials.

Unprofessional Install/Missing Trim (Multiple Locations)

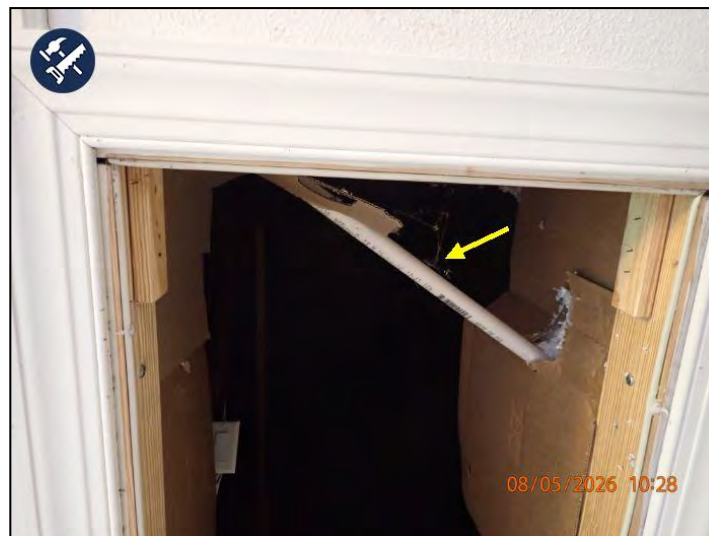
- **NOTE:** The pull down ladder was insulated at the time of inspection.
- **IMPROVE:** The condensate drain was blocking the access to the attic at the time of inspection. Recommend a qualified contractor repair/reroute the drain line for ease of access to the attic and/or for optimal function.

Condensate Drain Over Access

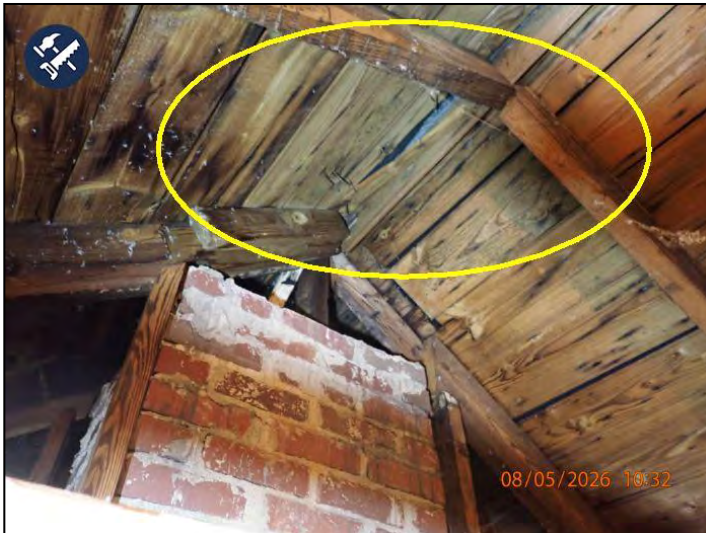
- **IMPROVE:** Damage to the roof sheathing was observed at the time of inspection, which may affect its ability to distribute roof loads and protect the building materials. Recommend a qualified roofing contractor further evaluate and repair or replace the materials as necessary to prevent further deterioration and ensure proper structural performance.
- **IMPROVE:** Past repairs to the attic structure were observed at the time of inspection. The quality and adequacy of these repairs could not be determined, which may affect the roof's support system. Recommend a qualified contractor further evaluate and make any necessary corrections to ensure the integrity of the roof's support system is not compromised.

Damaged Sheathing (Multiple Locations)

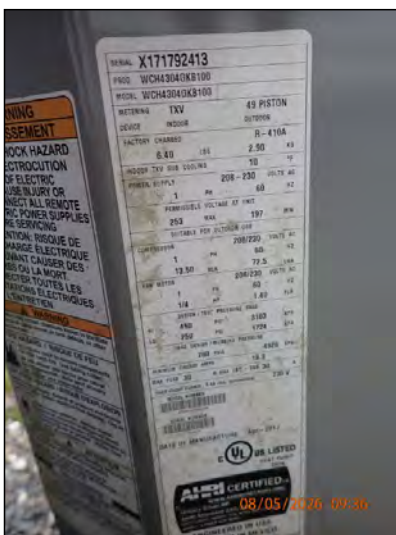
- **NOTE:** The Grandaire unit is approximately 9 years old. The average lifespan of this system is 10–15 years depending on a number of factors.

2017 Grandaire 2.5 Ton Unit

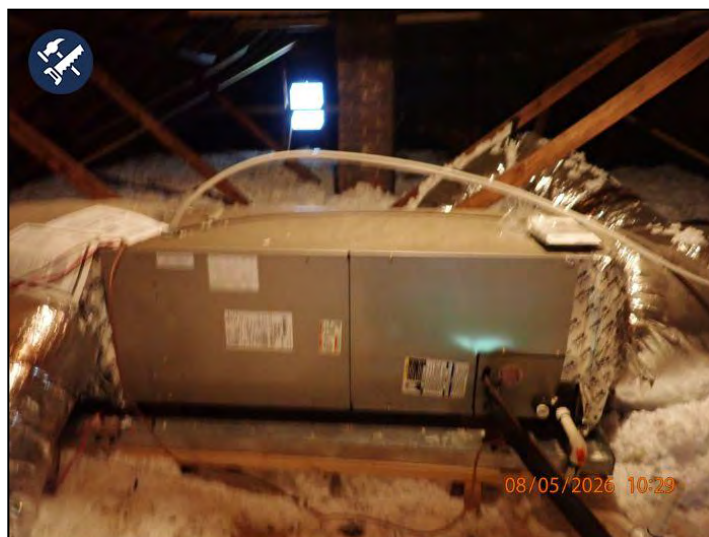
Location: Attic

- **NOTE:** The heat system was NOT tested at the time of inspection because the outside ambient temperature was above 70 degrees Fahrenheit within 24 hours.
- **IMPROVE:** The last service date for the electric heating unit could not be determined or was over one year ago at the time of inspection. HVAC specialists recommend annual inspections to maintain efficiency and prolonged service life. Recommend a qualified HVAC contractor inspect the unit for any deficiencies to ensure proper function.

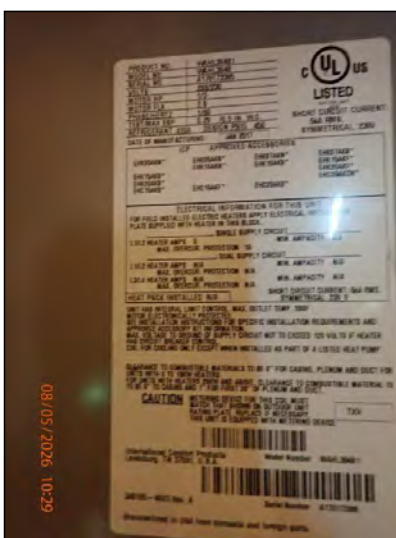
- **NOTE:** The ICP unit is approximately 9 years old. The average lifespan of a unit of this type is 16–20 years depending on a number of factors. Recommend annual servicing by a qualified HVAC contractor in order to prolong the life of the unit.

2017 ICP 2.5 Ton Unit

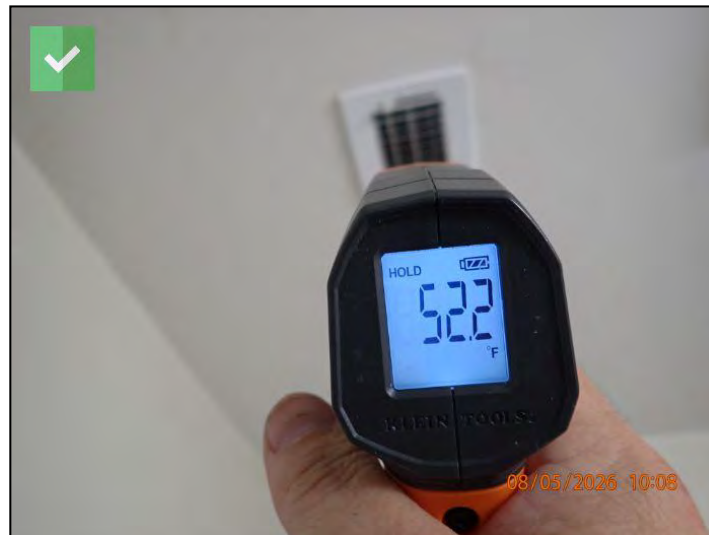
- **NOTE:** The typical temperature differential split (supply vs. return air) for this type of air conditioning unit is 15–20 degrees F. This system responded and achieved an acceptable differential temperature.

A/C Differential 23.2 Degrees F

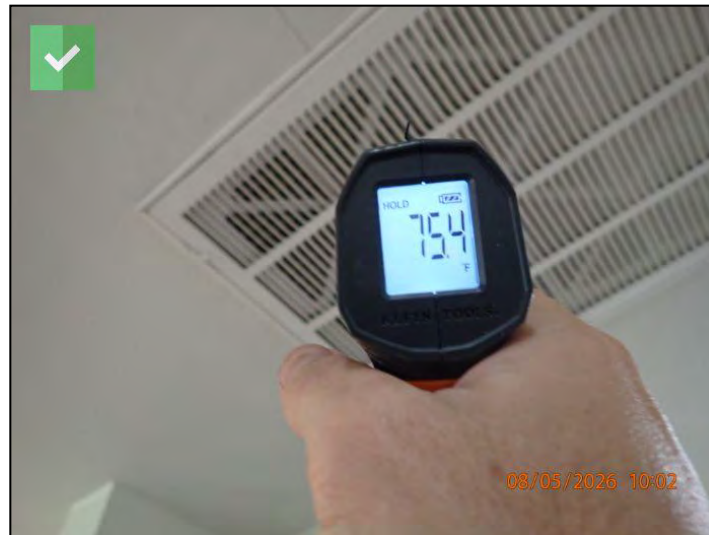
- **NOTE:** The typical temperature differential split (supply vs. return air) for this type of air conditioning unit is 15–20 degrees F. This system responded and achieved an acceptable differential temperature.

A/C Differential 23.2 Degrees F

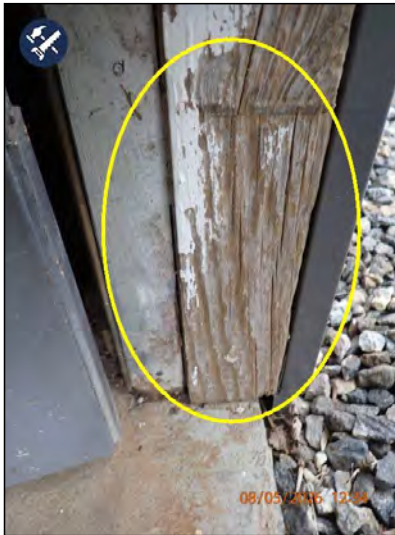
- IMPROVE: The door jamb and/or casing showed signs of damage and/or deterioration at the time of inspection. Damaged components can compromise door support and lead to further deterioration. Recommend a qualified contractor repair or replace the affected materials to restore proper support and prevent additional deterioration.

Damage/Deterioration

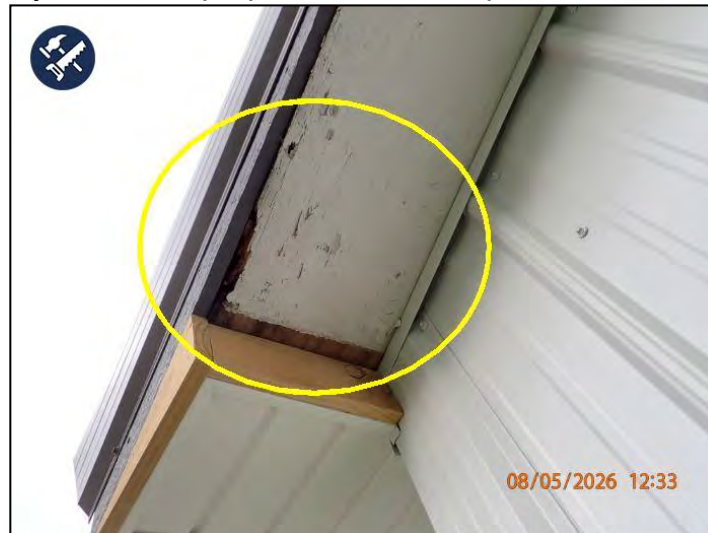
- **IMPROVE:** The fascia boards showed evidence of damage and/or deterioration in multiple locations at the time of inspection. Damaged or deteriorated fascia can compromise the protection of roof edges and allow moisture intrusion. Recommend a qualified contractor repair or replace the fascia boards as necessary to restore proper function and protect the building materials.

Damage/Deterioration (Multiple Locations)

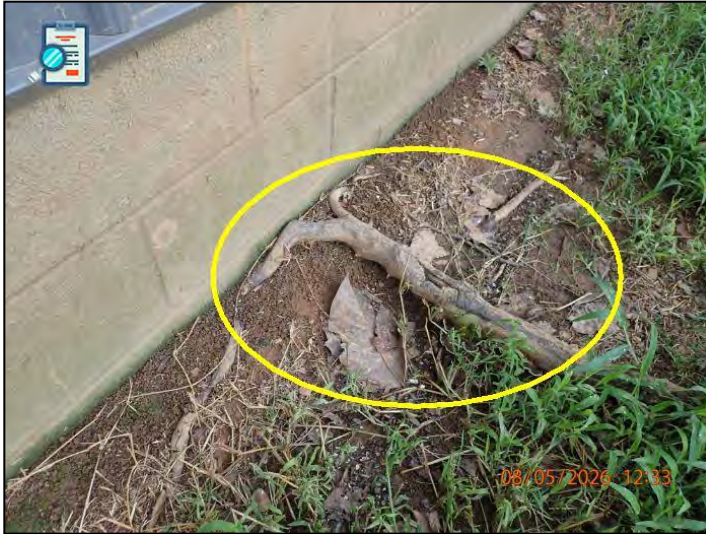
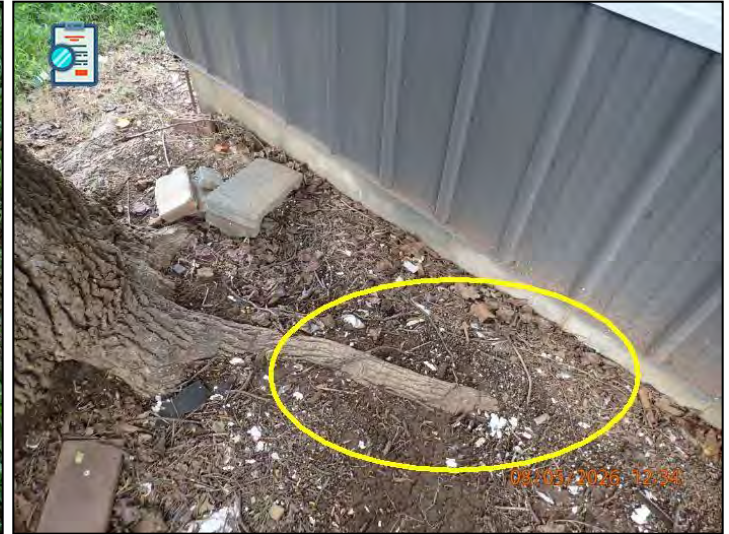
- **MONITOR:** Tree roots were observed close to the structure at the time of inspection. Roots in proximity to the foundation or underground utilities can contribute to plumbing or structural issues over time. Recommend monitoring the area(s) and, if problems arise, contacting a qualified landscaping contractor for further evaluation to prevent damage to building materials or utilities.
- **IMPROVE:** Tree branches were overhanging the roof and/or siding at the time of inspection. Overhanging branches can abrade roofing materials, damage siding, and provide pathways for pests. Recommend a qualified landscaping contractor trim the branches in contact with or in close proximity to the home to prevent further damage to building materials.

Tree Roots Close To Structure (Multiple Locations)

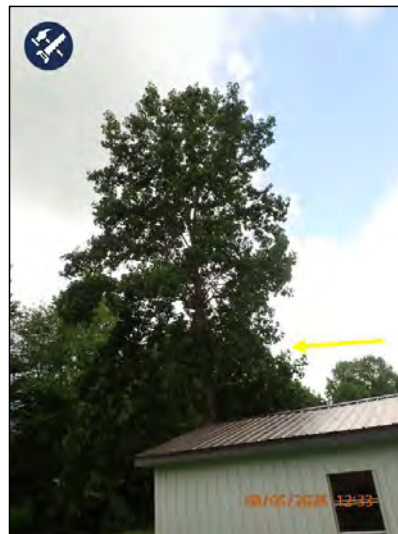
Tree Overhanging Roof/Against Siding

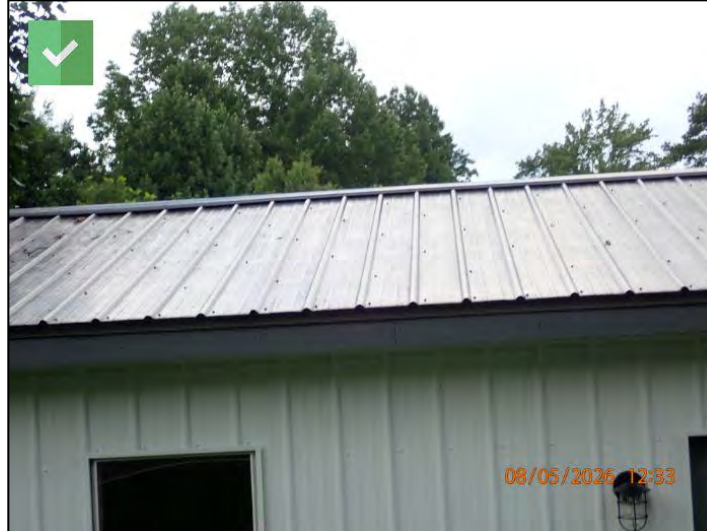
- **NOTE:** The average lifespan of metal standing seamed roofs can range from 30-50 years depending on a number of factors (climate, adequate attic ventilation, extreme temperatures, etc.).

Metal Standing Seamed Roof

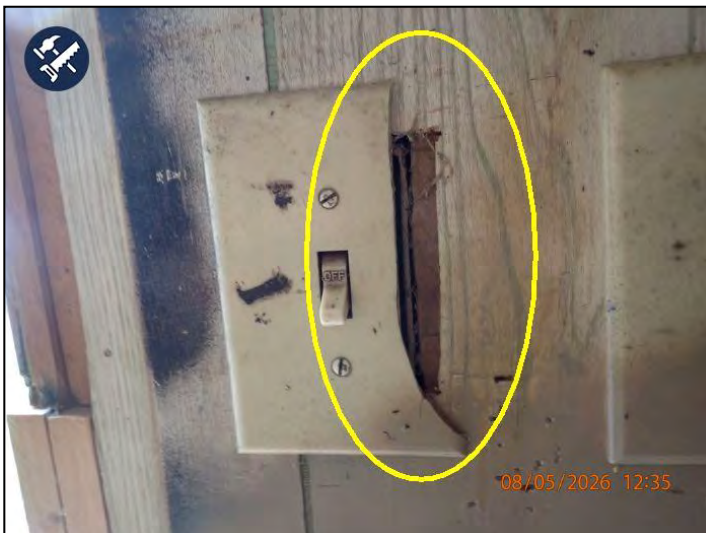
- **IMPROVE:** Damaged light switch cover(s) were observed at the time of inspection. Damaged covers can fail to protect electrical components, which may increase the risk of accidental contact, dust intrusion, and electrical hazards. Recommend a qualified contractor repair or replace the cover(s) to restore proper and safe function.
- **REPAIR:** Open junction box(es) were observed at the time of inspection. Open boxes leave splices exposed to separation, arcing, or shock. Recommend a qualified electrical contractor install proper covers to restore safe conditions and reduce the risk of fire.

Damaged Cover(s) (Multiple Locations)

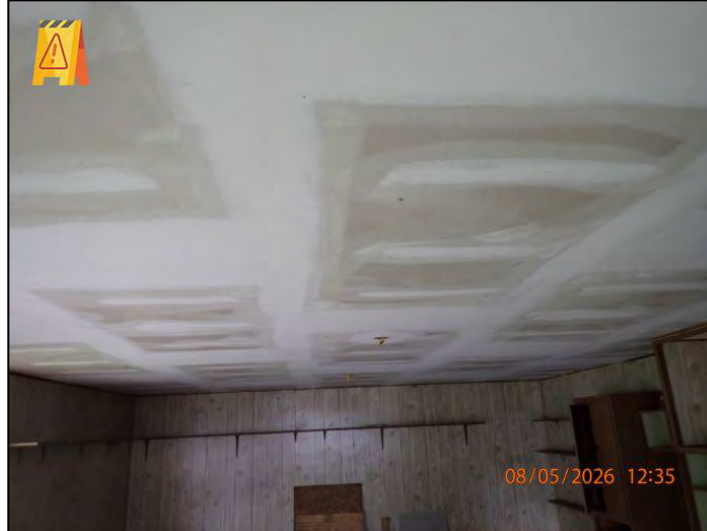
- **NOTE:** The inspector could not access the attic at the time of inspection. The condition of concealed areas could not be determined.

Could Not Access/No Access/Limited Visual

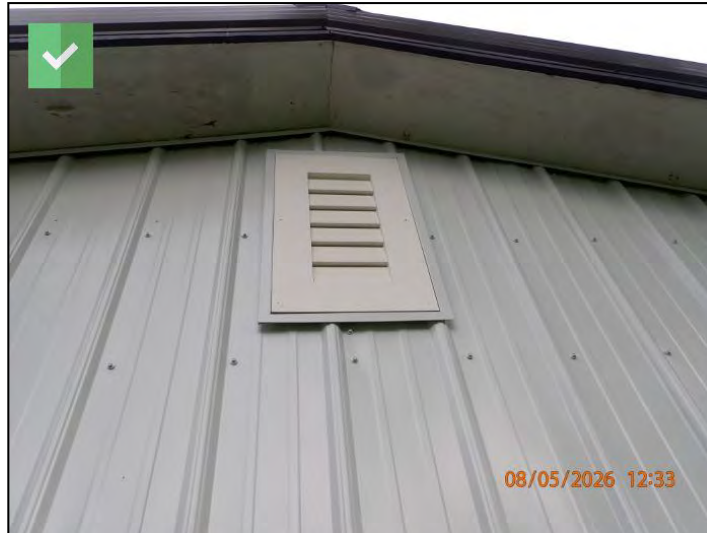
- **NOTE:** Adequate ventilation was observed at the time of inspection.

Gable Louver Vents
