V2 Plumbing

Reference Number: 20210720-18196798911
Form Name: V2 Plumbing
Submitter Name: Rynn Stolworthy (rynnstolworthy) | rynnstolworthy
Submission Date: Jul 20, 2021 11:26:22 AM MST
Location:

LEAK DETECTION REPORT

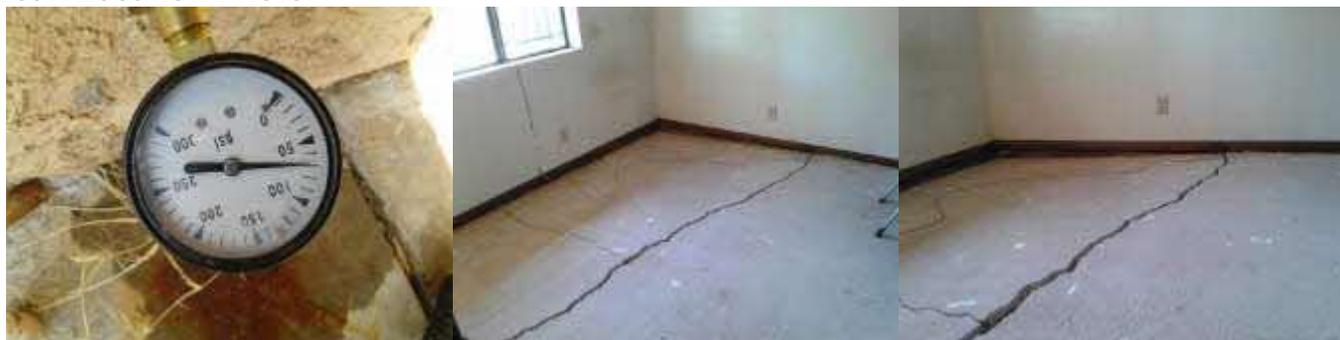
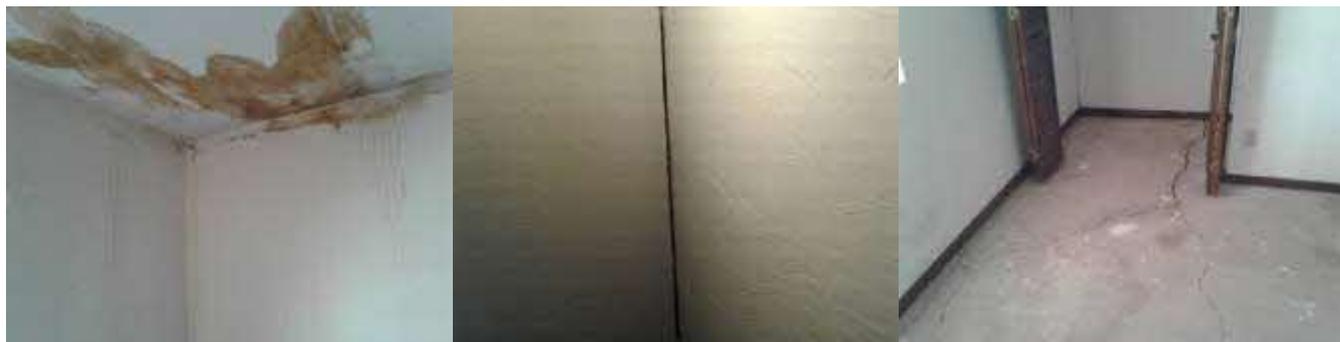
Domestic plumbing of home is fine. Northern most bedroom floor is cracked and has sunk. It also has affected the closet of next room in front of house as well. Sinking room is not due to a leak in domestic plumbing. There is no sewer plumbing in this area either. Traced out sewer from street and found sewer enters into home between garage door and window in middle of home. There are no sewer clean outs to perform a sewer static test and if this is needed, clean outs will need to be installed. I do not know if there is a sewer issue but sewer is not in area of shifting. Homeowner is aware and will consider whether or not to do sewer testing. Cracks have been present in walls of home for years as well as the stain on ceiling in shifting room. Roof leak was fixed years ago for this stain and it doesn't get water in home any longer.
