## **DEED DESCRIPTION (BOOK 915, PAGE 399):**

DATE OF SURVEY: 7-23-2024 PROJECT: 24-07-003 scroggins

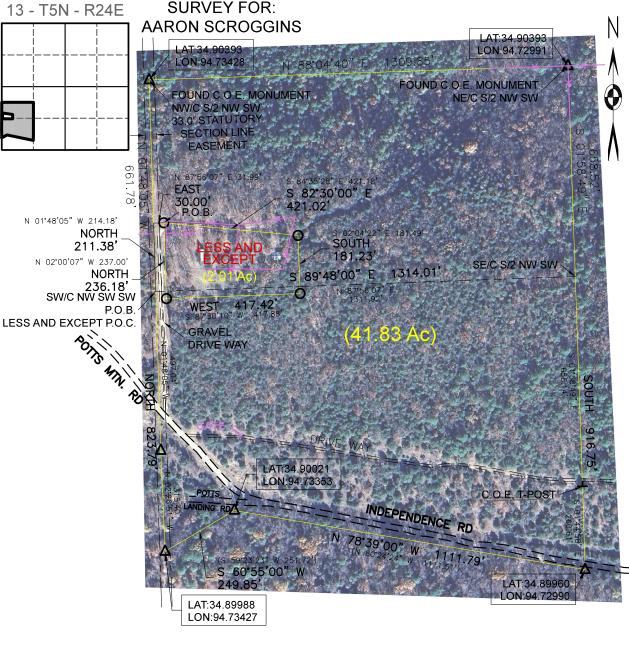
THE SOUTH HALF (S/2) NORTHWEST QUARTER (NW/4) SOUTHWEST QUARTER (SW/4) of Section Thirteen (13), Township Five North (T5N), Range Twenty-four East (R24E) and that part of the Southwest Quarter (SW/4) Southwest Quarter (SW/4) said Section Thirteen (13) beginning at the Northwest (NW) corner of said Southwest (SW) Southwest (SW) and running South 89 degrees 48 minutes East a distance of 1314.01 feet to the Northeast (NE) corner of said Southwest (SW) Southwest (SW); thence South 00 degree 21 minutes Wet a distance of 916.75 feet; thence North 78 degrees 39 minutes West a distance of 1111.79 feet; thence South 60 degrees 55 minutes west a distance of 249.85 feet to the West line of said Southwest (SW) Southwest (SW); thence North a distance of 823.79 feet to the point of beginning, LESS AND EXCEPT that part of the Southwest (SW) Northwest (NW) Southwest (SW) and part of the Northwest (NW) Southwest (SW) Southwest (SW) of said Section Thirteen (13) beginning at a point 211.38 feet North and 30.00 feet East of the Southwest (SW) corner of said Northwest (NW) Southwest (SW) Southwest (SW) and running South 82 degrees 30 minutes East a distance of 421.02 feet; thence South a distance of 181.23 feet: thence West a distance of 417.42 feet; thence North a distance of 236.19 feet to the point of beginning.

BASIS OF BEARINGS: ASSUMED S 89°48'00" E ALONG THE NORTH LINE OF THE SW SW FROM THE DEED FOUND IN BOOK 915, PAGE 399.
