Perfection Home Inspections
Mesa, AZ 85203
602-524-2916
perfectionhomeinspections.com

1646 E. Hermosa Drive

Inspected 9/4/21 8:00 AM

Inspection Summary

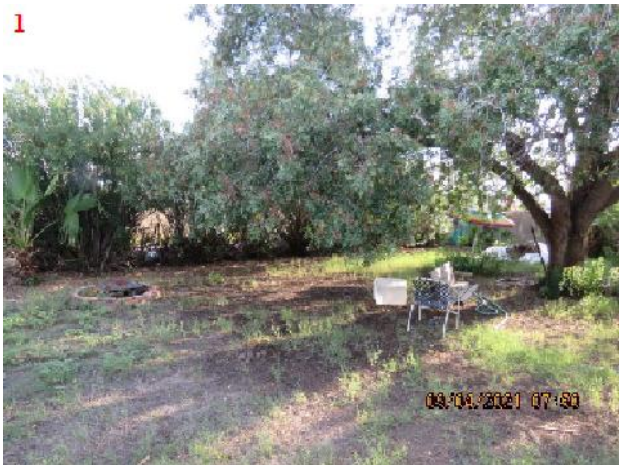
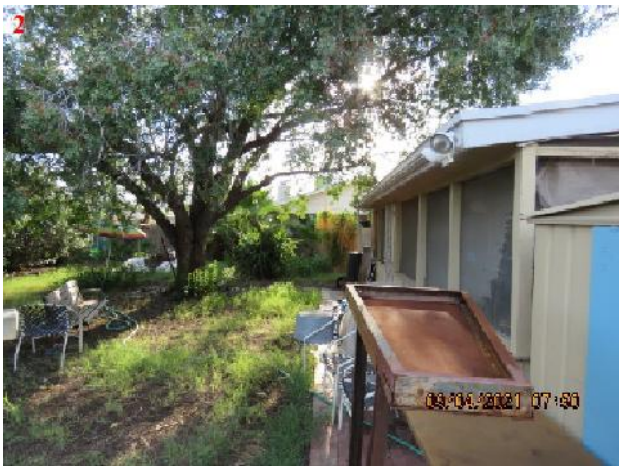
Sample picture of the back yard.

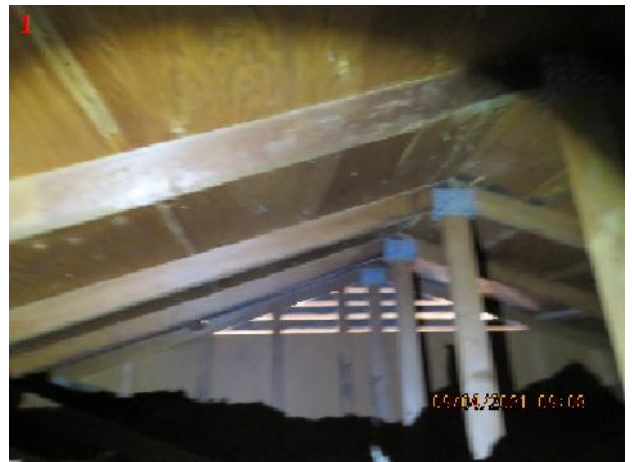
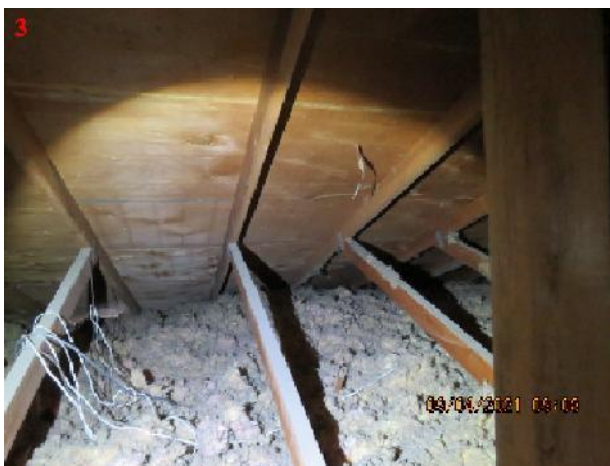
Sample pictures of the garage attic area.

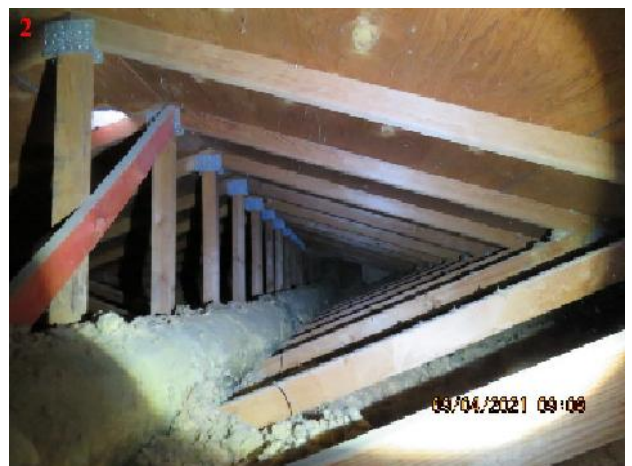
Satisfactory Attic Wiring - Covered with Insulation

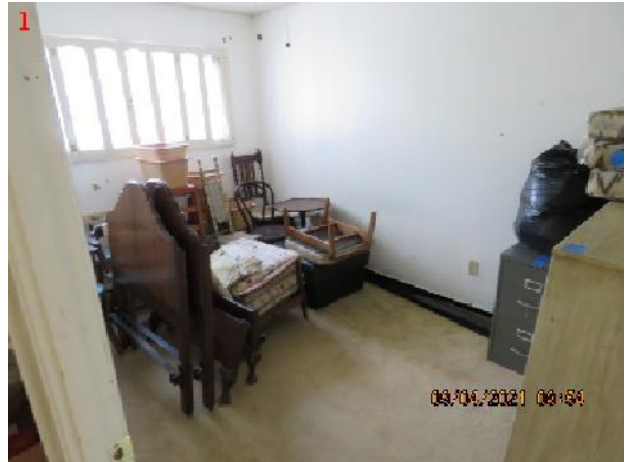
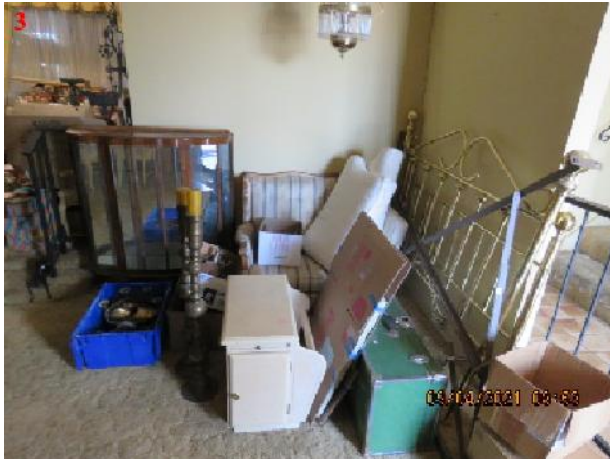
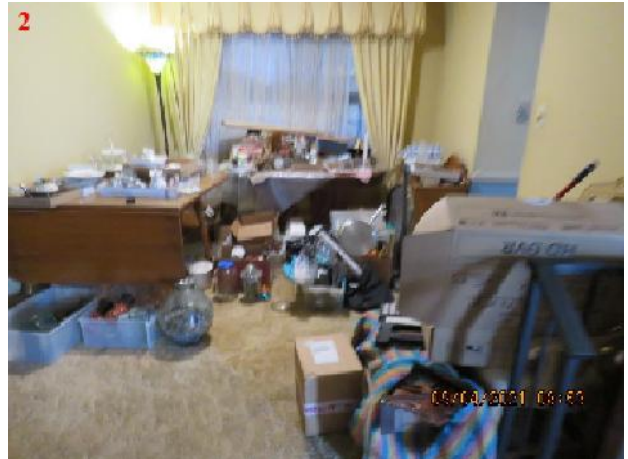
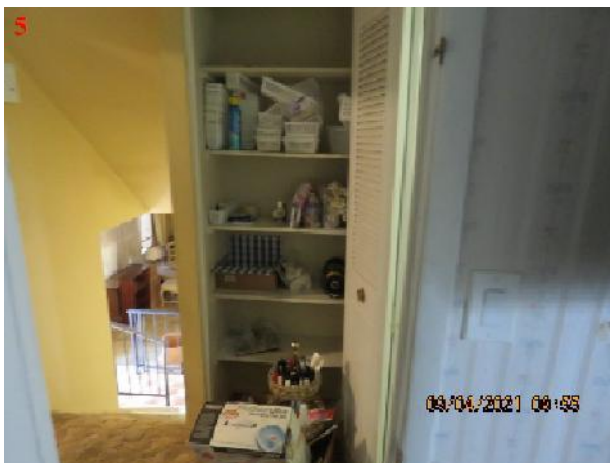
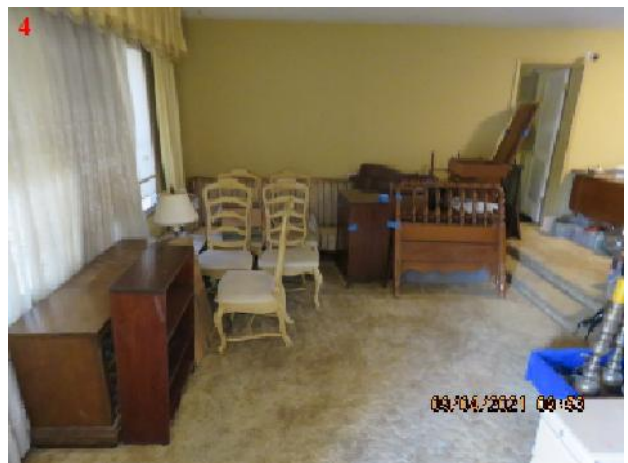
Lots of stuff in this home blocking access to area.

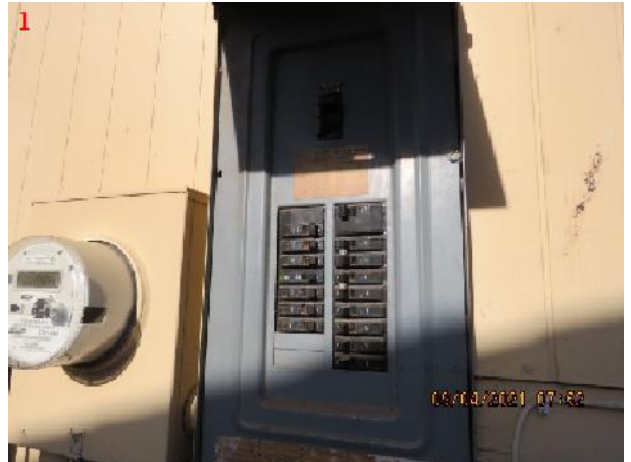
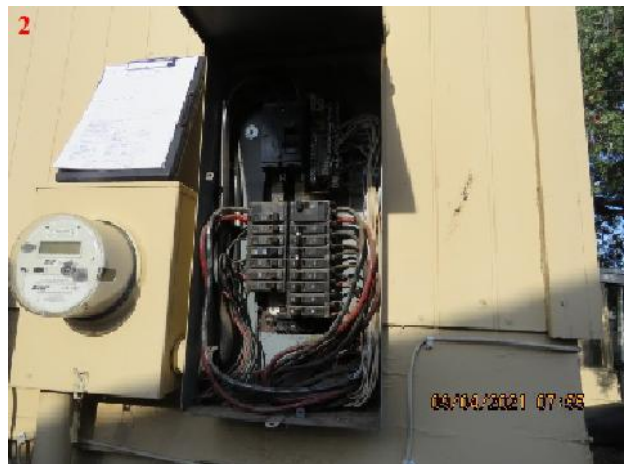
Sample picture of the main electric panel.
