Above And Beyond Home Inspection
6721 COUNTY ROAD 248
OBRIEN FL 32071
386-697-1356
HOMEINSPECTOR386@GMAIL.COM

Inspection reference: 2438

Confidential Inspection Report

515 NW Lake Lona Loop
Lake City FL 32055

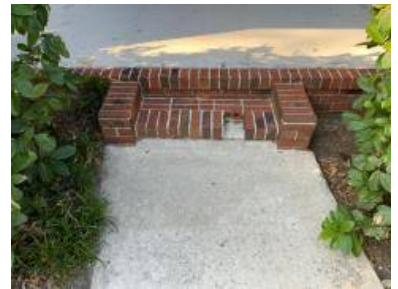
☐ ☐ ☒ Erosion noted.

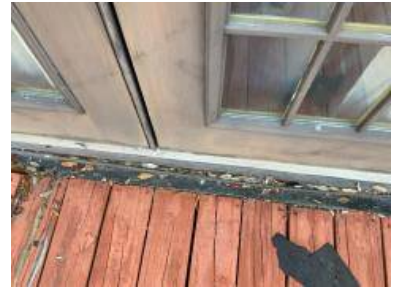
**Exterior Doors Mil***Rear Entry Door:*☐ ☐ ☒

Wood rot noted at door trim. Dead bolt lock needs adjustment.

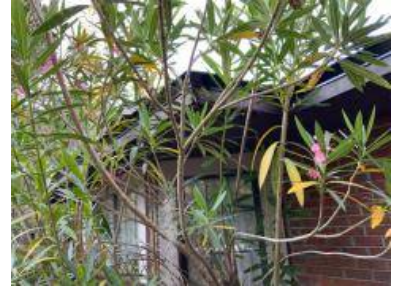
☐ ☐ ☒ Fascia rotted at front.

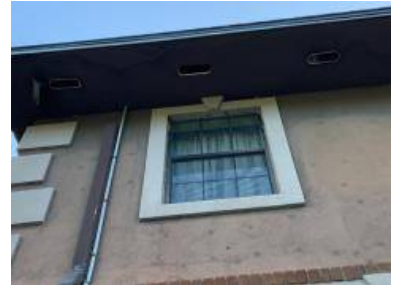
- ☐ ☒ ☐ Fascia metal is missing.

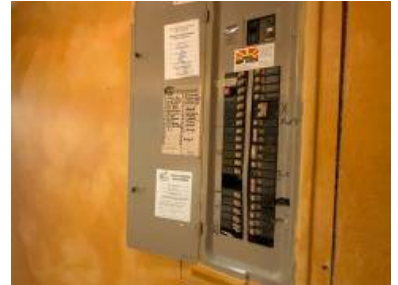
☐ ☐ ☒ Double taps and terminated wiring noted in panel.

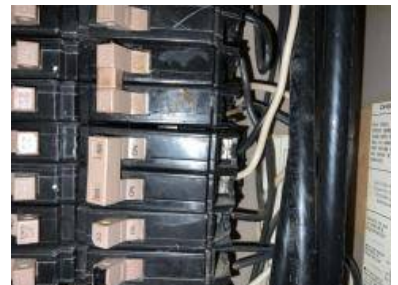
☐ ☐ ☒ Overfused.

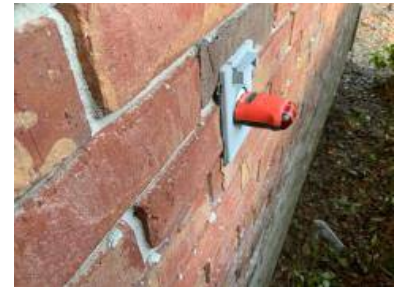
☐ ☒ ☐ Inoperable.

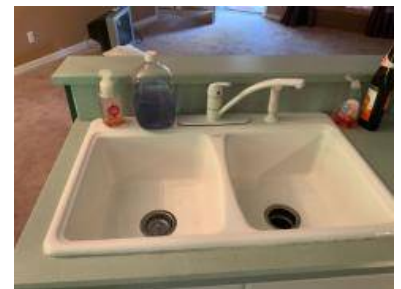
Kitchen Sink: ☐ ☒ ☐ Sprayer inoperable.
Kitchen Sink Mil ☒ ☐ ☐

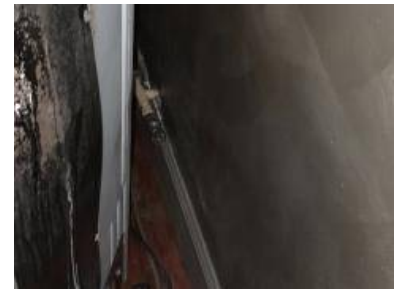
☐ ☒ ☐ No water line connected.

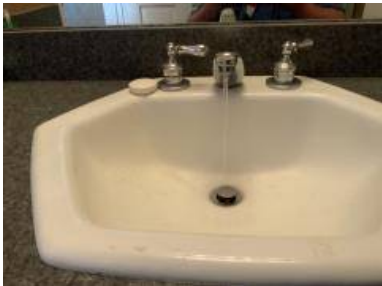
<i>Bath Between Bedrooms:</i>	<input type="checkbox"/>	<input checked="" type="checkbox"/>	<input type="checkbox"/>	Low pressure.

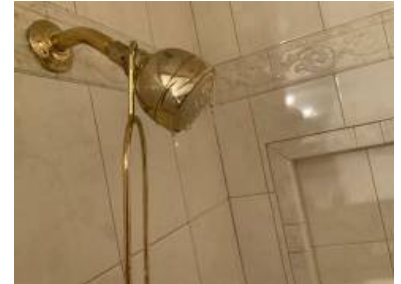
<input type="checkbox"/>	<input type="checkbox"/>	<input checked="" type="checkbox"/>	Low pressure in shower. Diversion valve will not close.
--------------------------	--------------------------	-------------------------------------	---

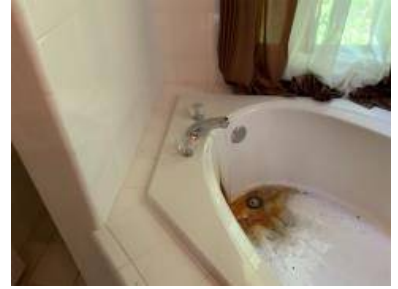
Master Bath Mil☐ ☒ ☐ Low pressure at tub.

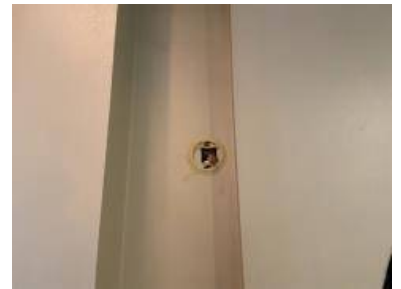
We suggest additional smoke detectors be installed in appropriate locations, Some are inoperable.
