# GUARDIAN REAL ESTATE INSPECTIONS

## PUNCHLIST INSPECTION

380 Fort Island Rd  
Eure, NC 27935

Jake Forbes  
05/22/2026

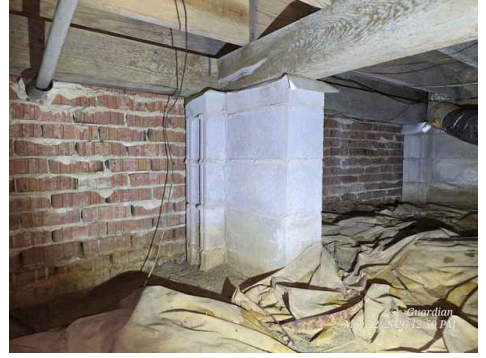
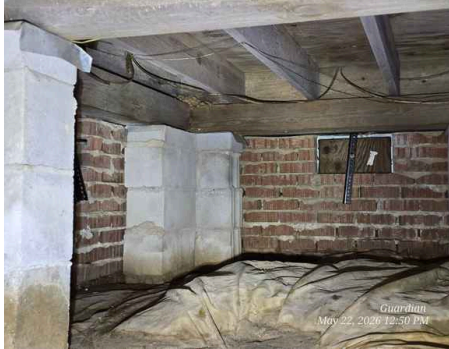
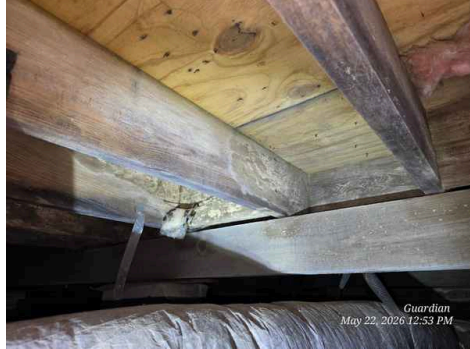
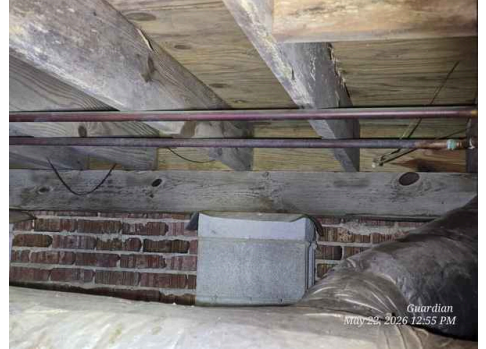
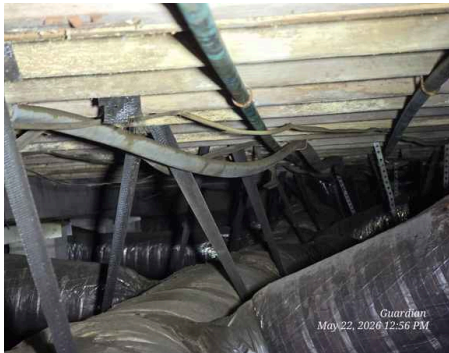
Organic growth was observed on the floor joists and subfloor throughout the crawlspace at the time of this inspection. The levels noted were not unusual for a vented crawlspace in North Carolina.

Growth was visible on multiple framing members, consistent with elevated humidity and periodic moisture exposure. The property owner reported that river water levels have risen to the foundation, and the foundation vents were covered, limiting ventilation. Only visible and accessible areas of the crawlspace were evaluated; no destructive testing or microbial identification was performed.

Organic growth in a vented crawlspace is common in humid regions; however, the reported river-level rise to the foundation and blocked vents indicate conditions that may be contributing to persistent moisture retention. Prolonged elevated moisture can lead to:

- Continued or worsening organic growth
- Elevated wood moisture content
- Deterioration of framing components
- Potential structural concerns if moisture levels remain high

Given the environmental conditions and the extent of visible growth, further assessment is warranted.

Recommend a full evaluation of the floor structure and wood moisture levels by a qualified foundation contractor. Based on findings, appropriate moisture-mitigation protocols—such as drainage improvements, ventilation correction, vapor-barrier installation, or encapsulation—should be outlined and performed by a licensed contractor to reduce moisture levels and prevent recurrence.

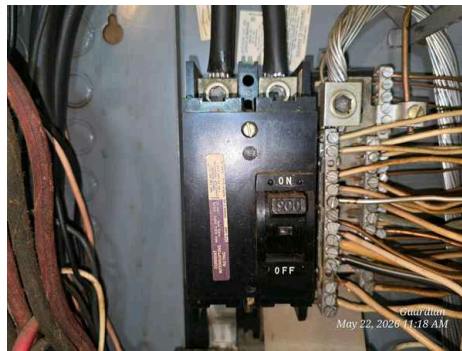
**Main Panel: Panel Capacity & Voltage**  
200 AMP

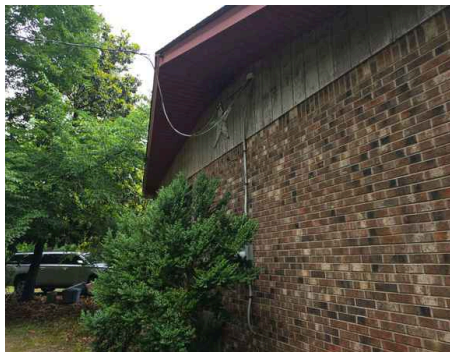
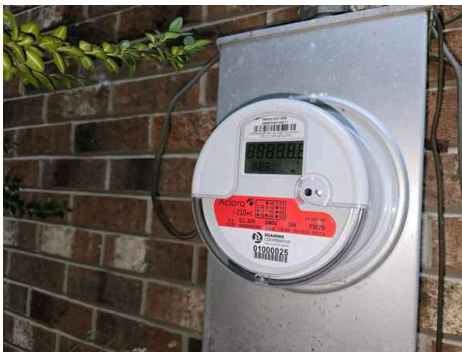
**Main Panel: Grounding Type**  
Driven Rod (Soil)

**Main Service: Electrical Service Conductors**  
Overhead

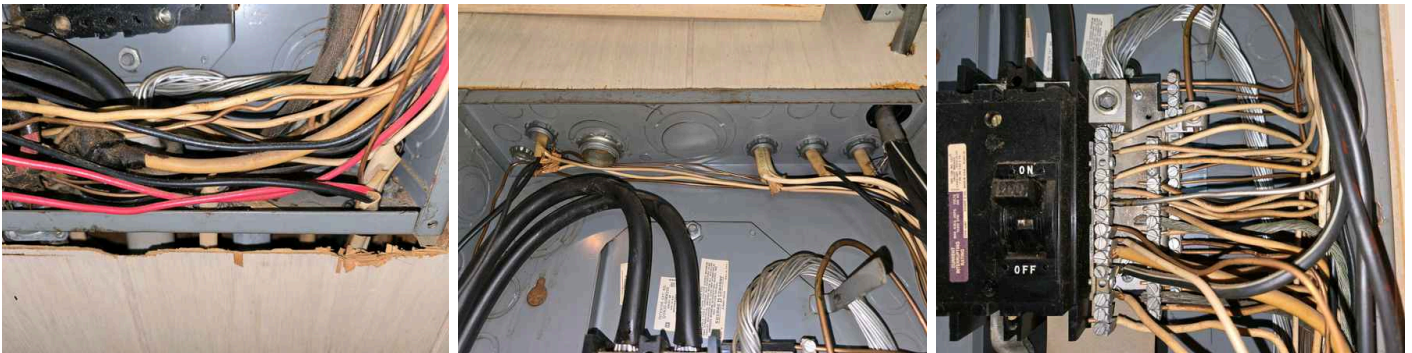
**Main Panel: Wiring Method**

Non-Metallic (Plastic)

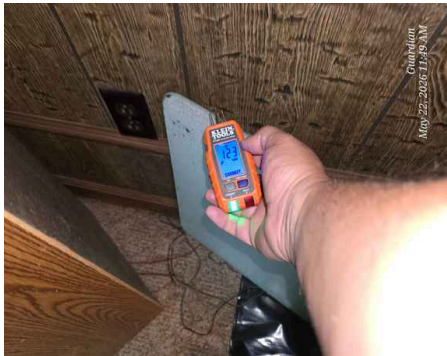
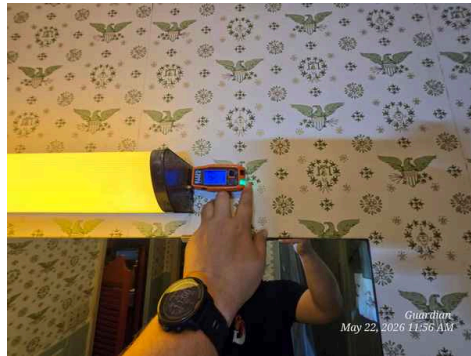
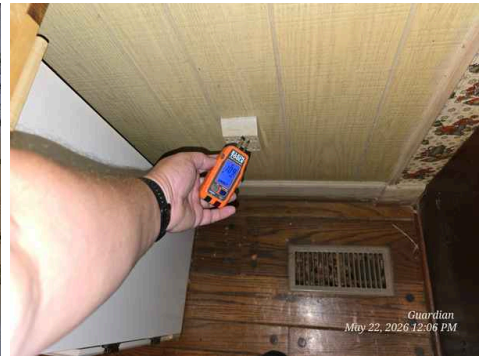
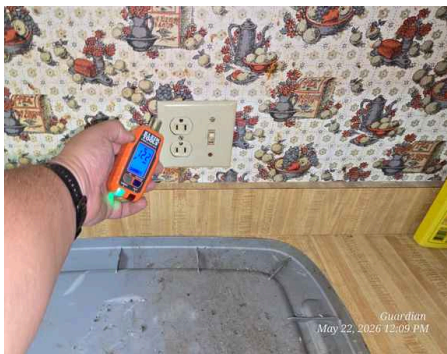
Exterior, Interior

Tested all accessible receptacles at the time of this inspection. Interior receptacles tested with 120V and proper grounding.

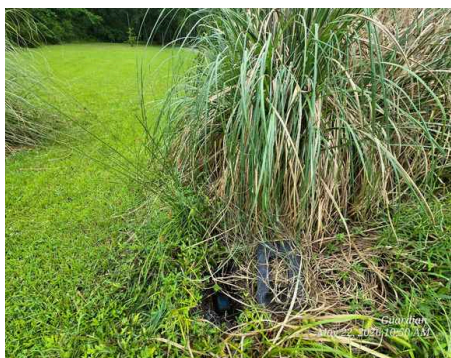
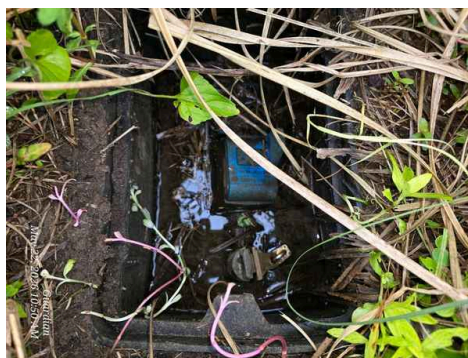
**Water Supply: Main Shut-Off**  
Utility Service Connection

The water utility shut-off was observed to be locked by the utility company at the time of this inspection.

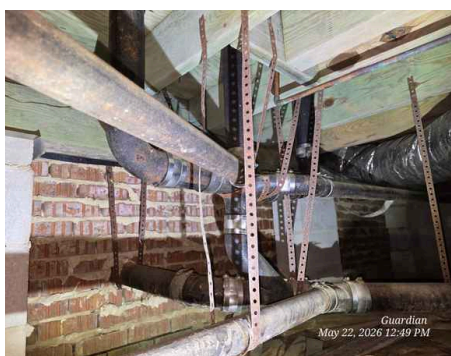
**Drain, Waste, & Vent Systems: Material**  
Cast Iron

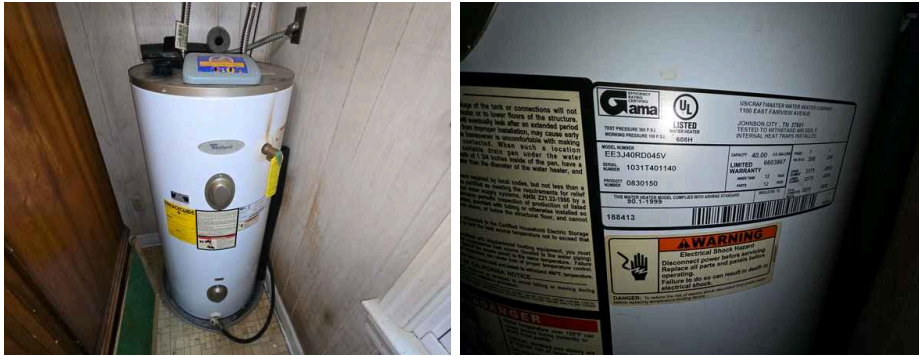
## Water Heater: Location

Utility Room

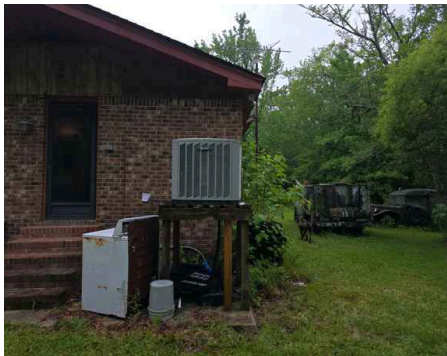
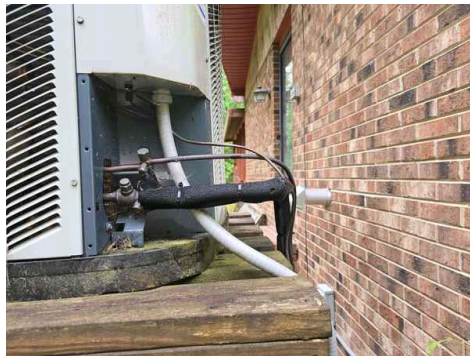
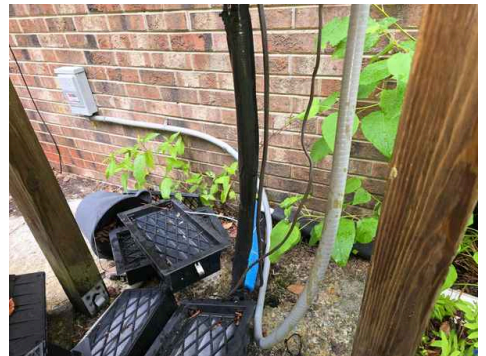
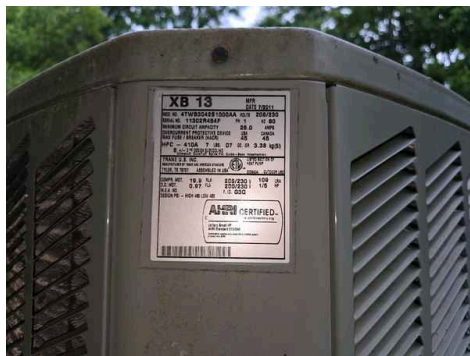
### Cooling Equipment: Location of Condensers

Exterior Rear of Structure

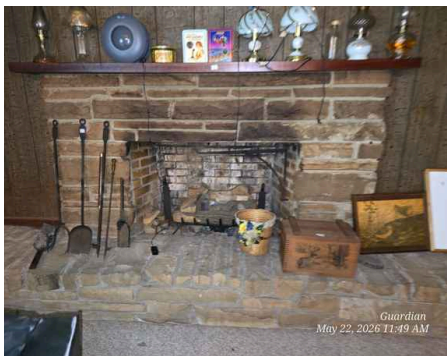
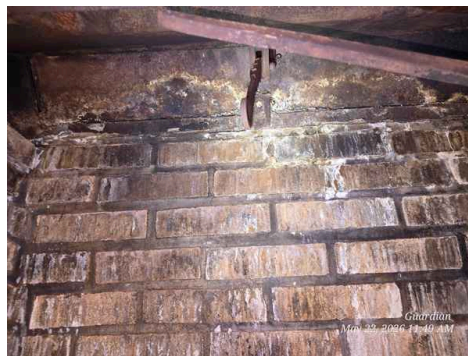
### Fireplace, Stove: Location

Living Room

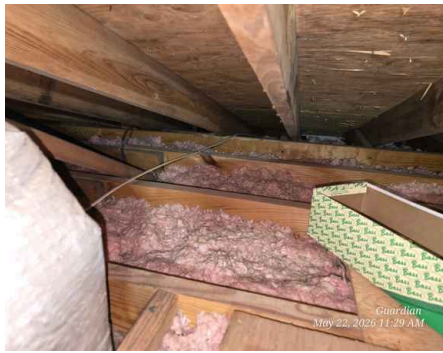
### Insulation and Ventilation: Attic Insulation

Fiberglass: Loose

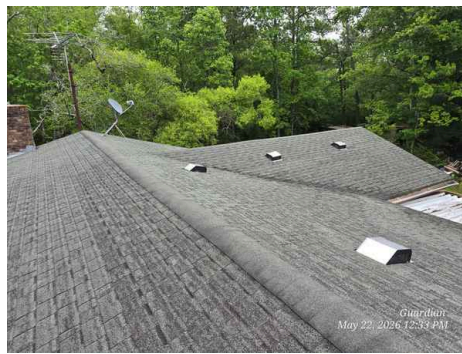
### Insulation and Ventilation: Attic Ventilation

Soffit Vents, Gable Vents, Roof Vent

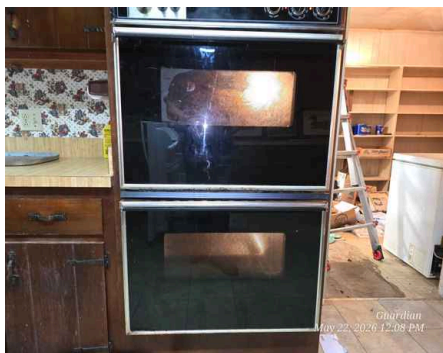
**Range/Oven: Cooktop Energy Source**  
Electric

**Range/Oven: Oven Energy Source**    **Dryer: Power Source**  
Electric    Electric
