# Inspection Report

119 Currituck Drive  
Hertford NC 27944

**Home Spec of NC, Inc.**

<b>Date:</b> 4/10/2024	<b>Time:</b> 09:30 AM	<b>Report ID:</b> 2404101
<b>Property:</b> 119 Currituck Drive Hertford NC 27944	<b>Customer:</b> Mr. Arie van der Meulen	<b>Real Estate Professional:</b> Jake Forbes United Country

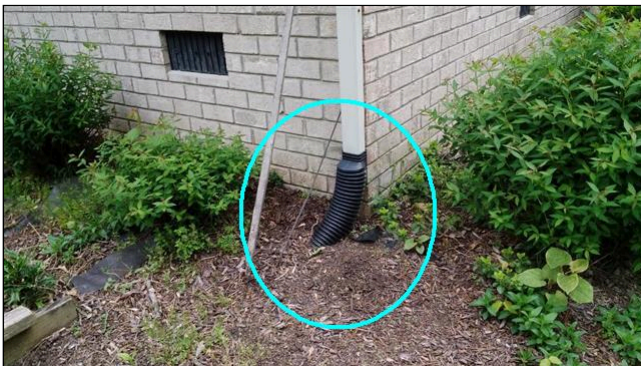
1.3 Item 1(Picture)

1.3 Underground drains are present. Item 1(Picture)

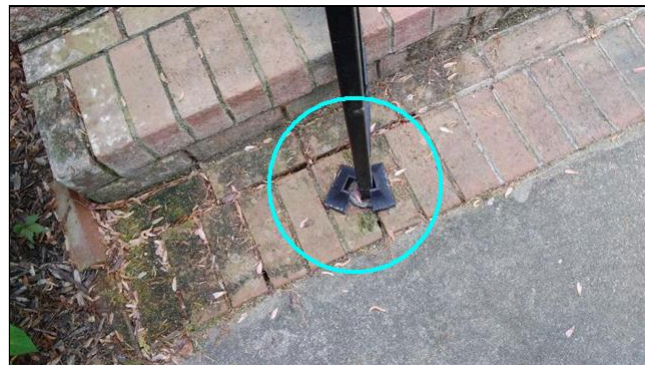
2.3 Item 2(Picture)

🏠 **2.3** (1) Front metal railings are loose at their attachment to the masonry. Item 1(Picture) Item 2(Picture) Item 3(Picture)

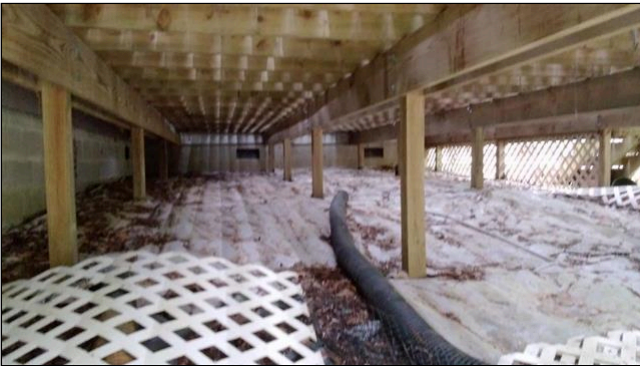
2.3 Item 4(Picture)

(2) Picture of the structure under the rear deck. Item 4(Picture)

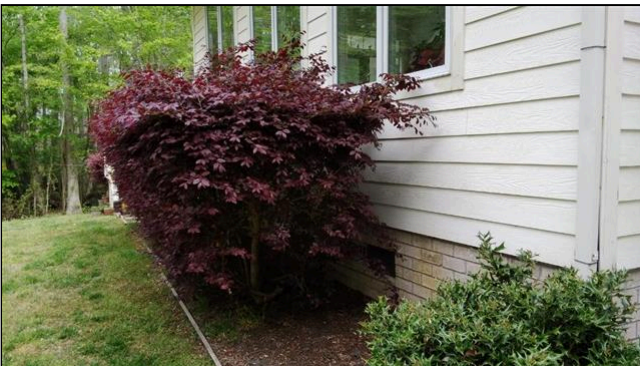
2.4 Item 1(Picture)

Maintain trimming of all plant materials away from the house, roof, outbuildings, and all mechanical system equipment. Examples: Item 1(Picture) Item 2(Picture)

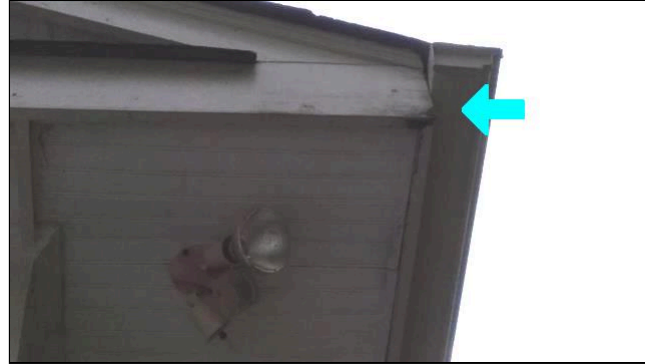
2.5 Item 2(Picture)

Rear fascia corner shows moisture damage. Item 2(Picture)

Refer to a siding contractor for full evaluation and all necessary repairs or replacement.

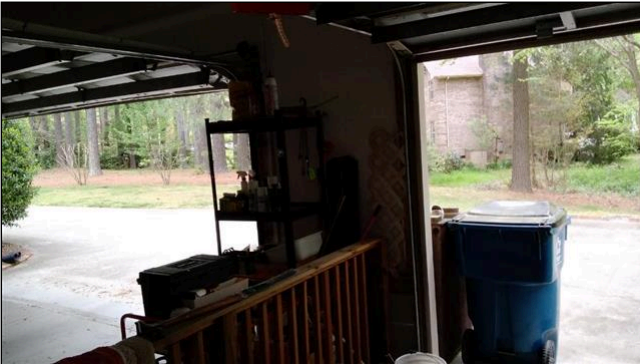
3.3 Item 1(Picture)

3.3 Functioned as intended. Item 1(Picture) Item 2(Picture)

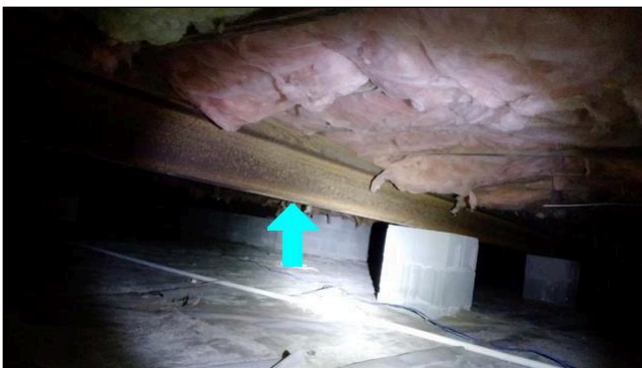
5.3 Item 1(Picture)

**5.3** Steel I-Beams and floor trusses are present. Item 1(Picture) Item 2(Picture) Item 3(Picture) Item 4(Picture)

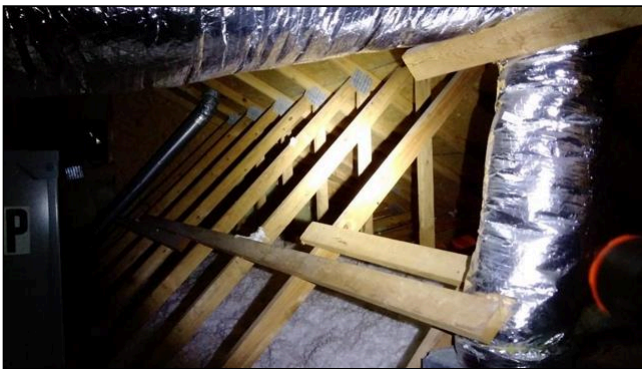
5.5 Item 1(Picture)

5.5 Roof structure consists of wooden trusses and OSB sheathing. (Picture1) Item 2(Picture) Item 3(Picture) Item 4(Picture) Item 5(Picture)

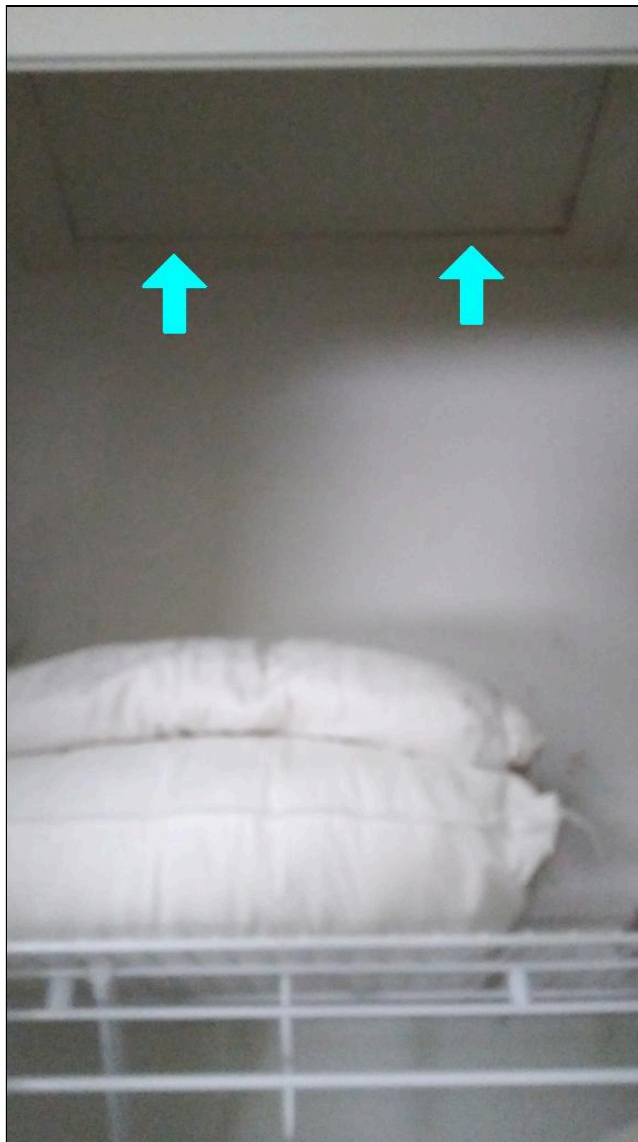
5.5 Item 6(Picture)

There is a hatch for entry to the left side attic space in a bedroom closet. Item 6(Picture) The vaulted living room divides the attic spaces.

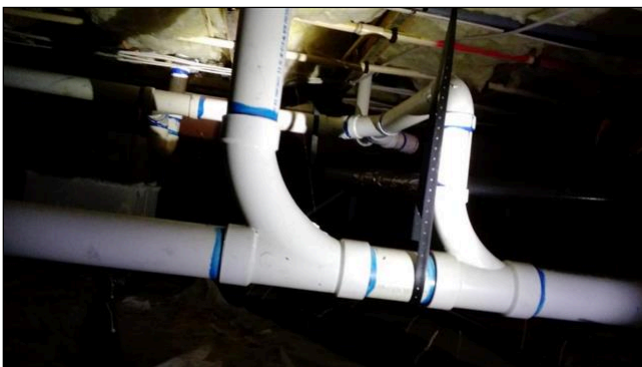
6.0 Item 1(Picture)

6.0 PVC material has been used for the drain and waste piping. Item 1(Picture)

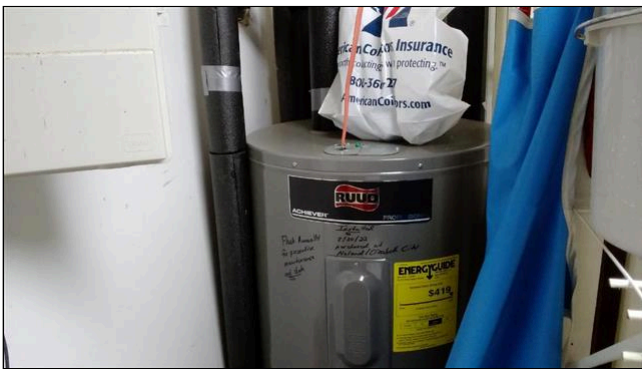
6.3 Item 1(Picture)

6.3 Ruud brand, 50 gallon, 2022, electric water heater. Item 1(Picture) Item 2(Picture) Item 3(Picture)

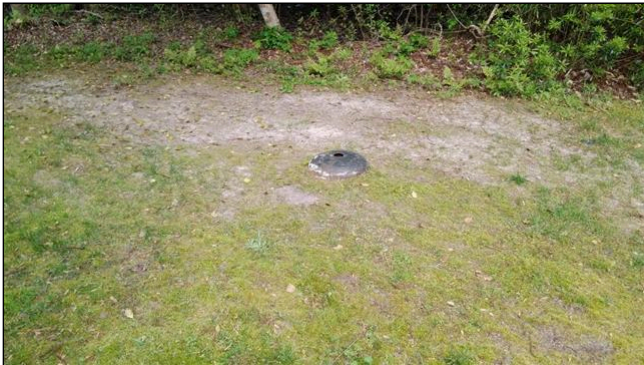
6.5 Item 1(Picture)

**6.5** Fuel storage and shut-off are both located at the propane tank in the yard. Item 1(Picture)

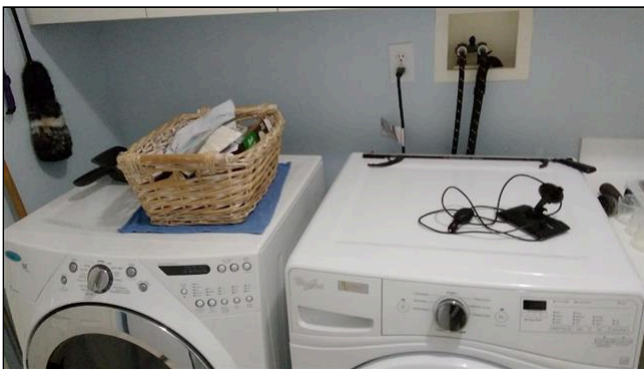
6.6 Item 1(Picture)

**6.6** Basic washer and dryer water and electric connections are present. Item 1(Picture)

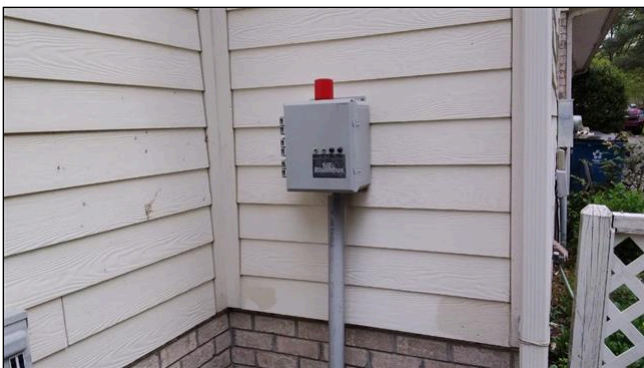
6.8 Item 1(Picture)

**6.8** This home has a holding tank and an alarm system present. This system was not evaluated. Item 1(Picture)  
Item 2(Picture)

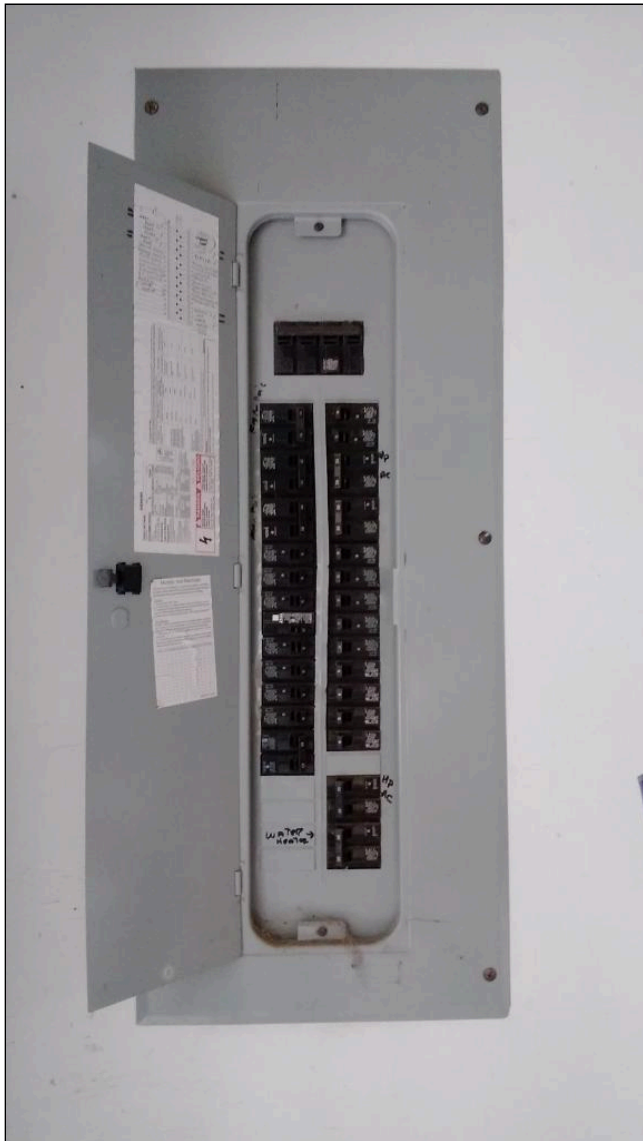
7.1 Item 1(Picture)

7.1 The main panel box is located in the garage. There were no sub-panels found. The panel was opened for observation. Item 1(Picture) Item 2(Picture) Item 3(Picture)

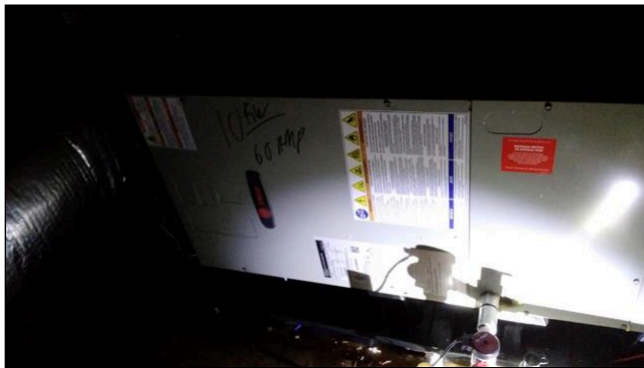
8.0 Item 1(Picture)

8.0 Trane, 2017, 2 1/2 ton capacity split system heat pump. Item 1(Picture) Item 2(Picture) Item 3(Picture)

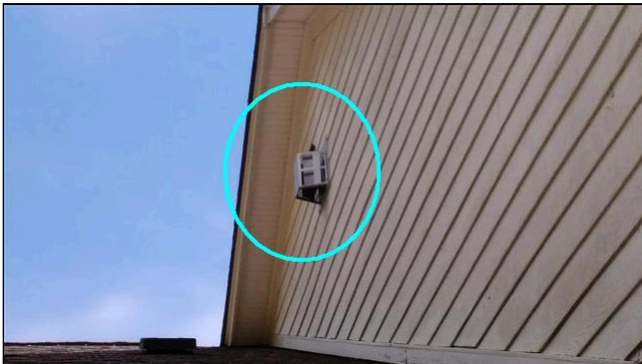
8.6 Item 1(Picture)

8.6 Gas fireplace vent. Item 1(Picture)

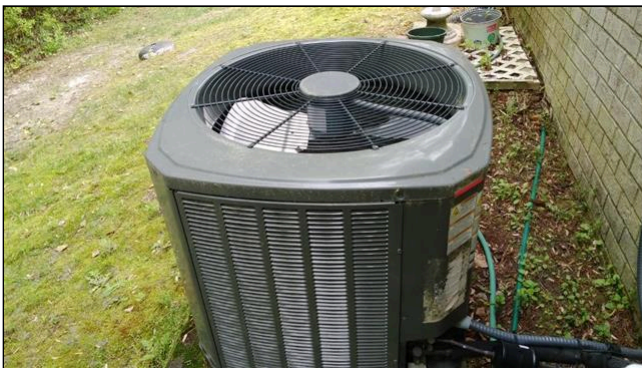
8.8 Item 1(Picture)

8.8 (1) Trane, 2017, 2 1/2 ton capacity split system heat pump. Item 1(Picture) Item 2(Picture)

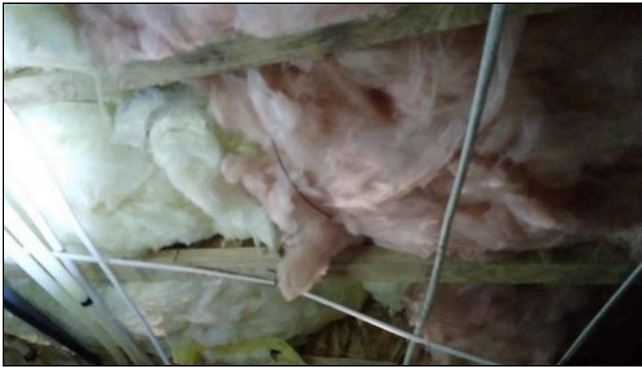
9.1 Item 1(Picture)

9.1 Fiberglass batting is present as a floor system insulation material. Item 1(Picture)

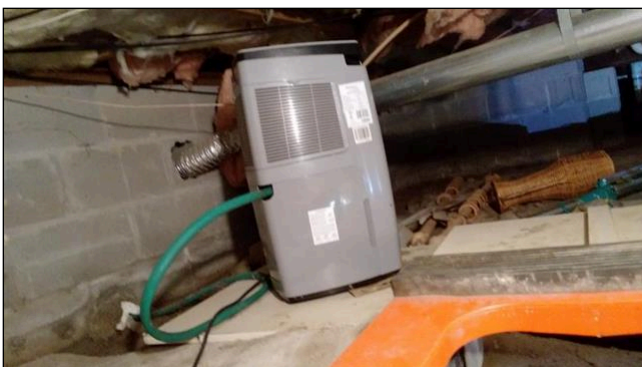
9.3 Item 1(Picture)

9.3 A dehumidifier is present in this crawl space. Item 1(Picture)

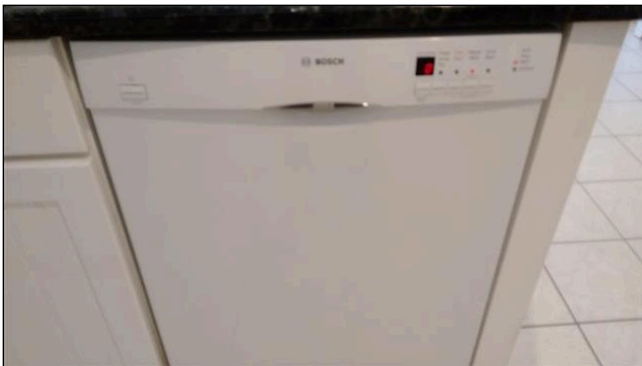
10.0 Item 1(Picture)

10.0 Functioned as intended. Item 1(Picture) Item 2(Picture)

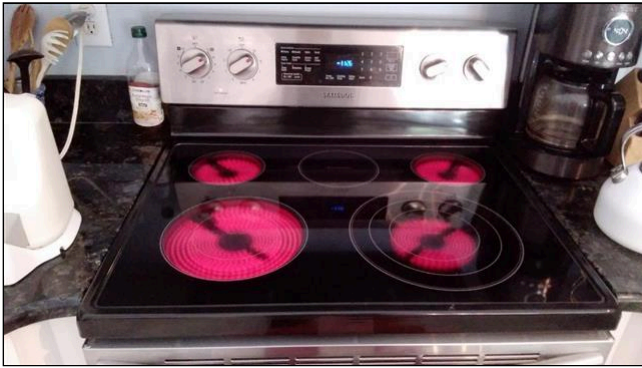
10.1 Item 1(Picture)

10.1 Functioned as intended. Item 1(Picture) Item 2(Picture)

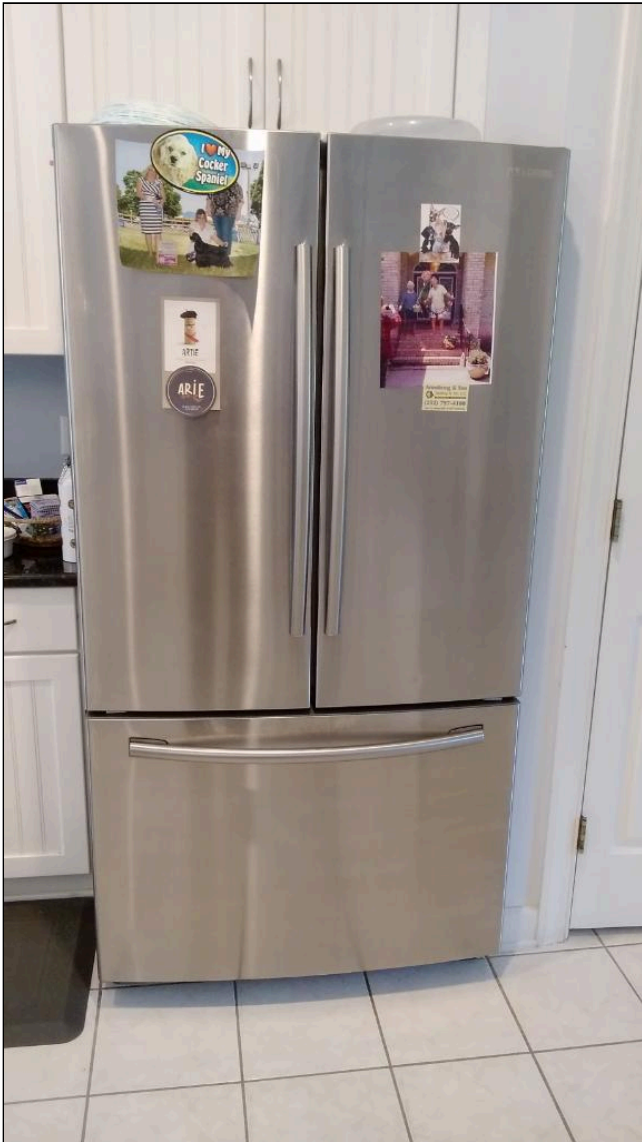
10.3 Item 1(Picture)

10.3 Functioned as intended. Item 1(Picture) Item 2(Picture)

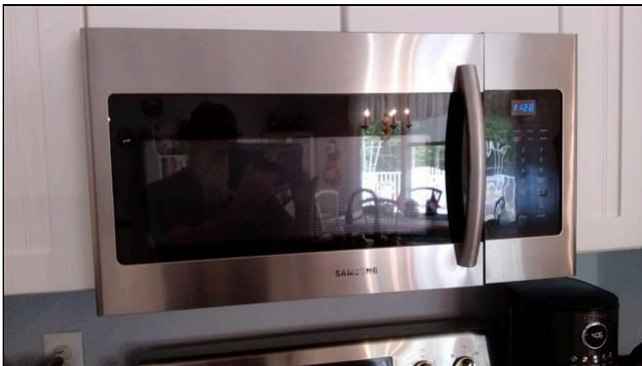
10.4 Item 1(Picture)

10.4 Functioned as intended. Item 1(Picture) Item 2(Picture)
